7011 RETAIN TIPS  
(as of 05/16/98 at 07:36:33 EDT )

RETAIN Technical Data

May 16, 1998

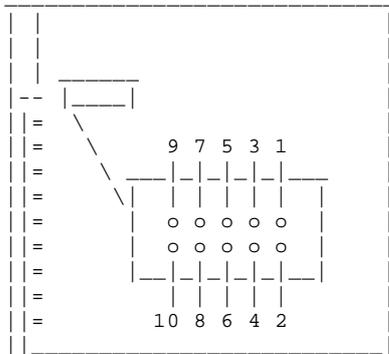
VALID ADDRESSES

Due to the End of Manufacturing of the 540MB disk drive, P/N51G8237 will sub to a different drive. The replacement drive that will be used when the sub takes place will be the 2.2GB drive, P/N74G6996. The form factor will remain constant, however the address jumper setting will be different. Use the following table when setting the address jumpers on the replacement drive.

Address	Jumper 5 - 6	Jumper 3 - 4	Jumper 1 - 2
0	OFF	OFF	OFF
1	OFF	OFF	ON
2	OFF	ON	OFF
3	OFF	ON	ON
4	ON	OFF	OFF
5	ON	OFF	ON
6	ON	ON	OFF

(top view)
