7012 RETAIN TIPS  
(as of 05/09/98 at 09:00:46 EDT )

RETAIN Technical Data

May 9, 1998

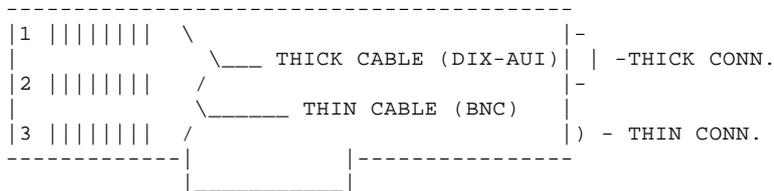
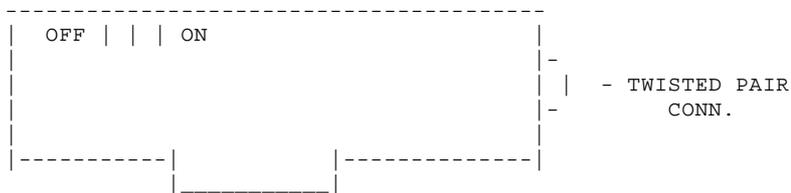
ETHERNET RISER CARD REQUIRE THE CORRECT JUMPER SETTINGS TO ENSURE ETHERNET OPERATION. THERE ARE 3 ROWS OF 8 JUMPER PINS. REFERENCING FROM THE TOP OF THE RISER CARD POSITION 1 IS THE TOP MOST ROW (FARTHEST AWAY FROM MICROCHANNEL I/O CONTACTS).

ALL 8 JUMPERS MUST BE FROM ROW 1 TO ROW 2 WHEN USING THICK CABLE  
 ALL 8 JUMPERS MUST BE FROM ROW 3 TO ROW 2 WHEN USING THIN CABLE  
 IF INSTALLING TWISTED PAIR ETHERNET CARD ASK CUSTOMER IF " LINK  
 INTEGRITY " WILL BE USED. THE SINGLE JUMPER MUST BE SET IN THE  
 RIGHT TWO PINS FOR LINK INTEGRITY TO BE " ON " OR THE LEFT  
 TWO PINS FOR LINK INTEGRITY TO BE " OFF " .

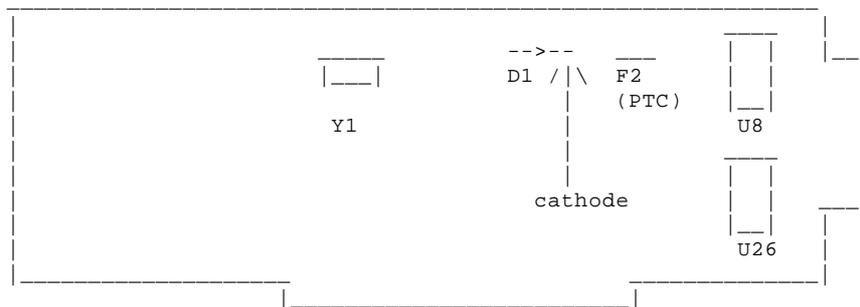
STEP 2. LOCATE BELOW DIODE D1 AND CONNECT THE (+) POSITIVE OHM-METER LEAD TO THE CATHODE OF D1 (THE END NEAREST THE PTC F2).  
 LOCATE BELOW OCILLATOR Y1 AND CONNECT THE (-) NEGATIVE OHMMETER LEAD TO THE CAN OF Y1.

STEP 3. IF BOTH DIFFERENTIAL TERMINATORS ARE INSTALLED ON THE ENDS OF THE SCSI-2 BUS (TWO TERMINATORS ON THE ADAPTER U8 AND U26 AS WELL AS THE TERMINATOR AT THE LAST DEVICE ON THE BUS), THE RESISTANCE SHOULD INDICATE BETWEEN 19 AND 25 OHMS.

\* IF RESISTANCE IS BETWEEN 19 AND 25 OHMS THERE IS NO APPARENT CAUSE FOR THE TRIPPED PTC.

\* IF RESISTANCE IS GREATER THAN 25 OHMS, ONE OF THE BUS END TERMINATORS IS MISSING AND SHOULD BE REPLACED.

\* IF RESISTANCE IS LESS THAN 19 OHMS, TROUBLE SHOOT THE SYSTEM BY DISCONNECTING CABLES, TERMINATORS AND THE DEVICES ATTACHED TO THE BUS UNTIL THE CAUSE OF THE LOW RESISTANCE IS FOUND.

1. MORE THAN TWO TERMINATORS ON THE BUS.
2. A SHORTED TERMINATOR OR CABLE. (CHECK FOR BENT PINS)
3. INTERMITTENT PTC TRIPPING MAY BE DUE TO A SHORTED CABLE OR IMPROPERLY SEATED CABLE CONNECTOR.
4. A SHOTED DEVICE
5. MISSING ON CARD TERMINATORS U8 AND U26. (TERMINATORS SHOULD

\*\*\*\*\*  
 DO NOT REPLACE THE SCSI-2 DIFFERENTIAL ADAPTER BECAUSE THE PTC HAS TRIPPED. USE THE FOLLOWING ISOLATION PROCEDURE TO LOCATE THE CABLE, TERMINATOR, OR DEVICE ON THE EXTERNAL BUS CAUSING THE PTC TO TRIP.  
 \*\*\*\*\*

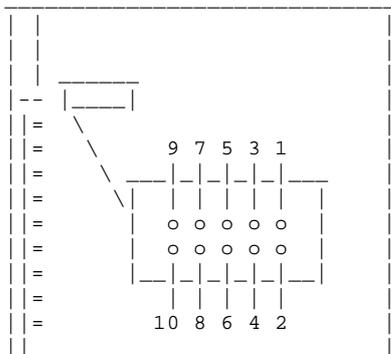
VALID ADDRESSES

Due to the End of Manufacturing of the 540MB disk drive, P/N51G8237 will sub to a different drive. The replacement drive that will be used when the sub takes place will be the 2.2GB drive, P/N74G6996. The form factor will remain constant, however the address jumper setting will be different. Use the following table when setting the address jumpers on the replacement drive.

Address	Jumper 5 - 6	Jumper 3 - 4	Jumper 1 - 2
0	OFF	OFF	OFF
1	OFF	OFF	ON
2	OFF	ON	OFF
3	OFF	ON	ON
4	ON	OFF	OFF
5	ON	OFF	ON
6	ON	ON	OFF
