# Pentium<sup>®</sup> Processor Specification Update

Release Date: January, 1997

Order Number 242480-024

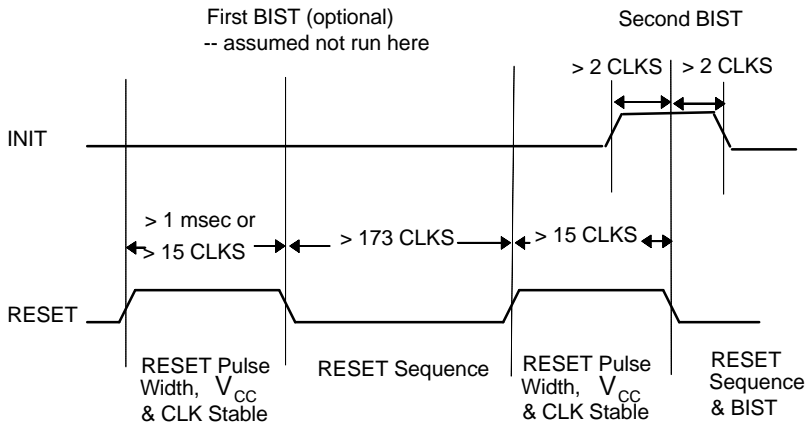
**IMPLICATION:** The BIST may report an incorrect signature indicating self-test failure even though the processor may not be faulty.

1. Invoke a double RESET — All false BIST failures have occurred during cold RESET. In order to accurately execute BIST, a double RESET sequence may be performed as shown in the figure below:

The first RESET pulse is used to ensure that all logic used in the BIST test is correctly initialized; optionally, INIT may be driven high to enter BIST at the falling edge of the first RESET. In this case the results of the first BIST should be ignored.

After deassertion of the first RESET pulse, a minimum of 173 clocks must elapse before assertion of the second RESET. (Note that if BIST was entered at the end of the first RESET, this 173-clock requirement is satisfied by the time required to complete the first BIST.) During the second RESET, INIT is toggled high in order to run the 'real' BIST. This BIST correctly returns results in EAX.

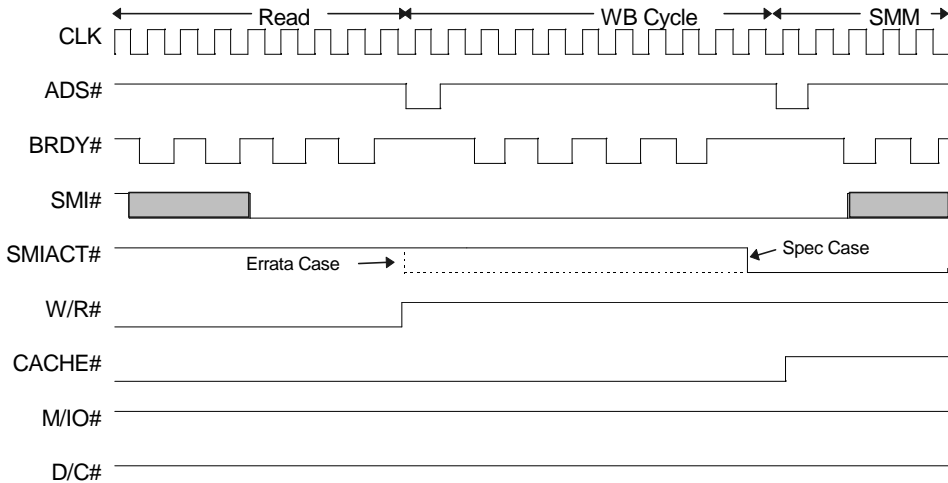
Before the processor asserts SMI $\overline{ACT\#}$  in response to an SMI $\#$  request, it should complete all pending write cycles (including emptying the write buffers). However, if the appropriate conditions occur, the SMI $\overline{ACT\#}$  signal may get asserted during the replacement writeback cycle, at anytime during the writeback cycle. See below diagram.

**IMPLICATION:** If the SMI $\overline{ACT\#}$  signal is used by the system logic to decode SMRAM (e.g., SMRAM is located in an area that is overlaid on top of normal memory space, e.g. system, video etc.), then the replacement writeback cycle with SMI $\overline{ACT\#}$  asserted could occur to SMM space. Systems that locate SMRAM in its own distinct memory space (non-overlaid) should not experience data corruption once the SMRAM has been initialized and relocated.

Some board designs and/or chip sets may contain logic which locks when an SMI $\overline{ACT\#}$  is asserted during the writeback cycle. This is logic dependent and not all systems will fail when this condition occurs, although data corruption could still result.

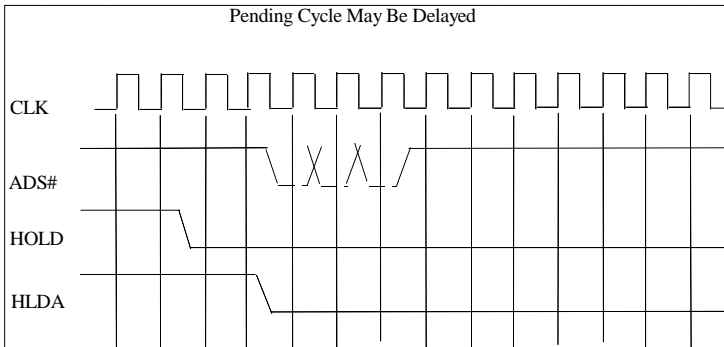
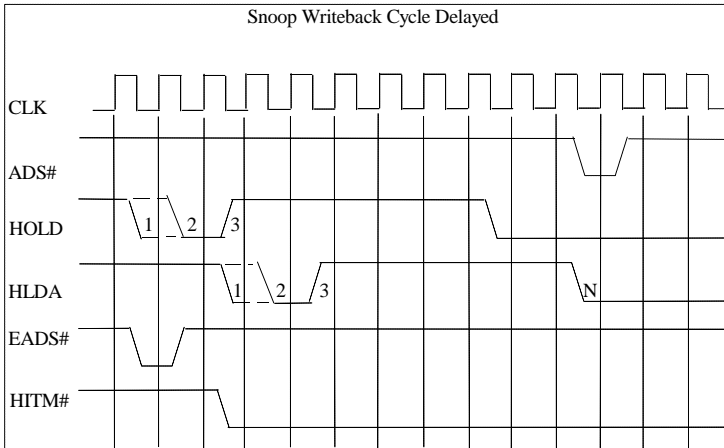
**PROBLEM:** The Pentium processor typically starts a pending bus cycle on the same clock that HLDA is deasserted. However, it may be delayed by as many as two clocks. See the diagram below.

In two cases, for example, if HOLD is deasserted for one clock (i.e., clock 2) or two clocks (i.e., clocks 1 & 2) and then reasserted, the window may not be large enough to start a pending snoop writeback cycle. The writeback cycle may be delayed until the HLDA is deasserted again (i.e., clock N). See diagram below.

**IMPLICATION:** If the system expects a cycle, for example a writeback cycle, and depends on this cycle to commence within the HLDA deassertion window, then the system may not complete the handshake and cause a hang.

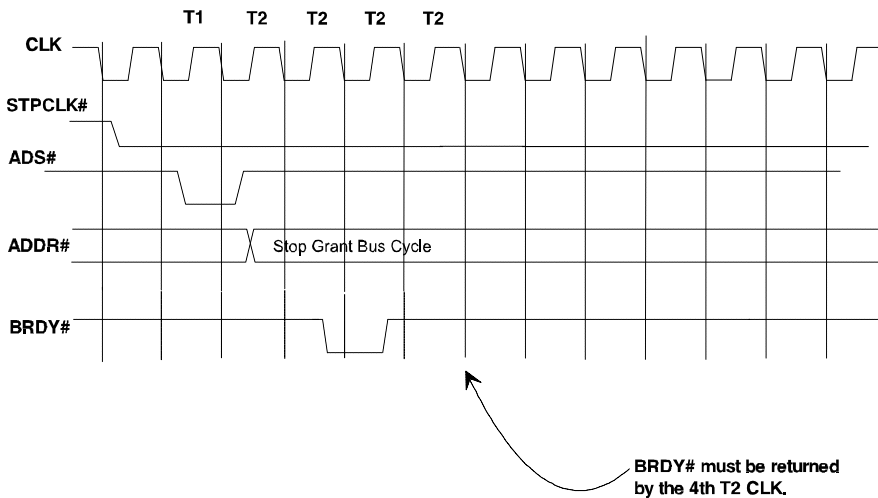
**IMPLICATION:** This problem occurs only in dual processor systems and will cause one of the processors to hang.

1. Do not assert STPCLK#.
2. Ensure that BRDY# is asserted within 4 CLKs after the Stop Grant bus cycle has begun.

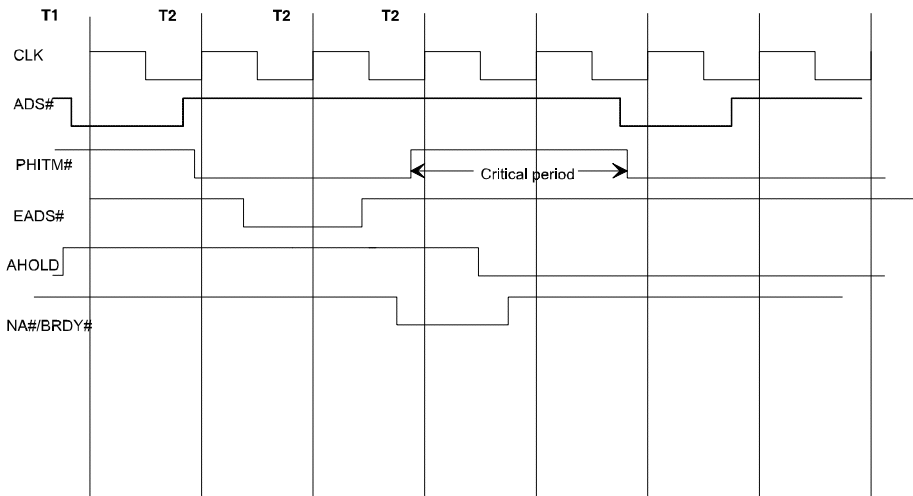
6. After the memory-write cycle is complete, the LRM performs its writeback.
7. The MRM then re-issues the memory write-cycle again. This cycle, now being issued for the third time, causes an internal hangup in the MRM.

**IMPLICATION:** If a memory write or memory read cycle is pending on the bus and an external snoop occurs, one of the processors may hang.

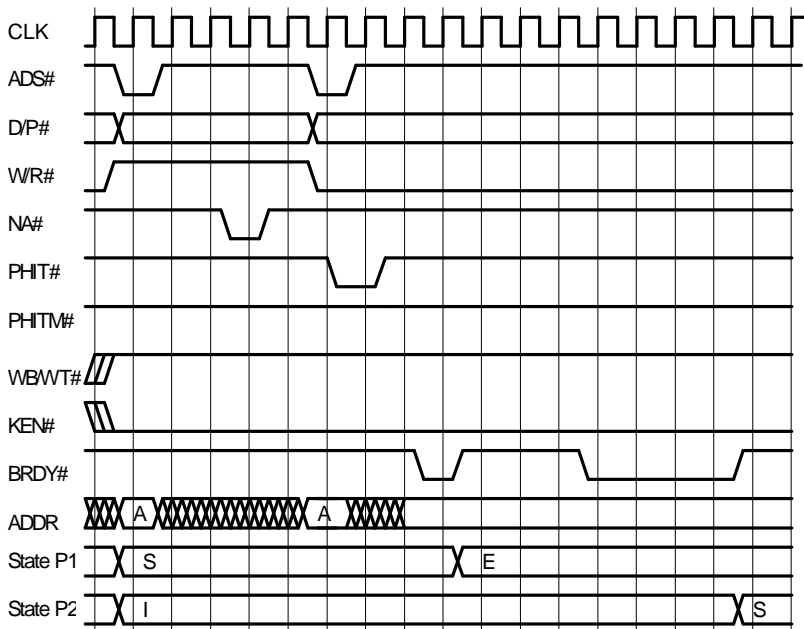
**PROBLEM:** This is a dual processor erratum: If there is a READ generated by processor 2 pipelined into a WRITE generated by processor 1, and both of these cycles are to the identical address, the cache states for these lines become inconsistent. In this case the WB/WT# pin is driven HIGH, and the KEN# pin is active. Processor 1 will have data that changes from the (S) shared state to the (E) exclusive state, and processor 2 will have data that changes from the (I) invalid state to the (S) shared state. This violates the cache coherency protocol, since any writes to the line that is in the (E) state in processor 1 will not be seen on the bus, resulting in the second processor operating with stale data. This is a symmetrical problem, such that the initiator of the WRITE cycle can either be the primary or dual processor in a two processor configuration. The reason this happens is that each ADS# causes a snoop in the LRM processor, but in this case at the time of the snoop the line state is (S) which will generate the PHIT#, and no PHITM#, the transition to the (E) state has been posted but is not performed until the BRDY# of the WRITE cycle.

**IMPLICATION:** If the described conditions are met, then an additional write to the same address in processor 1 will cause a cache state transition from (E) to (M) and will not generate a bus cycle. This will mean that the data in processor 2 is stale but it could continue operating with the stale data. For example: When 2 processors are sharing a cached semaphore, and processor 1 is updating the semaphore just as processor 2 is reading the semaphore, then processor 2 would eventually end up with stale data in its cache. Due to the nature of the problem, this could cause a number of unknown system problems and may or may not cause a system to hang.

**WORKAROUND:** Disable pipelining while using dual processing, this is done by not asserting NA#.

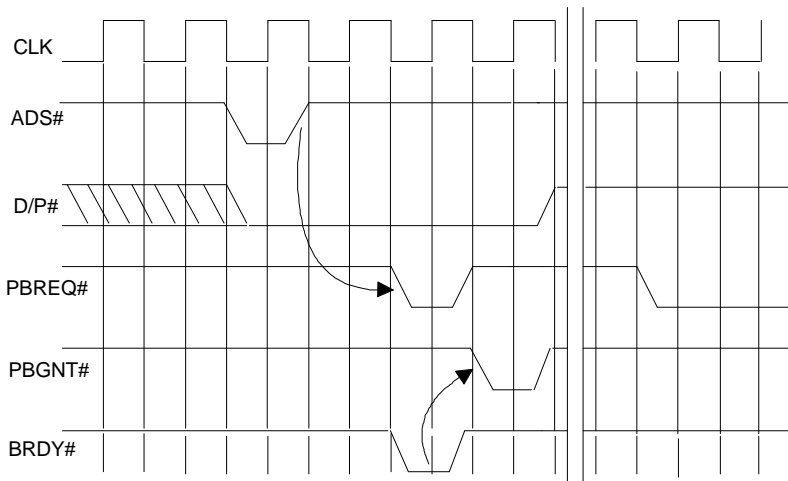
7. CPU A asserts PBREQ# to CPU B in order to obtain bus ownership back to run its pending cycle.
8. CPU B, however does not grant the bus back to CPU A since it needs to run a bus cycle before relinquishing the bus ownership. Since interrupts are disabled and the processor is executing in a tight 'spin' loop, it does not have any bus cycles to run and does not relinquish the bus.

**IMPLICATION:** A system lockup can occur because one CPU requests the bus, while the other CPU does not relinquish bus control. Running Windows NT operating system, it has been observed that when the hang condition occurs, the code inside the Windows NT kernel is always inside a very tight code loop, with at least one of the processors 'spinning' on a semaphore location, with interrupts disabled, waiting for the other CPU to complete its task.

**WORKAROUND:** Asserting STPCLK# to the processor that owns the bus will cause the system to come out of the lock up condition. Using a timer, when the PBREQ# signal is seen asserted for a few thousand clocks without the PBGNT# signal asserted, STPCLK# can then be asserted to the processor that owns the bus in order to get it out of the hang condition and resume normal operation. The D/P# pin can be used to tell which processor owns the bus. Alternatively, asserting STPCLK# to both processors will also work.

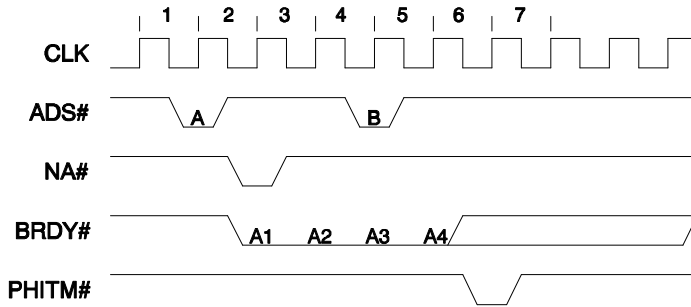
- The processor issues read cycle A which may be pipelined into an earlier (not shown) cycle.
- Cycle A will be completed by the system as a 2-1-1-1 (zero wait state) cycle.
- One clock after issuance of the ADS#, NA# is asserted by the system.
- A pipelined cycle (B) is asserted by the MRM in clock 4.
- Cycle A completes on the bus in clock 5.
- One clock later, PHITM# is issued by the LRM.

Specifically given the above conditions, the error condition occurs internally in the CPU due to the assertion of PHITM# or BOFF# one clock after the final BRDY# of cycle A. If this occurs, the CPU will respond to the PHITM# or BOFF# by subsequently re-issuing both cycles A and B, where expected operation would be that only cycle B is re-issued.

**IMPLICATION:** The code fetch or data read cycle (A) will be re-issued even though it is already completed. The second occurrence of the cycle, even if harmless from a system point of view, will confuse the internal state of the CPU and may cause subsequent CPU mis-operation.

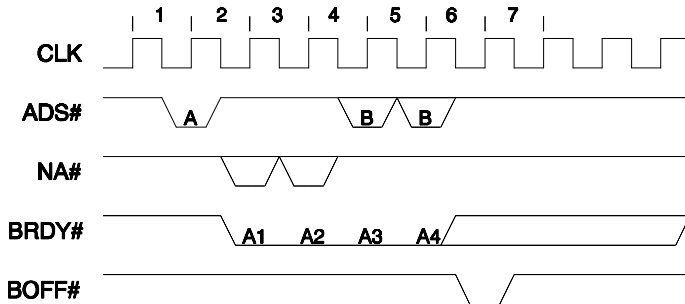
- The processor issues read cycle A which may be pipelined into an earlier (not shown) cycle.
- Cycle A will be completed by the system as a 2-1-1-1 (zero wait state) cycle.
- One or two clocks after issuance of the ADS#, NA# is asserted by the system.
- A pipelined cycle (B) is asserted by the MRM in either clock 4 or clock 5.
- Cycle A completes on the bus in clock 5.
- One clock later, BOFF# is issued by the system.

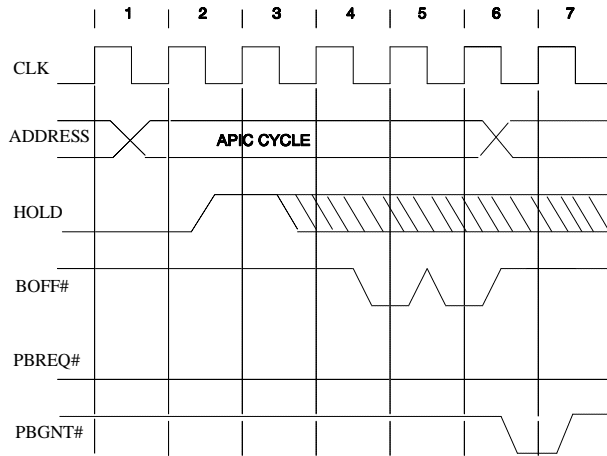
1. One of the CPUs initiates an internal APIC cycle (read or write). The LRM CPU requests ownership of the bus by asserting PBREQ#
2. HOLD is asserted during the APIC cycle
3. BOFF# is asserted before the APIC cycle gets completed, two or three clocks after HOLD is asserted (as shown in figure below)
4. Once BOFF# is deasserted, both processors may assume ownership of the bus at the same time resulting in possible contention of the CPU pins.

**IMPLICATION:** This problem affects dual processing (with CPU local APIC enabled) that assert HOLD and BOFF#. When the problem occurs, the dual processing arbitration machines of both processors get out of synchronization causing both processors to park on the bus. This will result in a system hang.

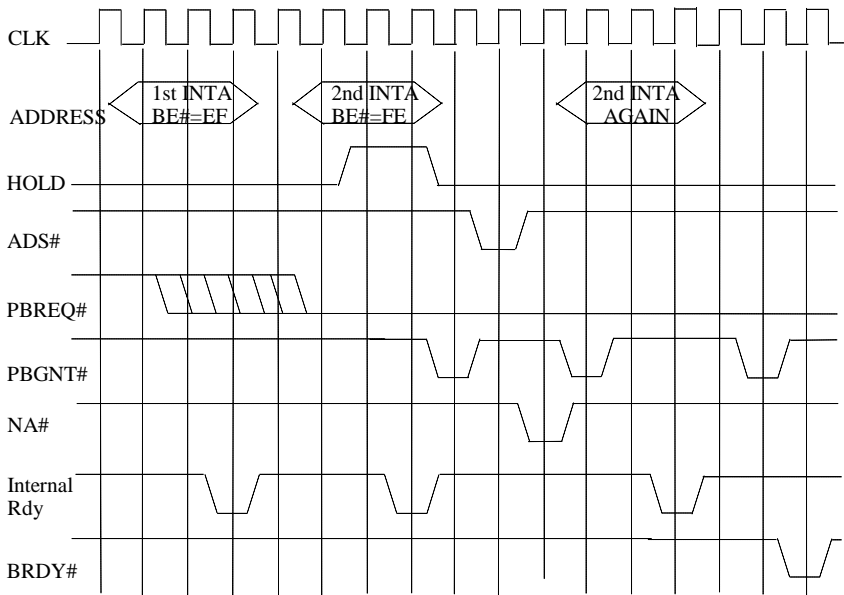
1. One of the CPU's (i.e. CPU A) initiates the first and second internal APIC INTA cycles. The INTA cycles are not driven on the external bus. CPU B requests ownership of the bus by asserting PBREQ#.
2. HOLD is asserted during the 2<sup>nd</sup> INTA cycle and PBGNT# is asserted.
3. CPU B issues a read or write cycle and receives NA# before completion of the cycle. The bus is granted back to CPU A.
4. CPU A reissues the second INTA cycle and grants the bus to CPU B.
5. CPU A hangs because the internal Rdy# and BRDY# were recognized out of order.

**IMPLICATION:** Asserting HOLD during the second INTA cycle causes the processors to lose synchronization. The external cycle completes on the bus after the INTA cycle completes which hangs the system.

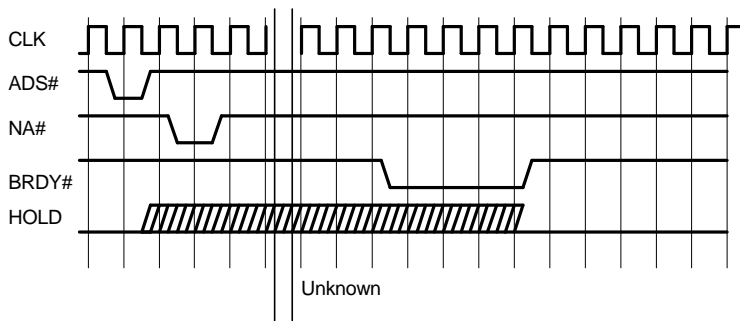
**PROBLEM:** This is an APIC related dual processor erratum: When an APIC read cycle is interprocessor pipelined into any other allowable cycle, and HOLD is prior to the last BRDY# of the outstanding cycle, the MRM processor will hang.

**IMPLICATION:** A system that uses dual processor with pipelining enabled, is subject to periodic lockups if HOLD/HLDA# protocol is used.

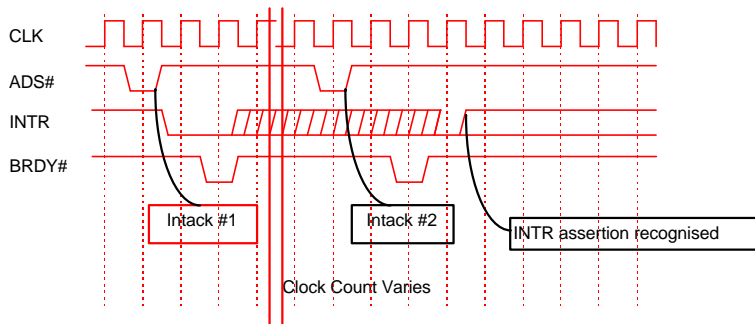
Software disabling of the APIC by clearing bit 8 of the SVR (spurious vector interrupt register) will not prevent this from occurring.

**IMPLICATION:** If the conditions listed above are met the system may hang up since there would be an interrupt that would not get serviced.

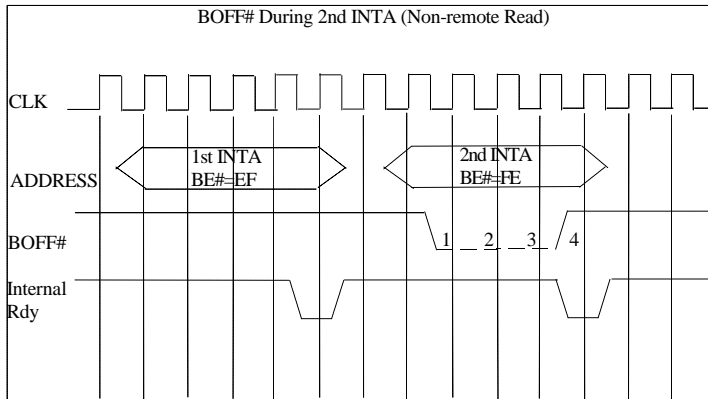
Similarly, if HOLD is asserted anytime during the second INTA cycle, and during a remote read, the processor will hang.

**IMPLICATION:** If the system does not assert BOFF# when the processor bus is idle, then this problem will not occur. Internal APIC INTA cycles are run only when the bus is idle, thus asserting BOFF# during an external bus cycle (e.g. started by an ADS#) will avoid these circumstances. In systems that can assert BOFF# when the bus is idle, asserting BOFF# for a least 4 clocks will avoid the problem for non-remote read cases. Note that there may be other implementations that guarantee BOFF# is not asserted in the problematic window. For example, if BOFF# is only asserted with AHOLD active and AHOLD always precedes BOFF# by at least 4 clocks, the erratum is avoided.

If a remote read is occurring (e.g. between two processors) this will delay completion of the second INTA cycle by up to 8 clocks (i.e. bus clocks), and BOFF# asserted during this time may hang the system. Remote reads are typically performed during system debug and not in normal operation. Not performing remote reads will avert this case.
