# Pentium® Processor Specification Update

Release Date: March 1997

Order Number 242480-025

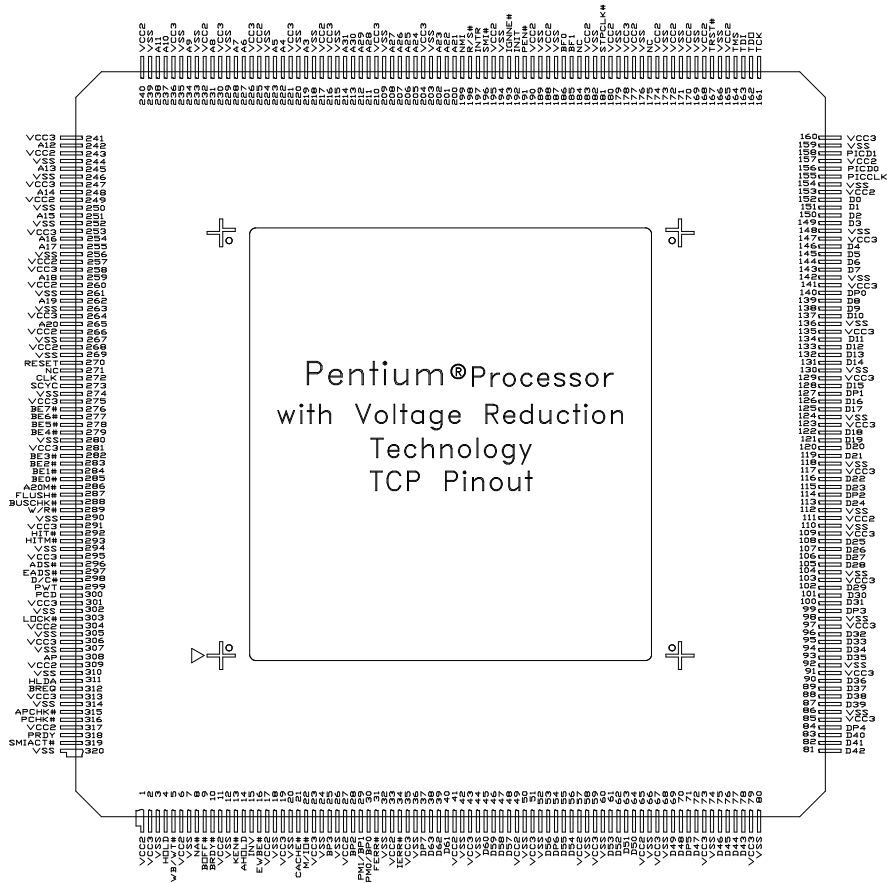
### 2. ***Incorrect TCP Pinout Drawing***

The TCP pinout drawing on page 8 of the Pentium Processor with Voltage Reduction Technology Data Sheet was inadvertently rotated. The correct orientation is shown below.
