Pentium[®] Processor Specification Update

Release Date: December 1997

Order Number 242480-033

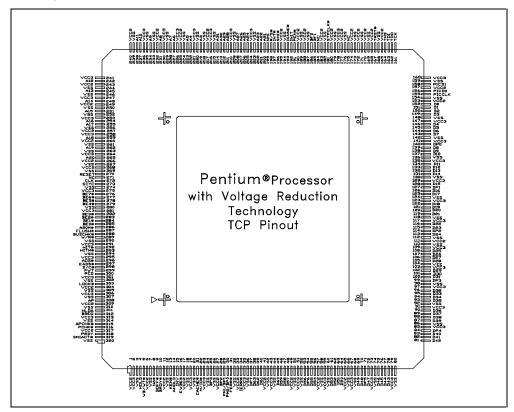
2. Incorrect TCP Pinout Drawing

The TCP pinout drawing on page 8 of the *Pentium Processor with Voltage Reduction Technology* datasheet was inadvertently rotated. The correct orientation is shown below.
