Pentium[®] Processor Specification Update

Release Date: April 1998

Order Number 242480-036

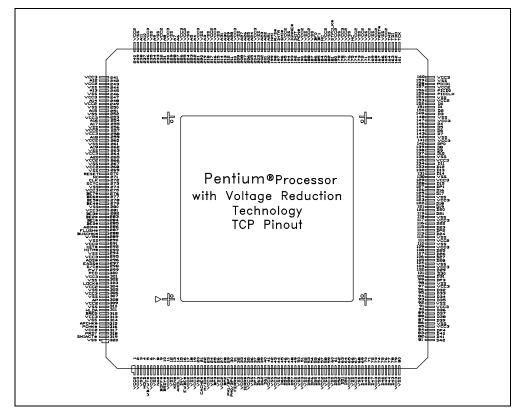
2. Incorrect TCP Pinout Drawing

The TCP pinout drawing on page 8 of the *Pentium Processor with Voltage Reduction Technology* datasheet was inadvertently rotated. The correct orientation is shown below.

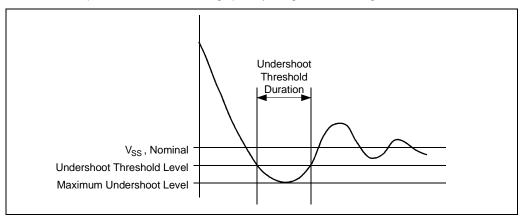
Figure 14-1. Maximum Undershoot Level, Undershoot Threshold Level, and Undershoot Threshold Duration

UNDERSHOOT THRESHOLD DURATION SPECIFICATION: A snapshot of the clock signal should be taken at 500 mV/div and 500 pS/div (for CLK). Adjust the vertical position and horizontal offset position to view the threshold duration. The undershoot threshold duration is defined as the sum of all time during which the clock signal is below –0.5V within a single clock period. The undershoot threshold duration must not exceed 20% of the period.
