Pentium[®] Processor Specification Update

Release Date: June 1998

Order Number 242480-037

The Pentium[®] processor may contain design defects or errors known as errata which may cause the product to deviate from published specifications. Current characterized errata are documented in this Specification Update.

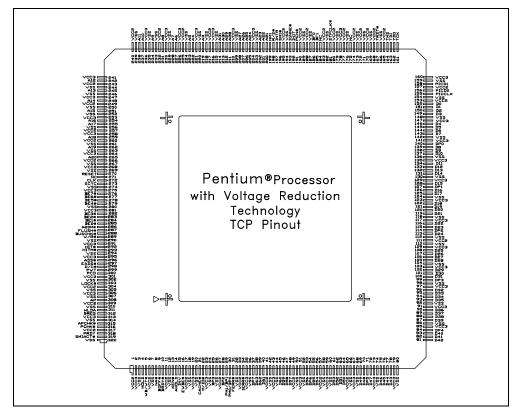
2. Incorrect TCP Pinout Drawing

The TCP pinout drawing on page 8 of the *Pentium Processor with Voltage Reduction Technology* datasheet was inadvertently rotated. The correct orientation is shown below.
