**xSeries 366**  
**Service and Support Considerations**

Rev 2.7.1

March 2, 2006

## **Overview**

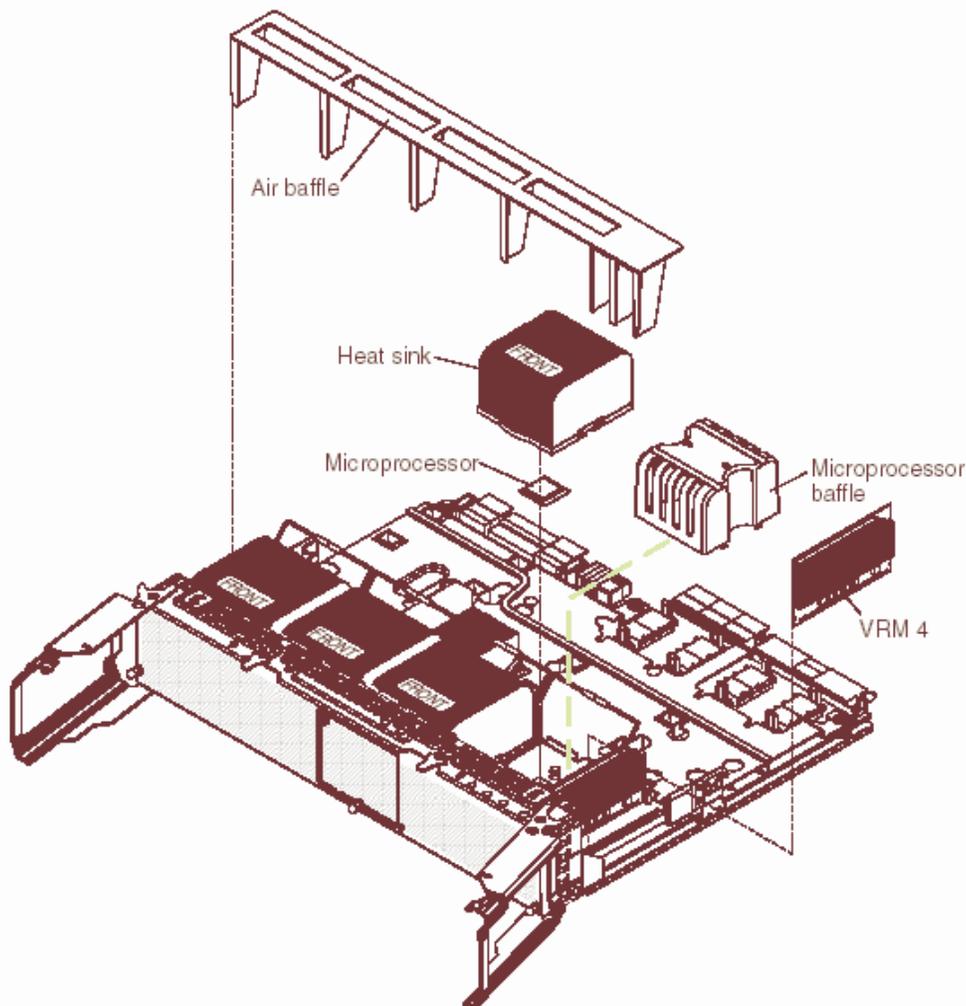
When removing the microprocessor tray through the front of the server, the memory cards or planar will be damaged unless the memory cards are removed first. Please note that all Fans must be removed as well before CPU tray can be removed. Also during removal of the tray, the microprocessor heat sinks may hit or interfere with the top of the chassis making removal difficult. To help alleviate the heat sink chassis interference, lift up on the top of the chassis while removing the tray. A recommended lift point is via the drive bay. Please see <http://www-307.ibm.com/pc/support/site.wss/migr-60199.html> for additional information on tray removal.

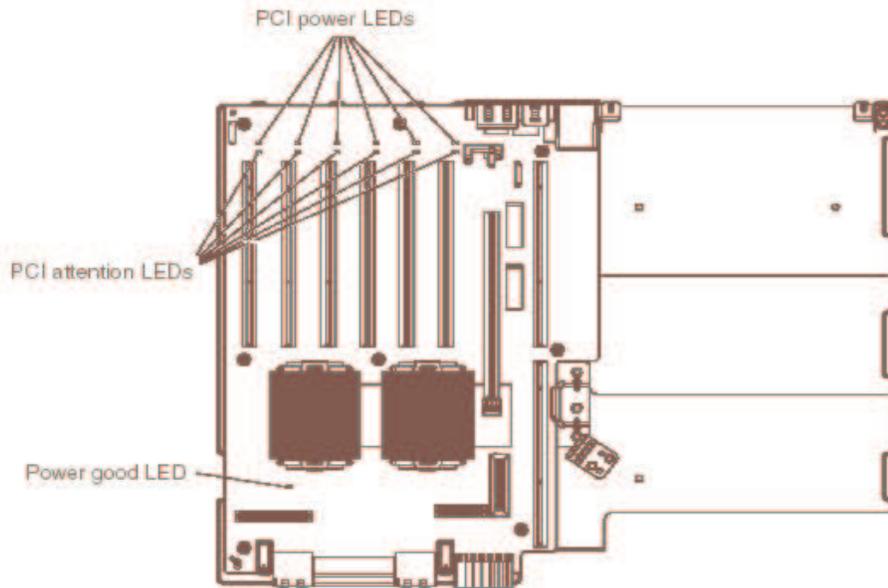
The following illustration shows the LEDs on the PCI-X board.

In other systems, when viewing the PCI slots from the rear of the system, a PCI error condition can be seen because the amber "attention" LED is light-piped to the rear of the system. On the x366 however, the PCI slot Attention and Power LED's are reversed so the green "power" LED is seen on any populated slot when the system is powered on. To see whether there is a PCI error, first check the LightPath panel. If the "PCI" LED is lit, then remove the top cover and view the individual slot Attention LED's to determine which slot is affected.
