AMD-K6[™]

MMX[™] Enhanced Processor

Revision Guide

Publication # 21266 Issue Date: July 1997 Amendment/0

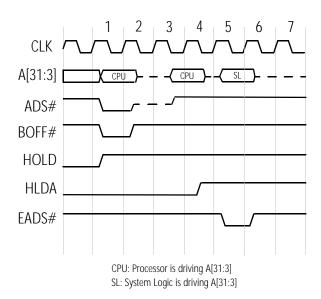
Figure 1. AMD-K6™ Processor Assertion of HLDA Due to Simultaneous BOFF#/HOLD Assertion

Non-conformance. If BOFF# and HOLD are sampled asserted on the same clock edge that negates ADS#, the processor asserts HLDA two clock edges after HOLD is sampled asserted.

- If the system logic asserts BOFF# for a duration of one clock, anticipates the assertion of HLDA in clock 3 (see Figure 1)—which is the normal specified operation—and drives the address bus and EADS# for an inquire cycle in clock 3, then the processor will not sample EADS# asserted. In addition, address bus contention will occur in clock 3.

- If the system logic asserts BOFF# for a duration of two clocks, anticipates the assertion of HLDA in clock 3, and drives the address bus and EADS# for an inquire cycle in clock 3, then the processor will not sample EADS# asserted. (No address bus contention occurs in this case.)

- If the system logic asserts BOFF# for a duration of one clock, anticipates the assertion of HLDA in clock 3, and drives the address bus and EADS# for an inquire cycle in clock 4, then address bus contention may occur in clock 4. (The processor will sample EADS# asserted in this case.)

If the processor does not sample EADS# asserted during an inquire cycle, cache/memory incoherency will occur. Address bus contention can affect the reliability of the processor and the system logic.

Suggested Workaround. The system logic must sample the assertion of HLDA before asserting EADS# and driving the address bus for an inquire cycle—as shown in clock 5 of Figure 1.
