# Pentium<sup>®</sup> Processor Specification Update

Release Date: January, 1997

Order Number 242480-024

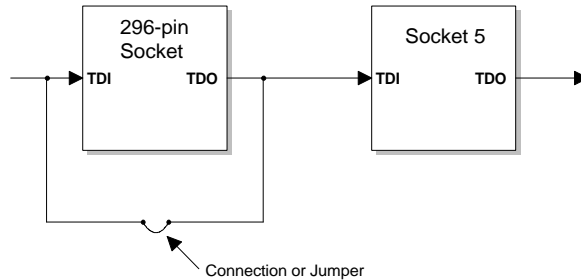
Other implications of this workaround include Boundary Scan, and any other signals not connected together between Socket 5 and the 296-pin SPGA socket site.

If Socket 5 follows the 296-pin socket in the Boundary Scan chain, the TDI input and TDO output of the 296-pin socket site must be connected together by the OEM prior to system sale in order to skip this socket site and complete the path to socket, as shown in the following figure. This connection is necessary only if Boundary Scan will be used by end-users after system sale.

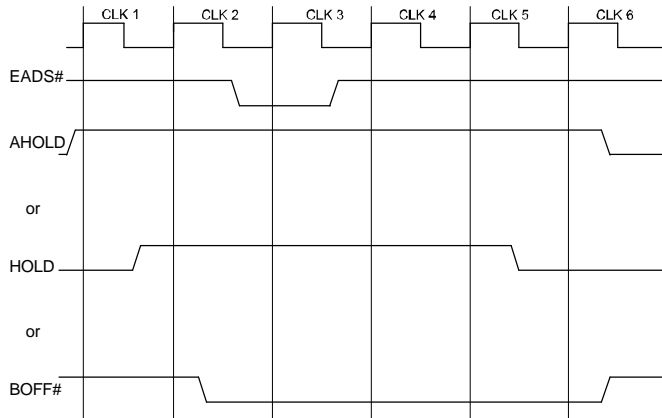
All of the listed workarounds prevent the MRM processor from starting a new cycle, thus preventing the third restart of the pending cycle.

4. Drive BOFF# for 3 clocks after the EADS# was sampled active. See the following figure.

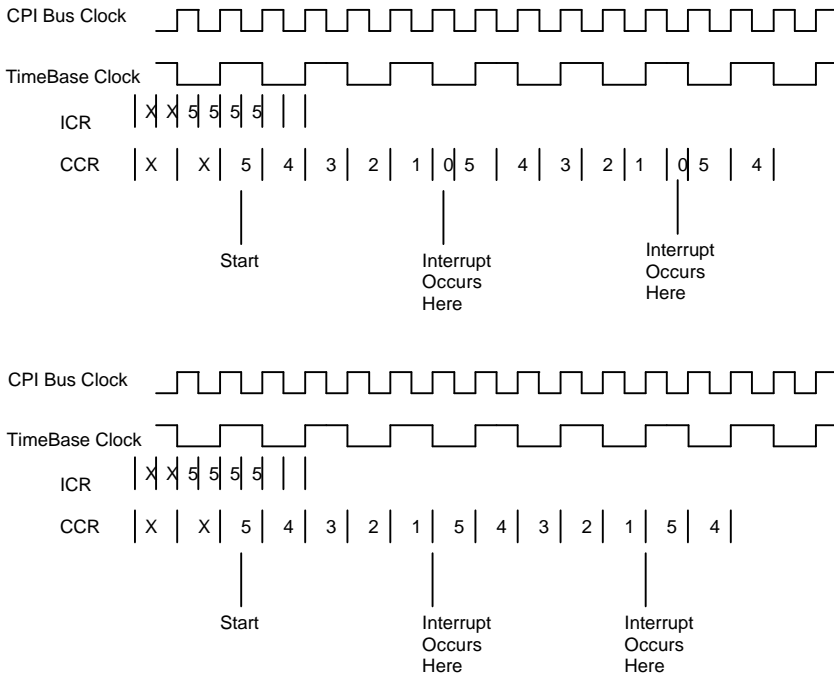
ticks is of the same pulse width, but the last tick is held for just one single timer clock regardless of the divisor programmed. This results in a slightly inaccurate timer. This last tick pulse width is shown in the top diagram. The lower diagram shows how the accuracy of the timer will be corrected in a future stepping. This phenomenon occurs when the timer is used as a single shot generator as well.

NOTE: The CPU Bus clock in which the CCR is loaded from the ICR occurs one clock after the ICR is loaded.

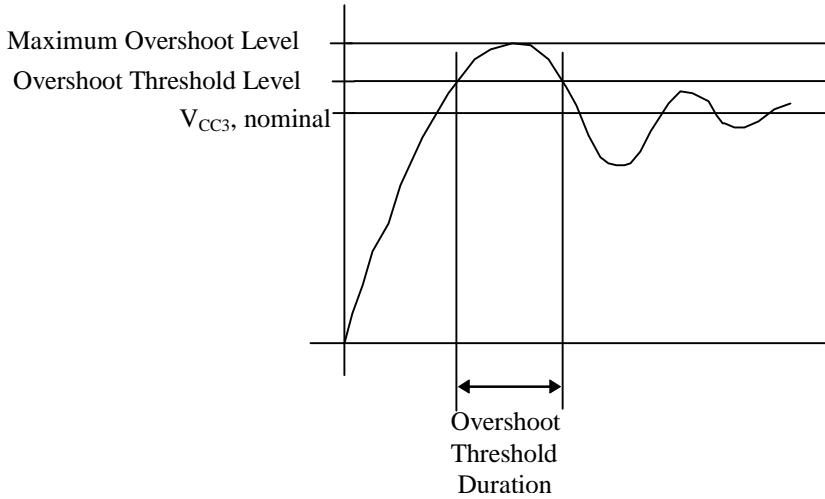
Figure 47-1. Maximum Overshoot Level, Overshoot Threshold Level, and Overshoot Threshold Duration

These overshoot and undershoot specifications are illustrated graphically in Figure 47-1 to Figure 47-4.

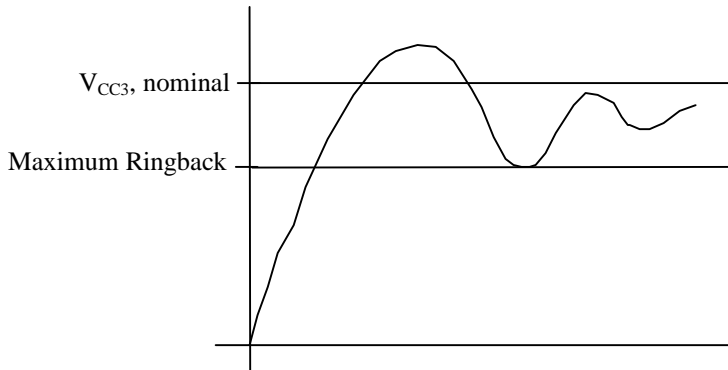
Figure 47-2. Maximum Ringback Associated with the Signal High State

**MAXIMUM RINGBACK SPECIFICATION:** The maximum ringback of CLK/PICCLK associated with their high states (overshoot) must not drop below  $V_{CC3} - 0.8V$  as shown in Figure 47-2. Similarly, the maximum ringback of CLK/PICCLK associated with their low states (undershoot) must not exceed  $0.8V$  as shown in Figure 47-4.

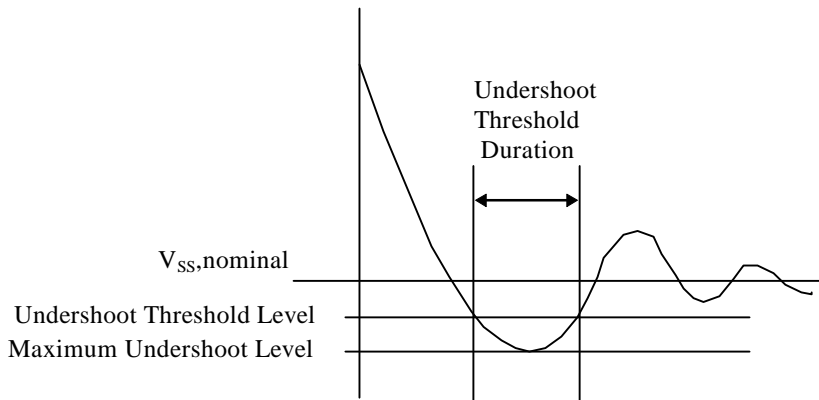
Figure 47-3. Maximum Undershoot Level, Undershoot Threshold Level, and Undershoot Threshold Duration

**UNDERSHOOT THRESHOLD DURATION SPECIFICATION:** A snapshot of the clock signal should be taken at 500 mV/div and 500 pS/div (for CLK) or 2 nS/div (for PICCLK). Adjust the vertical position and horizontal offset position to view the threshold duration. The undershoot threshold duration is defined as the sum of all time during which the clock signal is below -0.5V within a single clock period. The undershoot threshold duration must not exceed 20% of the period.
