Pentium[®] Processor Specification Update

Release Date: June 1998

Order Number 242480-037

The Pentium[®] processor may contain design defects or errors known as errata which may cause the product to deviate from published specifications. Current characterized errata are documented in this Specification Update.

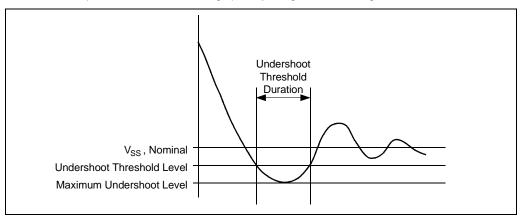
Figure 14-1. Maximum Undershoot Level, Undershoot Threshold Level, and Undershoot Threshold Duration

UNDERSHOOT THRESHOLD DURATION SPECIFICATION: A snapshot of the clock signal should be taken at 500 mV/div and 500 pS/div (for CLK). Adjust the vertical position and horizontal offset position to view the threshold duration. The undershoot threshold duration is defined as the sum of all time during which the clock signal is below –0.5V within a single clock period. The undershoot threshold duration must not exceed 20% of the period.

This undershoot specifications are illustrated graphically in Figure 14-1 and Figure 14-2.

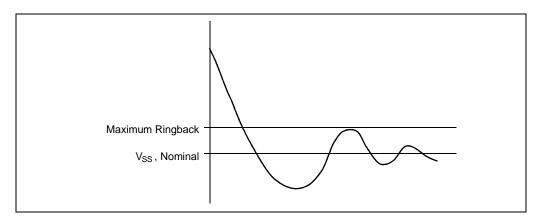
Figure 14-2. Maximum Ringback Associated with the Signal Low State

MAXIMUM RINGBACK SPECIFICATION: The maximum ringback of CLK associated with its low state (undershoot) must not exceed 0.8V as shown in Figure 14-1.
