2074 Console Support Controller Installation and Maintenance Information

G229-9028-03

Fourth Edition (June 2003)

This document refers to the IBM® 2074 Console Support Controller.

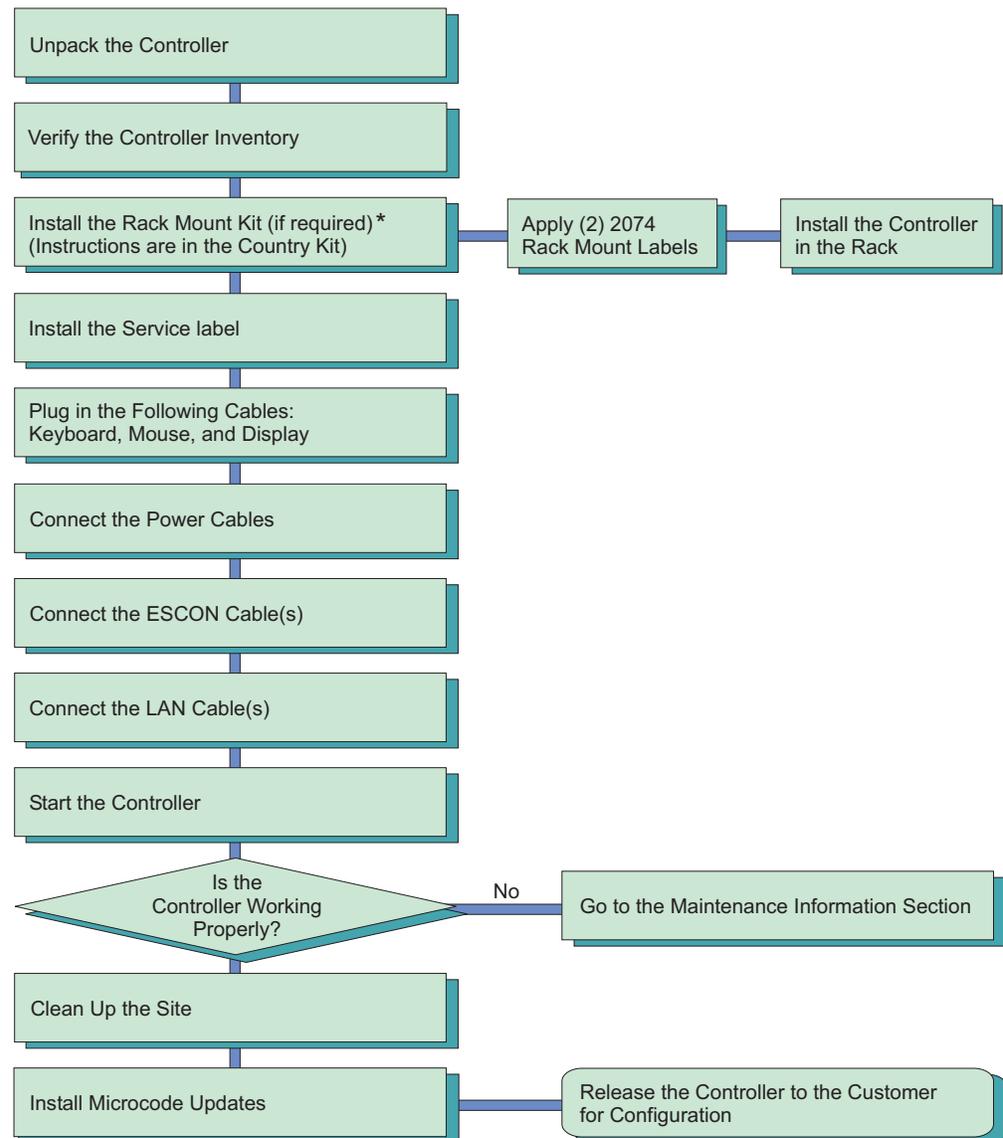
Figure 1-1. Flowchart describing the installation process

Use the following flowchart as a guide for installing the 2074:

* Remove hot-pluggable power supplies prior to two-person lift

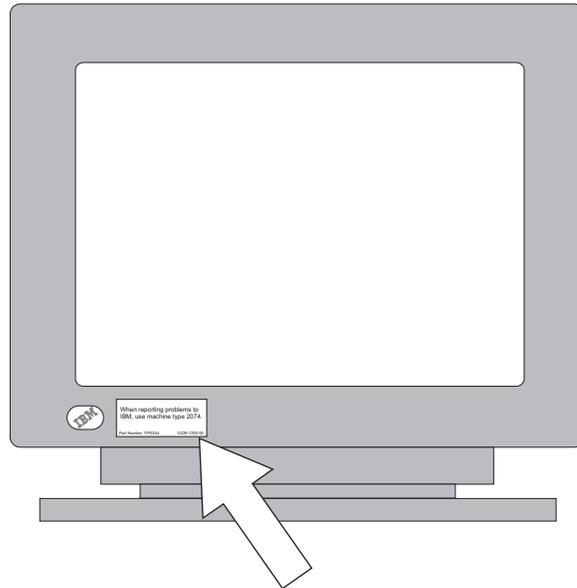
Figure 1-2. Proper label placement.

Place the 2074 either next to a suitable table, or install it into an approved rack using the optional rack mounting kit. Place the service label as shown in the following diagram.

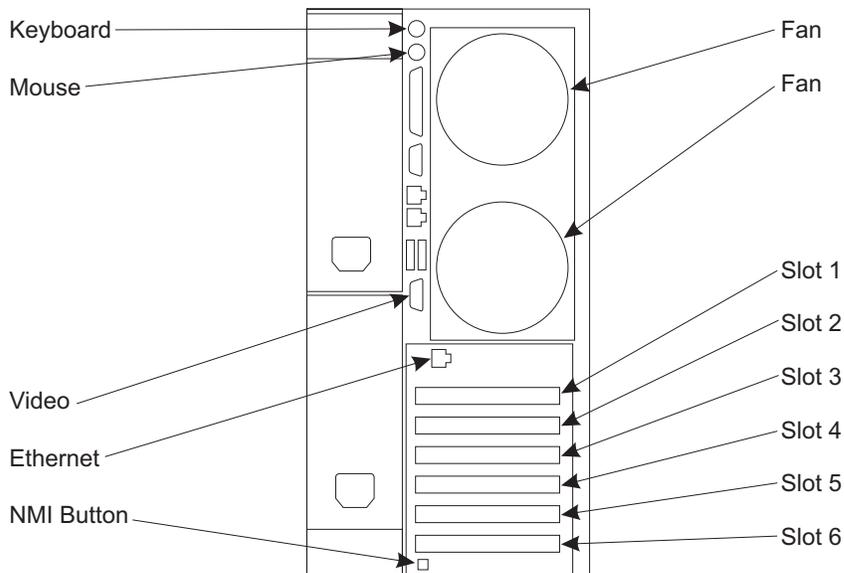
Figure 1-3. Model 3 connector and slot locations - tower view

1. The video connector is **ALWAYS** blue and is appropriately labeled on the panel itself.
2. The "non-Maskable Interrupt" request button is labeled "NMI" on the panel. Do NOT activate the NMI button unless you have been instructed to by IBM 2074 Support, as it will crash the 2074 and cause a system dump to be taken.

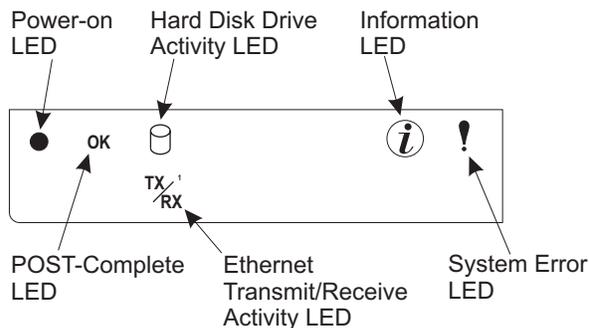
Figure 1-4. 2074 Operation Information Panel - Model 003

- Is the “system error” LED on? If it is, then refer to the appropriate xSeries® Hardware Maintenance Manual.

- If the customer attached Ethernet cables, verify that the green LINK LED is on for each Ethernet. LAN0 has its LED in the RJ-45 socket. There is also a green “link” LED in the RJ-45 socket for LAN0. LAN1 LED is on the rear of the PCI adapter in slot 4. If it isn’t, verify that the cable is attached to a HUB and refer to the MAPS in this book.

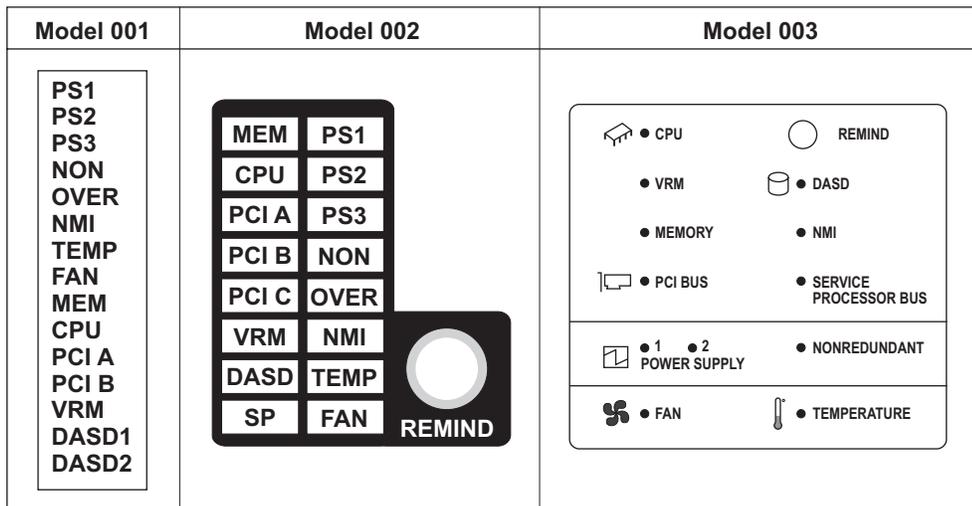
Figure 2-1. 2074 Diagnostics Panel

You can use the light path diagnostics built into your 2074 to quickly identify the type of system error that occurred. Your 2074 is designed so that any LEDs that are illuminated remain illuminated when the 2074 shut down, as long as the AC power source is good and the power supplies can provide +5V DC current to the 2074. This feature helps you isolate the problem if an error causes the 2074 to shut down.

The following illustrations show the LEDs on the diagnostics panel on the system board of the 2074 Model 001, Model 002, and Model 003.

The System Error LED on the operator information panel is lit when certain system errors occur. If the System Error LED on your 2074 is lit, use the "Lit LED on diagnostics panel" section in the appropriate xSeries Hardware Maintenance Manual to help determine the cause of the error, and the action you should take. If you need to run PC diagnostics, refer to the "Diagnostic programs and error messages" of the appropriate xSeries Hardware Maintenance Manual.

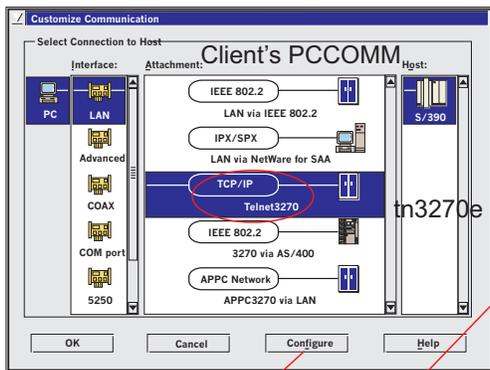
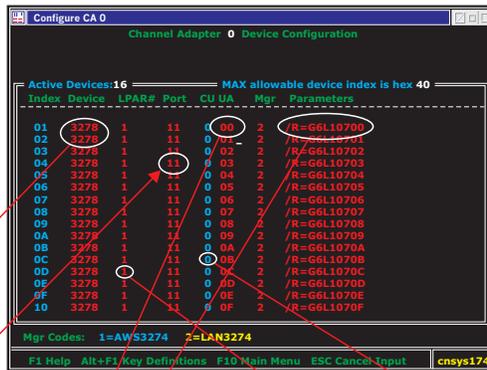
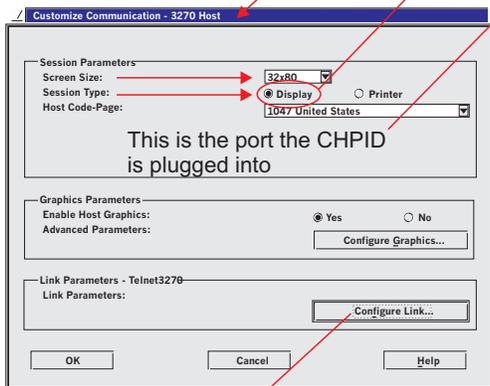
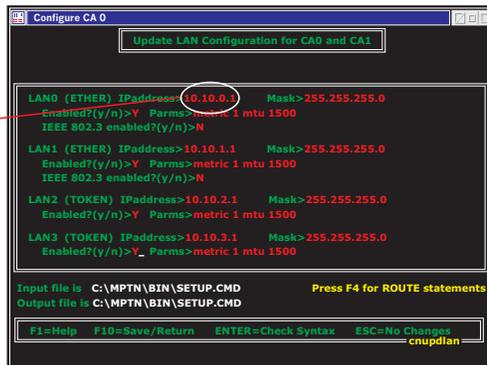
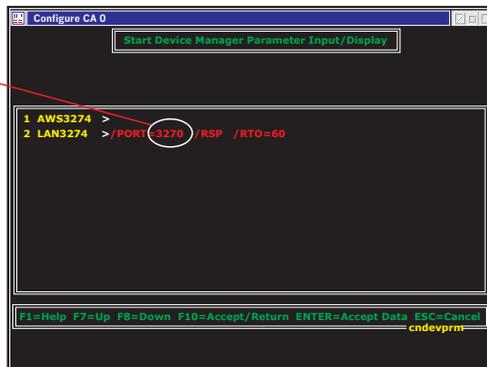
Figure 2-4. How things relate on the 2074.

How things relate on the 2074

Note: HCD had F0, IOCCS has 00 also MODEL=X is needed

LU Name is only available in tn3270e

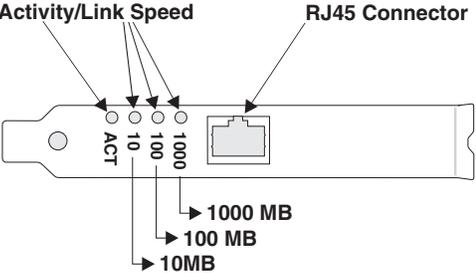
<p>Ethernet</p>
<p>2 Is an Ethernet PCI adapter installed with a cable attached?</p> <p>No Yes</p> <p>Next Go to Step 9.</p>	<p>Ethernet PCI</p> <p>Activity/Link Speed RJ45 Connector</p>

<p>ACT 10 100 1000</p> <p>1000 MB 100 MB 10MB</p>
<p>Start Planar Ethernet Diagnostic</p>	
<p>3 Is a cable plugged into the Ethernet port on the planar?</p> <p>Yes No</p> <p>Next No LANs are in use</p> <p>Is the link ok LED in the RJ-45 socket on solid?</p> <p>Yes No</p> <p>Next Refer to Table 2.5</p>

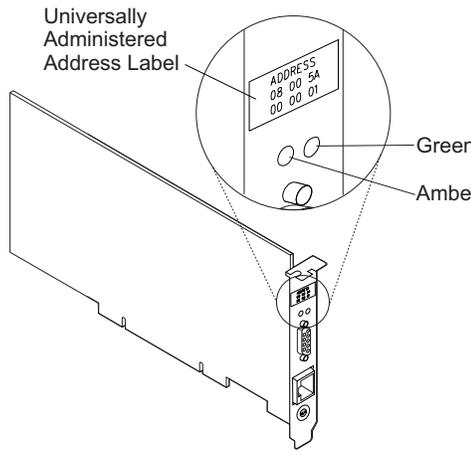
<p>6 Using the graphic on the right, examine the LEDs located on the cable end bracket. Match the state of the LEDs to the following tables. The first shows the normal start-up sequence which you can observe when powering the system up. The second lists possible problem states and the actions to take.</p>

<p>The diagram shows a token-ring adapter with a cable end bracket. A circular callout highlights a label with the text 'ADDRESS 08 00 5A 00 00 01'. Below the label are two LEDs, one labeled 'Green' and one labeled 'Amber'.</p>
---	---

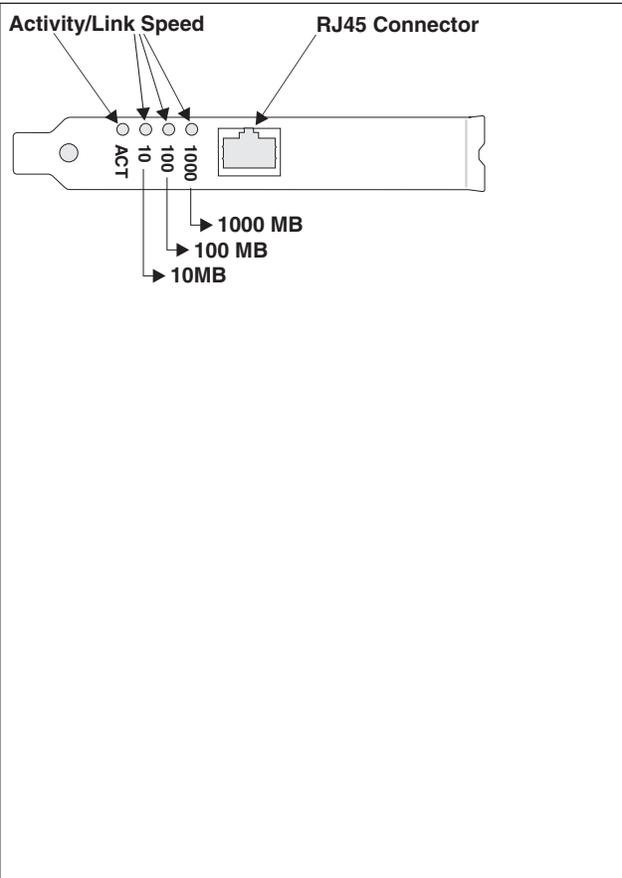
<p>9</p> <p>Examine the LEDs located on the cable end bracket. There are four LEDs on the Ethernet PCI adapter:</p> <p>ACT (for activity) LED:</p> <ul style="list-style-type: none"> • Off <ul style="list-style-type: none"> – The adapter is not sending or receiving network data <i>or</i> – The adapter and switch are not receiving power <i>or</i> – The cable connection between the switch and the adapter is faulty <i>or</i> – You have a driver configuration problem • Flashing <ul style="list-style-type: none"> – The adapter is sending or receiving network data. The frequency of the flashes varies with the amount of network data. <p>Link Speed LEDs:</p> <ul style="list-style-type: none"> • On - indicates link speed. • Off - Refer to Table 2-8.

<p>The diagram shows the cable end bracket of an Ethernet PCI adapter. On the left side, there are four circular LEDs labeled 'ACT', '10', '100', and '1000'. On the right side, there is an RJ45 connector. Arrows point from the '10', '100', and '1000' LEDs to labels '1000 MB', '100 MB', and '10MB' respectively. The 'ACT' LED is labeled 'ACT (for activity) LED' in the text to the left.</p>

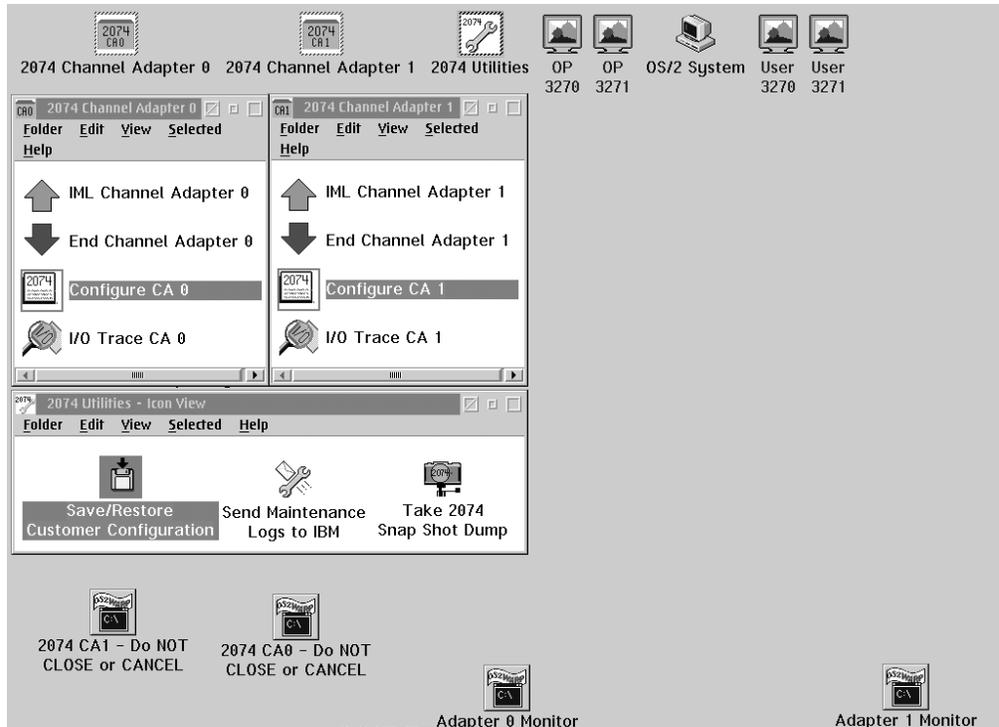
Figure 3-1. OS/2 Desktop Displaying 2074 Icons

Access the IBM 2074 from the OS/2 desktop by selecting icons from one of the three 2074 folders.

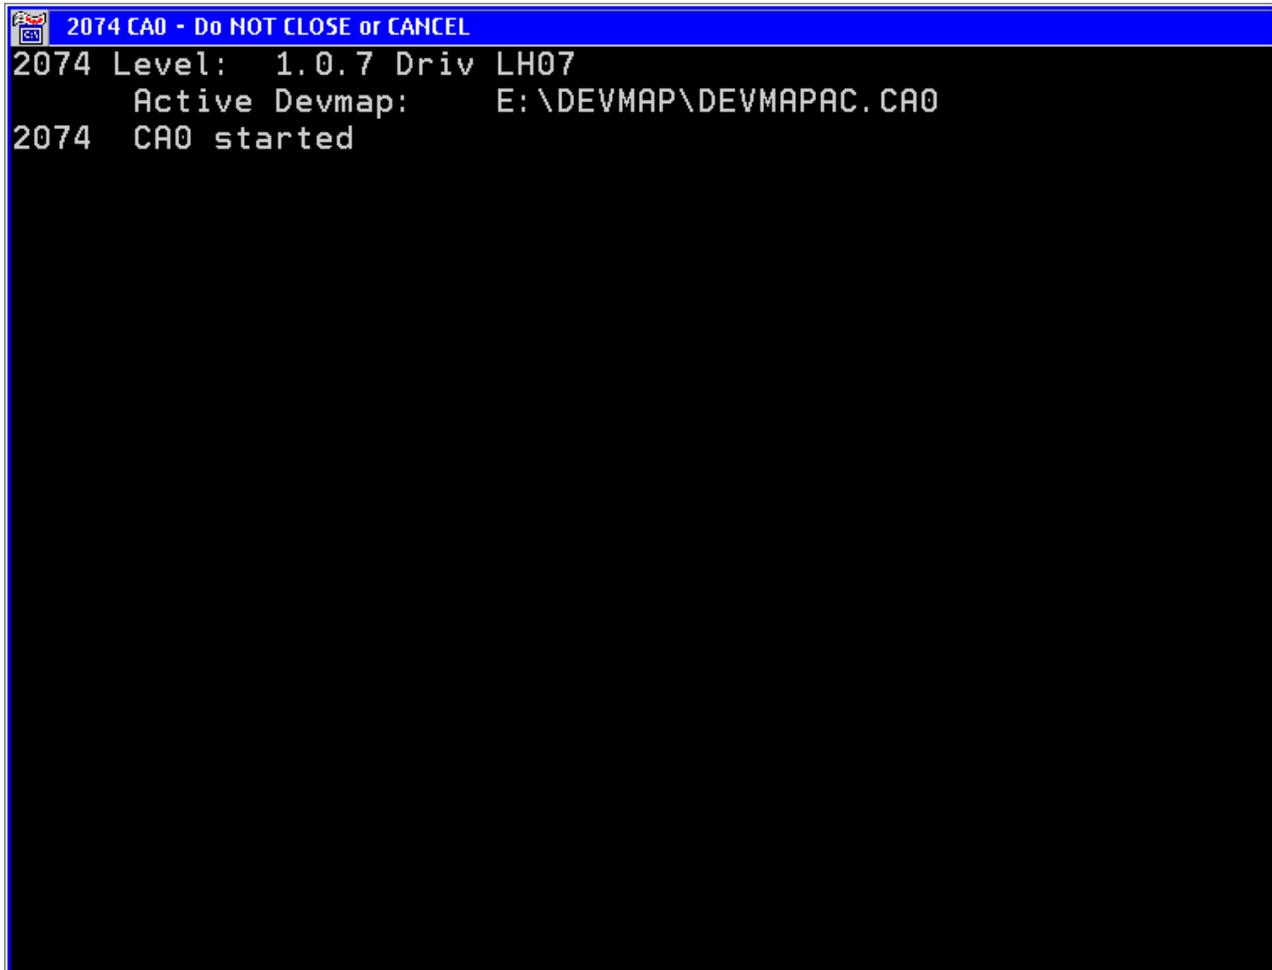
Figure 3-2. Example of the Display of 2074 CA0 started window.

It may be useful to check whether the 2074 Channel Adapters are currently started. When the 2074 Channel Adapters are started, there is a minimized ICON created for each adapter on the OS/2 Desktop. Each ICON will be labeled: '2074 CAx Do NOT CLOSE or CANCEL' where x is 0 or 1. If you double-click to maximize one of the ICON's then the panel will look similar to Figure below. The line on the panel that indicates the status will read '2074 CAx started'. Once you are done viewing this panel, be sure to carefully minimize the panel (**DO NOT CLOSE THIS PANEL**). To minimize, click the ICON in the upper left corner of the panel and select 'Minimize' from the pull-down menu.

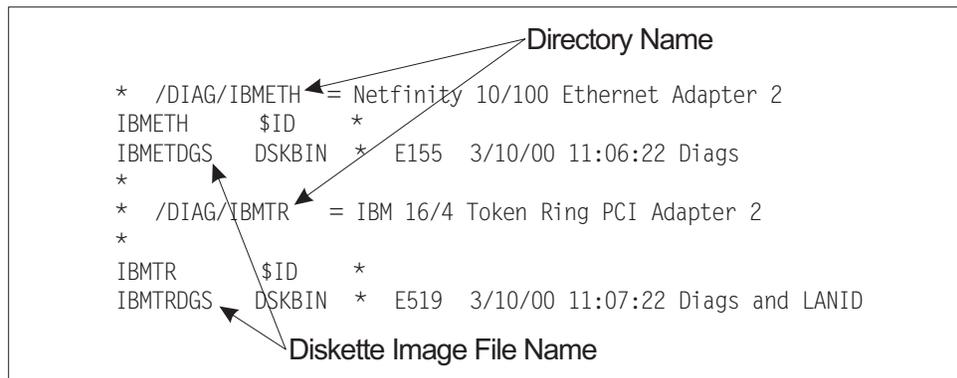
Figure 3-4. DIAG.PAC

DIAG.PAC contains the names of all the diagnostics that are shipped on the CD. To view this file enter **TEDIT H:\DIAG\DIAG.PAC**.

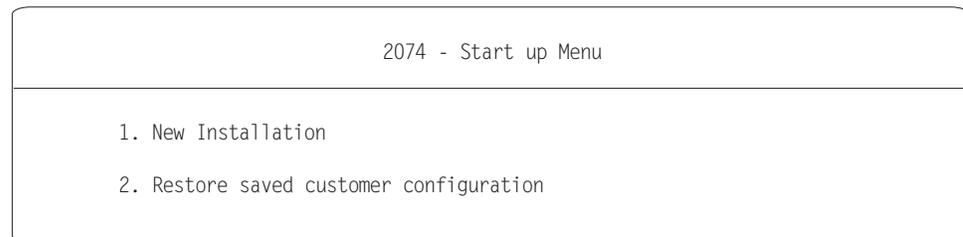
Figure 3-5. 2074 Start up Menu

10. Remove the CD from the CD-ROM drive, and press Ctrl-Alt-Del to reboot from the newly restored hard drive.
11. When the OS/2 desktop comes up, a menu will be displayed:

Most of the time, you will choose selection **2**. You will be prompted to insert the "Customer Configuration Save" diskette into drive A: that you created earlier in this procedure.

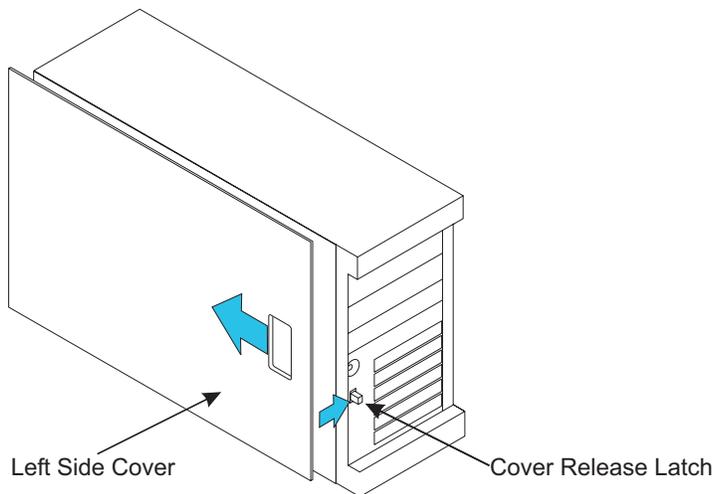
Figure 3-6. Removal of the 2074 Cover (Tower Configuration)

3. Slide the cover-release latch, located on the front panel, to the open position. Then slide the top cover (rack mounted) or left side cover (tower configuration) toward the rear of the 2074 about 25 mm (1 inch). Lift the cover off the 2074 and set the cover aside.

Attention: For proper cooling and airflow, replace the cover before turning on the 2074. Operating the 2074 for extended periods of time (over 30 minutes) with the cover removed might damage 2074 components.

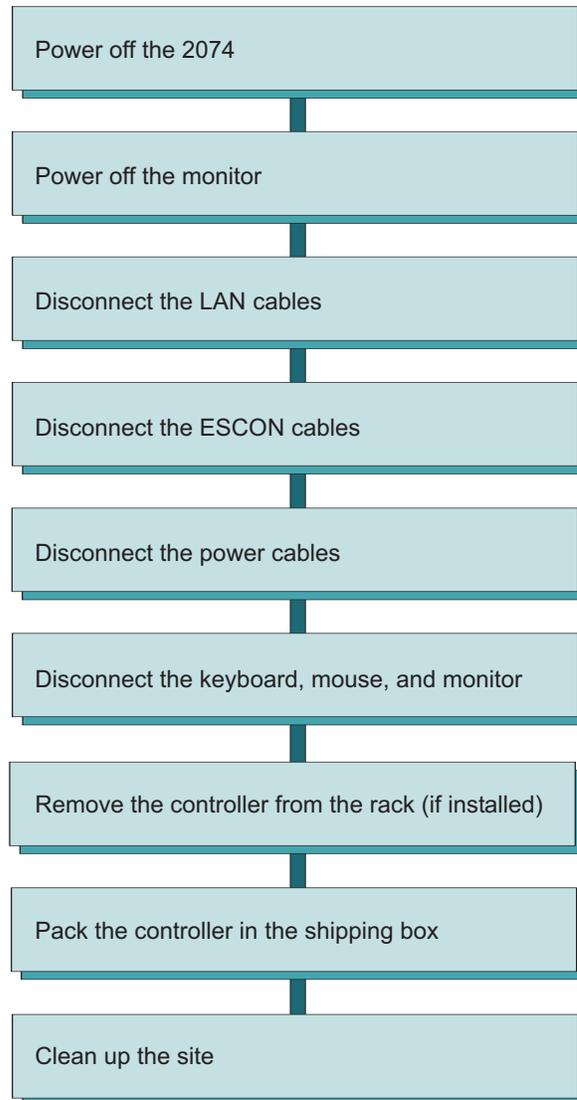
Use the following flowchart as a guide for discontinuing the 2074
