Enterprise Storage Server

Service Guide
2105 Models E10/E20, F10/F20, and
Expansion Enclosure
Volume 1

Chapters 1, 2, and 3

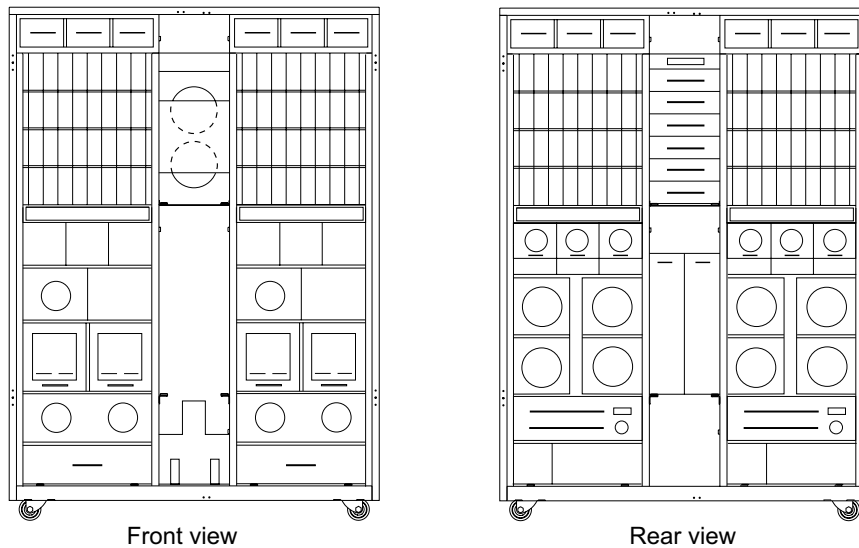
Figure 1. 2105 Model Exx/Fxx Front and Rear Views (s007725m)

The 2105 Models E20 or F20 with the expansion enclosure provides up to 11 terabytes (TB) of storage capacity, with a choice of 9.1, 18.2, or 36.4 gigabyte (GB) DDMs. See Figure 1 and Figure 2 for illustrations of the 2105 models.

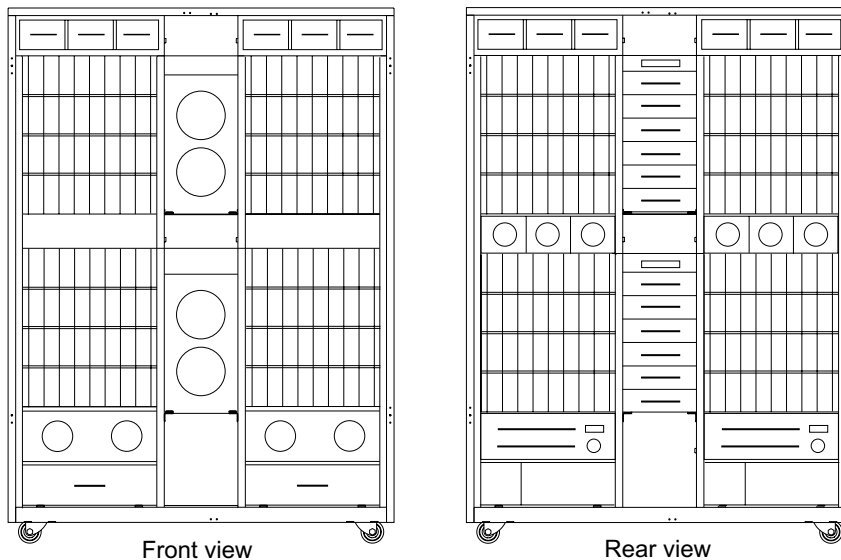
Figure 2. 2105 Expansion Enclosure Front and Rear Views (S007726m)

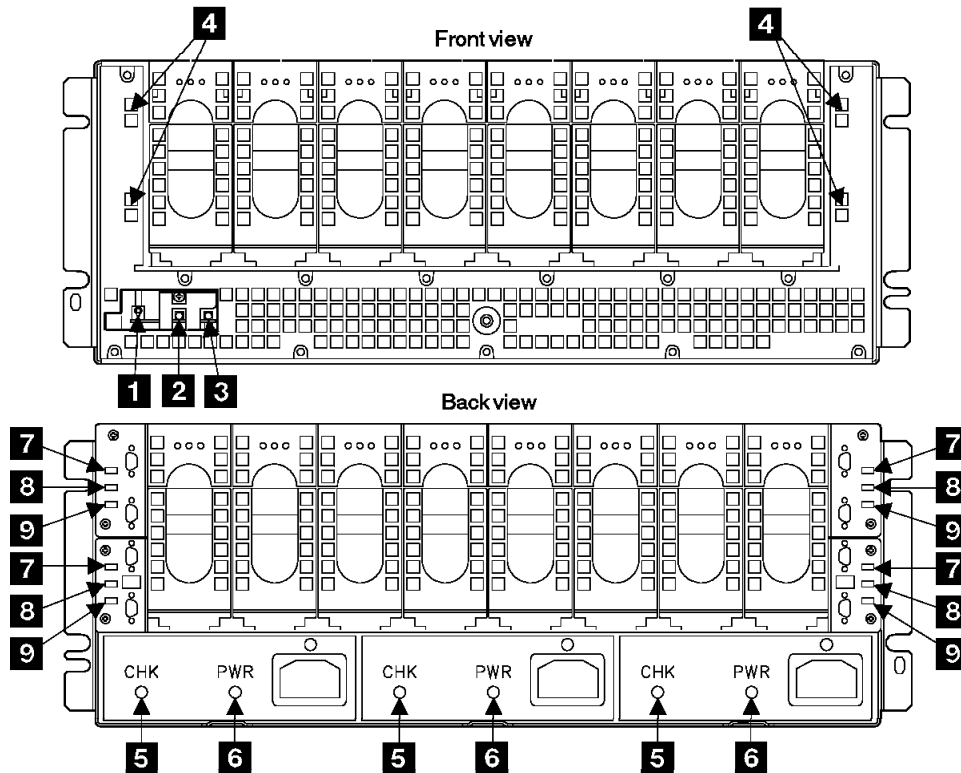
1 [Figure 3] **Power Switch (On/Off)** This switch controls the internal dc power that is supplied to the SSA DASD drawer by the fan-and-power-supply assemblies.

2 [Figure 3] **SSA DASD Drawer Power Indicator** This green indicator is on when the power switch has been pressed to power on the dc voltage, and the dc voltage is present in the SSA DASD drawer.

3 [Figure 3] **SSA DASD Drawer Check Indicator** This amber indicator comes on if a failure occurs in the SSA DASD drawer. The drawer might be able to continue operating satisfactorily although the failure of a particular part has been detected.

4 [Figure 3] **Power Card Indicator** This green indicator is on when electrical power is present on the card.

5 [Figure 3] **Fan-and-Power Check indicator** This amber indicator comes on and stays on if dc output from the power supply part of the fan-and-power-supply assembly fails or is disabled.

6 [Figure 3] **Power Indicator** This green indicator is on when rack electrical power is present in the fan-and-power-supply assembly.

7 [Figure 3] **Link Status (Ready) Indicator** This green indicator shows the status of the port (for example, port 1) through which the bypass card is connected to the SSA device card:

8 [Figure 3]**Mode Indicator** This indicator shows in which mode the bypass card is operating.

9 [Figure 3]**Link Status (Ready) indicator** This green indicator shows the status of the port (for example, port 2) through which the bypass card is connected to the SSA device card:

Figure 3. SSA DASD Model 020 Drawer Indicators and Power Switch (t007290n)

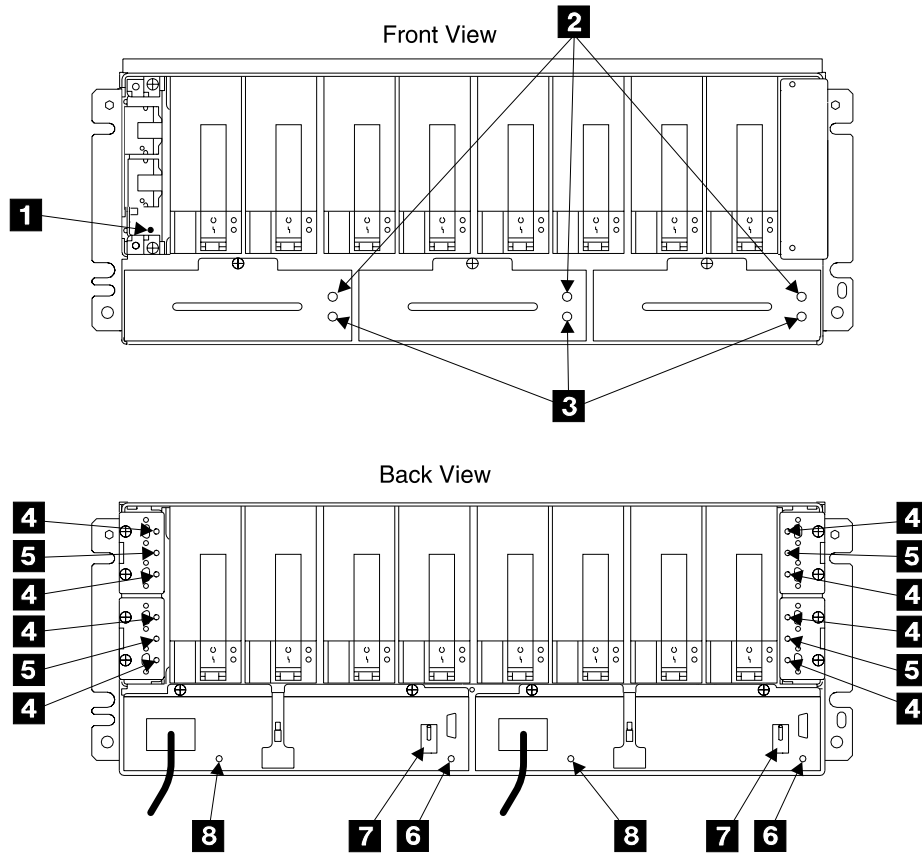
1 [Figure 4]**Controller Card Indicator** This amber indicator is on when the controller card fails.

2 [Figure 4] **Fan Power Indicator** This green indicator is on when dc voltage is present at the fan.

3 [Figure 4] **Fan Check Indicator** This amber indicator comes on and remains on when the fan fails.

7 [Figure 4] **PWR/FAULT RESET Switch** This switch switches off the dc output voltage from the power supply. To switch off the dc voltage, pull the switch out, then push it down. To switch on the dc voltage, pull the switch out, then push it up.

8 [Figure 4] **PWR Indicator** This green indicator comes on when rack power is present in the power supply.

6 [Figure 4] **CHK/PWR-GOOD Indicator** This indicator has two colors that show power supply status:

4 [Figure 4] **Link Status (Ready) Indicator** This green indicator shows the status of the port (for example, port 1) through which the bypass card is connected to another device:

5 [Figure 4] **Mode Indicator** This indicator has two colors that show which mode the bypass card is operating in:

Figure 4. SSA DASD Model 040 Drawer Indicators (t007661p)

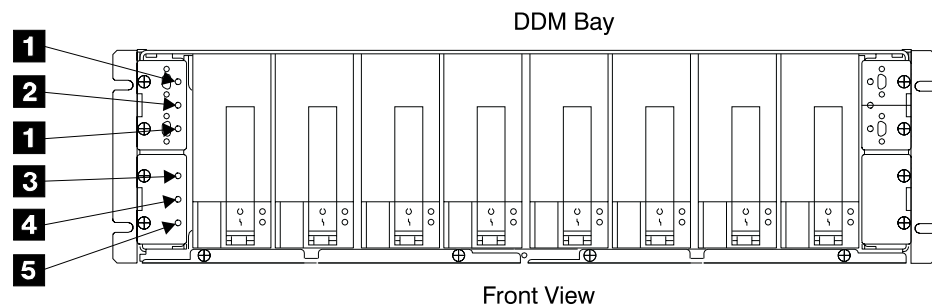
3 [Figure 5] **Controller Card Power Check Indicator** This green indicator is on when controller card power is present.

4 [Figure 5] **DDM Check Indicator** This amber indicator is on when a DDM fails.

5 [Figure 5] **Controller Card Indicator** This amber indicator is on when the controller card fails.

1 [Figure 5] **Link Status (Ready) Indicator** This green indicator shows the status of the port (for example, port 1) through which the bypass card is connected to another device:

2 [Figure 5] **Mode Indicator** This indicator has two colors that show which mode the bypass card is operating in:

Figure 5. DDM Bay Indicators (S008108I)

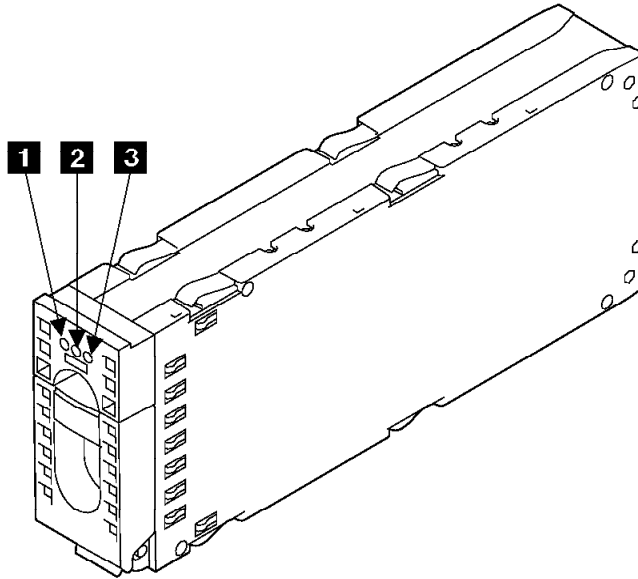
Figure 6. SSA DASD Model 020 Drawer Disk Drive Module Indicators (t007383m)

1 [Figure 6] **Power Indicator** This green indicator is on when dc voltage is present and inside the specified limits.

2 [Figure 6] **Ready Indicator** This green indicator shows the following conditions:

3 [Figure 6] **Check Indicator** This amber indicator shows the following conditions:

Note: If the amber check indicator on one of the two DDMs is on, replace that DDM first, see Figure 6 on page 14.

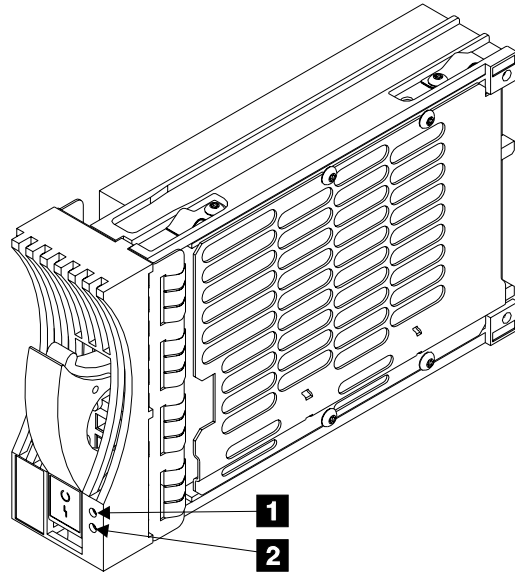
Figure 7. SSA DASD Model 040 Drawer Disk Drive Module Indicators (t007660m)

1 [Figure 7] **Ready Indicator** This green indicator shows the following conditions:

2 [Figure 7] **Check Indicator** This amber indicator shows the following conditions:

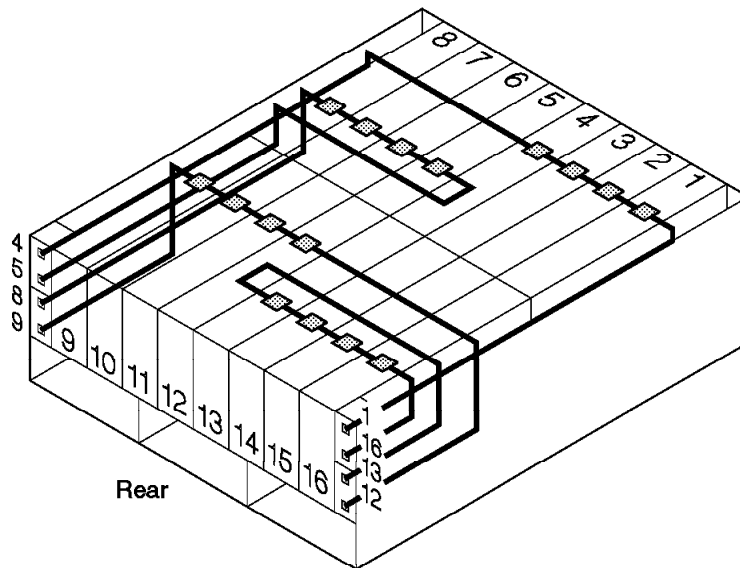
Table 4 summarizes the relationship between the DDM strings and the external SSA connectors.

Figure 8. SSA DASD Model 020 and 040 Drawer Internal SSA Connections (t007304m)

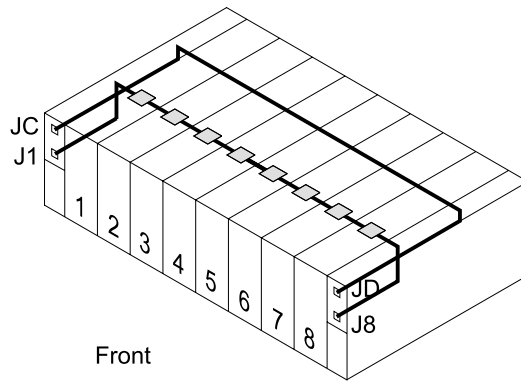
The diagram below shows the relationship between the DDM string and the external SSA connectors.

Figure 9. DDM Bay Internal SSA Connections (S008107I)

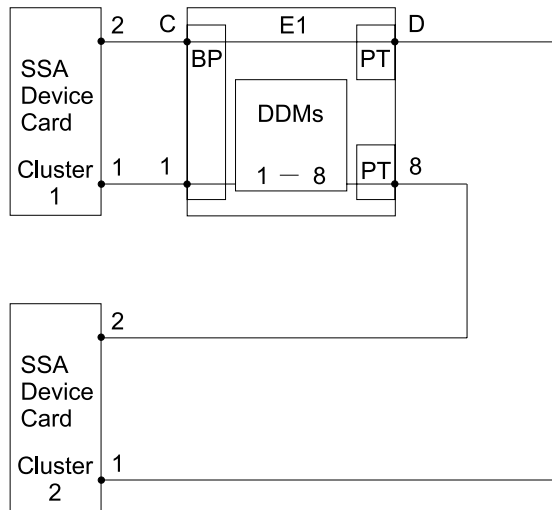
Figure 11. One DDM Bay External SSA Connections (S008129m)

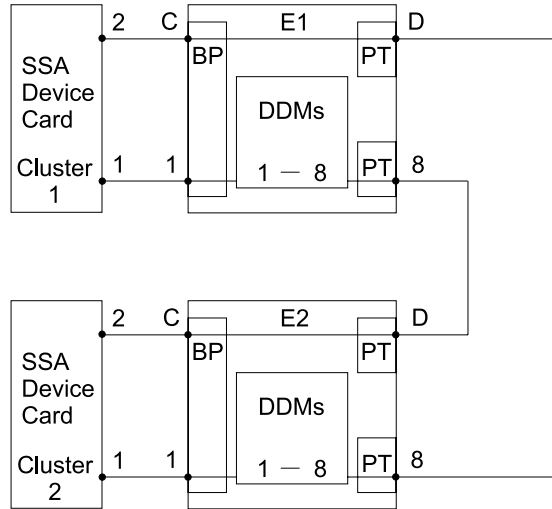
Figure 13. Two DDM Bay Final External SSA Connections (S008127m)

Note: Figure 12 on page 18 and Figure 13 on page 19 show the two stages necessary to concurrently connect a second (E2) DDM bay.

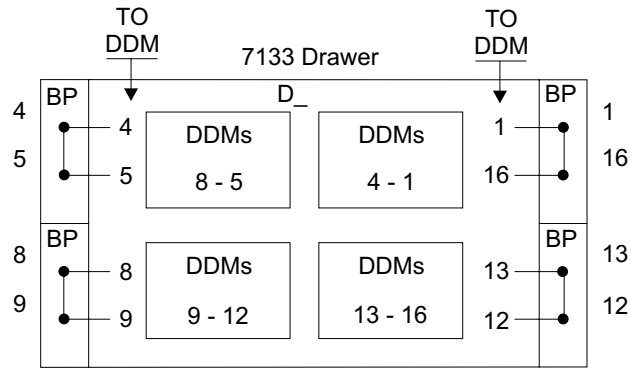
Note: The lines connecting the two terminals in a bypass card show that these two terminals are automatically connected when no cable is installed. The automatic connection occurs when no cable is connected between either of the terminals and another powered up drawer or SSA device card.

D_ = 7133 Model 020/040 Drawer Number
 BP = Bypass Card

Figure 18. SSA DASD Model 040 Drawer Diagram Explanation (S008134m)

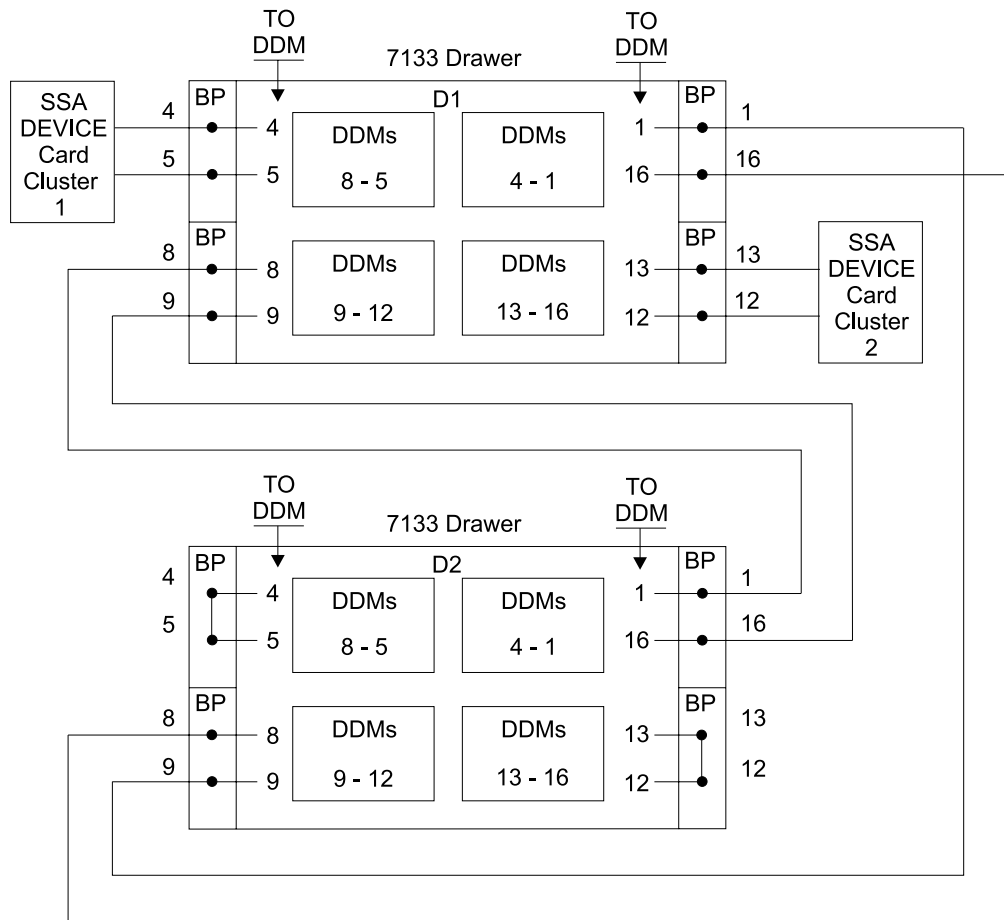
Figure 21. Two SSA DASD Model 040 Drawer Final External SSA Connections (S008138p)

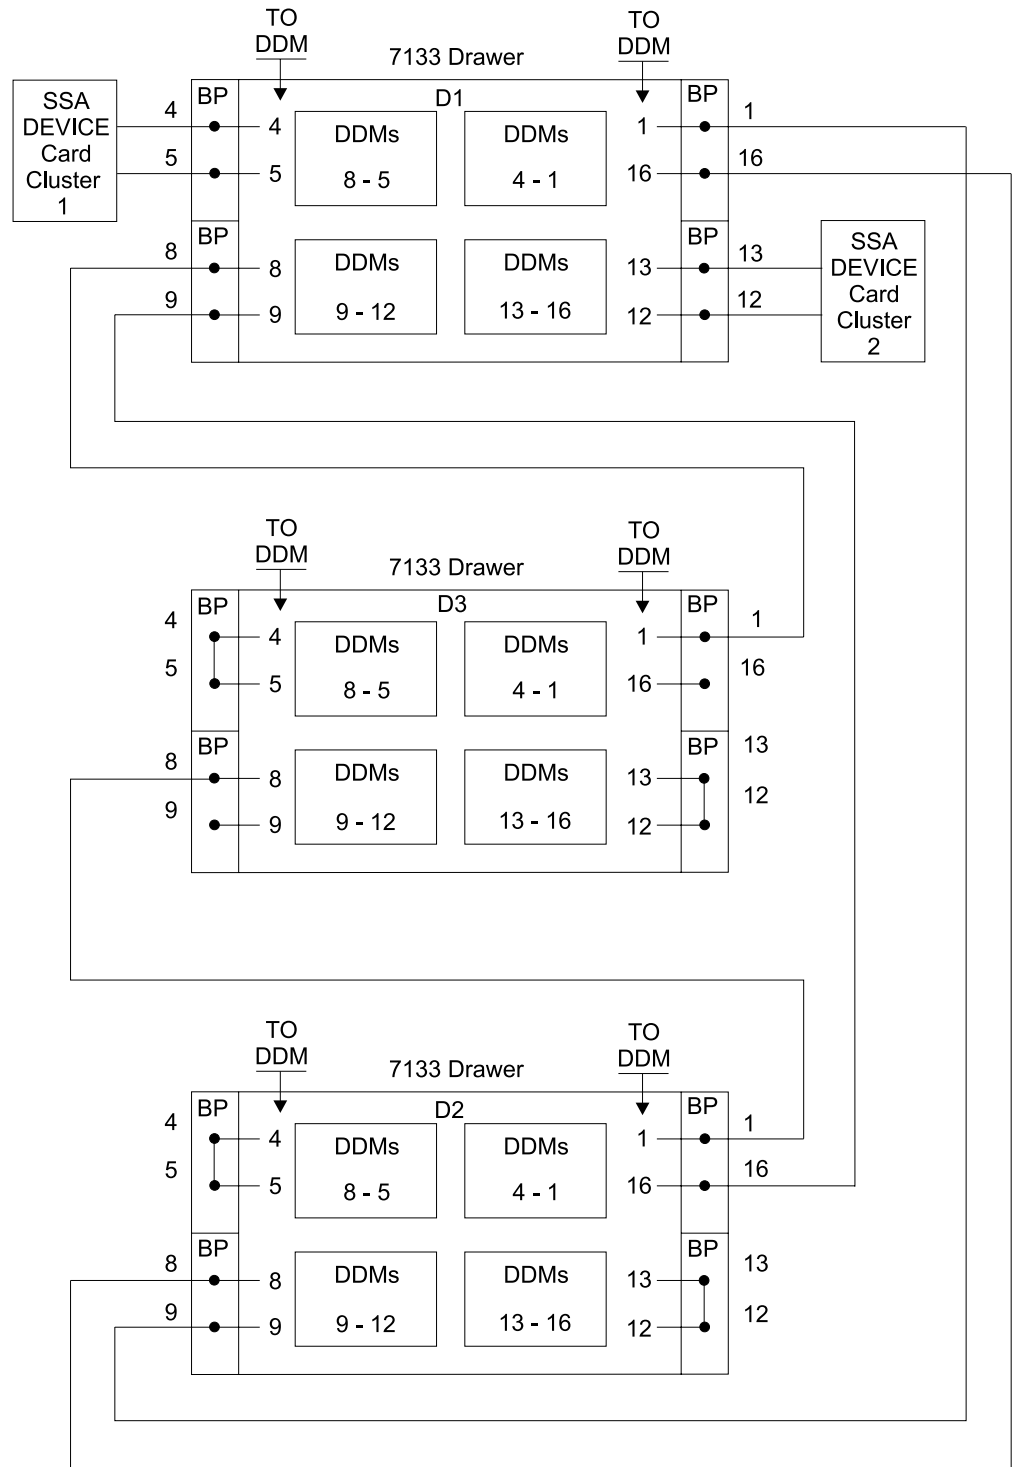
Figure 22. Three SSA DASD Model 040 Drawer External SSA Connections (S008136s)

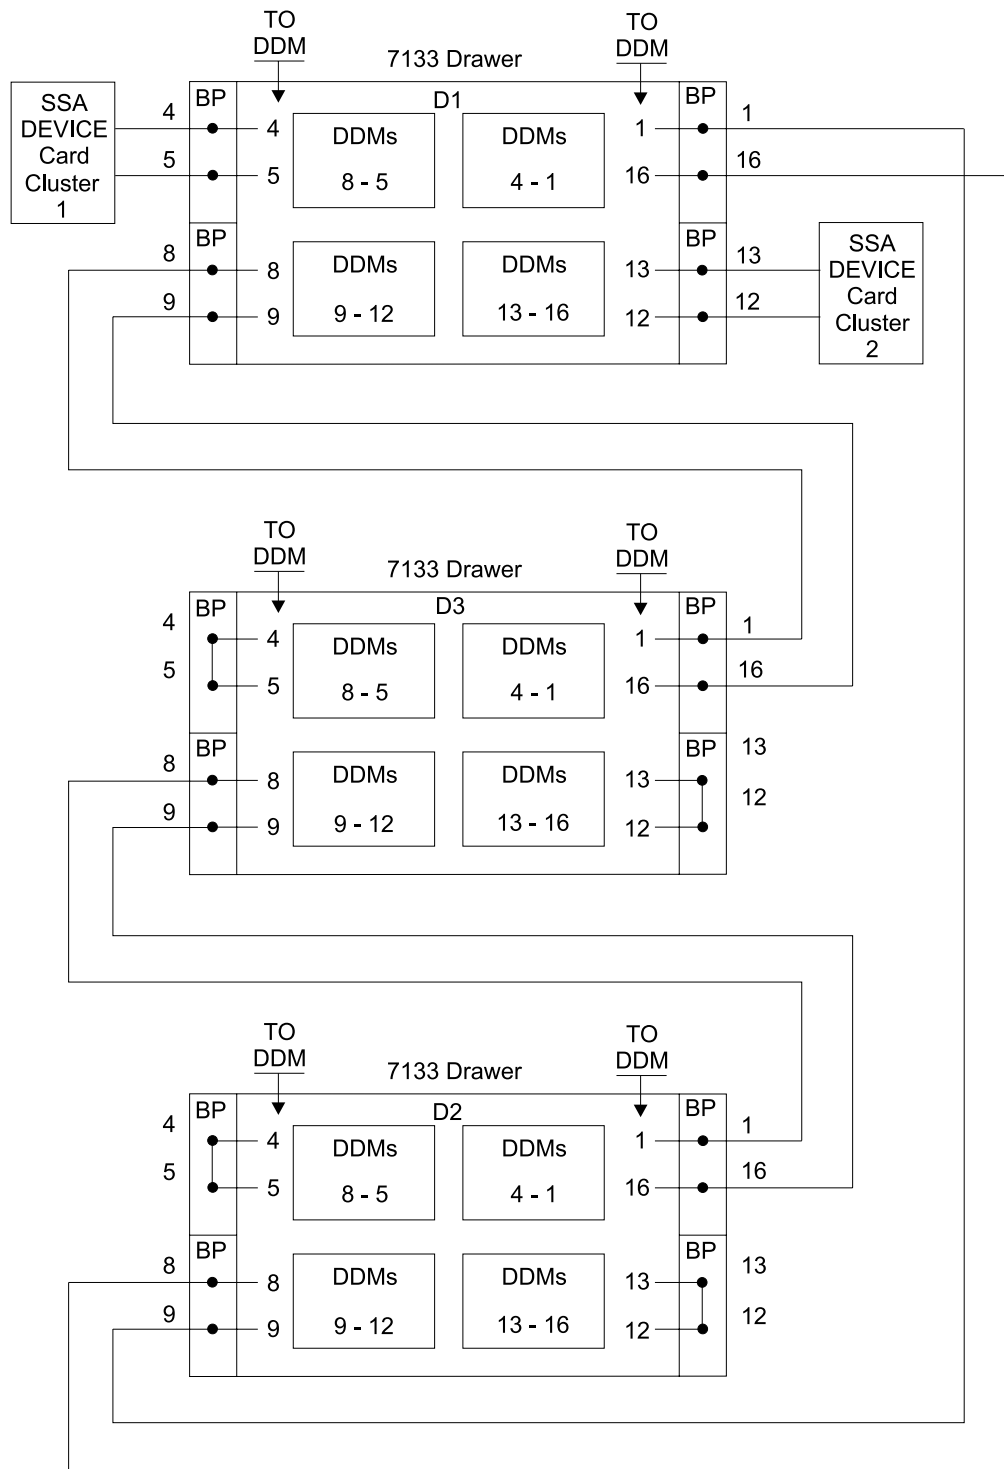
Figure 23. Four SSA DASD Model 040 Drawer External SSA Connections (S008135s)

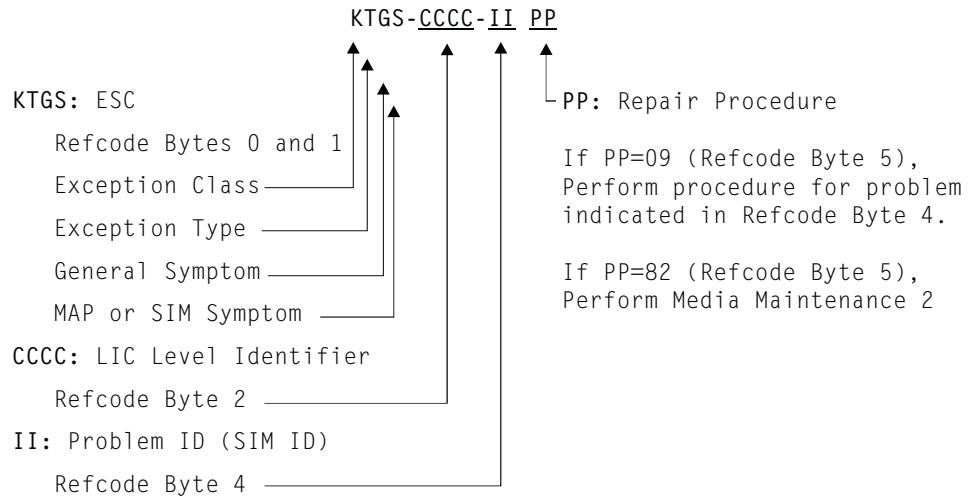
The refcode is a 6-byte field that contains information you can use to locate and repair a 2105 error condition. This section explains how to decode the refcode and find the probable failing FRUs, see Figure 26 on page 37.

Figure 26. Decoding the Refcode (s008597m)

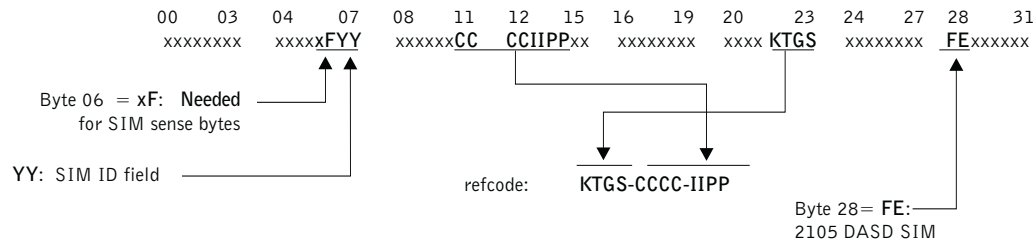
The refcode is created from SIM sense byte data as shown in Figure 27 below. For details about the refcode, see “Decode a Refcode” on page 36.

Figure 27. Refcode in the 2105 SIM Sense Bytes (S008594n)

Use the information in Figure 27 on page 37 to determine the refcode if the EREP or similar function is not available. See “ERP Reports” on page 35 for more information. If the record type in the Event History report is ASYNCH, that indicates this record contains SIM sense bytes. If the record type in the Event History report is OBRxxx, the record is a unit check sense and does not contain SIM sense bytes.

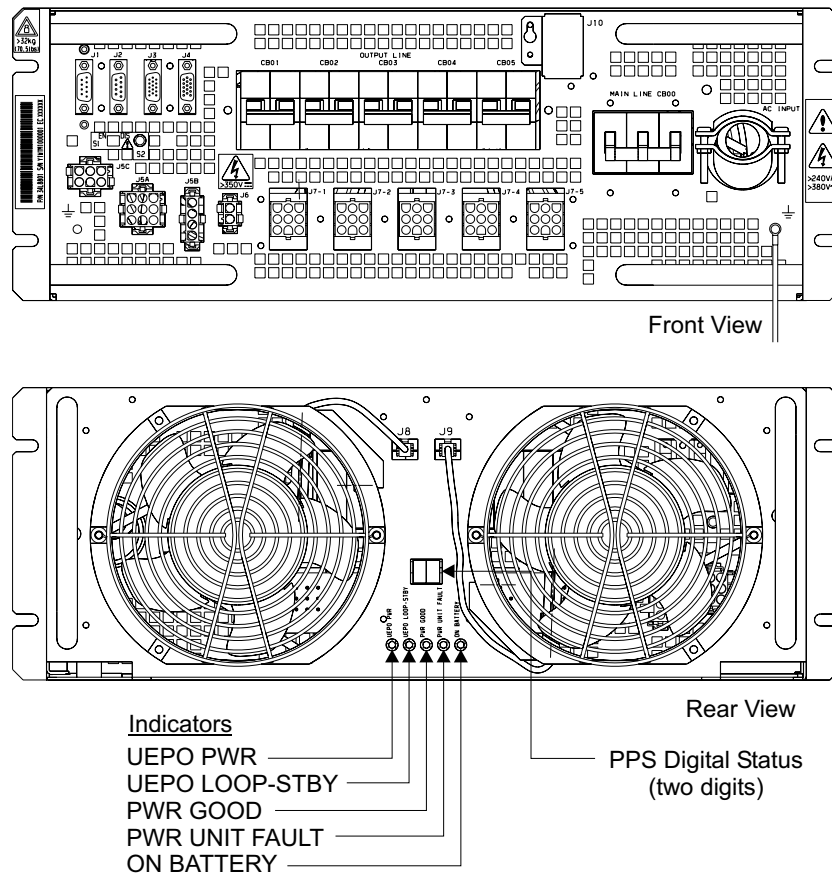
The PPS UEPO PWR indicator is on when the PPS has customer input power, the input circuit breaker is on and the PPS internal logic is providing UEPO logic voltage. The UEPO LOOP-STBY indicator is on when the UEPO loop circuit is completed with the Unit Emergency switch on (up).

Figure 29. 2105 Primary Power Supply Locations (s009048)

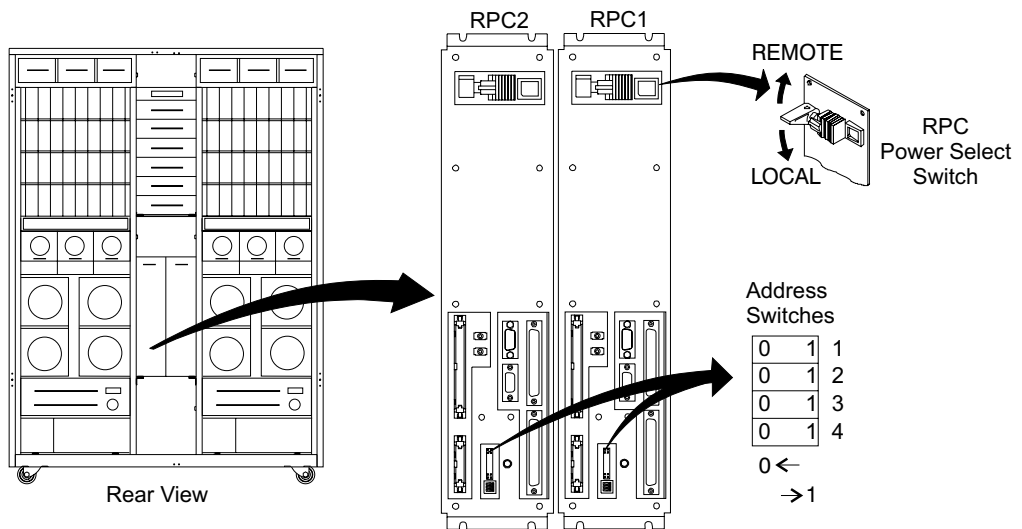
Figure 31. 2105 Model Exx/Fxx RPC Local/Remote Switch Location (S008612m)

1. At the 2105 Model Exx/Fxx, are the Local /Remote power switches on both RPC cards [Figure 31] set to Local mode (down)?
 - **Yes**, go to step 3 on page 92.
 - **No**, continue with the next step.
2. Set the RPC card Local/Remote power switches to Local mode (down). Attempt to power on the 2105 Model Exx/Fxx using the 2105 Model Exx/Fxx operator panel Local Power switch [Figure 33].

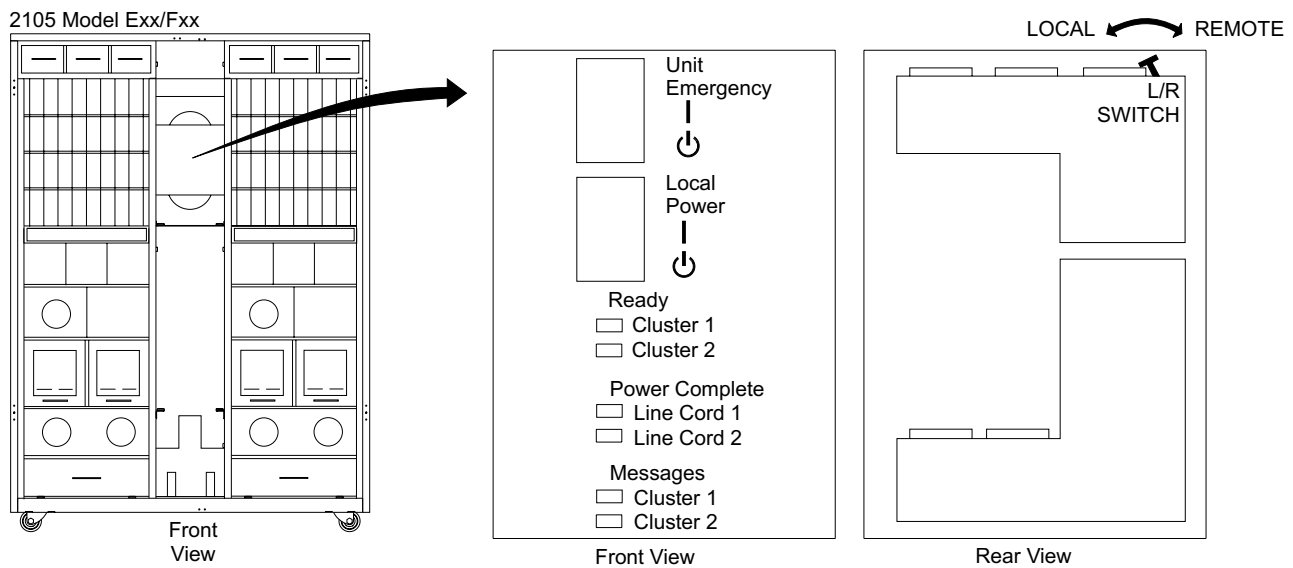
Figure 33. 2105 Model Exx/Fxx Operator Panel Locations (S008811m)

10. Observe the PPS Status Code display.
Is a status code displayed?
 - **Yes**, use the PPS status code displayed to repair the problem. Go to “MAP 2350: Isolating PPS Status Indicator Codes” on page 80. Return to the beginning of this MAP after the repair is complete.
 - **No**, continue with the next step.
11. Attempt to power on the 2105 Model Exx/Fxx. It is best to have the 2105 Model Exx/Fxx in local power control mode instead of remote power control mode. Ensure the Power Select switch on each 2105 Model Exx/Fxx RPC card is in the Local position (down). Press the 2105 Model Exx/Fxx operator panel Local power control switch momentarily to the on position. set to on (up).

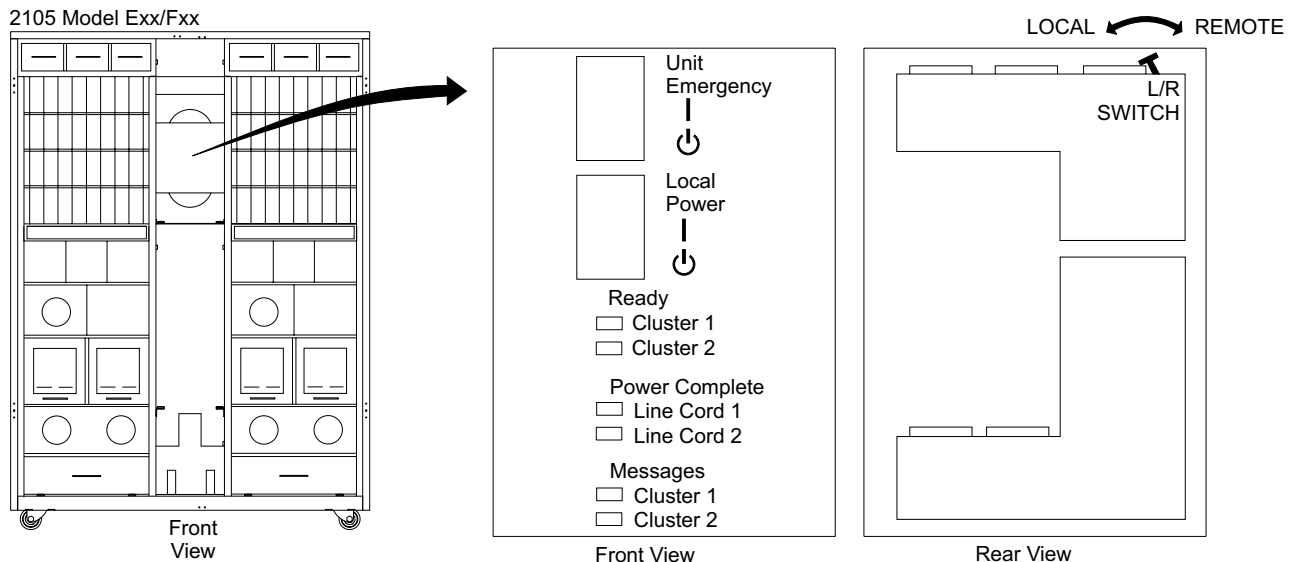
- **No**, continue with the next step.
 10. Attempt to power on the 2105 Expansion Enclosure It is best to have the 2105 Model Exx/Fxx in local power control mode instead of remote power control mode. Ensure the Power Select switch on each 2105 Model Exx/Fxx RPC card is in the Local position (down). Press the 2105 Model Exx/Fxx operator panel Local power control switch momentarily to the on position. set to on (up).

Figure 35. 2105 Model Exx/Fxx Operator Panel Locations (S008811m)

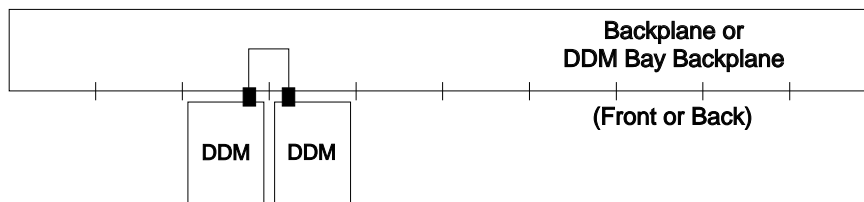
- DDM locations in SSA DASD Model 020 or 040 drawer, two adjoining DDMs in DDM drawer positions 1 to 4, 5 to 8, 9 to 12, or 13 to 16
- DDM locations in DDM bay, two adjoining DDMs in DDM drawer positions 1 to 8

Figure 38. SSA Link Failure, Two Adjoining DDMs (S007656I)

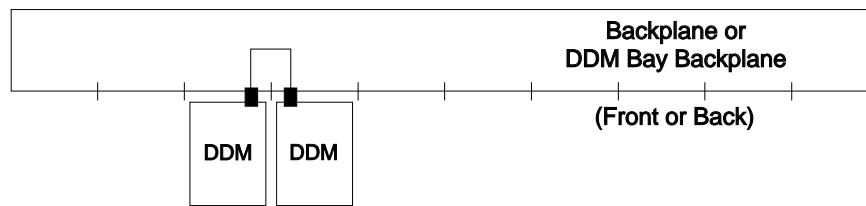
- DDM locations in DDM bay, two adjoining DDMs in DDM drawer positions 1 to 8

Figure 39. SSA Link Failure, Two Adjoining DDMs (S007656I)

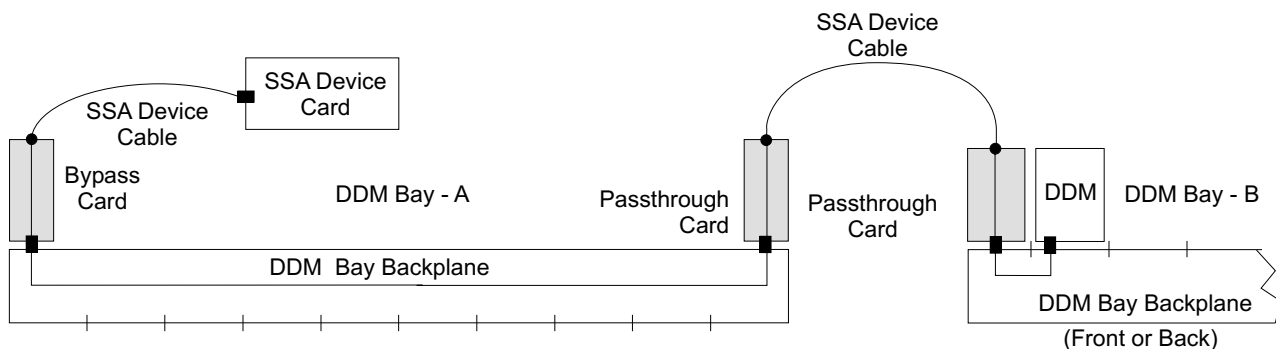
An SSA link failed between a DDM and the SSA device card. The failing FRU is either a center DDM, a signal or bypass card, a SSA device cable, or an SSA device card. See Figure 85 for the relationship of the DDM, signal or bypass card, backplane, SSA device cable and SSA device card FRUs involved with this failure.

Figure 40. SSA Link Failure, Signal or Bypass Card Link Between a DDM and SSA Device Card (S0080411)

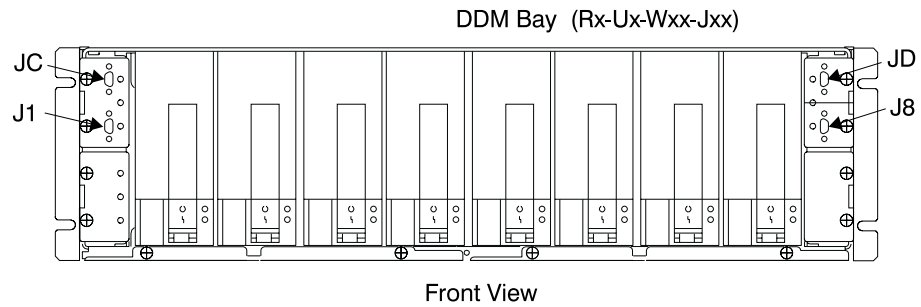
Figure 41. DDM bay SSA Connectors (S007693I)

- **No**, go to step 6.
6. Locate the SSA cables displayed on the service terminal as possible FRUs. For this isolation procedure, one of the the SSA cables is connected between a DDM bay and an SSA device card. The other SSA cable is connected between the same DDM bay and another DDM bay. The service terminal will identify the drawer and its SSA connector, and the SSA device card and its SSA connector. To locate a drawer see "Locating a DDM Bay or SSA DASD Model 020 or 040 Drawer in a 2105 Rack" in chapter 7 of the *Enterprise Storage Server Service Guide, Volume 3*. To locate SSA cable connectors on a drawer, see Figure 41 on page 115.

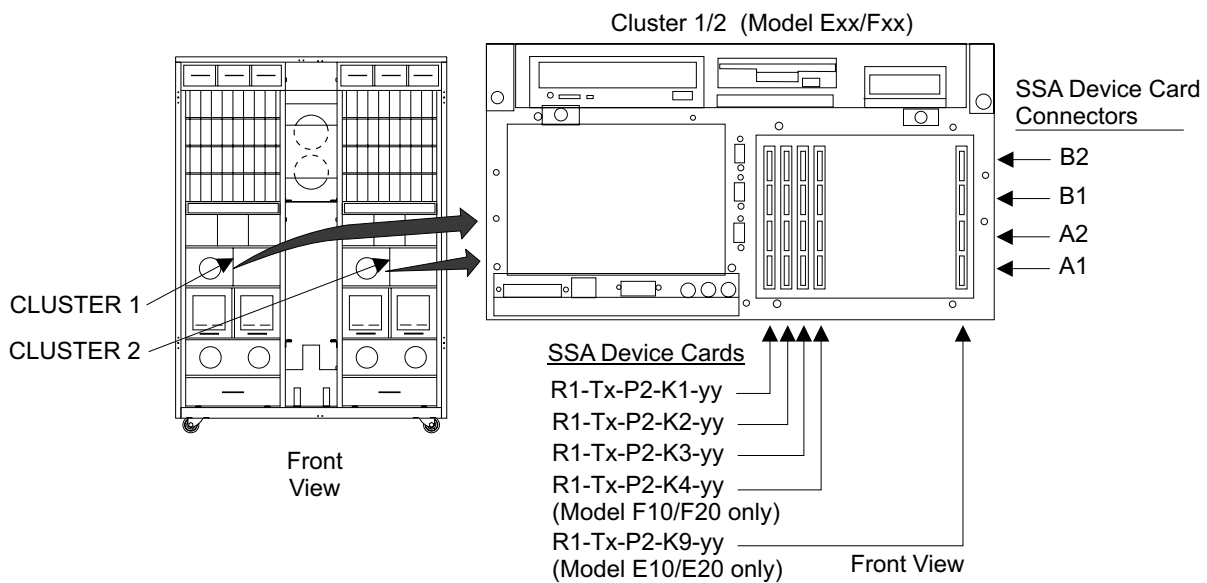
Figure 42. Cluster SSA Device Card Connector Locations (S008022m)

- *Tx* is the cluster, 1 or 2
- *Ky* is the card location, slot
- *yy* is the cable connector, A1, A2, B1, or B2

Use the figure below to locate an SSA device card cable connector.

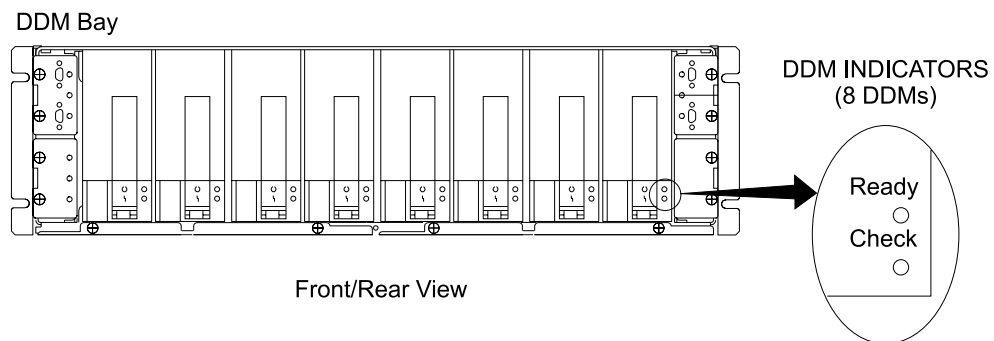
Figure 43. DDM bay DDM Indicator Locations (S0080211)

- **Yes**, go to step 8.
 - **No**, there is a DDM bay power problem, go to “MAP 3395: Isolating an SSA DASD DDM Bay Power Problem” on page 259.
8. Locate DDM bay B, it may be in the front or rear of the 2105. Observe all of the DDM bay, DDM Ready and Check indicators.

- Are any of the DDM bay DDM indicators on?
- **Yes**, go to step 9.
 - **No**, there is a DDM bay power problem, go to “MAP 3395: Isolating an SSA DASD DDM Bay Power Problem” on page 259.

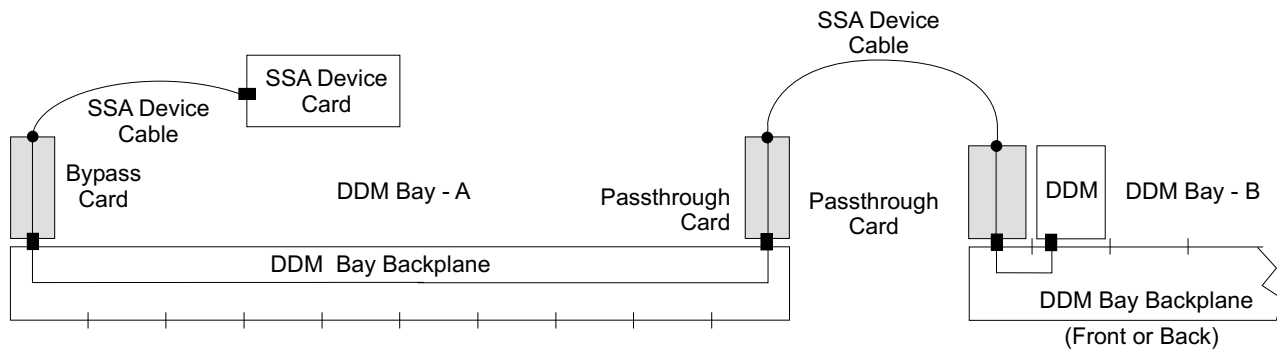
Figure 44. SSA Link Failure, Signal or Bypass Card Link Between a DDM and SSA Device Card (S0080411)

A 40 MB/s SSA link is degraded and is running at 20 MB/s, between a DDM and the SSA device card. The degraded FRU is either a center DDM, a signal or bypass card, a SSA device cable, or an SSA device card. See Figure 85 for the relationship of the DDM, signal or bypass card, backplane, SSA device cable and SSA device card FRUs involved with this failure.

- a. Disconnect one of the two SSA device cables shown in Figure 44 on page 118, and listed in the Problem FRU list.

- **No**, the SSA link is still degraded:
 - If all of the cards shown in Figure 44 on page 118, have been replaced, go to step 3.
 - If all of the cards shown in Figure 44 on page 118, have NOT been replaced, repeat this step until all of the cards have been replaced.

- **No**, the SSA link is still degraded:
 - If both of the SSA device cables shown in Figure 44 on page 118, have been replaced, go to step 4.
 - If both of the SSA device cables shown in Figure 44 on page 118, have NOT been replaced, repeat this step until all of the cables have been replaced.

- **Yes**, the problem is resolved. Return to the service terminal and select **Continue Repair Process**, to return the resources to the customer and cancel the problem.
- **No**, the SSA link is still degraded:
 - If all of the backplanes shown in Figure 44 on page 118, have been replaced, the SSA link is still degraded, call the next level of support.
 - If all of the backplanes shown in Figure 44 on page 118, have NOT been replaced, repeat this step until all of the backplanes have been replaced.

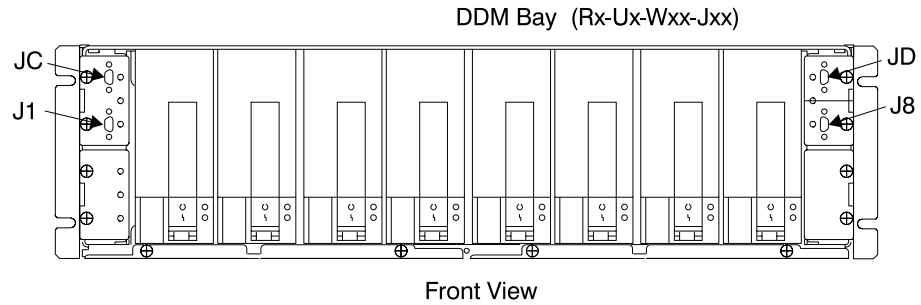
Figure 45. DDM bay SSA Connectors (S007693I)

1. Locate the SSA cables displayed on the service terminal as possible FRUs. For this isolation procedure, one of the SSA cables is connected between a DDM bay and an SSA device card. The other SSA cable is connected between the same DDM bay and another DDM bay. The service terminal will identify the drawer and its SSA connector, and the SSA device card and its SSA connector. To locate a drawer see "Locating a DDM Bay or SSA DASD Model 020 or 040 Drawer in a 2105 Rack" in chapter 7 of the *Enterprise Storage Server Service Guide, Volume 3*. To locate SSA cable connectors on a drawer, see Figure 45 on page 119.

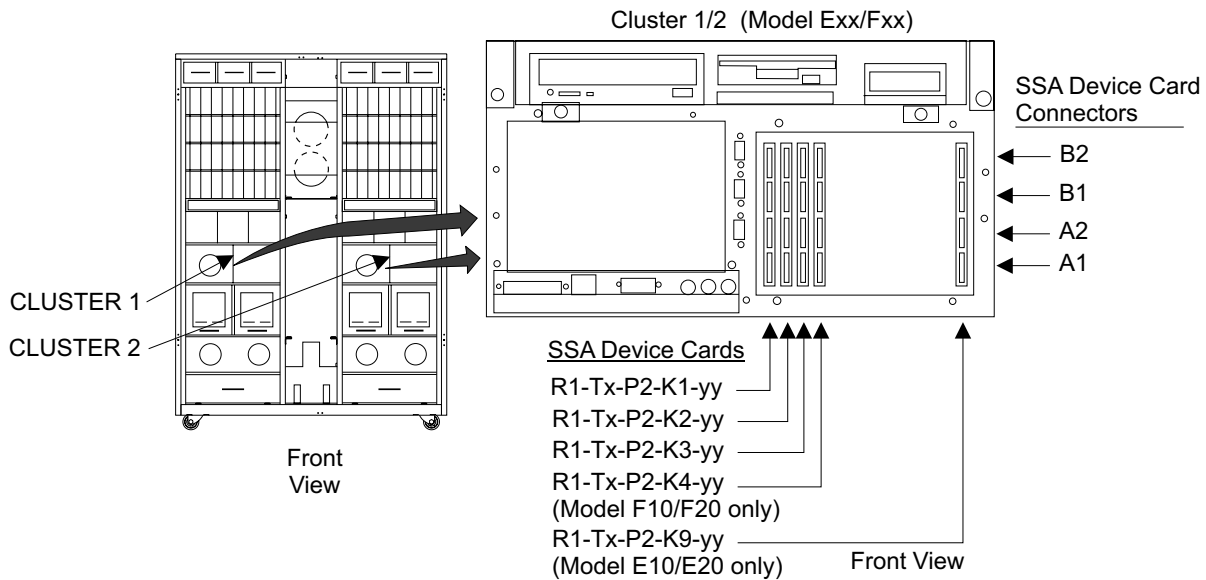
Figure 46. Cluster SSA Device Card Connector Locations (S008022m)

Note: The SSA device card cable connector is in the format *R1-Bx-Ky-yy*, where *Bx* is the bay location, *Ky* is the card location, and *yy* is the cable connector. To locate an SSA device card cable connector, see Figure 46 on page 119.

Note: The SSA device card cable connector is in the format *R1-Tx-P2-Ky-yy*, where:

- Tx is the cluster, 1 or 2
- Ky is the card location, slot
- yy is the cable connector, A1, A2, B1, or B2

Use the figure below to locate an SSA device card cable connector.

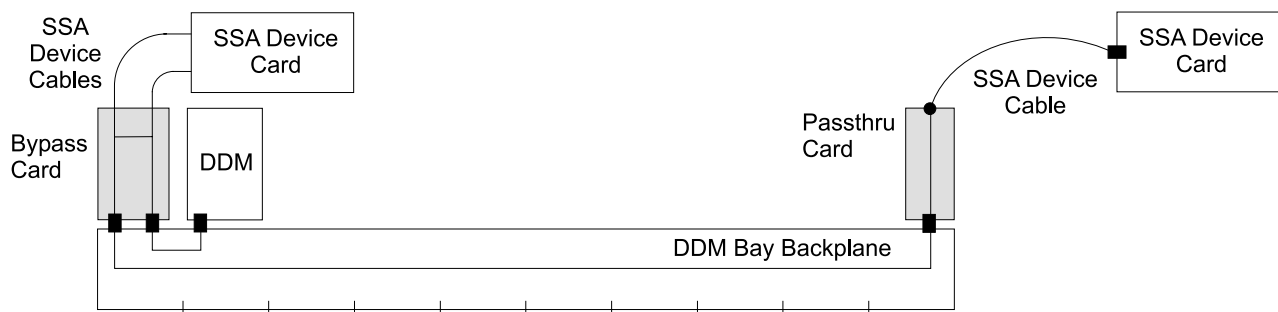
Figure 47. SSA Link Failure, Signal or Bypass Card Link Between a DDM and SSA Device Card (S008141I)

An SSA link between a DDM and two SSA device cards is failing. The failing link includes two SSA device cards, one bypass card, one passthrough card, three SSA cables, and the DDM bay backplane. See Figure 47 for the relationship of these FRUs.

The failure or incorrect connection of any of these components can cause the link to fail. Other failures can also cause the link to fail. For example, a hot reset line to the SSA device card can cause the connection between the two loop inputs to appear to be open.

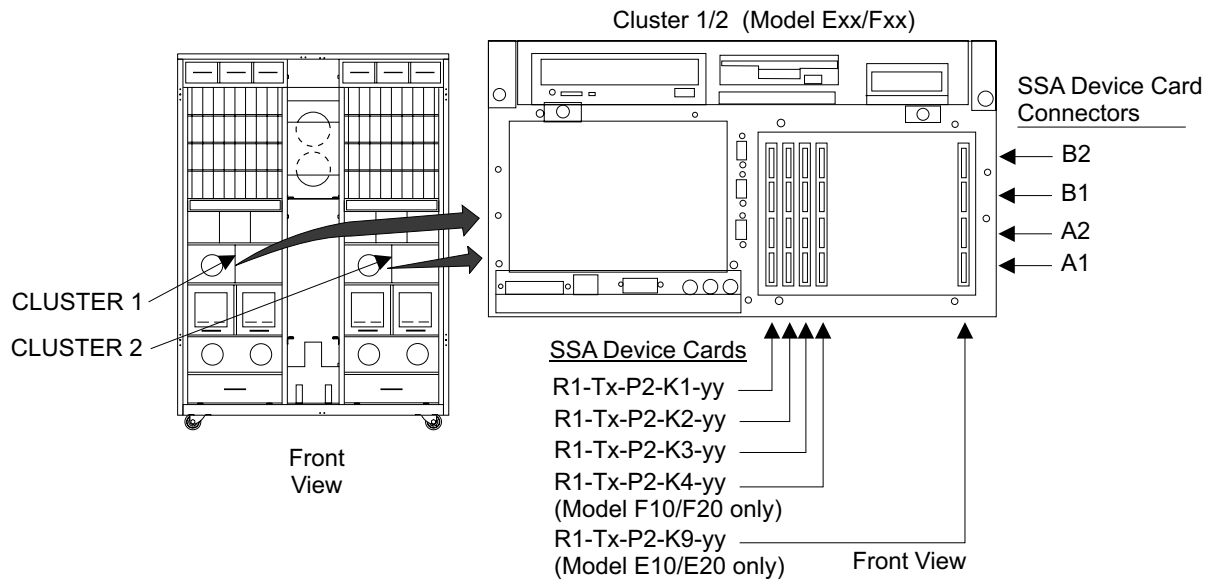
Figure 49. Cluster SSA Device Card SSA Connector Locations (S008022m)

- Tx is the cluster, 1 or 2
- Ky is the card location, slot
- yy is the cable connector, A1, A2, B1, or B2

To locate an SSA device card cable connector, see Figure 49.

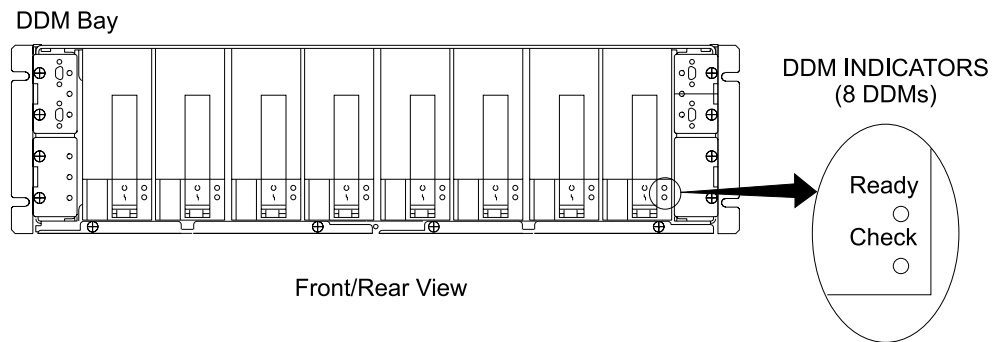
Figure 50. DDM bay DDM Indicator Locations (S008021)

- **Yes**, the problem is resolved. Return to the service terminal and select **Continue Repair Process**, to return the resources to the customer and cancel the problem.
 - **No**, continue with the next step.
8. Locate the DDM bay, it may be located in the front or rear of the 2105. Observe all of the DDM bay DDM Ready and Check indicators.
- Are any of the DDM bay DDM indicators on?
- **Yes**, go to step 9.
 - **No**, there is a DDM bay problem, go to "MAP 3395: Isolating an SSA DASD DDM Bay Power Problem" on page 259.

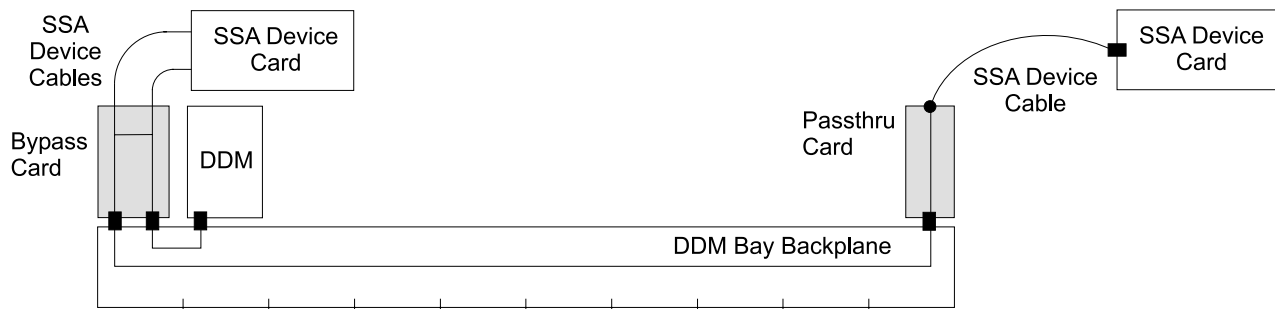
Figure 51. SSA Link Failure, Passthrough and Bypass Card Link Between a DDM and SSA Device Card (S0081411)

A 40 MB/s SSA link between a DDM and two SSA device cards is degraded and is running at 20 MB/s. The degraded link includes two SSA device cards, one bypass card, one passthrough card, three SSA cables, and the DDM bay backplane. See Figure 51 for the relationship of these FRUs. The failure or incorrect connection of any of these components can cause the link to run at a slower speed.

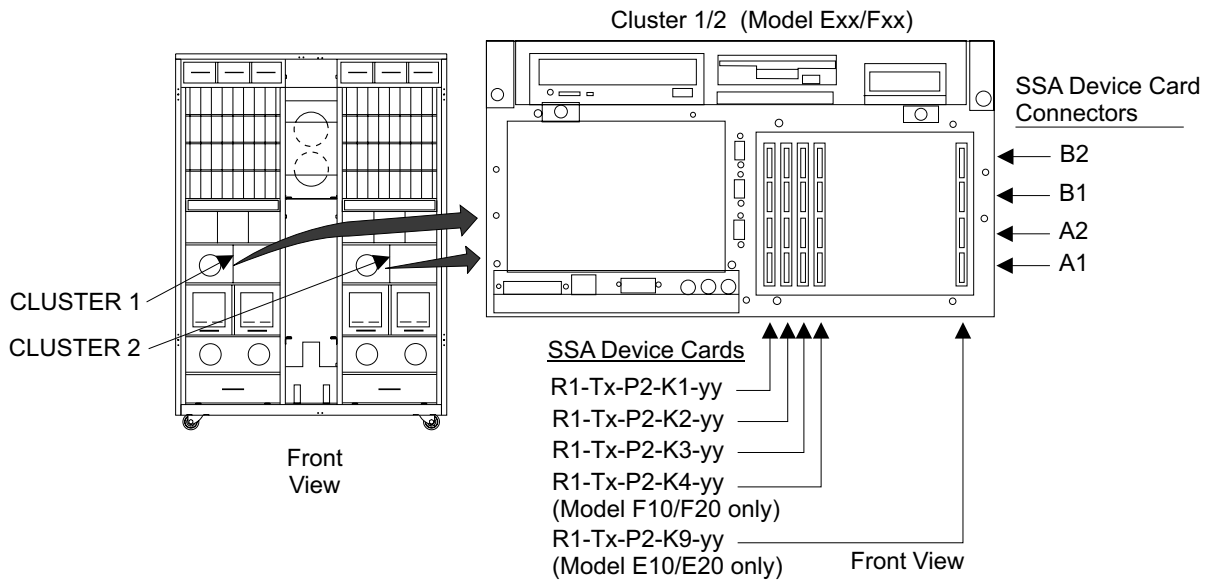
Figure 53. Cluster SSA Device Card SSA Connector Locations (S008022m)

- Tx is the cluster, 1 or 2
- Ky is the card location, slot
- yy is the cable connector, A1, A2, B1, or B2

To locate an SSA device card cable connector, see Figure 53.
