Enterprise Storage Server

Service Guide
2105 Models E10/E20, F10/F20, and
Expansion Enclosure
Volume 1

Chapters 1, 2, and 3

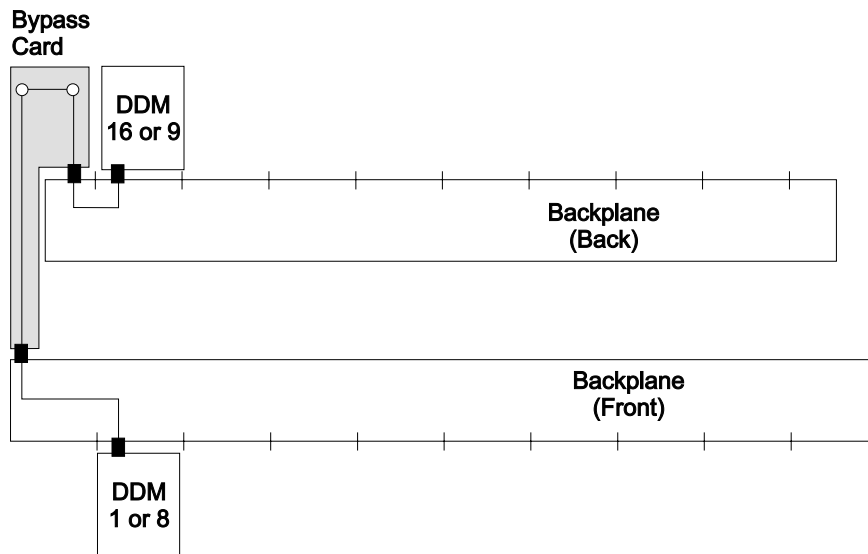
Figure 54. SSA Link Failure, Bypass Card and Two DDMs (S008144m)

The SSA link between two DDMs is failing. One of the following conditions is present:

- The failing link is between two end DDMs, on different backplanes, and the bypass card that links them. See Figure 54.
- The failing link is between two center DDMs, on the same backplane, and the bypass card they are connected to. See Figure 55.
- Drawer models, SSA DASD Model 020 or 040 drawer
- DDM locations in drawer, two DDMs in DDM drawer positions 1 and 16, 8 and 9, 4 and 5, or 12 and 13.
- Bypass card location in drawer, lower left (J8 and J9) or upper right (J1 and J16), lower right (J12 and J13) or upper left (J4 and J5),

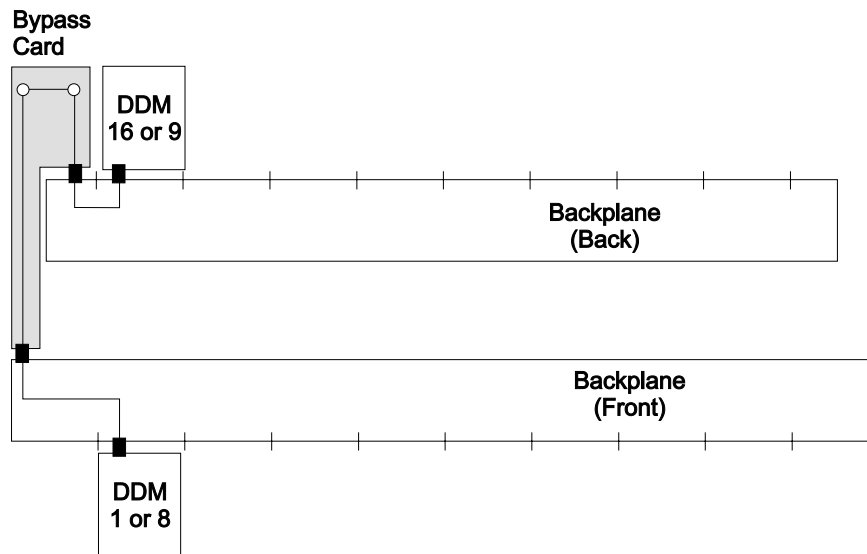
Figure 56. SSA Link Failure, Bypass Card and Two DDMs (S008144m)

- The degraded link is between two end DDMs, on different backplanes, and the bypass card that links them. See Figure 56.
- The degraded link is between two center DDMs, on the same backplane, and the bypass card they are connected to. See Figure 57.
- Drawer models, SSA DASD Model 040
- DDM locations in drawer, two DDMs in DDM drawer positions 1 and 16, 8 and 9, 4 and 5, or 12 and 13.
- Bypass card location in drawer, lower left (J8 and J9) or upper right (J1 and J16), lower right (J12 and J13) or upper left (J4 and J5),

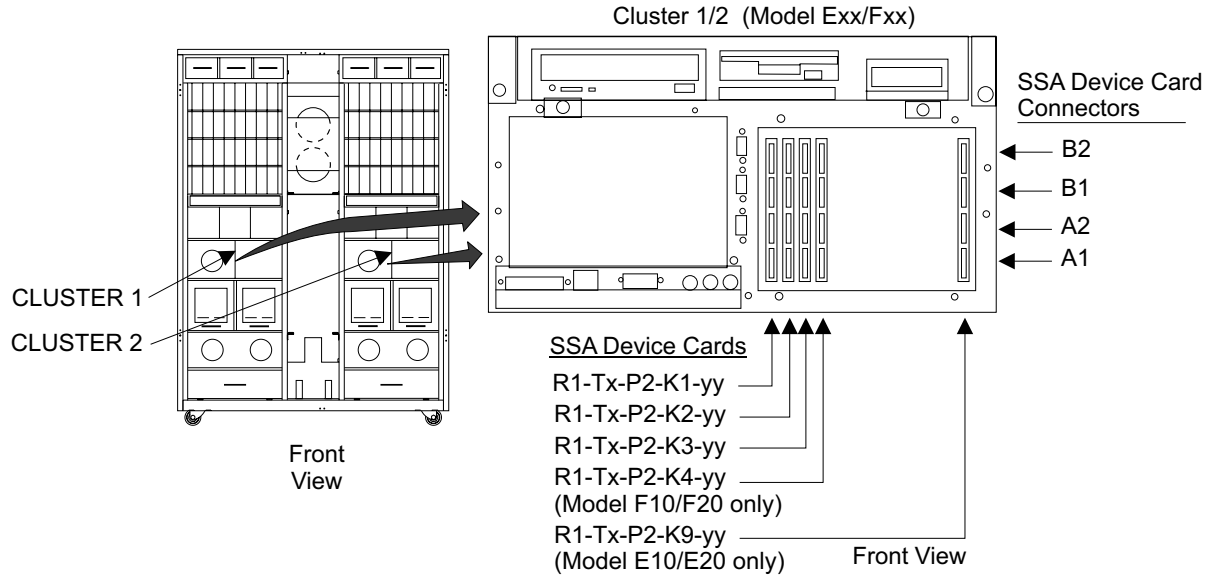
Figure 59. Cluster SSA Device Card SSA Connector Locations (S008022m)

- *Ky* is the card location, slot
- *yy* is the cable connector, A1, A2, B1, or B2

Use the drawing below to locate the SSA cable connectors on an SSA device card.

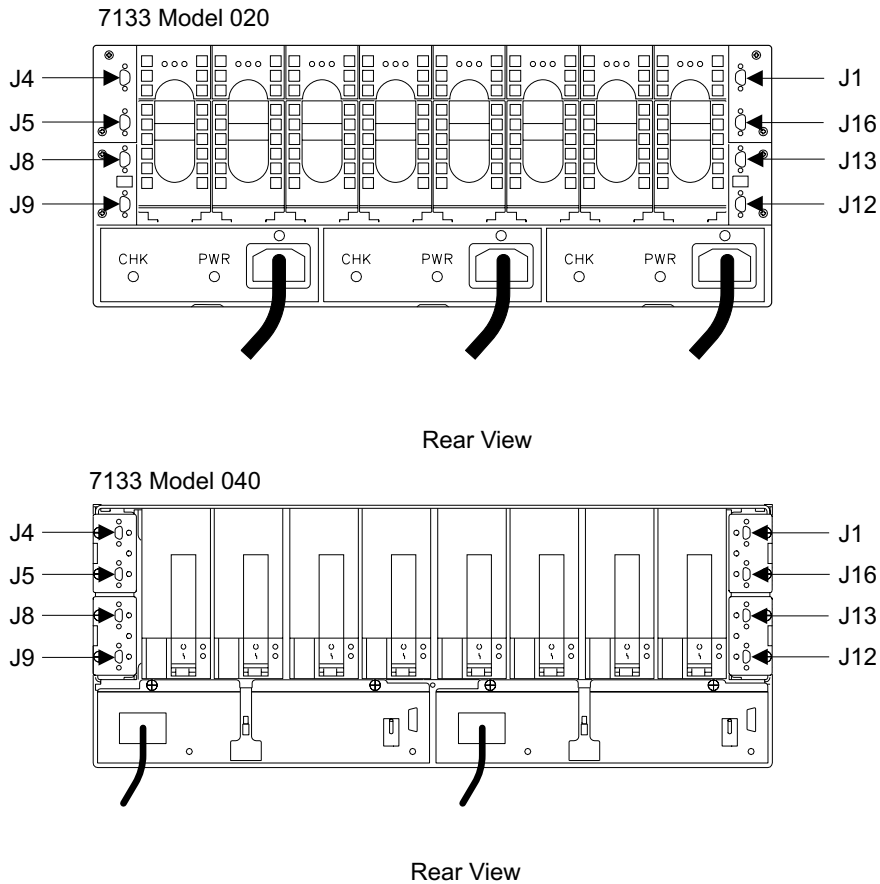
Figure 60. Drawer SSA Connector Locations (S008762p)

The drawer card cable connector is in the format *Rx-Yy-Jzz*, where:

Use the drawing below to locate the SSA cable connectors on a drawer.

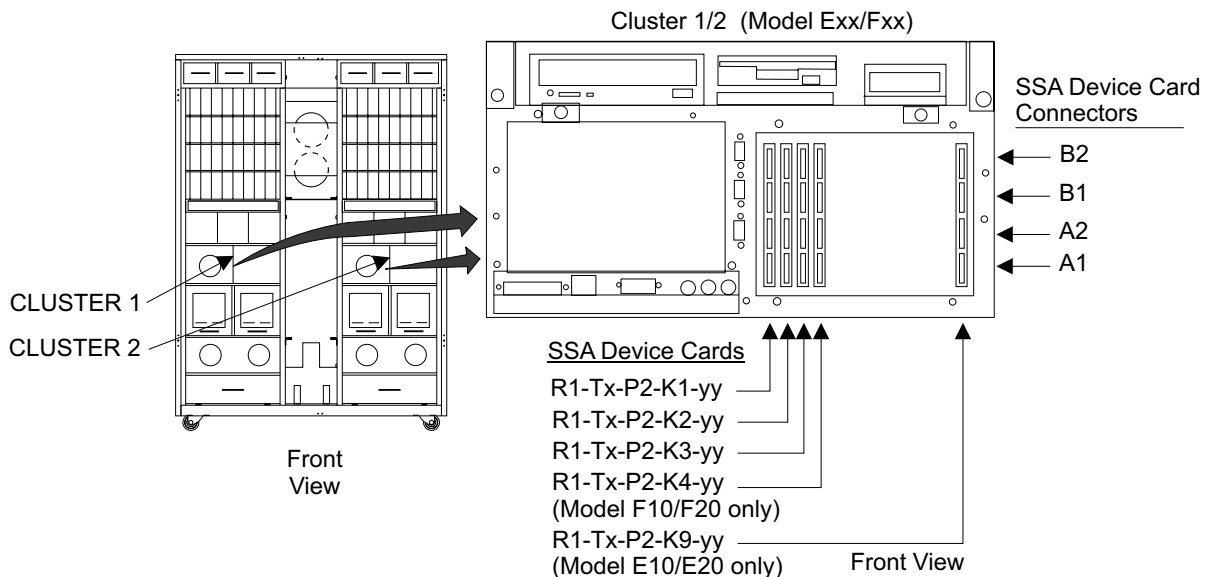
Figure 62. Cluster SSA Device Card SSA Connector Locations (S008022m)

- Tx is the cluster, 1 or 2
- Ky is the card location, slot
- yy is the cable connector, A1, A2, B1, or B2

Use the drawing below to locate the SSA cable connectors on an SSA device card.

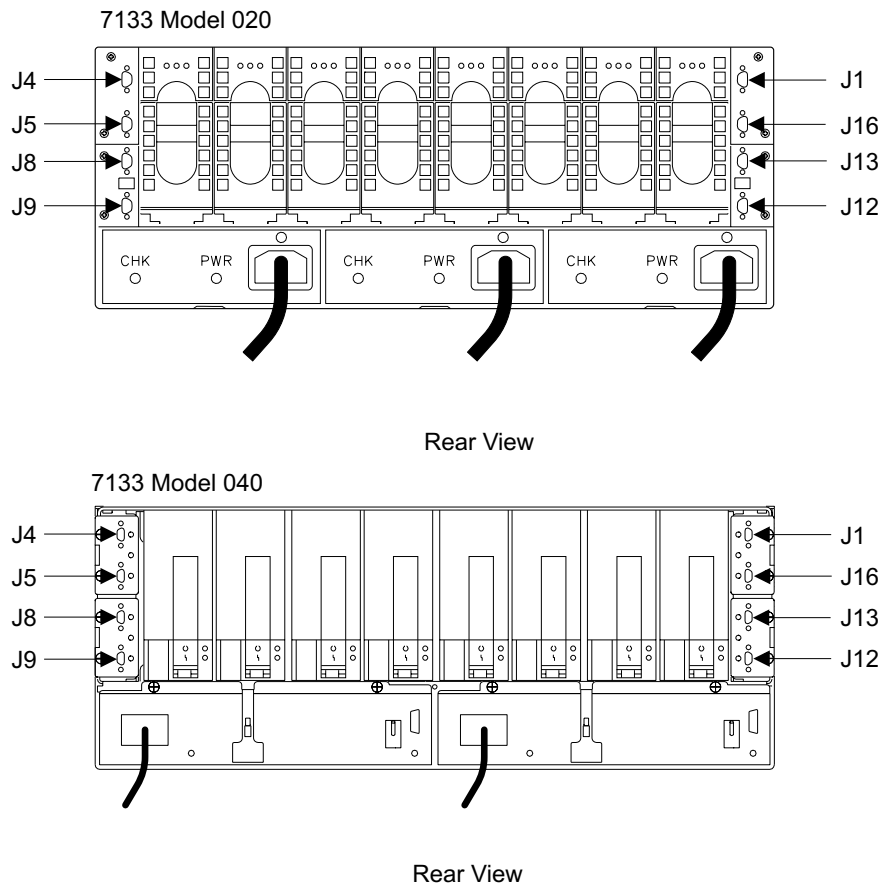
Figure 63. Drawer SSA Connector Locations (S008762p)

The drawer card cable connector is in the format *Rx-Yy-Jzz*, where:

Use the drawing below to locate the SSA cable connectors on a drawer.

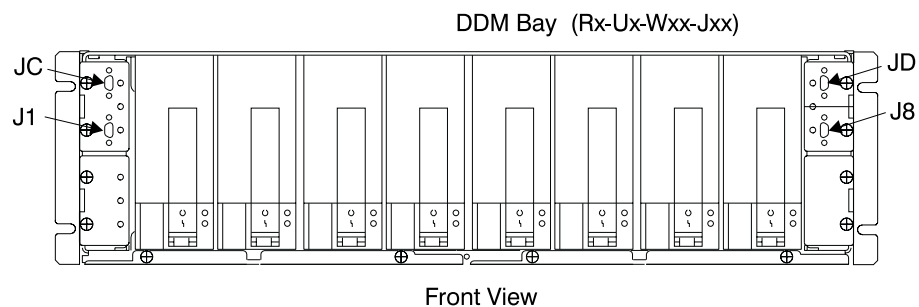
Figure 65. DDM bay SSA Connector Locations (S007693I)

- **No**, go to step 4.
4. Locate the two SSA cables displayed on the service terminal as possible FRUs. For this isolation procedure, the SSA cables will be connected between a DDM bay and SSA device cards. The service terminal will identify the DDM bays and their SSA connectors, and the SSA device cards and their SSA connectors. To locate a drawer see "Locating a DDM Bay or SSA DASD Model 020 or 040 Drawer in a 2105 Rack" in chapter 7 of the *Enterprise Storage Server Service Guide, Volume 3*. To locate SSA cable connectors on a DDM bay, see Figure 65.

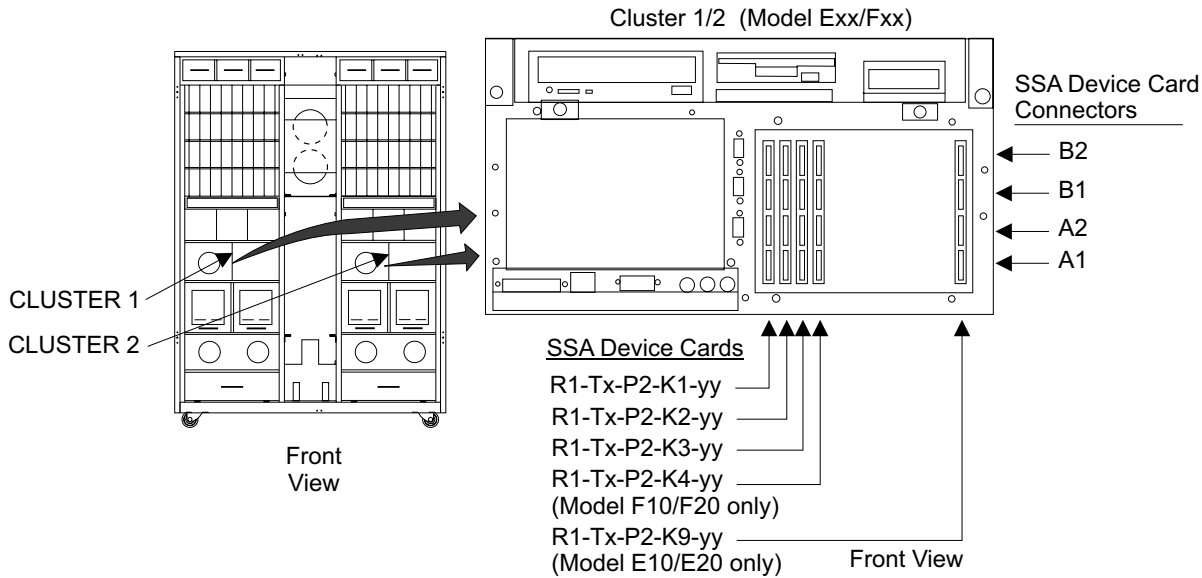
Figure 66. Cluster SSA Device Card SSA Connector Locations (S008022m)

- *Tx* is the cluster, 1 or 2
- *Ky* is the card location, slot
- *yy* is the cable connector, A1, A2, B1, or B2

To locate an SSA device card cable connector, see Figure 66 on page 146.

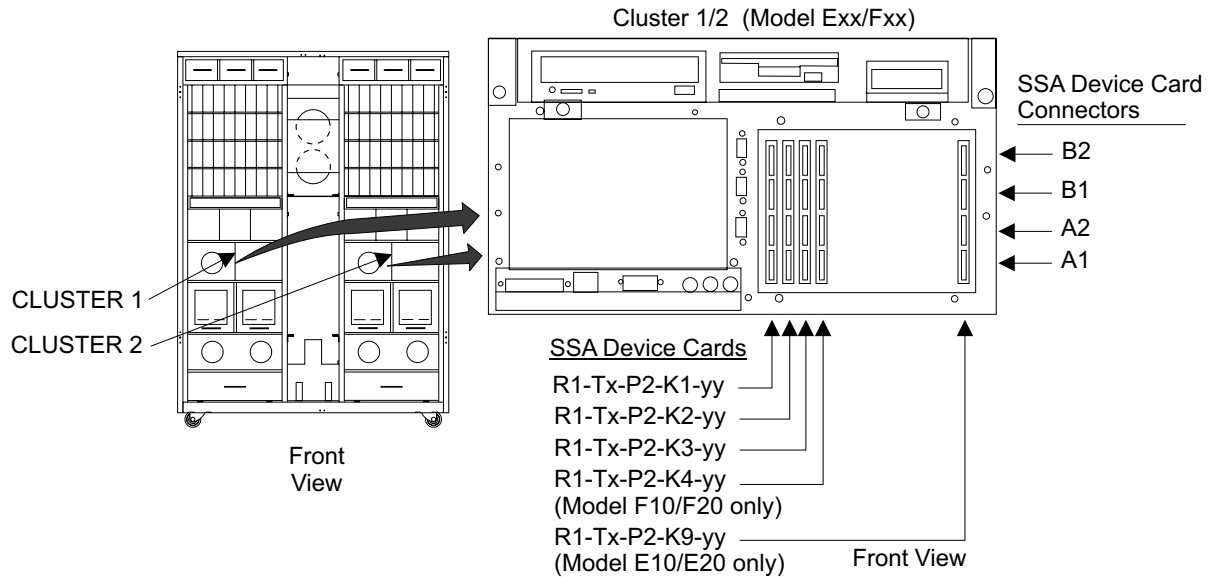
Figure 69. Cluster SSA Device Card SSA Connector Locations (S008022m)

To locate an SSA device card cable connector, see Figure 69 on page 149.

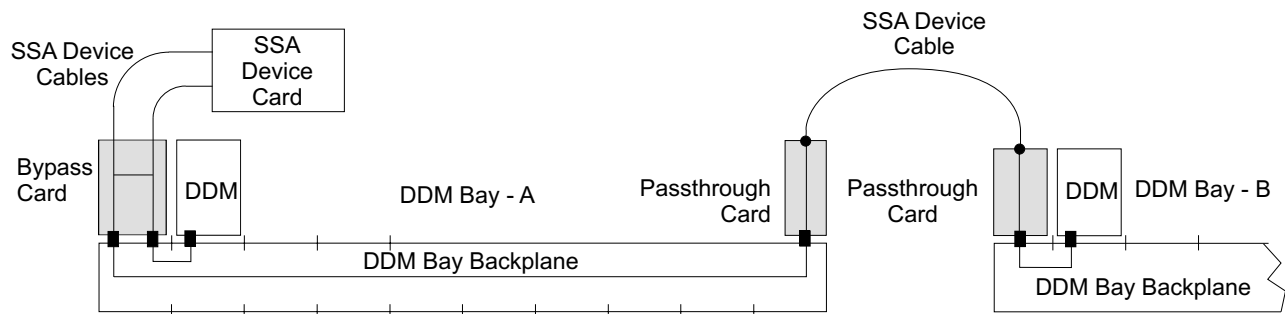
Figure 70. SSA Link Failure, Signal or Bypass Card Link Between a DDM and SSA Device Card (S008140I)

The failure or incorrect connection of any of these components can cause the link to fail. Other failures can also cause the link to fail. For example, a hot reset line to the SSA device card can cause the connection between the two loop inputs to appear to be open.

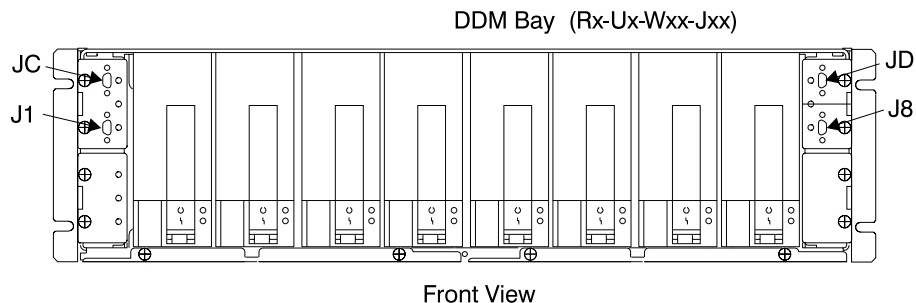
Figure 71. DDM bay SSA Connector Locations (S007693I)

Inspect the cable connectors for bent pins and correct any problems found. Reconnect both ends of the SSA device cable, ensure good connection.

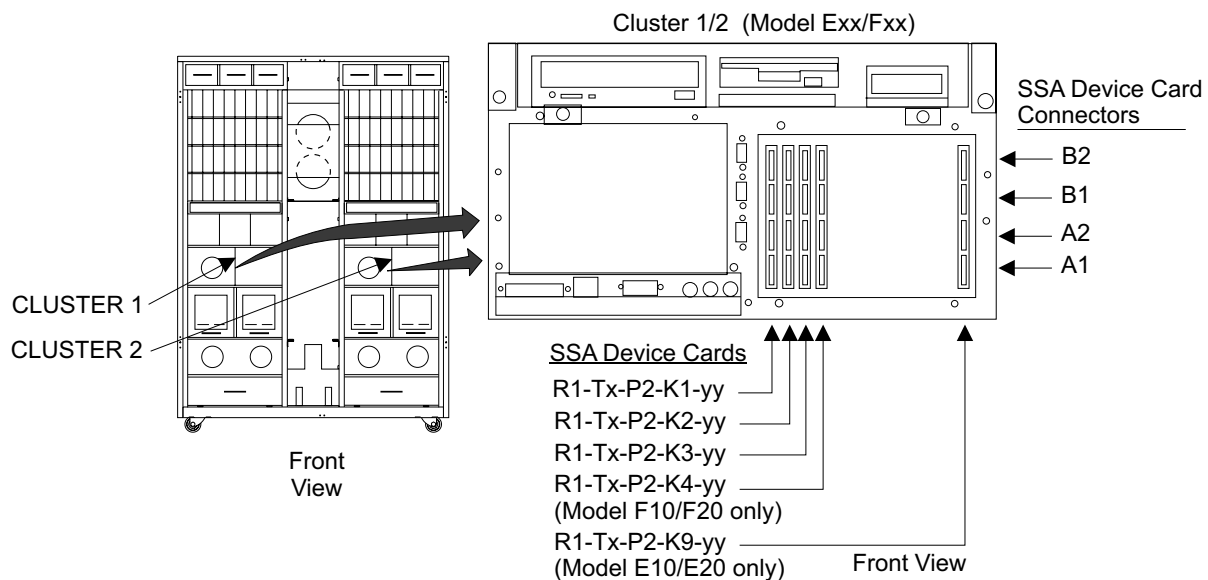
9. Determine if the problem is resolved. Return to the service terminal Detail Problem screen. Select any cable in the Possible FRUs to Replace list. Proceed through the repair but do not replace any FRU or disconnect any cables. This will simulate a repair and run verification.

8. Locate the two remaining SSA cables in the Possible FRU list. These SSA cable will be connected between a DDM bay and an SSA device card. The service terminal will identify the drawer and its SSA connector, and the SSA device card and its SSA connector.

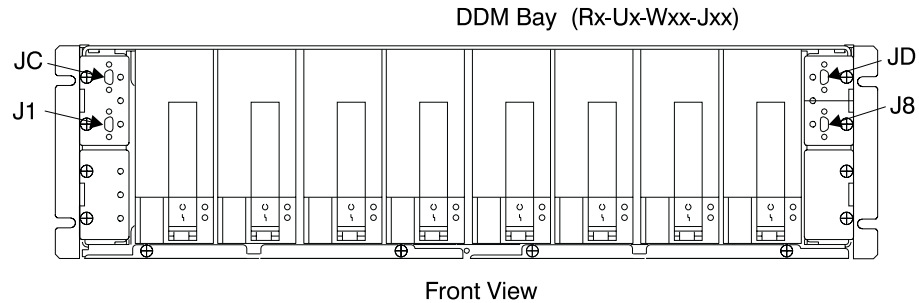
Figure 74. DDM bay SSA Connector Locations (S007693I)

1. Locate the SSA cable displayed on the service terminal as possible FRU. This SSA cable will be connected between two separate DDM bays. The service terminal will identify the drawer and SSA connector that each end of the SSA cable is connected to. To locate a DDM bay, see "Locating a DDM Bay or SSA DASD Model 020 or 040 Drawer in a 2105 Rack" in chapter 7 of the *Enterprise Storage Server Service Guide, Volume 3*. To locate SSA cable connectors on a SSA DASD drawer, see Figure 74 on page 157.
Continue with the next step.
2. Disconnect both ends of the SSA device cable.

Inspect the cable connectors for bent pins and correct any problems found. Each connector should have three pins. If there are less than three pins, replace the cable. Reconnect both ends of the SSA device cable, ensure good connection. Continue with the next step.

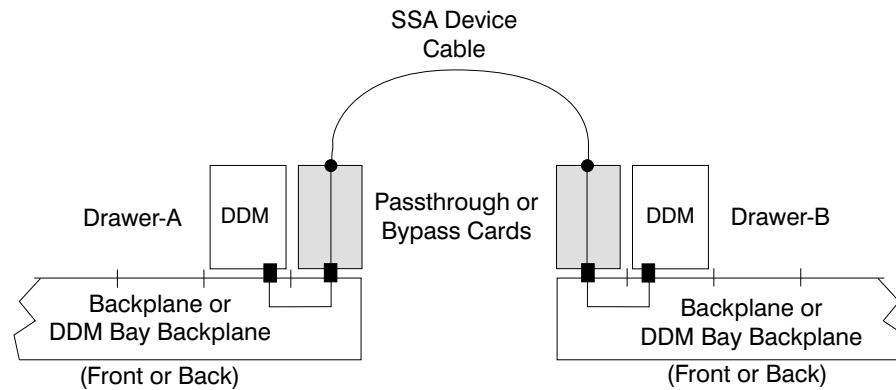
Figure 75. SSA Link Failure, Passthrough/Bypass Cards and Two DDMs (S007650I)

DDM locations in drawers

- SSA D ASD Model 020 or 040 drawers:
 - Drawer-A DDM 1, 4, 5, 8, 9, 13, or 16
 - Drawer-B DDM 1, 4, 5, 8, 9, 13, or 16
- DDM bays:
 - DDM 1 or 8

6. Determine if Drawer-A, in Figure 75 on page 159, is a Model 040.

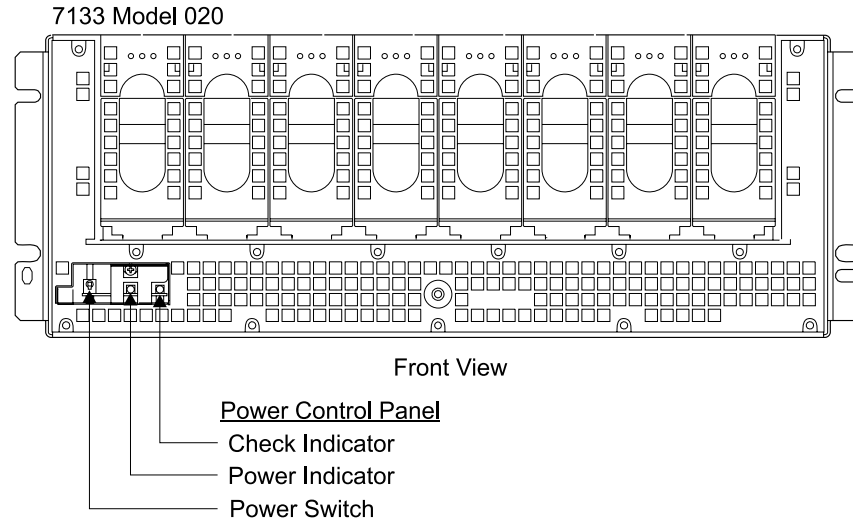
Figure 76. SSA DASD Model 020 Power Control Panel Locations (S008020m)

Power Indicator (green)

Check Indicator (amber)

9. Go to the front of the 2105 and locate Drawer-A with a DDM shown for replacement. Observe the SSA DASD drawer green power indicator on the drawer power control panel.

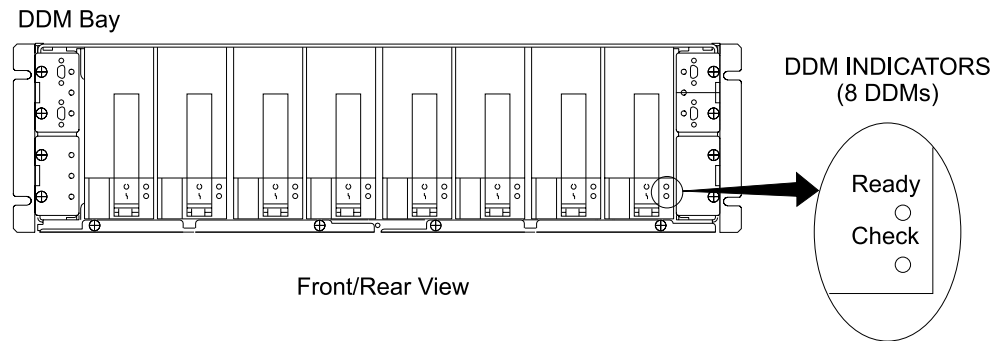
Figure 78. DDM Bay DDM Indicator Locations (S008021I)

19. Locate DDM bay-A, it may be located in the front or rear of the 2105. Observe all of the DDM bay DDM indicators, see Figure 78.

32. Locate DDM bay-B, it may be located in the front or rear of the 2105. Observe all of the DDM bay DDM indicators, see Figure 78 on page 163.

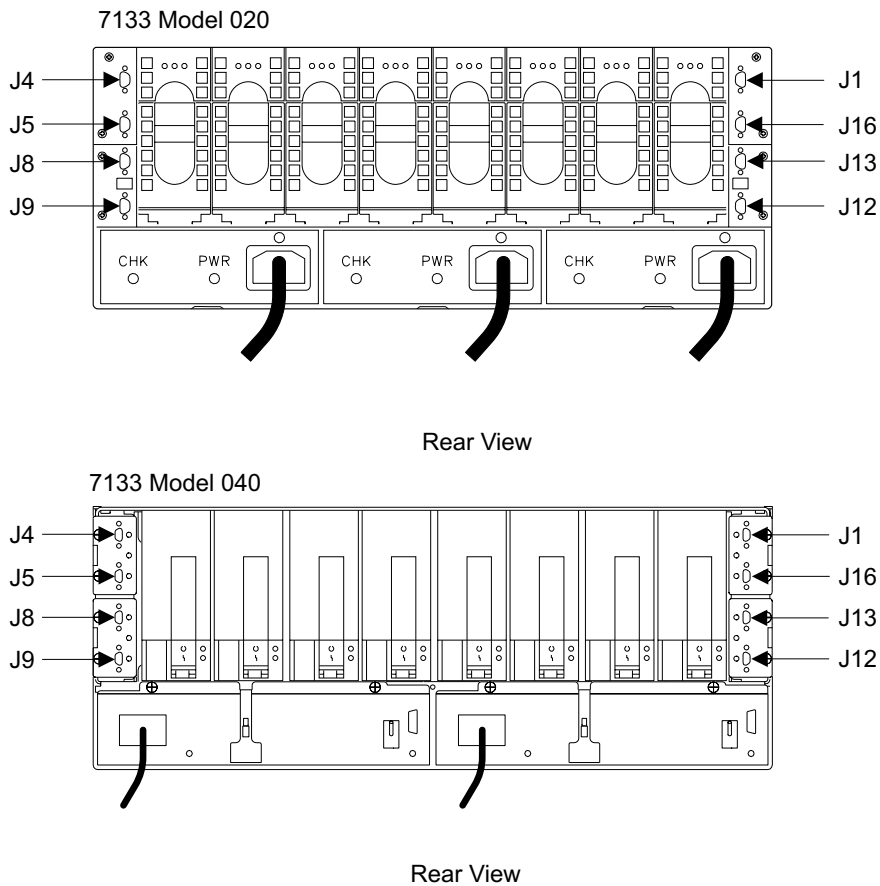
Figure 79. SSA DASD Model 020 and 040 drawer SSA Connectors (S008762p)

33. Locate the SSA cable displayed on the service terminal as a possible FRU. For this isolation procedure, the SSA cable will be connected between two separate drawers or DDM bays. The service terminal FRU Location will identify the drawer and SSA connector to which each end of the SSA cable is connected. To locate a drawer, see "Locating a DDM Bay or SSA DASD Model 020 or 040 Drawer in a 2105 Rack" in chapter 7 of the *Enterprise Storage Server Service Guide, Volume 3*. Use the drawing below to locate SSA cable connectors on a drawer. Select the cable shown on the service terminal for repair.

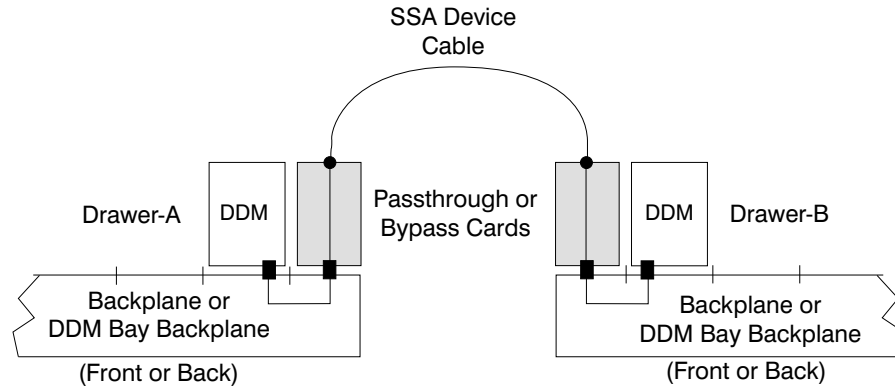
Figure 81. SSA Link Failure, Passthrough/Bypass Cards and Two DDMs (S007650I)

The 40 MB/s SSA link between two DDMs is degraded and is running at 20 MB/s. The degraded link is between two DDMs, in different drawers or DDM bays, two signal and/or bypass cards and the SSA cable that links them. See Figure 81 for the relationship of the DDM, signal and/or bypass card, and backplane FRUs involved with this failure.

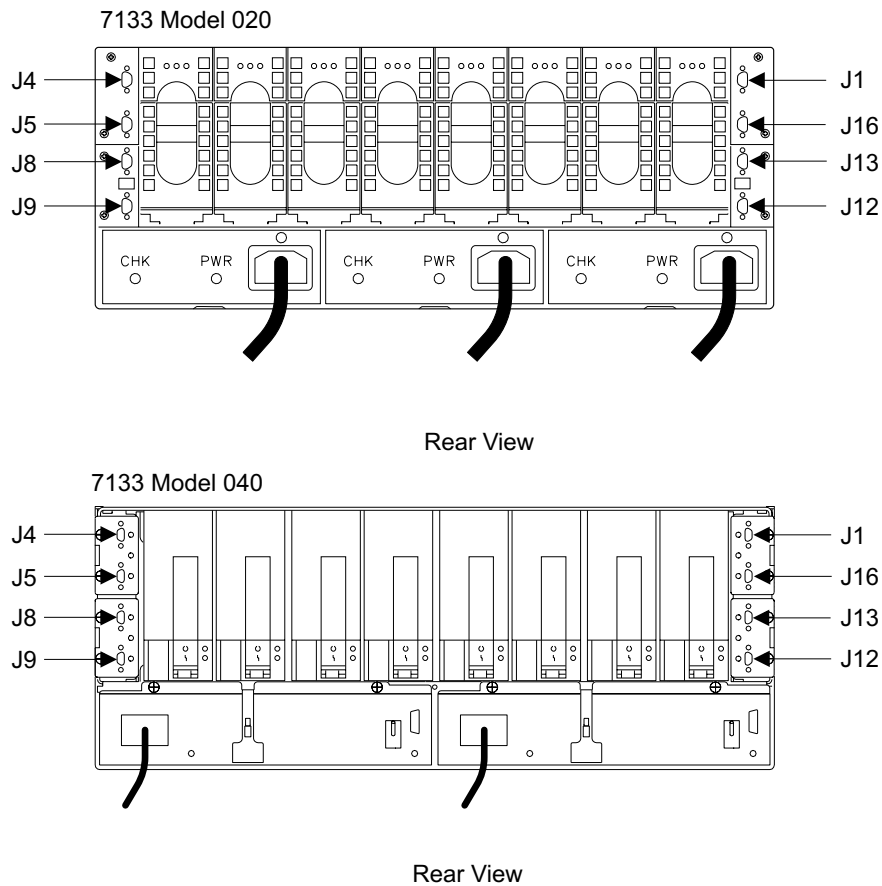
Figure 82. SSA DASD Model 020 and 040 Drawer SSA Connectors (S008762p)

1. Locate the SSA cable displayed on the service terminal as a possible FRU. For this isolation procedure, the SSA cable will be connected between two separate drawers or DDM bays. The service terminal FRU Location will identify the drawer and SSA connector to which each end of the SSA cable is connected. To locate a drawer, see Locating a DDM Bay or SSA DASD Model 020 or 040 Drawer in a 2105 Rack in chapter 7 of the *Enterprise Storage Server Service Guide, Volume 3*. Use the drawing below to locate SSA cable connectors on a drawer. Select the cable shown on the service terminal for repair.

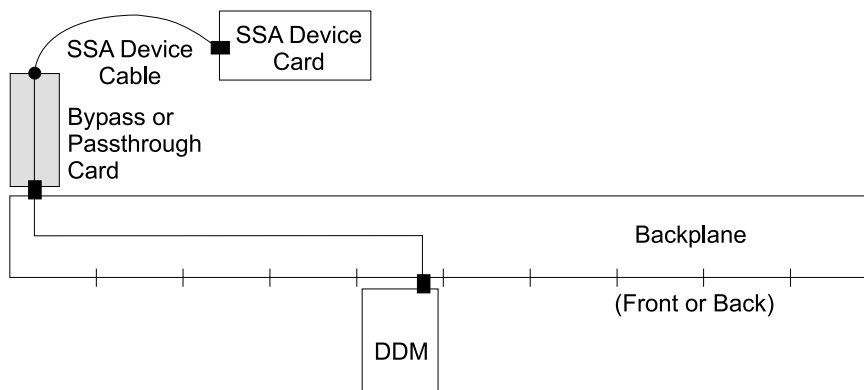
Figure 85. SSA Link Failure, Passthrough or Bypass Card Link Between a DDM and SSA Device Card (S0076521)

An SSA link failed between a DDM and the SSA device card. See Figure 85 for the relationship of the DDM, passthrough or bypass card, backplane, SSA device cable and SSA device card FRUs involved with this failure.

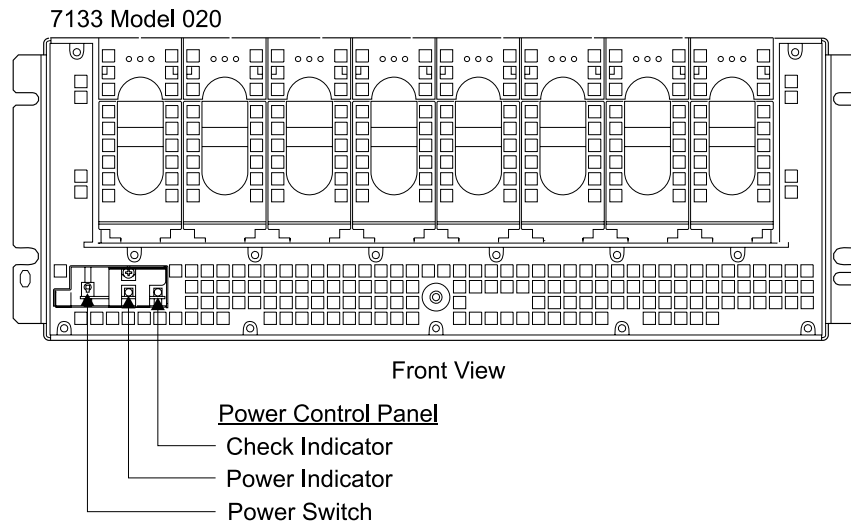
Figure 86. SSA DASD Model 020 Power Control Panel Locations (S008020m)

Note: The drawer is a SSA DASD Model 020 drawer.
 Power Switch (On/Off)
 Power Indicator (green)
 Check Indicator (amber)

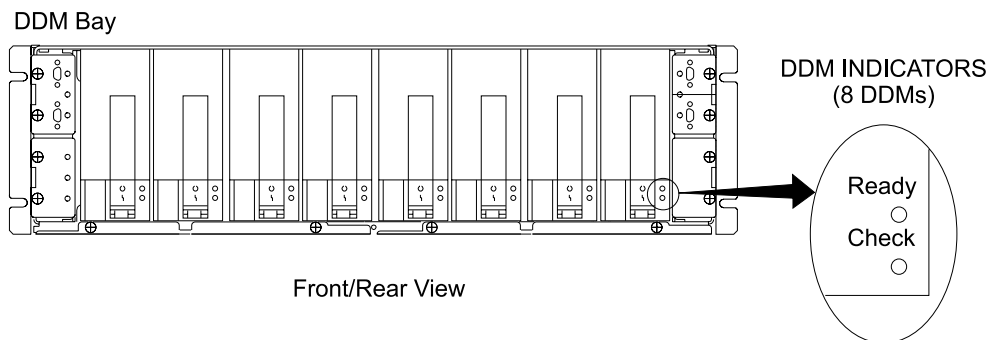
Figure 88. DDM bay DDM Indicator Locations (S008021)

20. Locate the DDM bay, it may be located in the front or rear of the 2105. Observe all of the DDM bay DDM indicators, see Figure 88 on page 178.
- Are any of the DDM bay indicators on?
- **Yes**, go to step 21 on page 178.
 - **No**, there is a DDM bay power problem, go to “MAP 3395: Isolating an SSA DASD DDM Bay Power Problem” on page 259.

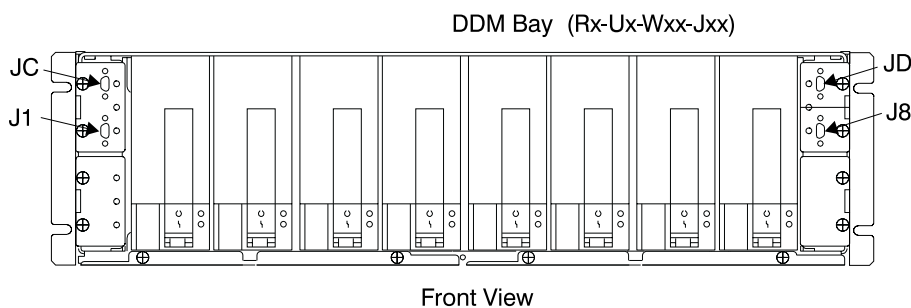
Figure 89. DDM bay SSA Connector Locations (S007693)

21. Locate the SSA cable displayed on the service terminal as a possible FRU. For this isolation procedure, the SSA cable will be connected between a drawer and an SSA device card. The service terminal FRU Location will identify the drawer and its SSA connector, and the SSA device card and its SSA connector. To locate a drawer, see "Locating a DDM Bay or SSA DASD Model 020 or 040 Drawer in a 2105 Rack" in chapter 7 of the *Enterprise Storage Server Service Guide, Volume 3*. To locate SSA cable connectors on a drawer, see Figure 89.

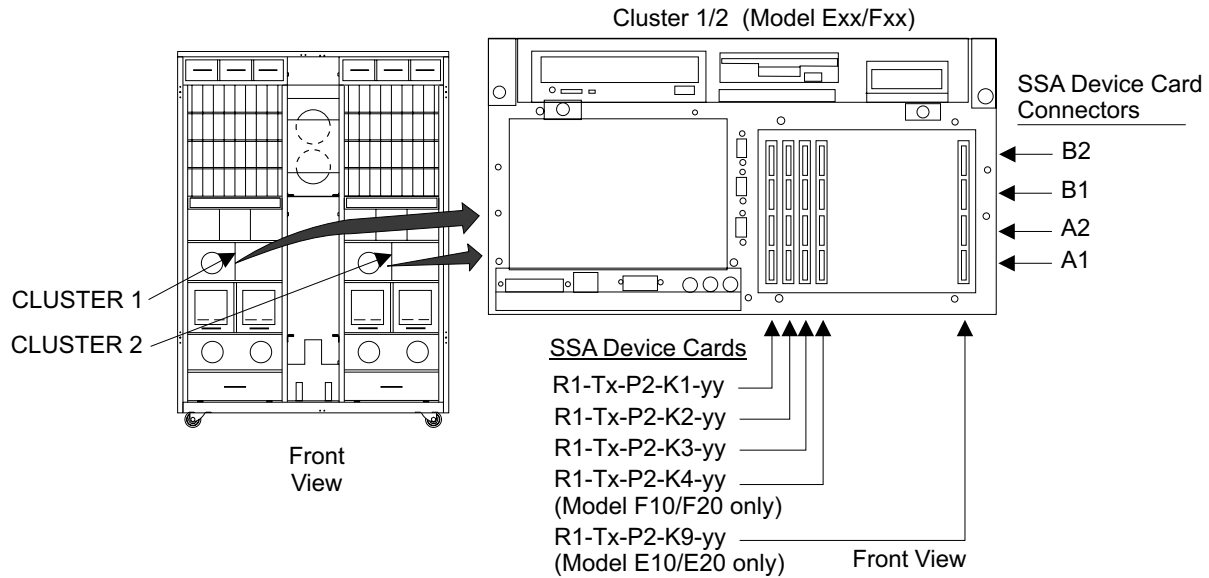
Figure 90. Cluster SSA Device Card SSA Connector Locations (S008022m)

- *R1* is rack 1
- *Tx* is the cluster, 1 or 2
- *P2* is the cluster planar
- *Kx* is the SSA device card location, slot
- *yy* is the cable connector, A1, A2, B1, or B2

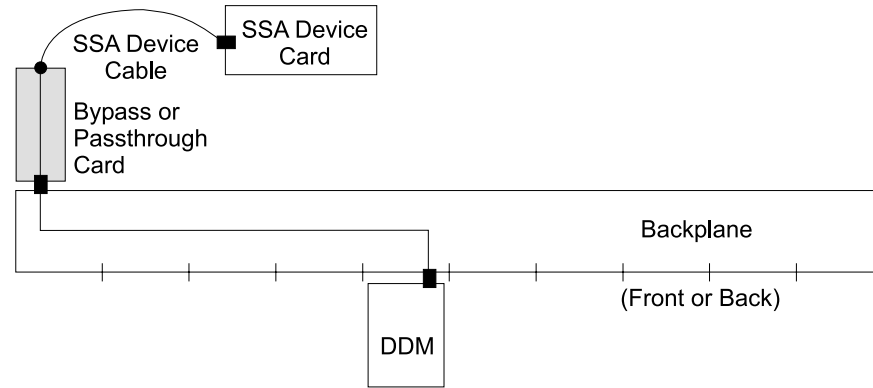
Figure 91. SSA Link Failure, Passthrough or Bypass Card Link Between a DDM and SSA Device Card (S007652I)

A 40 MB/s SSA link between a DDM and the SSA device card is degraded and is running at 20 MB/s. See Figure 91 for the relationship of the DDM, passthrough or bypass card, backplane, SSA device cable and SSA device card FRUs involved with this degraded link.

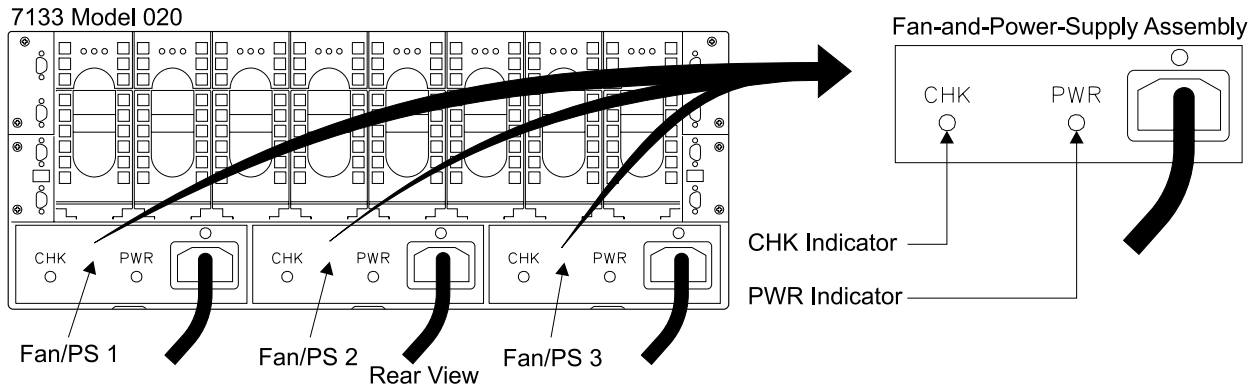
Figure 94. SSA DASD Drawer Fan-and-Power-Supply Assembly Indicators (S008029I)

3. Observe the SSA DASD drawer indicators, see “SSA DASD Model 020 Drawer Indicators and Power Switch” on page 9.
Is this SSA DASD drawers amber drawer check indicator on or blinking?
 - **Yes**, go to step 4.
 - **No**, go to step 8 on page 191.
4. Check the indicators on the fan-and-power-supply assemblies in the failing SSA DASD drawer.
Does any fan-and-power-supply assembly in the SSA DASD drawer have its fan-and-power CHK (check) indicator on or blinking?

Is the fan-and-power CHK (check) indicator on fan-and-power-supply assembly #1 (Fan 1 on Figure 94 on page 189) on or blinking?

Is the fan-and-power CHK (check) indicator on fan-and-power-supply assembly #3 (Fan 3 on Figure 94 on page 189) on or blinking?

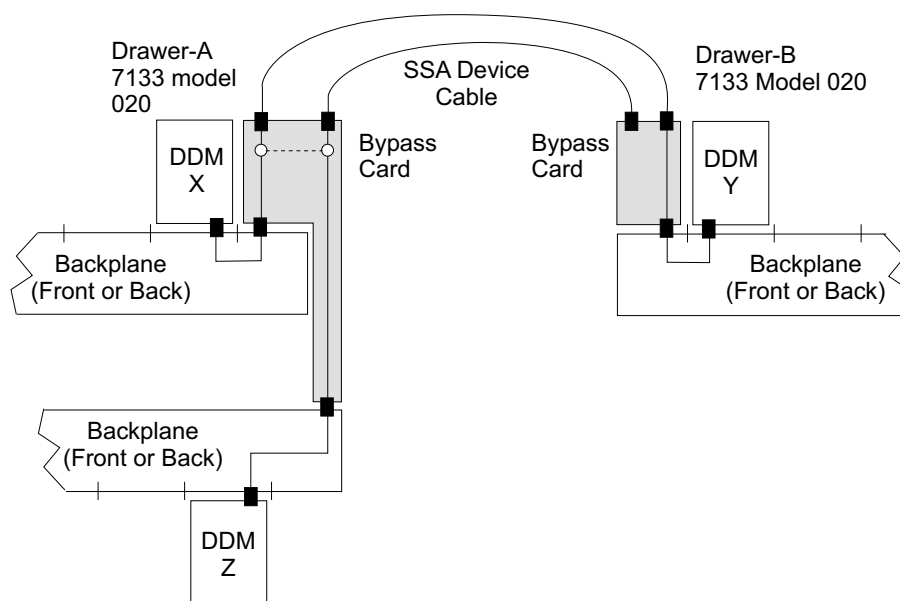
Figure 98. SSA Link Failure, Two SSA DASD Drawers (S007653n)

The SSA link between two drawers is failing. The failing link is between two SSA DASD Model 020 drawers. DDM Z was found next to DDM X in the loop when DDM Y was expected. The problem could be the bypass card in either drawer, or Drawer B could be powered off. See Figure 98 for the relationship of the drawers and bypass card and DDMs involved with this failure.

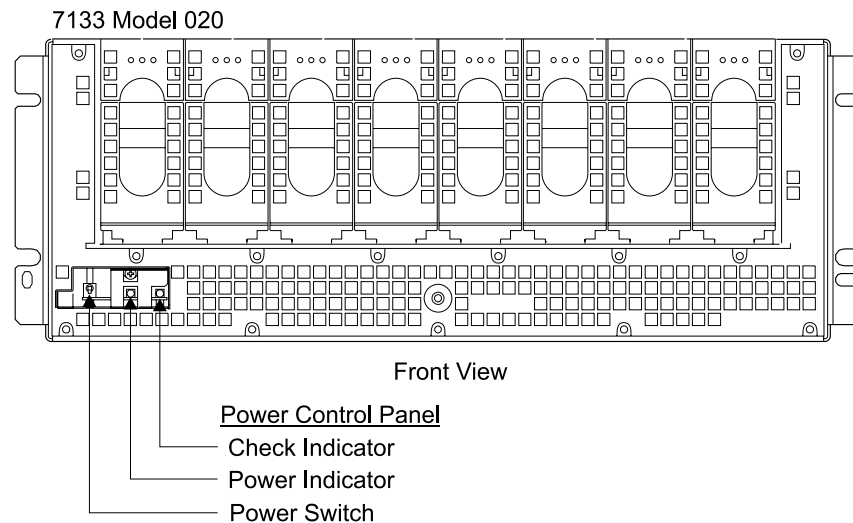
Figure 99. SSA DASD Model 020 Power Control Panel Locations (S008020m)

- **Yes**, Connect the cables to the correct connectors. Determine if the problem is resolved. Return to the service terminal Detail Problem screen. Select any of the FRUs. Proceed through the repair but do not replace any FRU or disconnect any cables. This will simulate a repair and run verification.
 - **No**, go to step 3.
3. Locate drawer-B, see "Locating a DDM Bay or SSA DASD Model 020 or 040 Drawer in a 2105 Rack" in chapter 7 of the *Enterprise Storage Server Service Guide, Volume 3*. Look at the Possible FRUs to Replace list. The Bypass Card with 35% probability will be in Drawer B. Use the location code of that card to find Drawer B. Use Figure 99 in the following steps to locate the switch and indicators on the SSA DASD drawer-B power control panel:
- Power Switch (On/Off)
 - Power Indicator (green)
 - Check Indicator (amber)

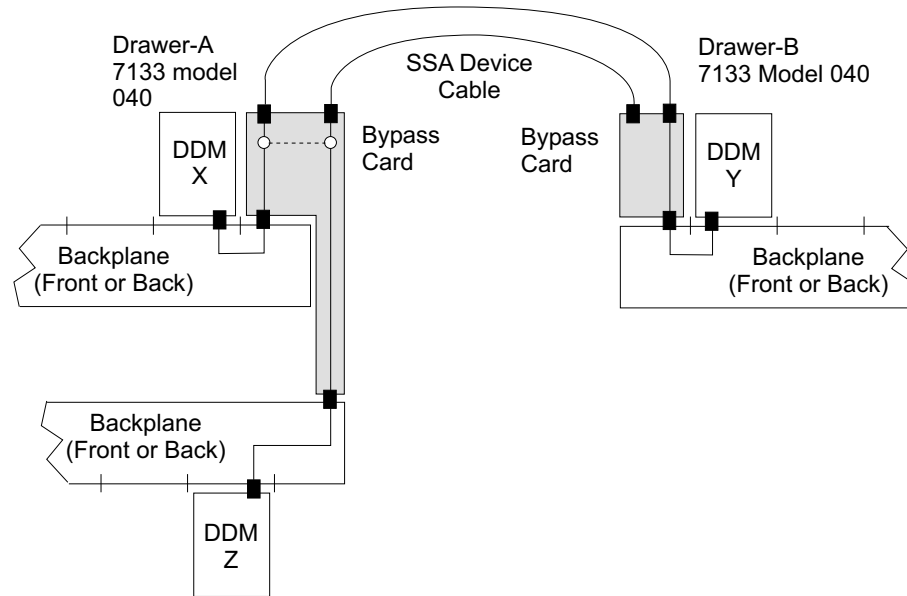
Figure 100. SSA Link Failure, Two SSA DASD Drawers (S007654n)

The SSA link between two drawers is failing. The failing link is between two SSA DASD Model 040 drawers. DDM Z was found next to DDM X in the loop when DDM Y was expected. The problem could be the bypass card in either drawer, or Drawer B could be powered off. See Figure 100 on page 199 for the relationship of the drawers and bypass card and DDMS involved with this failure.

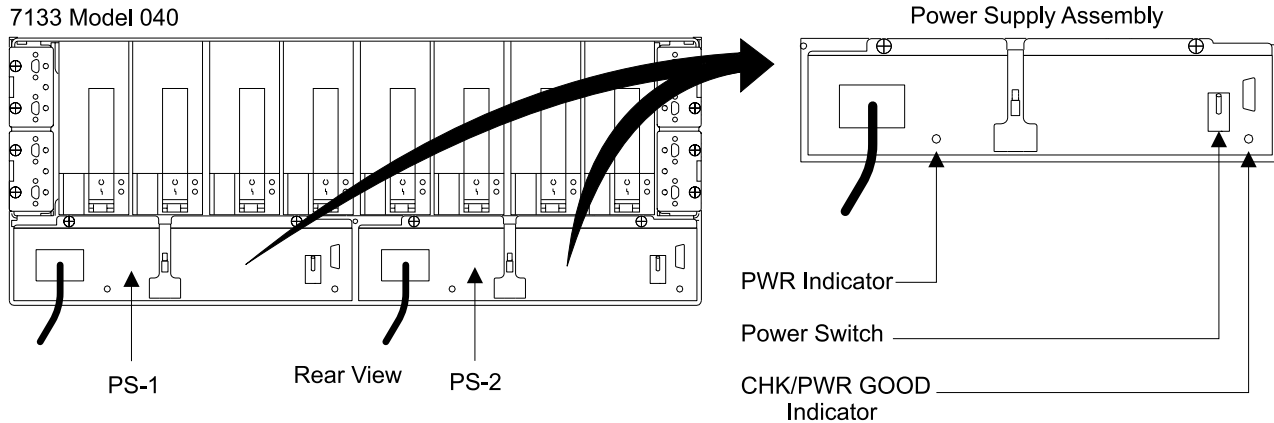
Figure 101. SSA DASD Model 040 Power Supply Assembly Locations (S008019m)

5. Power both drawer power supplies Off then On:
- a. Turn the Power/Reset switches on both power supply assemblies Off, pull the switch out then push down.
 - b. Wait about twenty seconds.
 - c. Turn the Power/Reset switches on both power supply assemblies On, pull the switch out then push up.

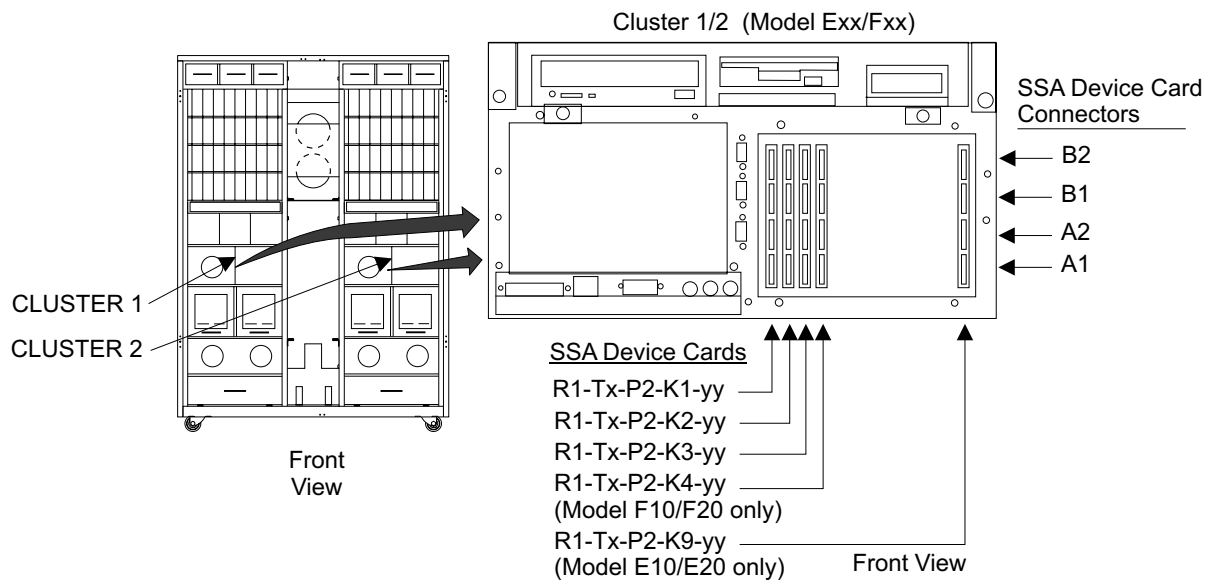
Figure 102. Cluster SSA Device Card Locations (S008022m)

1. Use the service terminal to locate the SSA device card displayed as a **Possible FRU to Replace**. Copy down the FRU location.
2. Locate the cluster and the SSA device card using the information below and in Figure 102.

Note: The SSA device card connector location is in the format *R1-Tx-P2-Kx-yy*, where:

- *R1* is rack 1
- *Tx* is the cluster, 1 or 2
- *P2* is the cluster planar
- *Kx* is the SSA device card location, slot
- *yy* is the cable connector, A1, A2, B1, or B2

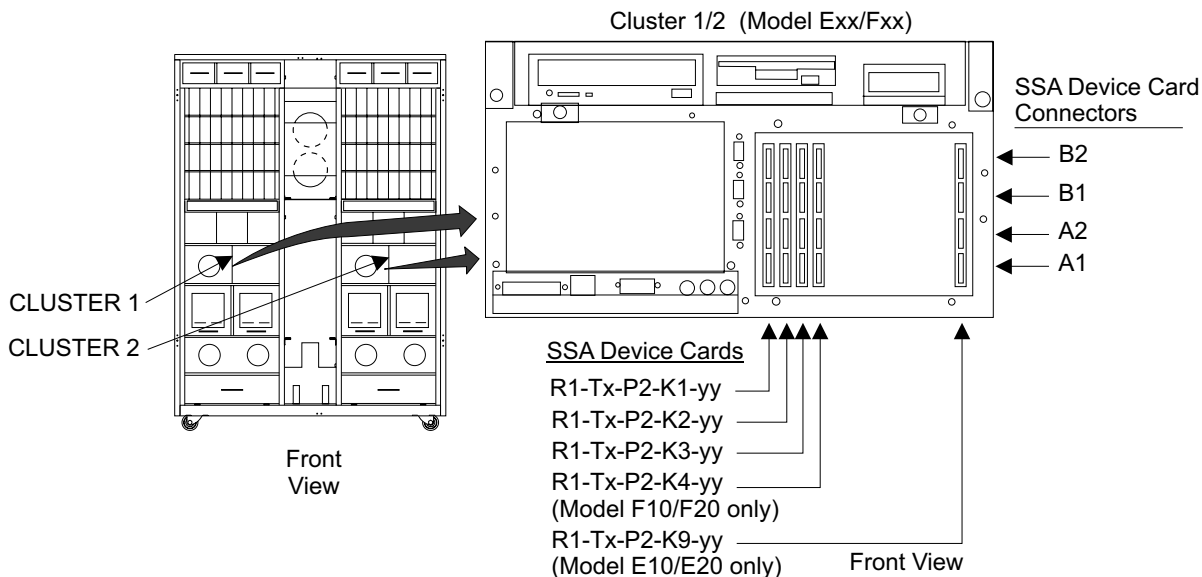
Figure 103. Cluster SSA Device Card Locations (S008022m)

1. Use the service terminal to locate the SSA device card displayed as a **Possible FRU to Replace**. Copy down the FRU location.
2. Locate the cluster and the SSA device card using the information below and in Figure 103.

Note: The SSA device card connector location is in the format *R1-Tx-P2-Kx-yy*, where:

- *R1* is rack 1
- *Tx* is the cluster, 1 or 2
- *P2* is the cluster planar
- *Kx* is the SSA device card location, slot
- *yy* is the cable connector, A1, A2, B1, or B2

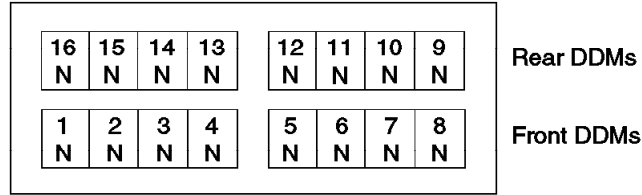
Figure 106. Expected SSA DASD Drawer DDM Locations (s007319I)

- Drawer models, SSA DASD Model 020 or 040 drawer
- Disk drive module (DDM) locations in drawer:
 - New DDM locations: 1 to 16

N = Newly Installed DDM

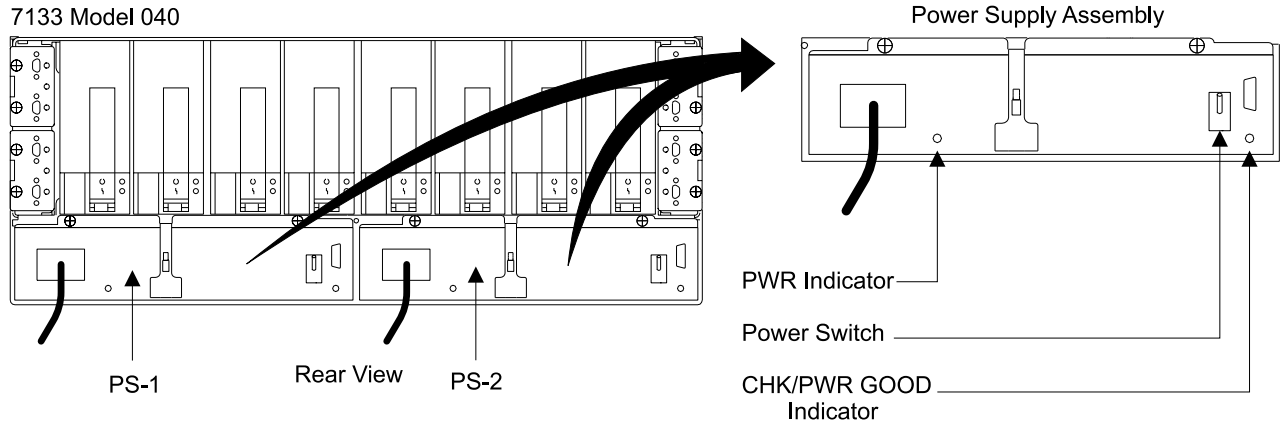
Figure 108. SSA DASD Model 040 Power Supply Assembly Indicators (S008019m)

8. Observe CHK/PWR Good (check/power) indicators on both power supply assemblies.
Are either of the indicators on (green)?
 - **Yes**, go to step 9.
 - **No**, go to “MAP 3380: Isolating 7133 Model 040 SSA DASD Drawer Power Problems” on page 234.
9. Check the drawer in the FRU list to see if the correct number of DDMs are installed in the correct positions. See Figure 106 on page 209.
Too few new DDMs are installed, remove any dummy DDMs and replace them with new DDMs.
10. If the problem is not resolved, call your next level of support.

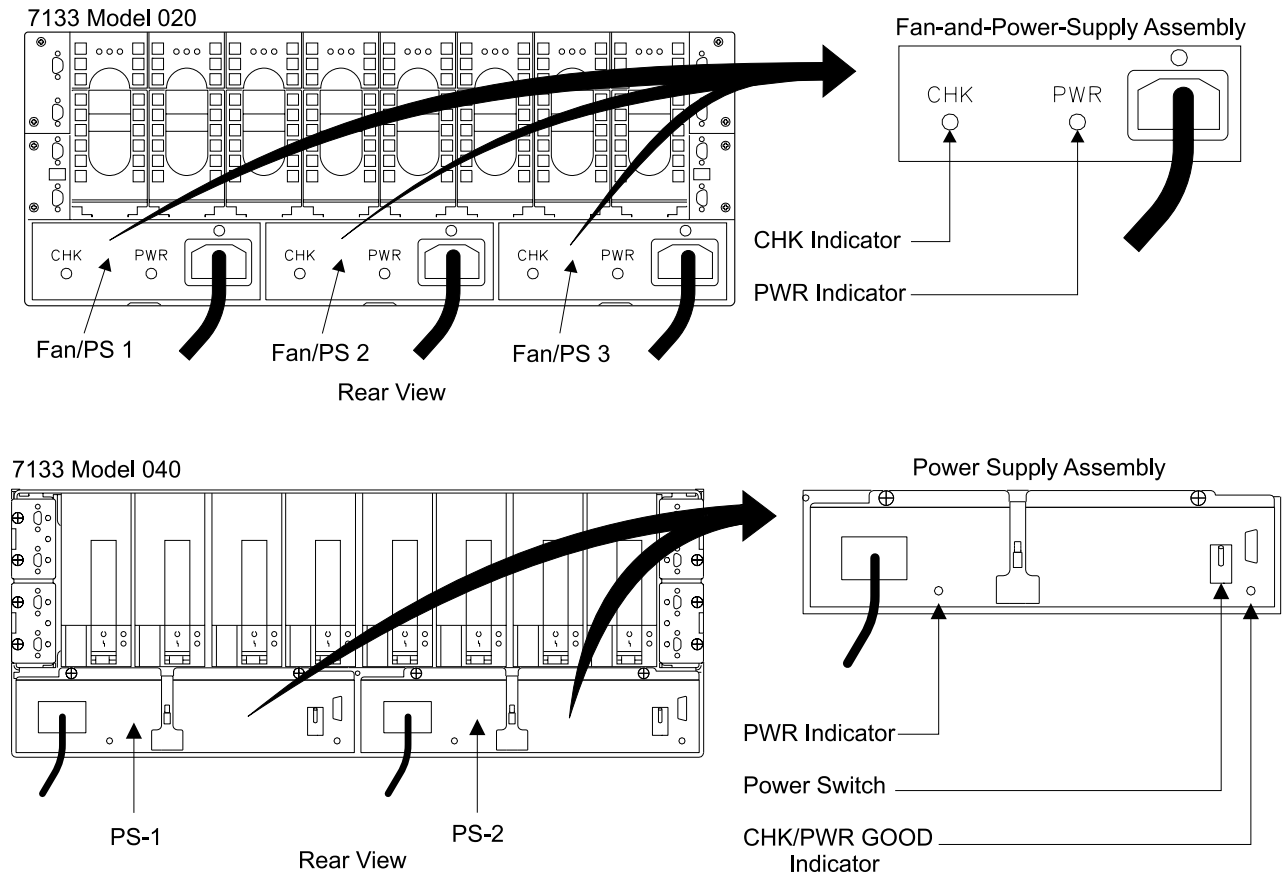
- a. Determine if the fan-and-power-supply with the failing PWR (power) indicator (off) is in drawer fan position 1, 2, or 3.
- b. Observe the PWR (power) indicators on the fan-and-power-supply or power supply assemblies in the same fan position in the other drawers in the same rack.
 - **SSA DASD Model 020 drawers**, see PWR (power) indicators on fan-and-power-supply assemblies 1, 2, and 3.
 - **SSA DASD Model 040 drawers**, see PWR (power) indicators on power supply assemblies 1 and 2 (position 3 is unused).

Figure 109. SSA DASD Model 020 and 040 Drawer PWR (Power) Indicator Locations (S008030p)

1. Observe PWR (power) indicators on the fan-and-power-supply assemblies in the failing drawer, see Model 020 drawer in Figure 109 on page 213.
