Enterprise Storage Server

Service Guide
2105 Models E10/E20, F10/F20, and
Expansion Enclosure
Volume 1

Chapters 1, 2, and 3

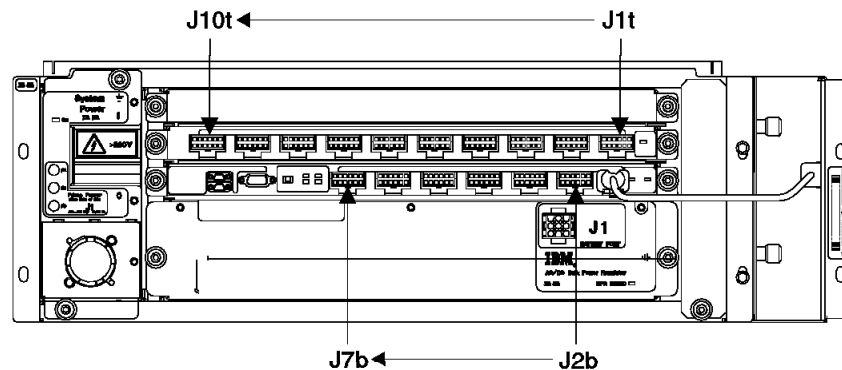
Figure 111. 2105 Primary Power Supply Connectors (S007380I)

- a. Locate where the two drawer power cables, from the failing fan-and-power-supply, connect to the same primary power supply. Disconnect both cables from the primary power supply. Swap the two drawer power cable connectors and reconnect them to the primary power supply.

4. Determine where the drawer power cable, from the failing SSA DASD drawer fan-and-power-supply, connects to a primary power supply. Also determine where the other drawer power cable from this drawer connects to the same primary power supply. Use the cabling information in Figure 111 for primary power supply connector names and locations.

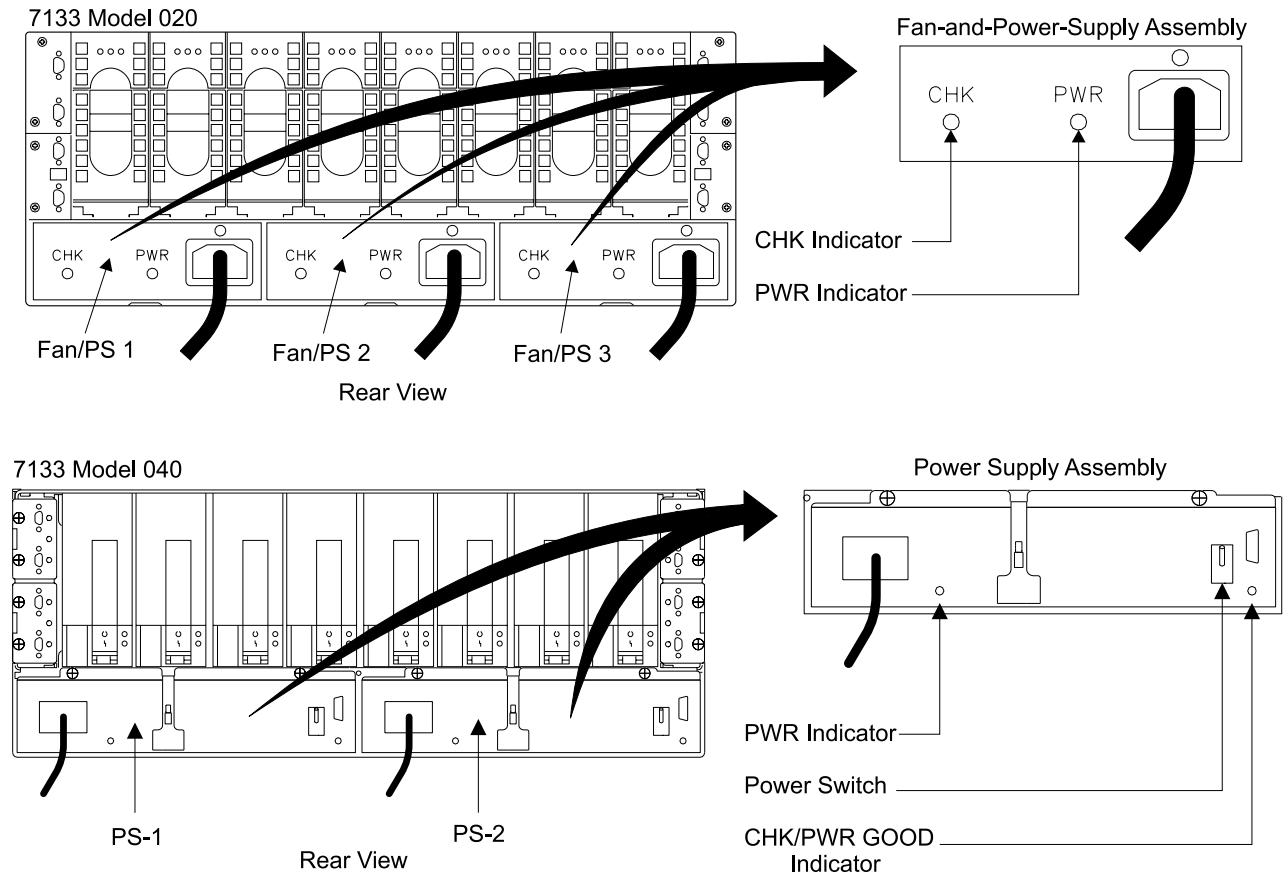
- a. Determine if the fan-and-power-supply with the failing PWR (power) indicator (off) is in drawer fan position 1, 2, or 3.
- b. Observe the PWR (power) indicators on the fan-and-power-supply or power supply assemblies in the same fan position in the other drawers in the same rack.
 - **SSA DASD Model 020 drawers**, see PWR (power) indicators on fan-and-power-supply assemblies 1, 2, and 3.
 - **SSA DASD Model 040 drawers**, see PWR (power) indicators on power supply assemblies 1 and 2 (position 3 is unused).

Figure 112. SSA DASD Model 020 and 040 Drawer PWR (Power) Indicator Locations (S008030p)

1. Observe PWR (power) indicators on the fan-and-power-supply assemblies in the failing drawer, see Model 020 drawer in Figure 112 on page 218.

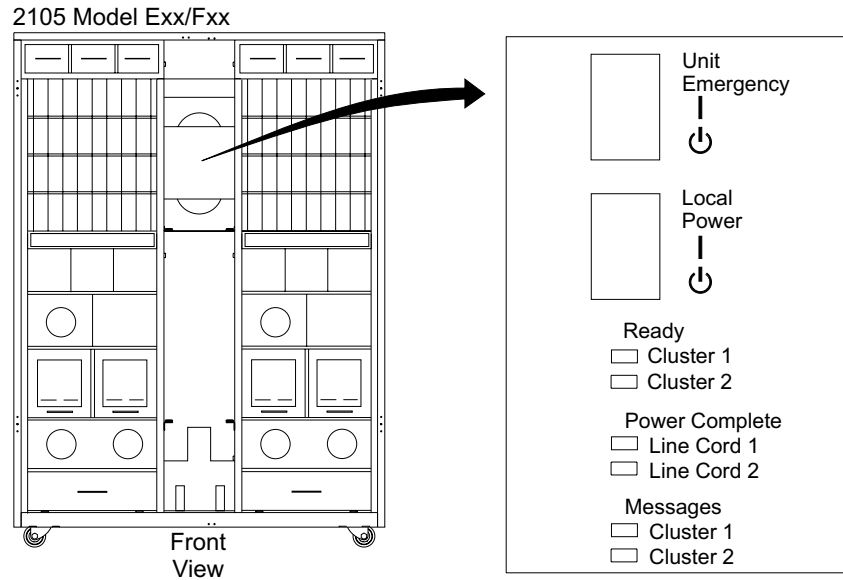
2. Go to the operator panel on the front of the 2105 Model Exx/Fxx, rack 1. Press the Local Power switch to On (up) for about two seconds.
At the rear of the 2105, is the SSA DASD drawer PWR (power) indicator still off?
 - **Yes**, go to step 3 on page 219.
 - **No**, the problem may be resolved. Verify the repair, go to “MAP 3500: Verifying an SSA DASD Drawer Repair” on page 279.
 - If repair verification is successful, go to “MAP 3360: Ending a DASD Service Action” on page 231.
 - If repair verification fails, repair the problem from the verification.

Figure 113. 2105 Model Exx/Fxx Operator Panel Locations (S008810m)

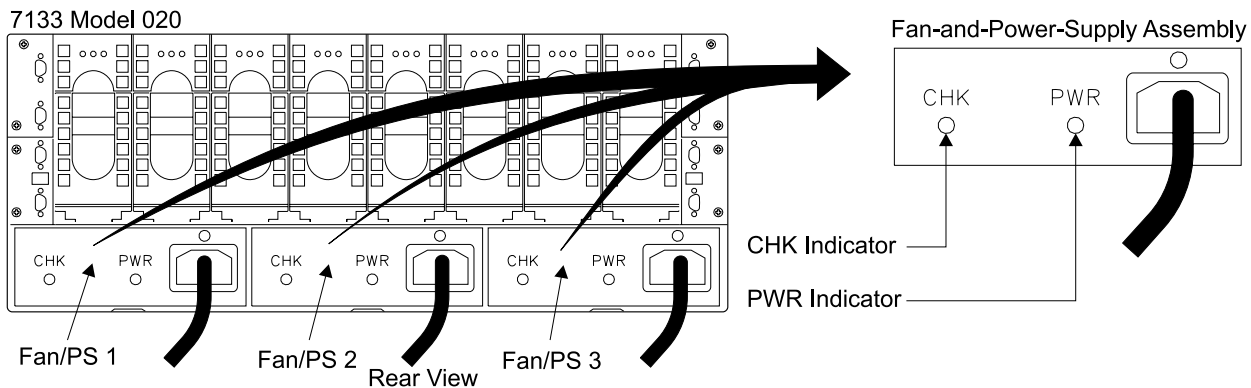
Note: The fan-and-power supply PWR (power) indicators may be hidden behind the fan mounting latches.

Figure 114. SSA DASD Model 020 Fan-and-Power-Supply Assembly Indicators (S008029I)

2. Does any fan-and-power-supply assembly in this SSA DASD drawer have its fan-and-power CHK (check) indicator on?
 - **Yes**, perform the following repairs:
 - a. Select the rσσαM1PwrSup## or rσσαM2PwrSup## listed as a FRU for the problem being repaired. Replace the fan-and-power-supply assembly, see "Fan and Power Supply Assembly, 7133 Model 020" in chapter 4 of the *Enterprise Storage Server Service Guide, Volume 2*.
 - b. Check the Power Complete, Line Cord 0 and 1 indicators in Figure 95 on page 190, on the front of the 2105 Model E10/E20.

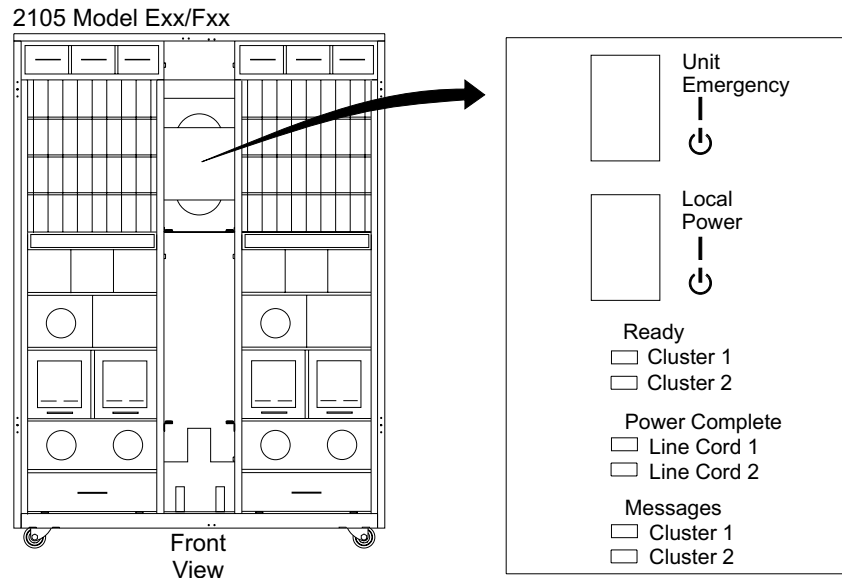
Note: Pressing the Local Power switch momentarily to On (up) clears any power errors that were generated by the failure. It also restores any power that was removed because of these failures. It does not affect 2105 power.

Figure 116. 2105 Model Exx/Fxx Operator Panel Locations (S008810m)

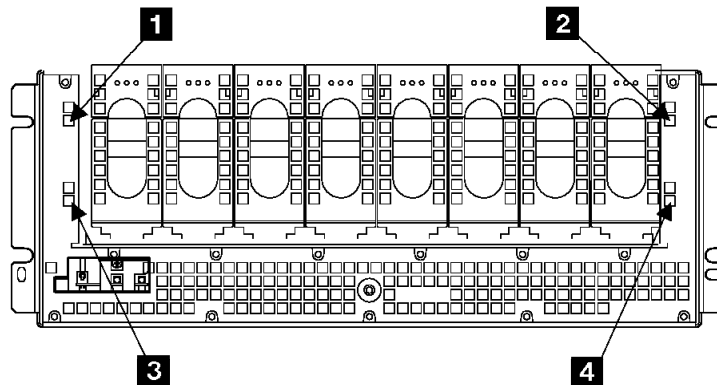
Note: Some indicators may be hidden from view by the internal cabling. If required, move the cables using a non-conductive tool such as a wooden pencil.

Figure 117. SSA DASD drawer Power Card Indicators (s007227I)

2. Perform the following actions:
 - a. Find the row whose pattern of Power Card indicators matches the pattern of the Power Card indicators of the SSA DASD drawer in Table 18 on page 225.
 - b. In the sequence given in that row, replace the FRUs with new ones. Ensure that for *each* FRU replacement, you go to “MAP 3500: Verifying an SSA DASD Drawer Repair” on page 279 to verify the repair.
 - If repair verification is successful, go to “MAP 3360: Ending a DASD Service Action” on page 231.

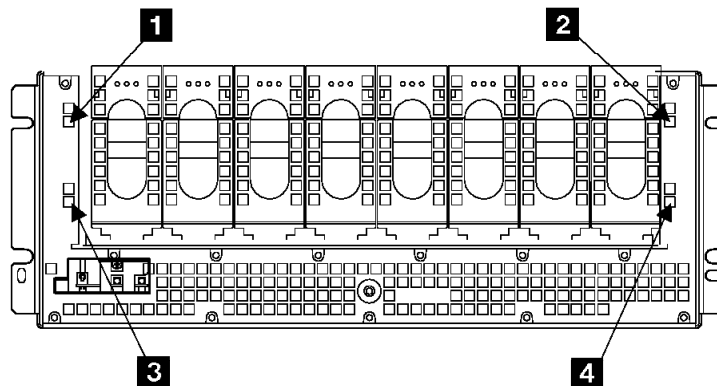
Note: Some indicators may be hidden from view by the internal cabling. If required, move the cables using a non-conductive tool such as a wooden pencil.

Figure 118. SSA DASD drawer Power Card Indicators (s007227I)

2. Perform the following actions:
 - a. Find the row whose pattern of Power Card indicators matches the pattern of the Power Card indicators of the SSA DASD drawer in Table 19 on page 227.
 - b. In the sequence given in that row, select the FRU to be replaced from the problem display. Replace the FRUs with new ones. Ensure that after *each* FRU replacement, you indicate that the FRU replacement is complete and then verify it.
 - If repair verification is successful, the problem is resolved.
 - If repair verification fails, replace the next FRU for this indicator pattern.

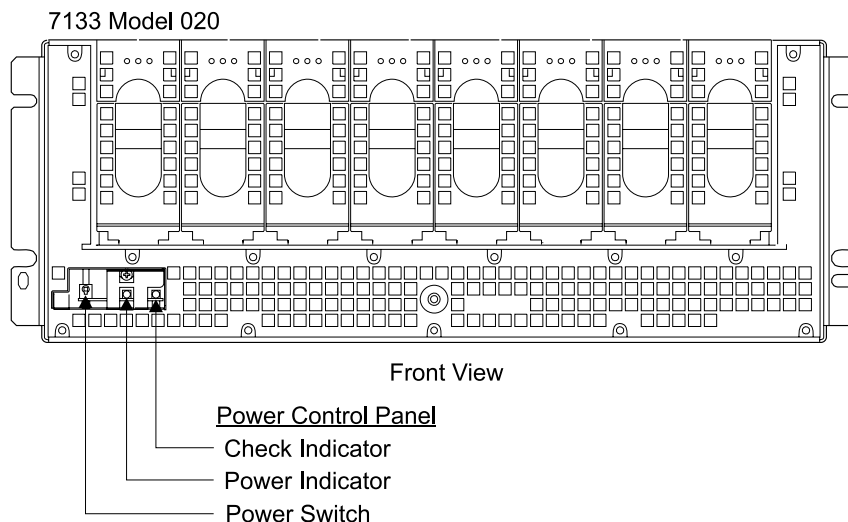
- d. Use Figure 119 in the following steps to locate the switch and indicators on the SSA DASD drawer power control panel:
 - Power Switch (On/Off)
 - Power Indicator (green)

- Check Indicator (amber)

Figure 119. SSA DASD Model 020 Power Control Panel Locations (S008020m)

Press and release the drawer power switch, on the drawer power control panel.

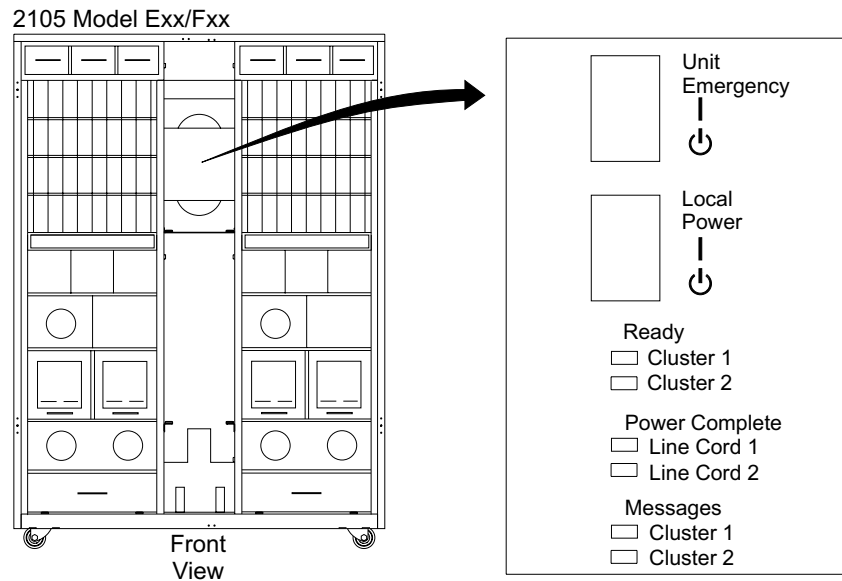
Note: Pressing the Local Power switch momentarily to On (up) clears any power errors that were generated by the failure. It also restores any power that was removed because of these failures. It does not affect 2105 power.

Figure 120. 2105 Model Exx/Fxx Operator Panel Locations (S008810m)

- e. Go to the operator panel on the front of the 2105 Model Exx/Fxx. Press the Local Power switch, in Figure 120, to On (up) for about two seconds.

- a. Reinstall a fan-and-power-supply assembly into position 2.
- b. Connect the drive power cable to the fan-and-power-supply assembly that is in position 2.
- c. Go to the operator panel on the front of the 2105 Model Exx/Fxx. Press the Local Power switch, in Figure 120 on page 229, to On (up) for about two seconds.

- a. Reinstall the fan-and-power-supply assembly into position 1.
- b. If reinstalling a fan-and-power supply assembly, connect the drawer
- c. Go to the operator panel on the front of the 2105 Model Exx/Fxx. Press the Local Power switch, in Figure 120 on page 229, to On (up) for about two seconds.

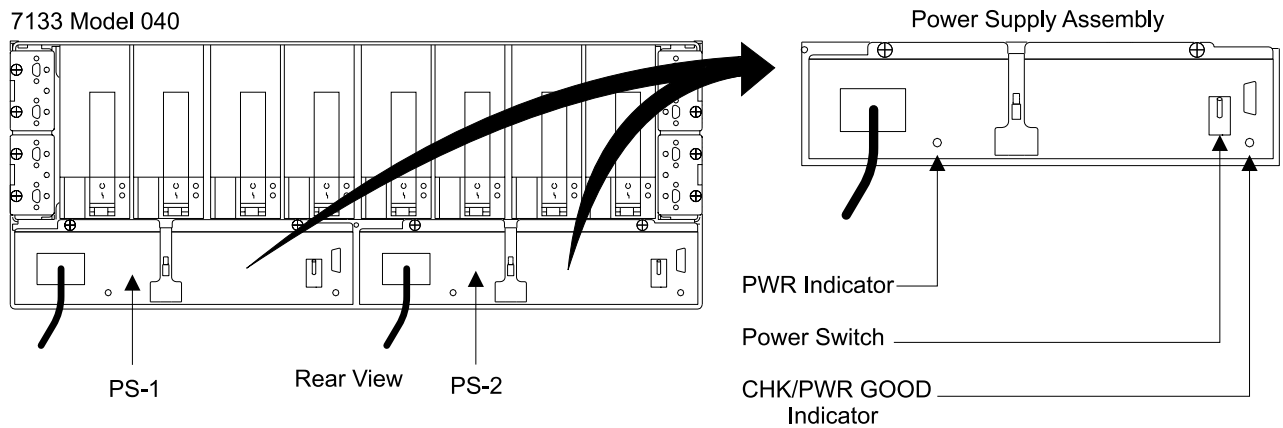
1. Observe PWR (power) indicators on the power supply assemblies in the failing drawer.
 - a. Determine if the power supply with the failing PWR (power) indicator (off) is in drawer power supply position 1 or 2.
 - b. Observe the PWR (power) indicators on the fan-and-power-supply or power supply assemblies in the same fan position in the other drawers in the same rack.
 - **SSA DASD Model 020 drawers**, see PWR (power) indicators on fan-and-power-supply assemblies 1, 2, and 3.
 - **SSA DASD Model 040 drawers**, see PWR (power) indicators on power supply assemblies 1 and 2 (position 3 is unused).

Figure 121. SSA DASD Model 020 and 040 Drawer PWR (Power) Indicator Locations (S008019m)

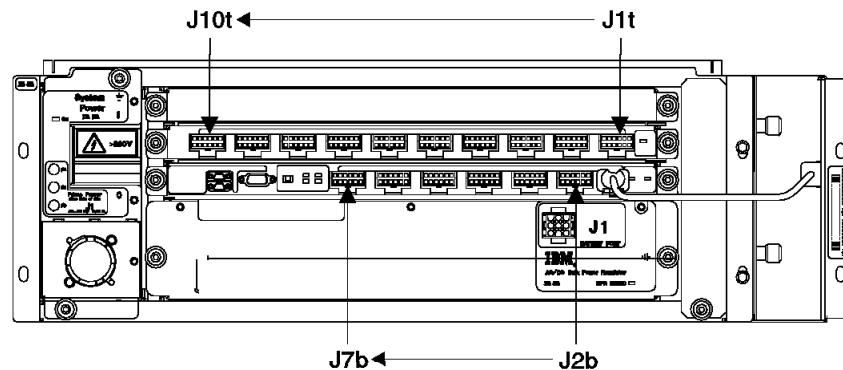
Figure 123. 2105 Primary Power Supply Connectors (5007380)

- a. Locate where the drawer power cable from the failing power supply assembly connect to the primary power supply. Disconnect this cables from the primary power supply and reconnect it into an unused connector on the primary power supply.
- b. Go to the operator panel on the front of the 2105 Model E10/E20. Press the Local Power switch to On (up) for about two seconds.
At the rear of the 2105, is the SSA DASD drawer PWR (power) indicator still off?
 - **Yes**, reconnect the swapped drawer power cable to its original connector on the PPS. Replace the SSA DASD drawer power supply assembly, go to "Power Supply Assembly, 7133 Model 040" in chapter 4 of the *Enterprise Storage Server Service Guide, Volume 2*. After the repair:
 - Go to the operator panel on the front of the 2105 Model E10/E20. Press the Local Power switch to On (up) for about two seconds.

5. Determine where the drawer power cable, from the failing SSA DASD drawer power supply, connects to a primary power supply. Also determine where the other drawer power cable from this drawer connects to the same primary power supply. See "Bulk Power Supply Connection Physical Location Codes" in chapter 7 of the *2105 Model 100 Attachment to ESS Service Guide* book, to determine where the power cables should be plugged. Refer to Figure 123 for primary power supply connector names and locations.

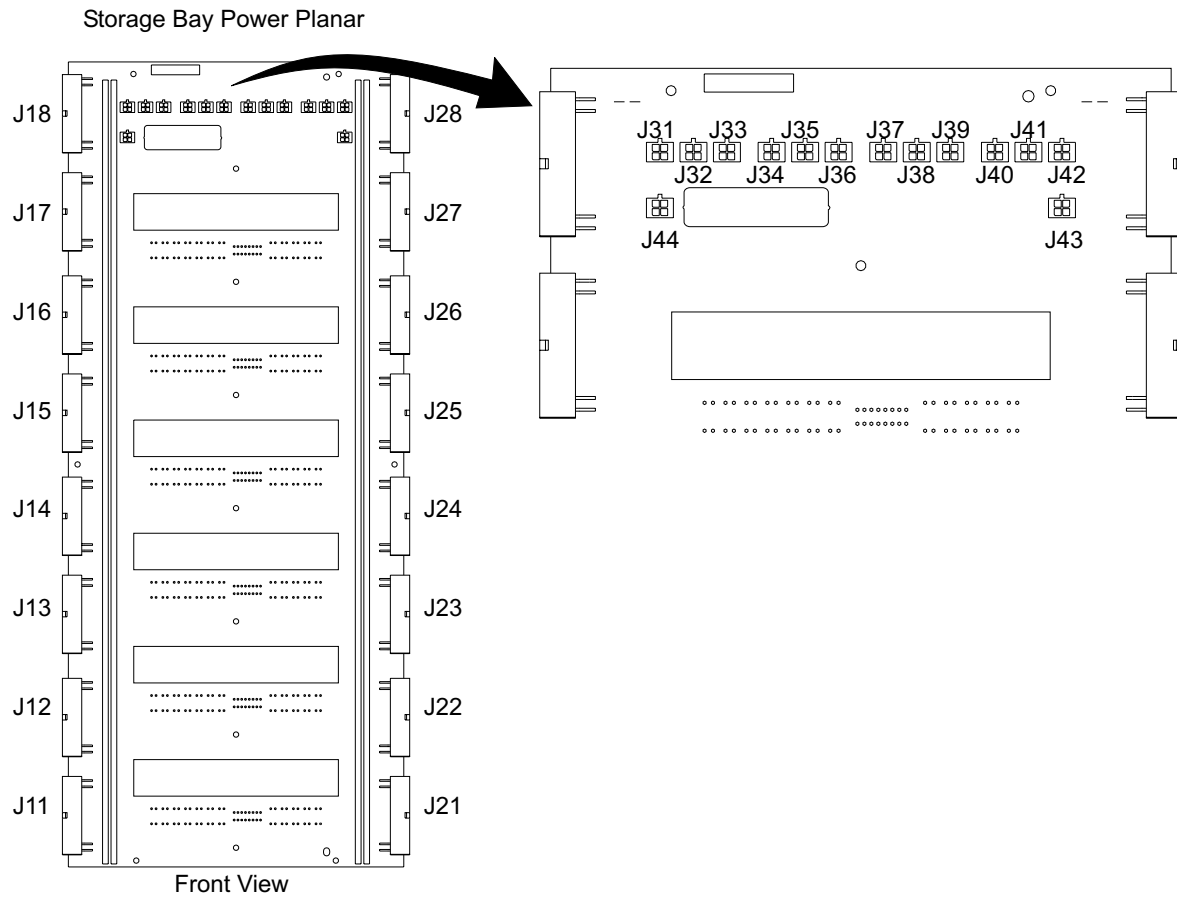
Figure 124. Storage Cage Power Planar Fan Jumper Locations (S008352p)

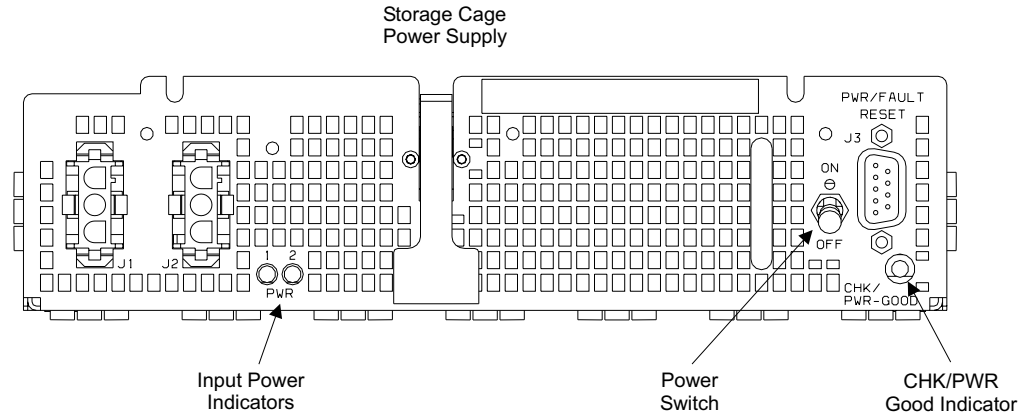
Figure 125. Storage Cage Power Supply Locations (S008495m)

- Observe the two green input power indicators **1** on the failing storage cage power supply:

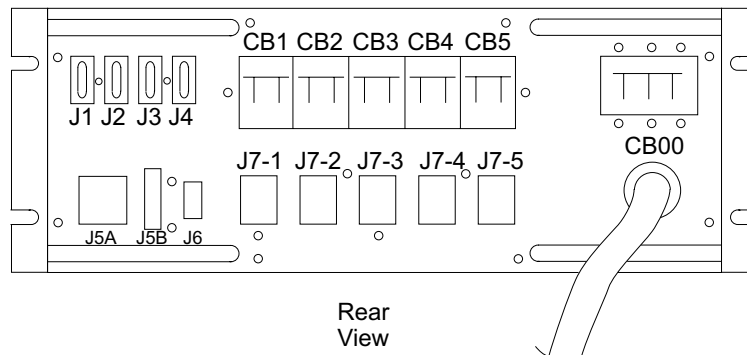
- **Yes**, go to step 12 on page 246.
 - **No**, do one of the following:
 - If the PWR-1 and PWR-2 indicators are both off, go to step 4.
 - If only the PWR-1 indicator is off, go to step 5.
 - If only the PWR-2 indicator is off, go to step 6.
- Replace the failing storage cage power supply, then verify the repair.
Is the storage cage power supply problem corrected?
 - **Yes**, use the service terminal to close the problem and end the call.
 - **No**, call your next level of support.
 - Do the following steps only on **PPS-1** and the failing storage cage power supply.
Go to step 7.
 - Do the following steps only on **PPS-2** and the failing storage cage power supply.
Go to step 7.
 - Locate primary power supply (PPS) circuit protector (CP that supplies power to the failing storage cage power supply:

Figure 126. Primary Power Supply CB and Connector Locations (S008496l)

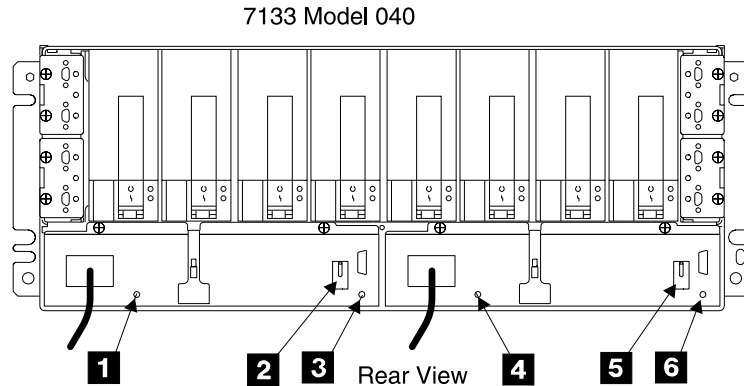
Figure 127. SSA DASD Model 020 and 040 Drawer PWR (Power) Indicator Locations (s007602I)

3. Observe CHK/PWR (check/power) Good indicators **3** and **6** on the power supply assemblies in the failing drawer.
Are one or both of the CHK/PWR Good indicators on with the color amber?

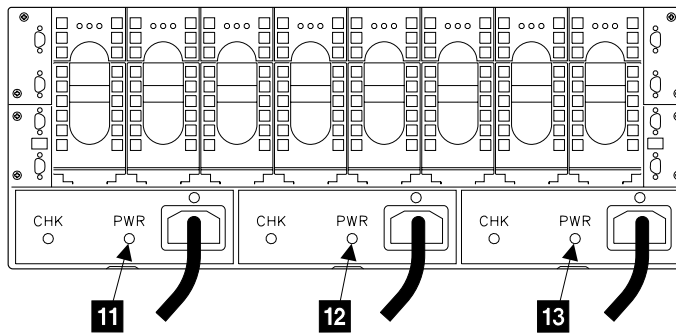
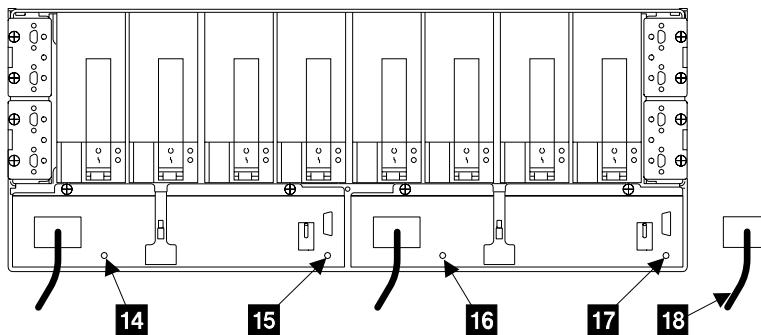
7133 Model 020

7133 Model 040

Figure 129. SSA DASD Model 020 and 040 Drawer PWR (Power) Indicator Locations (s007604p)

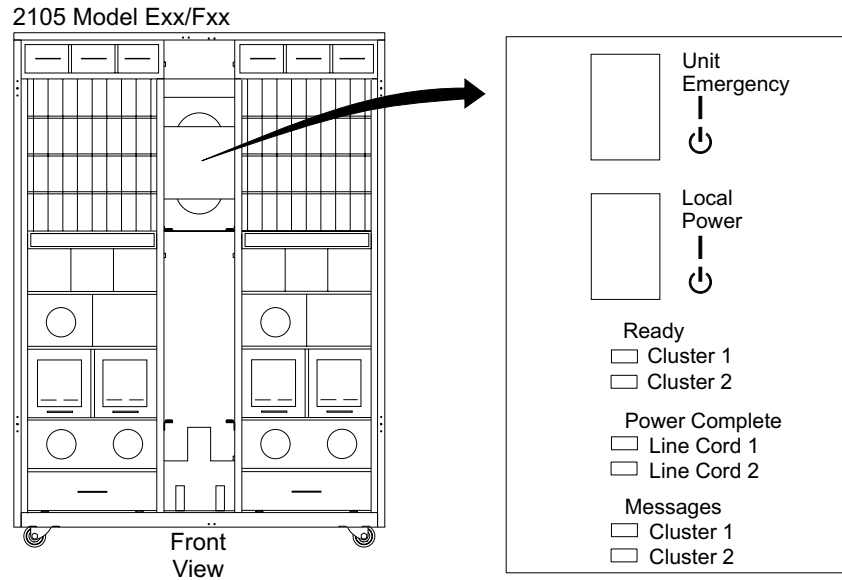
Note: Pressing the Local Power switch momentarily to On (up) clears any power errors that were generated by the failure. It also restores any power that was removed because of these failures. It does not affect 2105 power.

Figure 130. 2105 Model Exx/Fxx Operator Panel Locations (S008810m)

- Before you verify the repair, do the following:
- Go to the operator panel on the front of the 2105 Model Exx/Fxx. Press the Local Power switch, in Figure 130, to On (up) for about two seconds.

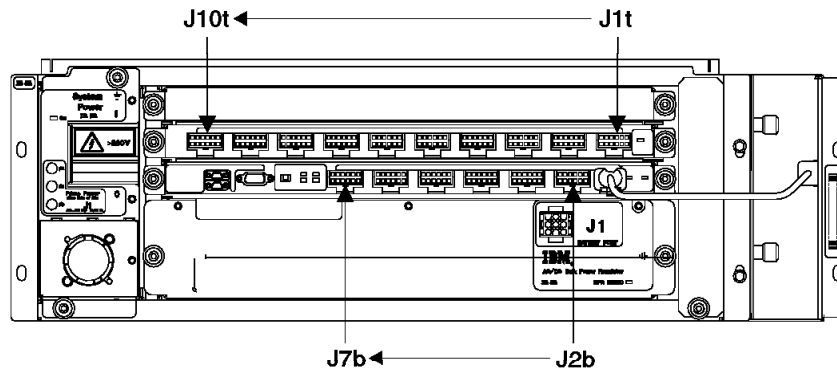
Figure 131. 2105 Primary Power Supply Connectors (S007380I)

- Locate where the drawer power cable from the failing power supply assembly connect to the primary power supply. Disconnect this cables from the primary power supply and reconnect it into an unused connector on the primary power supply.
- Go to the operator panel on the front of the 2105 Model Exx/Fxx. Press the Local Power switch to On (up) for about two seconds.

Refer to Figure 131 for primary power supply connector names and locations.

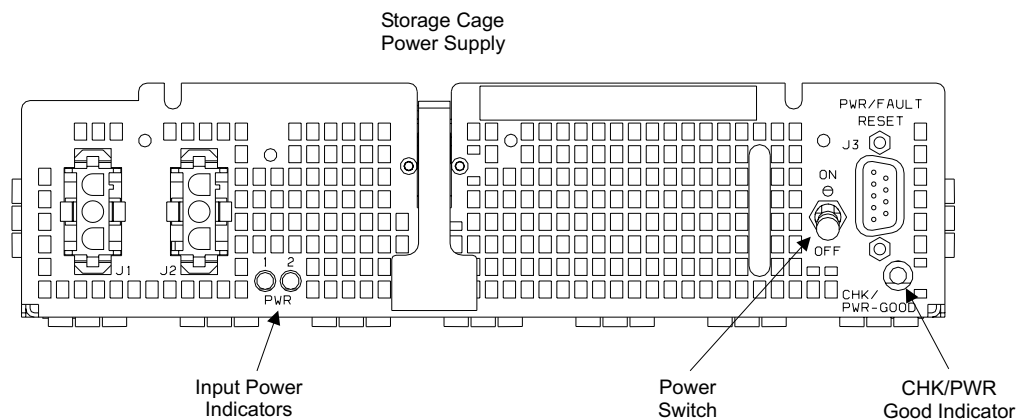
Figure 132. Storage Cage Power Supply Locations (S008495m)

2. Determine if the correct number of storage cage power supplies are installed. Count the DDM bays and the storage cage power supplies installed in the storage cages associated with the failing power supplies (storage cages 1 and 2 or 3 and 4).

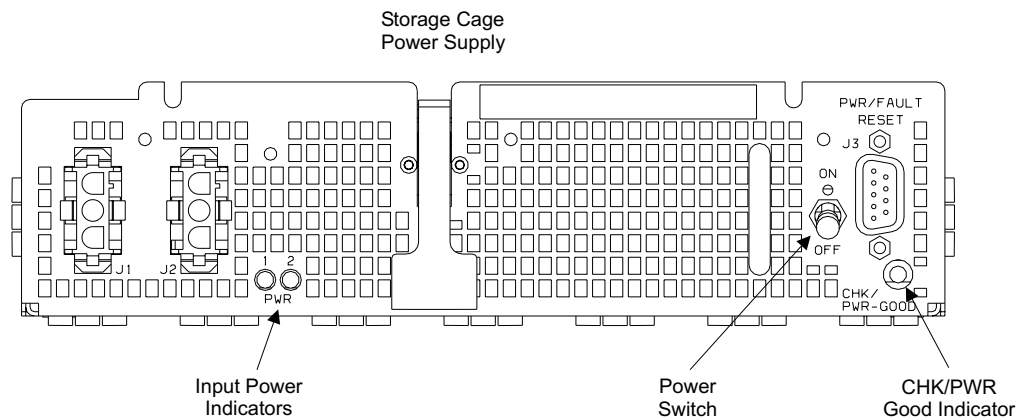
- **Yes**, go to step 5.
 - **No**, the failing DDM bay is in storage cage 3 or 4. Go to step 6.
5. Go to the rear of the 2105 Model E10/E20 or 2105 Expansion Enclosure. Locate the storage cage power supplies mounted between storage cages 1 and 2.

Observe the CHK/POWER GOOD indicators on all of the storage cage 1 and 2 power supplies.

Figure 133. Storage Cage Power Supply Locations (S008495m)

Are all of the storage cage 1 and 2 power supply CHK/POWER GOOD indicators On (amber)?

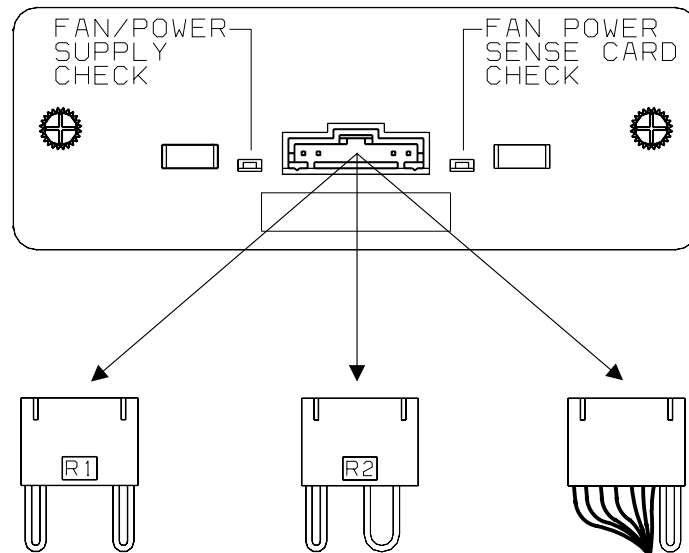
- The cage sense card R2 cable is failing.
- The lower fan/power sense card is reporting incorrectly.
- A DDM bay controller card is reporting incorrectly.

Figure 134. 2105 Primary Power Supply Connectors (5008774m)

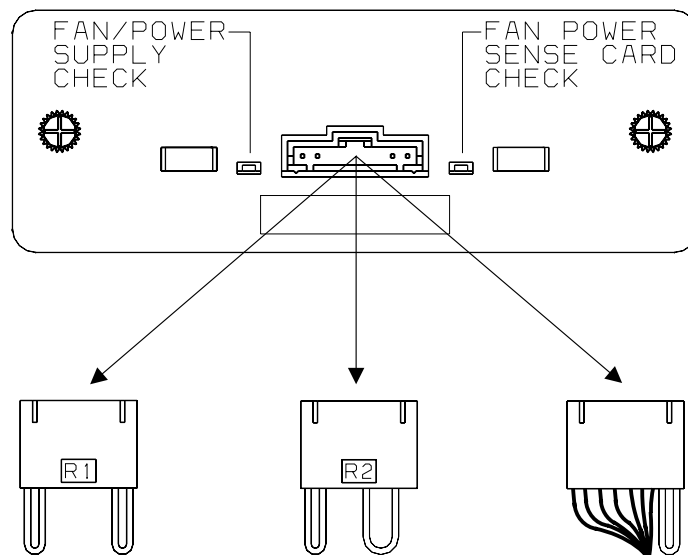
- Missing cage sense card R2 jumper
- Missing cage sense card R2 cable

Figure 135. 2105 Primary Power Supply Connectors (5008774m)

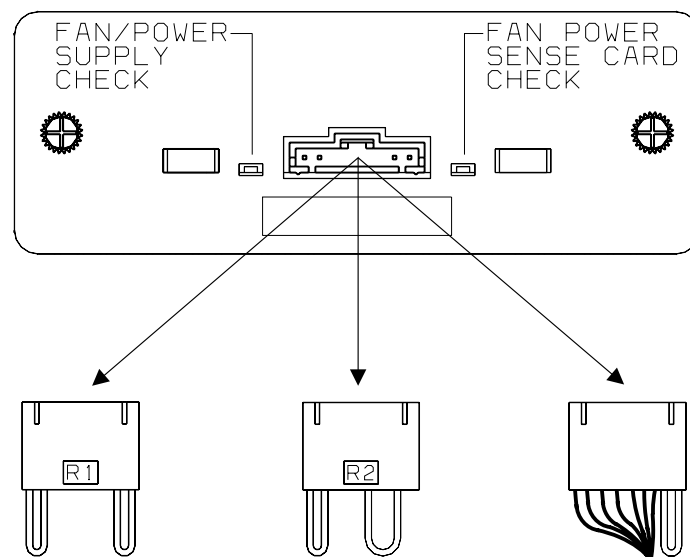
- The cage sense card R1 jumper is missing
- The cage sense card R1 jumper is failing
- The fan/power sense card is reporting incorrectly
- A DDM bay controller card is reporting incorrectly.

Figure 136. 2105 Primary Power Supply Connectors (5008774m)

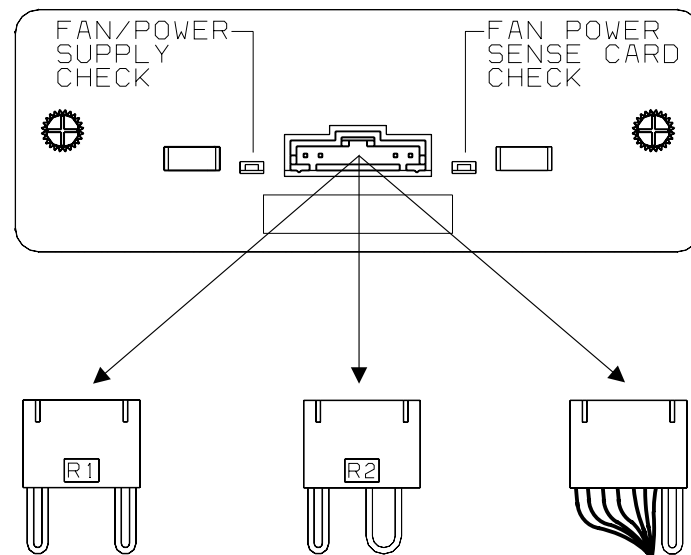
The storage cage fan/power sense card in 2105 Model Exx/Fxx has reported a failure that is only possible in 2105 Expansion Enclosure. This indicates that the 2105 Model Exx/Fxx cage sense card R1 jumper is failing.

Figure 137. 2105 Primary Power Supply Connectors (5008774m)

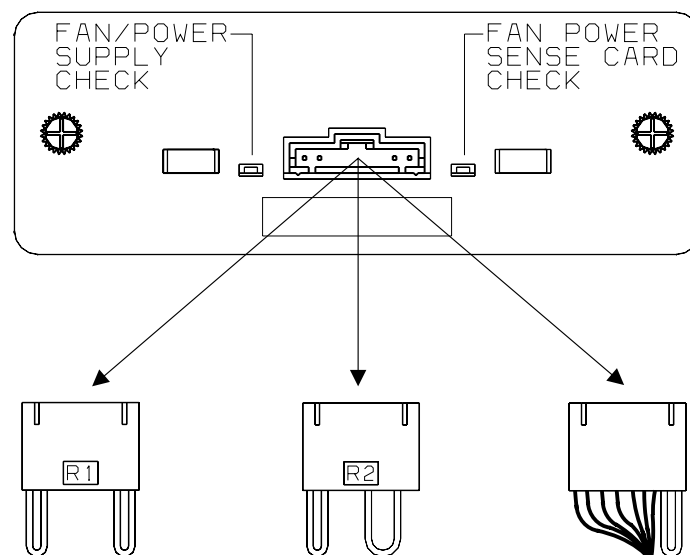
- The cage sense card R2 cable is failing
- The storage cage fan/power sense card that reported the failure is failing.
- A DDM bay controller card is reporting incorrectly.

Figure 138. 2105 Primary Power Supply Connectors (5008774m)

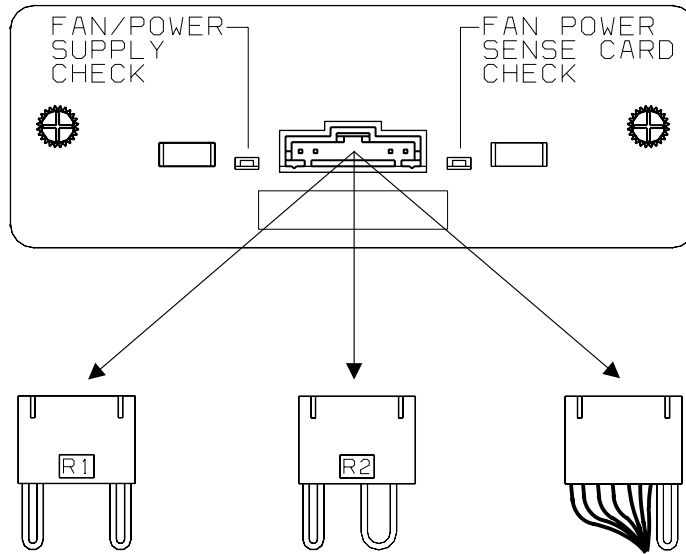
- A cage sense card R2 jumper has mistakenly been plugged onto the storage cage fan/power sense card in 2105 Model Exx/Fxx
- A cage sense card R1 jumper has mistakenly been plugged onto the storage cage fan/power sense card in the top half of 2105 Expansion Enclosure
- The DDM bay location selected by the service support representative for a DDM bay was in the wrong 2105, and needs to be changed.

Figure 139. Fan Sense Card Jumper and Cable Locations (S008774m)

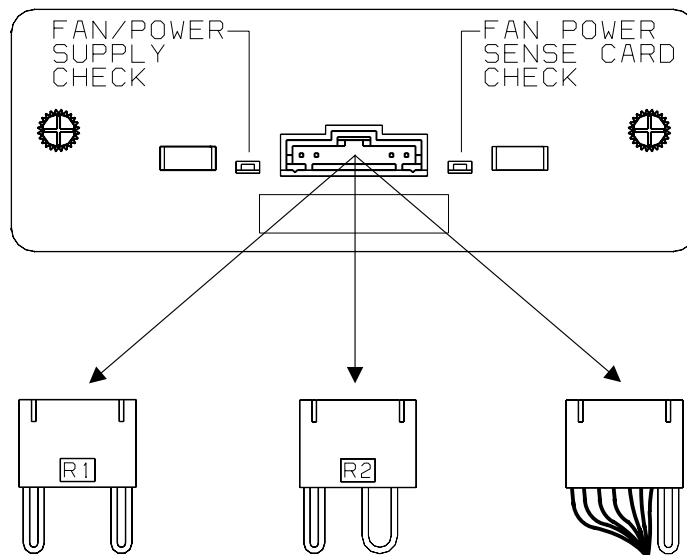
- The cage sense card R2 cable has been plugged backwards. The end marked **Fan Sense Card Top Power Stack** has been plugged into the lower sense card. The end marked **Fan Sense Card Bottom Power Stack** has been plugged into the upper sense card.
- The DDM Bay location selected by the CE for an DDM Bay was in the wrong bay, and needs to be changed.
- A DDM bay controller card is reporting incorrectly.

Figure 140. Fan Sense Card Jumper and Cable Locations (S008774m)

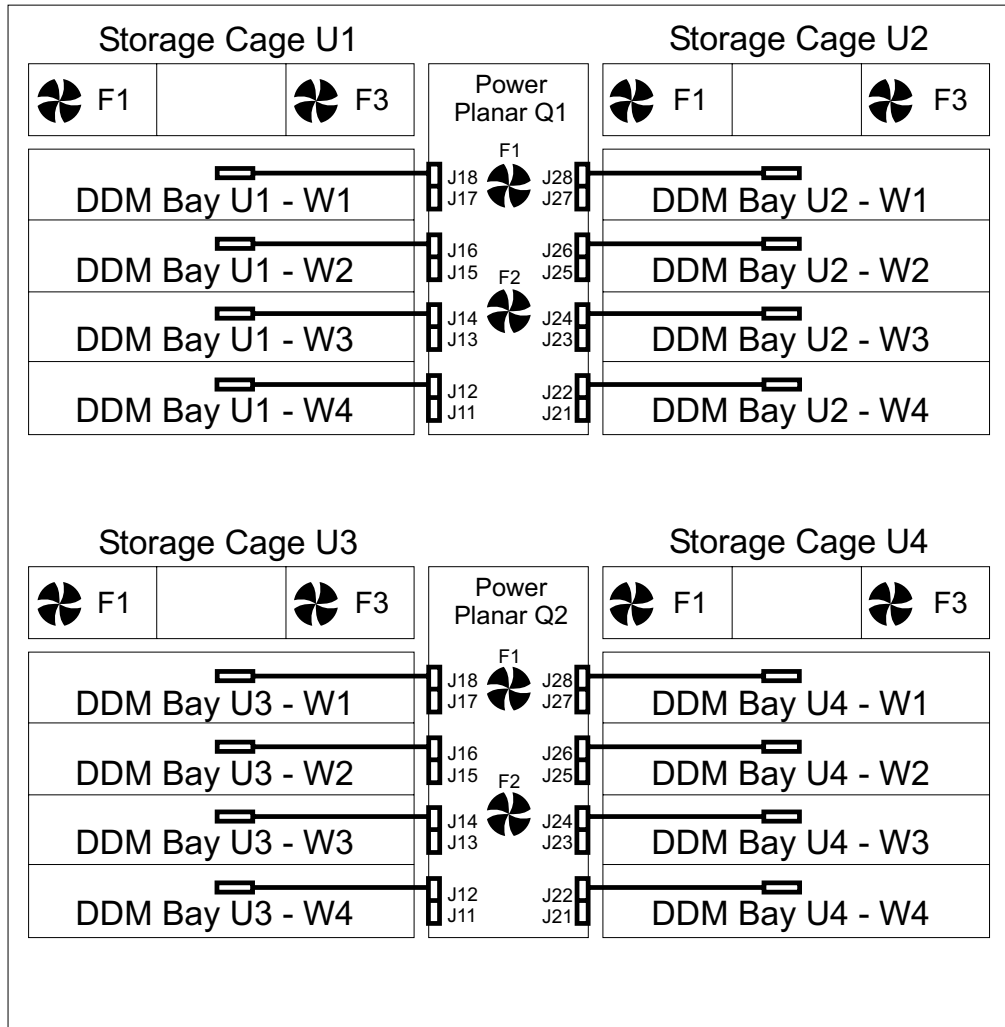
Front View

Figure 141. DDM Bay Front Power Cable Locations (S008812s)

- The power planar to DDM bay planar cable is plugged to the wrong connector position on the storage cage power planar. See Figure 141 on page 277 and Figure 142 on page 278
- The DDM bay location selected by the service support representative for a DDM bay was in the wrong location, and needs to be changed.
- A DDM bay controller card is reporting incorrectly.

4. The power planar to DDM bay planar cable may be plugged into the wrong connector position on the storage cage power planar. Remove the DDM bay in question and verify that the power planar to DDM bay planar cable is plugged correctly:
 - a. Remove the DDM bay, from the 2105. See *Frame Assembly Removal and Replacement, DDM Bay* in chapter 4 of the *Enterprise Storage Server Service Guide, Volume 2* book. Do only the steps necessary to remove and replace the DDM bay.
 - b. Verify that the power planar to DDM bay planar cable is plugged correctly. The most likely problem is the cables to a pair of front and rear DDM bays are swapped. See Figure 141 on page 277 and Figure 142 on page 278

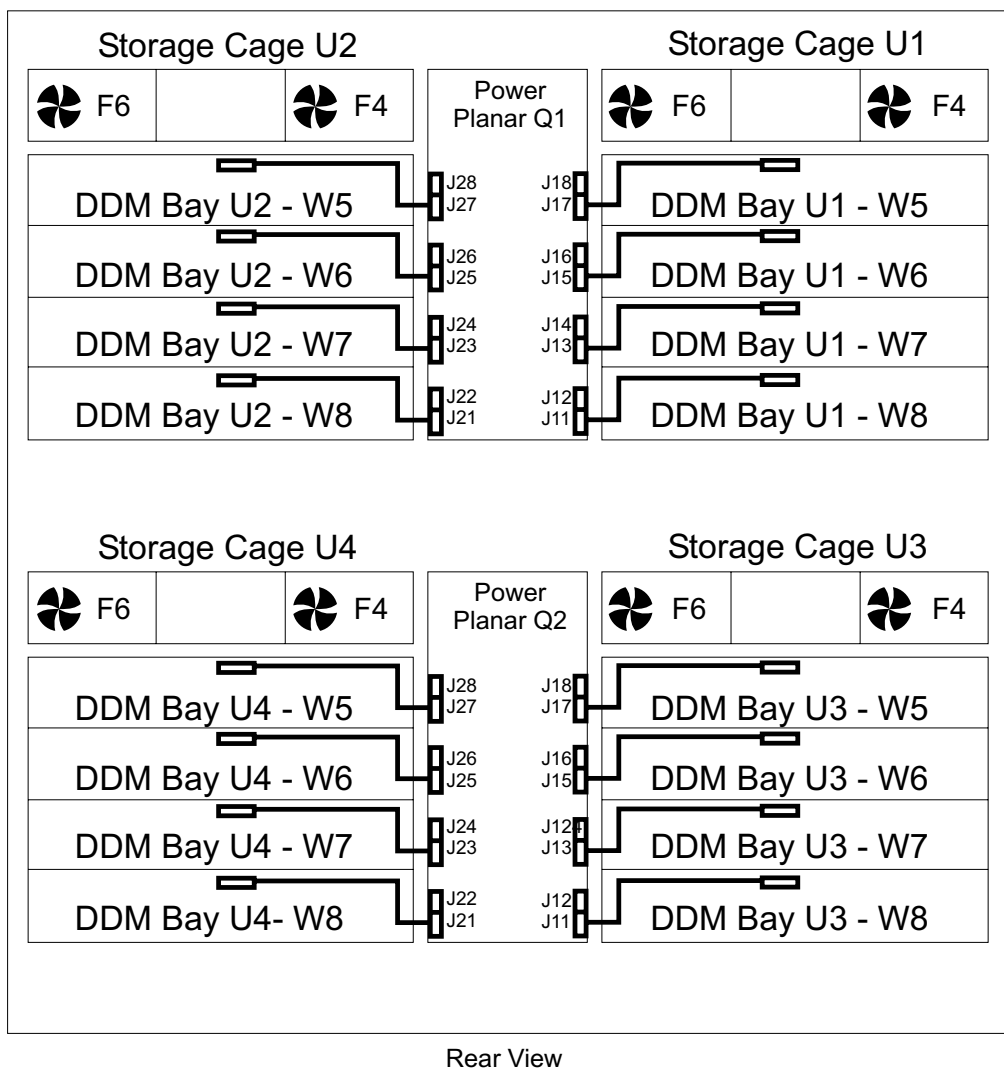
Figure 142. DDM Bay Rear Power Cable Locations (S008813s)

Note: The two lower storage cages (U4 and U3) are not present in 2105 Model Exx/Fxxs.

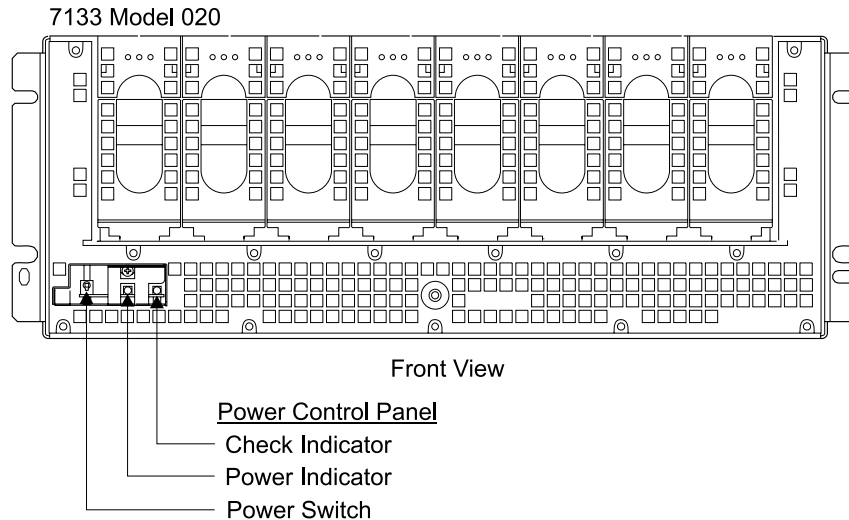
7. Use Figure 143 on page 284 in the following steps to locate the switch and indicators on the SSA DASD drawer power control panel:
Power Switch (On/Off)

Power Indicator (green)
Check Indicator (amber)

Figure 143. SSA DASD Model 020 Power Control Panel Locations (S008020m)

8. Go to the front of the 2105 and locate one of the SSA DASD drawers with a DDM shown for replacement. Observe the SSA DASD drawer green power indicator on the drawer power control panel.
Is the green drawer power indicator on?

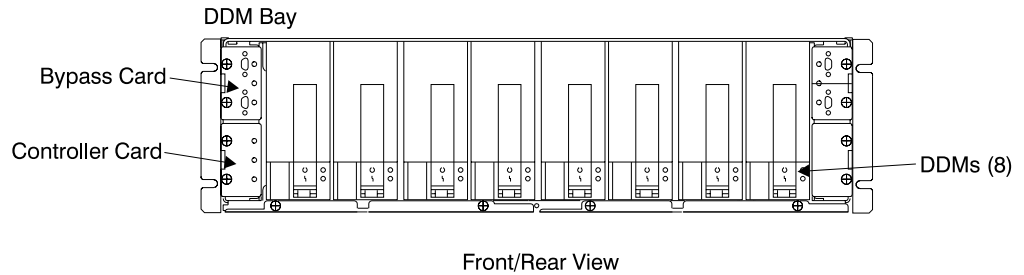
11. Observe the following indicators on the front of the DDM bay:
 - DDMs (eight)
 - Bypass card
 - Controller card

Figure 144. DDM bay Indicator Locations (S008018I)

12. Go to the DDM bay and observe the indicators.

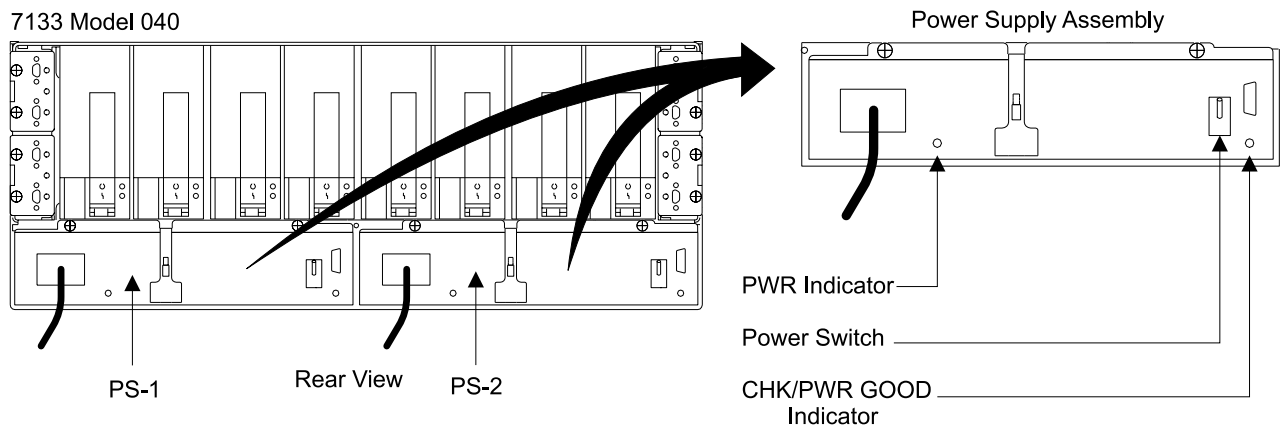
Figure 145. SSA DASD Model 040 Power Supply Assembly Indicators (S008019m)

2. Observe the SSA DASD drawer amber power supply CHK/PWR (check/power) Good indicators in Figure 145.
 - If the SSA DASD drawer power supply CHK/PWR (check/power) Good indicators are on or blinking (amber), go to “MAP 3105: Isolating a Loss of Power to a SSA DASD Model 040” on page 172.
 - If either of the SSA DASD drawer power supply CHK/PWR (check/power) Good indicators are on (green), go to step 3.
3. Call the next level of support for instructions on rebuilding the array.

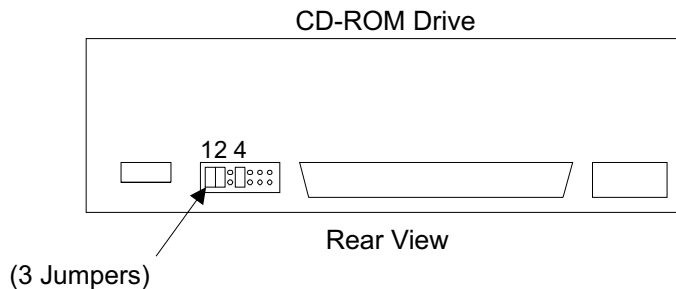
- **Yes**, continue with the next step.
 - **No**, go to step 8 on page 191.
 10. Ensure the three CD-ROM jumpers are plugged correctly. If they are not, there may be duplicate SCSI IDs.

Figure 146. CD-ROM Drive Jumpers (S008413I)

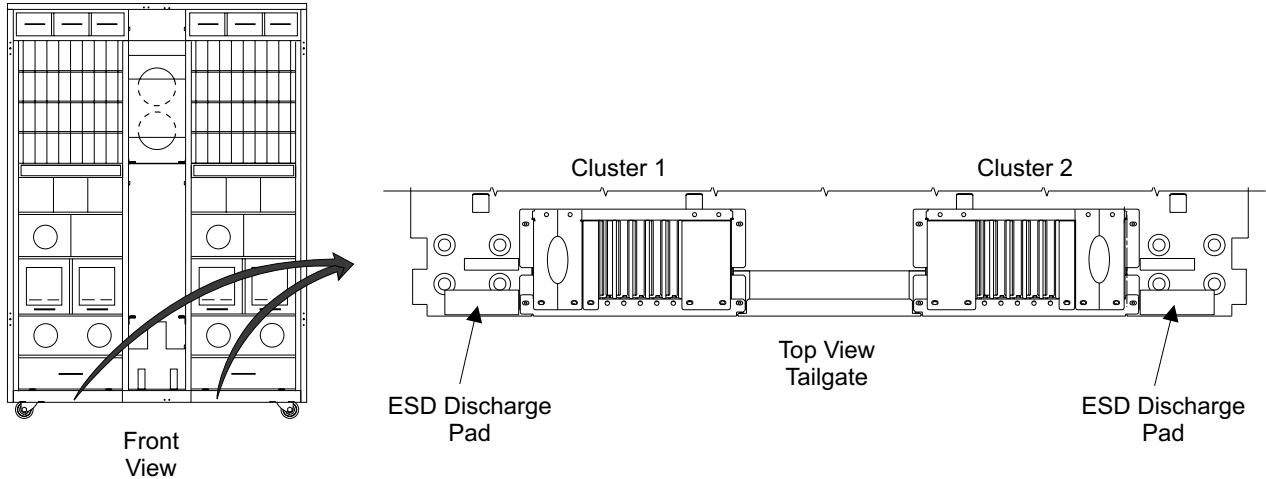
Figure 147. 2105 Model Exx/Fxx ESD Discharge Pad Locations (S008339m)

Attention: To prevent electrostatic discharge, ensure you discharge all SCSI host cables to the ESD discharge pad, before you plug them into the 2105 Model Exx/Fxx. The ESD discharge pads are mounted on the front right and left corners of the 2105 Model Exx/Fxx frame, next to each tailgate. See Figure 147 on page 409 for the location of the ESD discharge pads.

Attention: To prevent electrostatic discharge, ensure you discharge all SCSI host cables to the ESD discharge pad, before you plug them into the 2105 Model Exx/Fxx. The ESD discharge pads are mounted on the front right and left corners of the 2105 Model Exx/Fxx frame, next to each tailgate. See Figure 147 for the location of the ESD discharge pads.

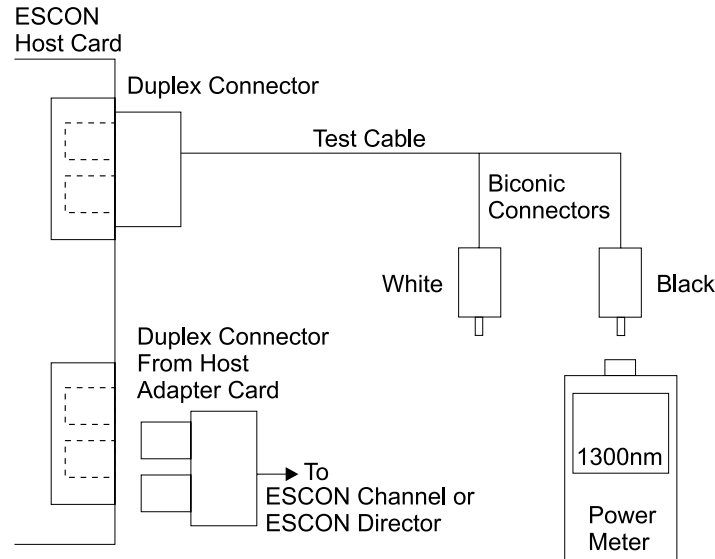
Figure 148. Measuring Optical Transmit Power (S008185m)

Isolation Procedure 1: Optical Transmitter Measurement: This procedure measures the optical power transmitted from the 2105 Model Exx/Fxx ESCON card through a short test cable (P/N 18F6948).

This MAP contains two procedures, “Isolation Procedure 1: Optical Transmitter Measurement” on page 419 and “Isolation Procedure 2: Optical Receiver Measurement” on page 420. These procedures measure the optical power at the 2105 Model Exx/Fxx ESCON card and the customer’s ESCON port cable using the optical power meter (P/N 18F7005). The coupler and test cable are part of the fiber optic test support kit (P/N 18F6953).

1. Ensure that the host bay containing the 2105 Model Exx/Fxx ESCON card is powered on.
2. Disconnect the fiber optic cable connector from the duplex connector on the 2105 Model Exx/Fxx ESCON card.
3. Connect the duplex connector of the optical power meter test cable to the 2105 Model Exx/Fxx ESCON card duplex connector (see Figure 148).

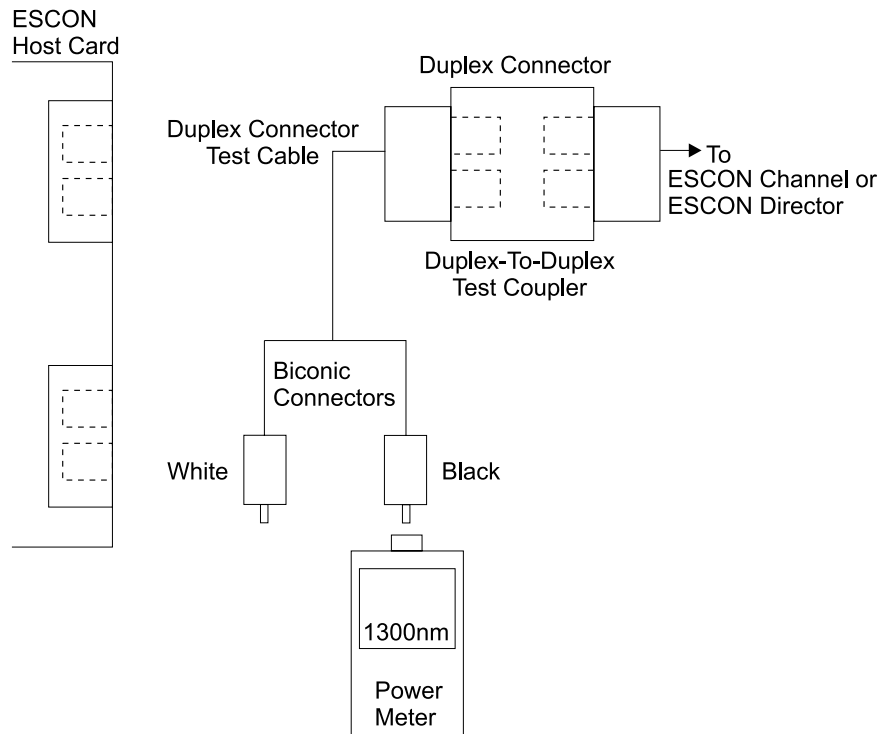
Figure 149. Measuring Optical Receive Power (s008186n)

Isolation Procedure 2: Optical Receiver Measurement: This procedure measures the power received at the end of the customer's ESCON link cable (input into optical receiver).

1. Ensure that the device on the other end of the link is powered on.
2. Disconnect the fiber optic cable connector from the duplex connector on the 2105 Model Exx/Fxx ESCON card.
3. Connect the duplex connector of the customer's fiber optic cable (the duplex connector that was removed from the 2105 Model Exx/Fxx ESCON card) into one side of the duplex-to-duplex test coupler, P/N 18F6952 (see Figure 149).
4. Connect the duplex connector of the optical power meter test cable into the other side of the duplex-to-duplex test coupler.
