Enterprise Storage Server

Service Guide
2105 Models E10/E20, F10/F20, and
Expansion Enclosure
Volume 1

Chapters 1, 2, and 3

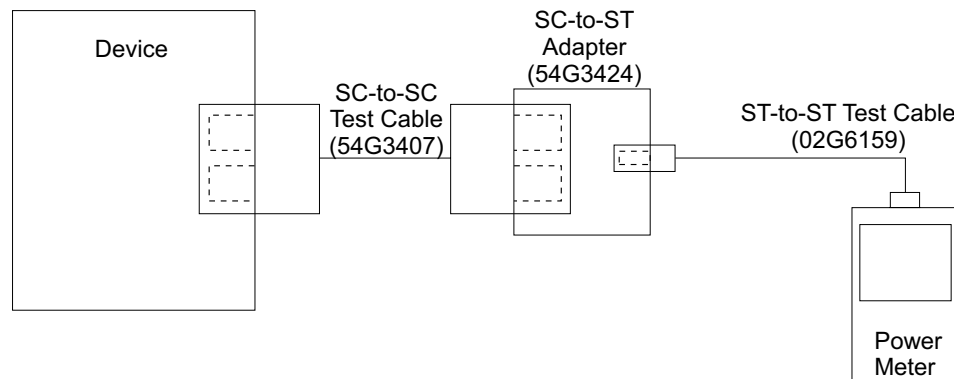
Fibre Channel Optical Transmitter Measurement This procedure measures the optical power transmitted from the 2105 Model Exx/Fxx Fibre Channel host card through a short C-to-SC test cable (P/N 54G3407), SC-to-ST adapter (P/N 54G3424) and ST-to-ST test cable (P/N 02G6159).

Figure 150. Measuring Fibre Channel Optical Transmit Power (S008840I)

1. Ensure that the host bay containing the 2105 Model Exx/Fxx Fibre Channel host card is powered on.
2. Disconnect the fiber optic cable connector from the 2105 Model Exx/Fxx Fibre Channel host card.
3. Connect one end of a SC-to-SC test cable to the SC-to-ST adapter; then connect the other end to the 2105 Model Exx/Fxx Fibre Channel host card (See Figure 150).
4. Connect the ST-to-ST test cable from the SC-to-ST adapter to the power meter.

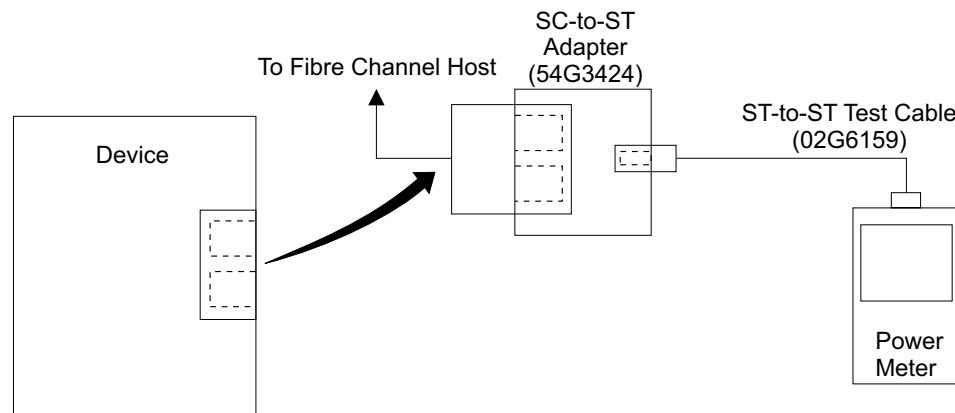
Fibre Channel Optical Receiver Measurement This procedure measures the power received at the end of the customer's Fibre Channel link cable (input into optical receiver) through a SC-to-ST adapter (P/N 54G3424) and ST-to-ST test cable (P/N 02G6159).

Figure 151. Measuring Fibre Channel Optical Receive Power (S008841m)

1. Ensure that the device on the other end of the link is powered on.
2. Disconnect the fiber optic cable connector from the 2105 Model Exx/Fxx Fibre Channel host card.
3. Connect the customer's fiber optic cable (that was removed from the 2105 Model Exx/Fxx Fibre Channel host card) to the SC-to-ST adapter (see Figure 151).
4. Connect the ST-to-ST test cable from the SC-to-ST adapter to the power meter.

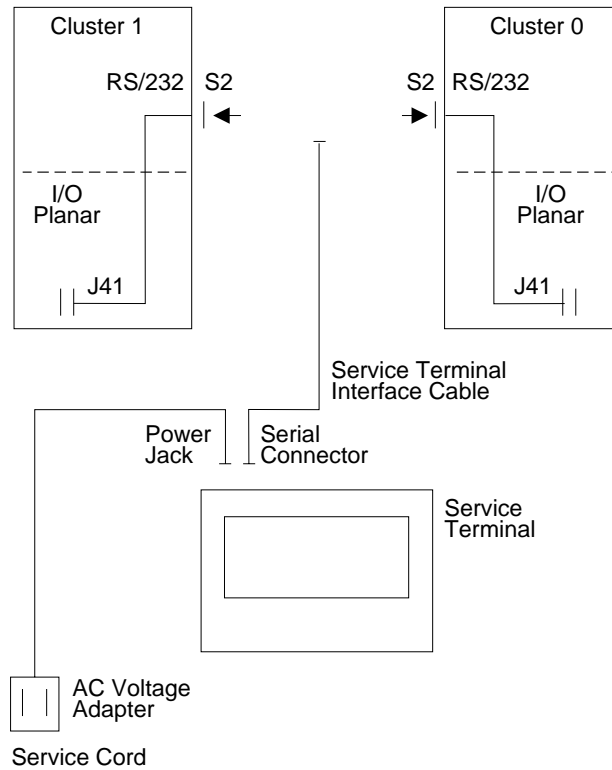
Service Terminal Connection Diagram

The following diagram shows the hardware and cables involved in connecting the service terminal to the 2105 rack and AC power.

Figure 153. Service Terminal Connections to Controllers and Power (S007525n)
