IBM TotalStorage UltraScalable Tape Library 3584

Maintenance Information

Ninth Edition (June 2003)

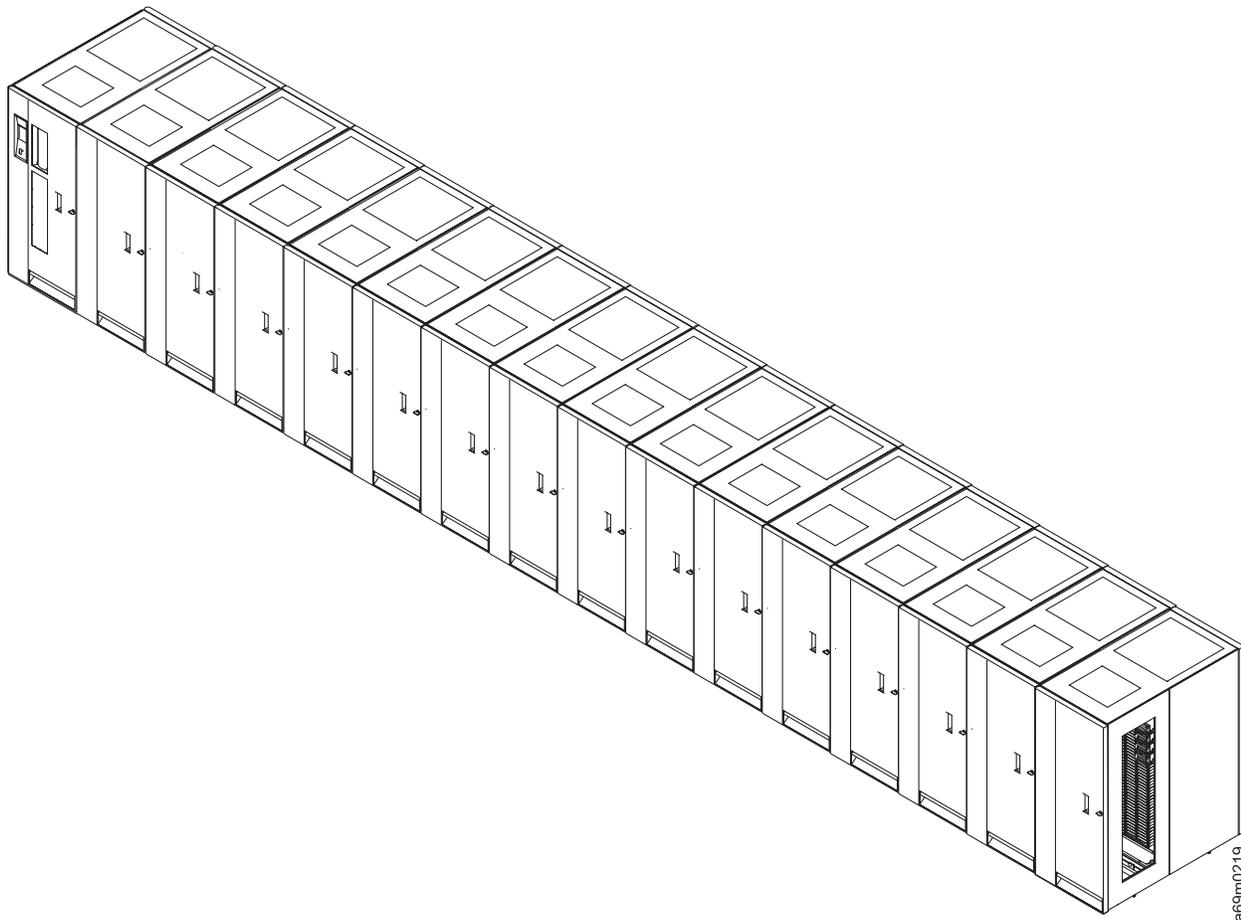
Figure 1 on page 4 shows an IBM TotalStorage UltraScalable Tape Library 3584 that contains 16 frames.

Figure 1. TotalStorage UltraScalable Tape Library 3584 with 16 Frames. Model L32 base frame (left) and fifteen Model D32 expansion frames (right of base frame).

With the Capacity Expansion Feature (additional storage slots enabled on the front door), the base frame (Model L32) in the library has as many as 281 cartridge storage slots and can support as many as 12 Ultrium Tape Drives. It contains a 10-slot input/output (I/O) station for moving cartridges to and from the library without requiring a re-inventory. For greater storage capacity, you can attach an expansion frame to the base frame. Each expansion frame (Model D32) has as many as 440 cartridge storage slots and contains as many as 12 Ultrium Tape Drives.

A fully-configured TotalStorage UltraScalable Tape Library 3584 (with one L32 base frame and fifteen D32 expansion frames) contains 2481 storage slots, and contains 4 to 72 tape drives (the number of storage slots will decrease as the number of tape drives is increased).

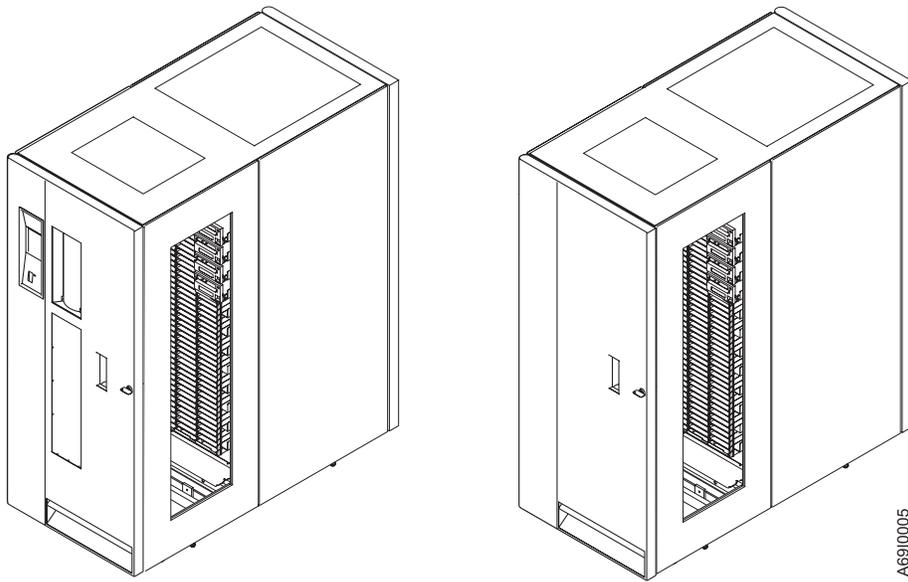
Figure 2 on page 5 shows a base frame and one expansion frame in the TotalStorage UltraScalable Tape Library 3584.

Figure 2. TotalStorage UltraScalable Tape Library 3584 Frames. Model L32 base frame (left) and Model D32 expansion frame which attaches to base frame.

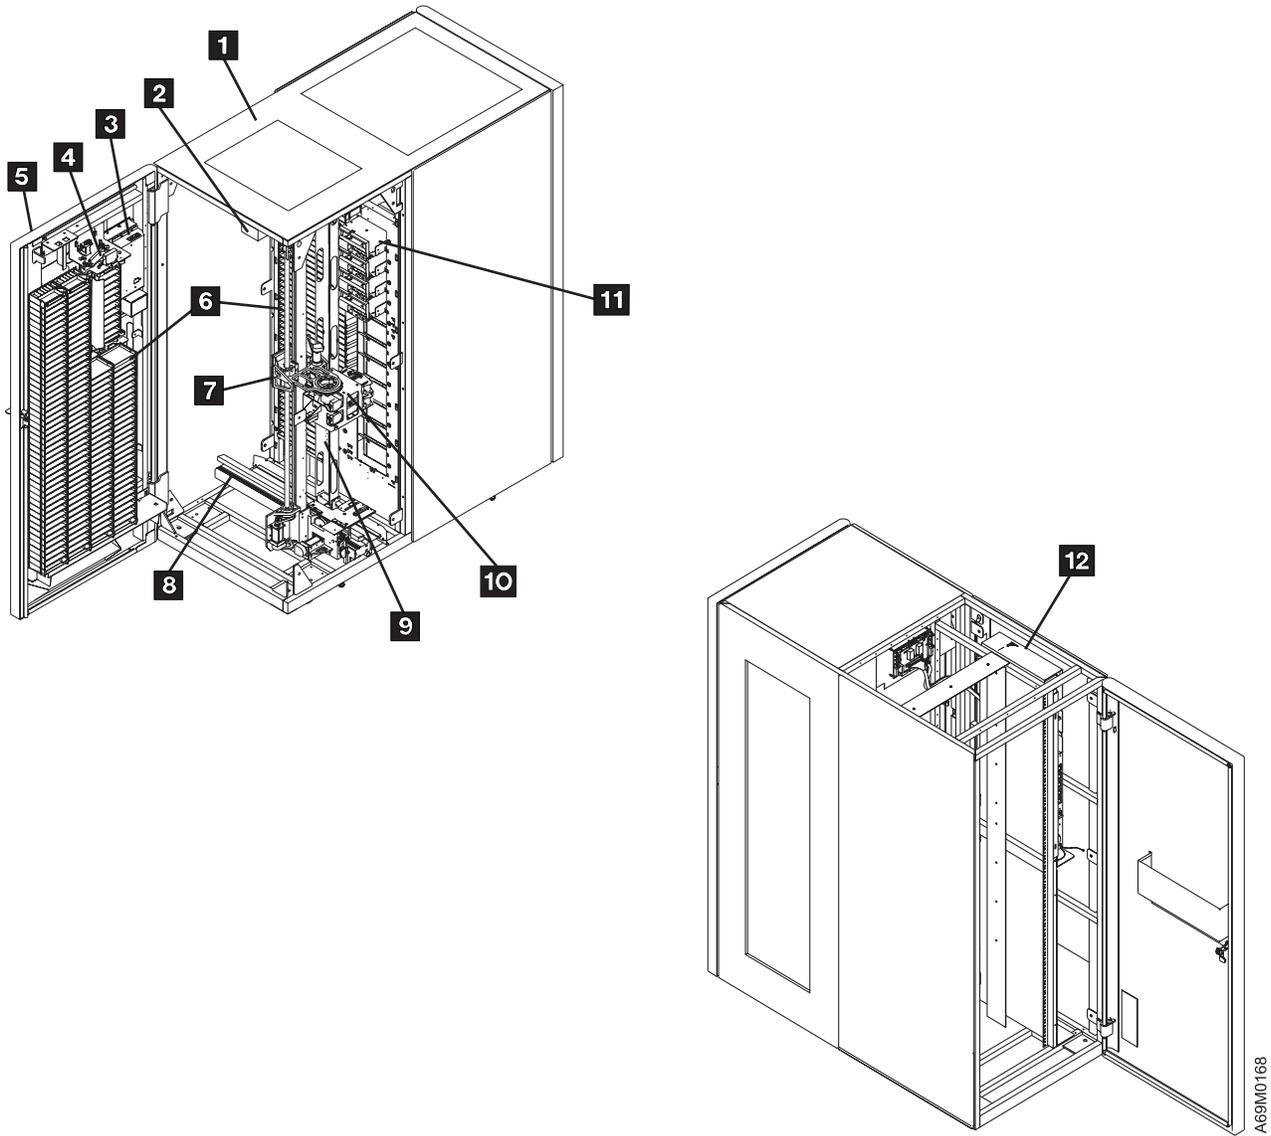
The TotalStorage UltraScalable Tape Library 3584 consists of the following major components shown in Figure 3 on page 15. The following paragraphs give a very brief description of each component. For greater detail, see “Library Components – Detail” on page 16:

An assembly of components that facilitate RS-422 communication between the set of drives within a frame and the accessor controller and operator panel controller. Includes the Media Changer Pack (MCP), power supply, and frame control assembly (FCA) which houses a receptacle for the incoming main AC power, 3 circuit protectors, and 2 vertical rows of 5 AC outlets for powering the tape drives.

Figure 3. IBM TotalStorage UltraScalable Tape Library 3584 Components. The front and rear of the library are shown.

The library frame (**1** at Figure 3 on page 15) is the basic building block for the TotalStorage UltraScalable Tape Library 3584. There are three types of frames:

The accessor controller card (**7** on Figure 3 on page 15) is an associated controller (logic card) for the cartridge accessor. The accessor controller handles accessor motion requests, including calibrations, moves, and inventory updates. It also provides centralized management for other aspects of the entire library, including configuration, insert and eject operations, automatic drive cleaning, and determination of element status.

The cartridge accessor moves through the library on a rail system (**8** in Figure 3 on page 15). The rail system consists of a lower X-rail, an upper X-rail, and a trough for the power and control cable. The lower X-rail includes a main bearing way with a rack gear. The L-shaped, upper X-rail runs along the top of the frames. The power and control cable is kept clear of the accessor in a covered trough located at the bottom rear of the library.

The cartridge accessor (**9** on Figure 3 on page 15) moves cartridges between the storage slots, tape drives, and the I/O Station. The accessor consists of several components:

Electromechanical device (mounted on the pivot assembly) that gets or puts cartridges from or to a storage slot, a drive, or the I/O station. There are two grippers on the assembly (Gripper 1 and Gripper 2). Each gripper is independently controlled and can grip a single cartridge. The grippers are located in the dual-gripper assembly **10**, on Figure 3 on page 15.

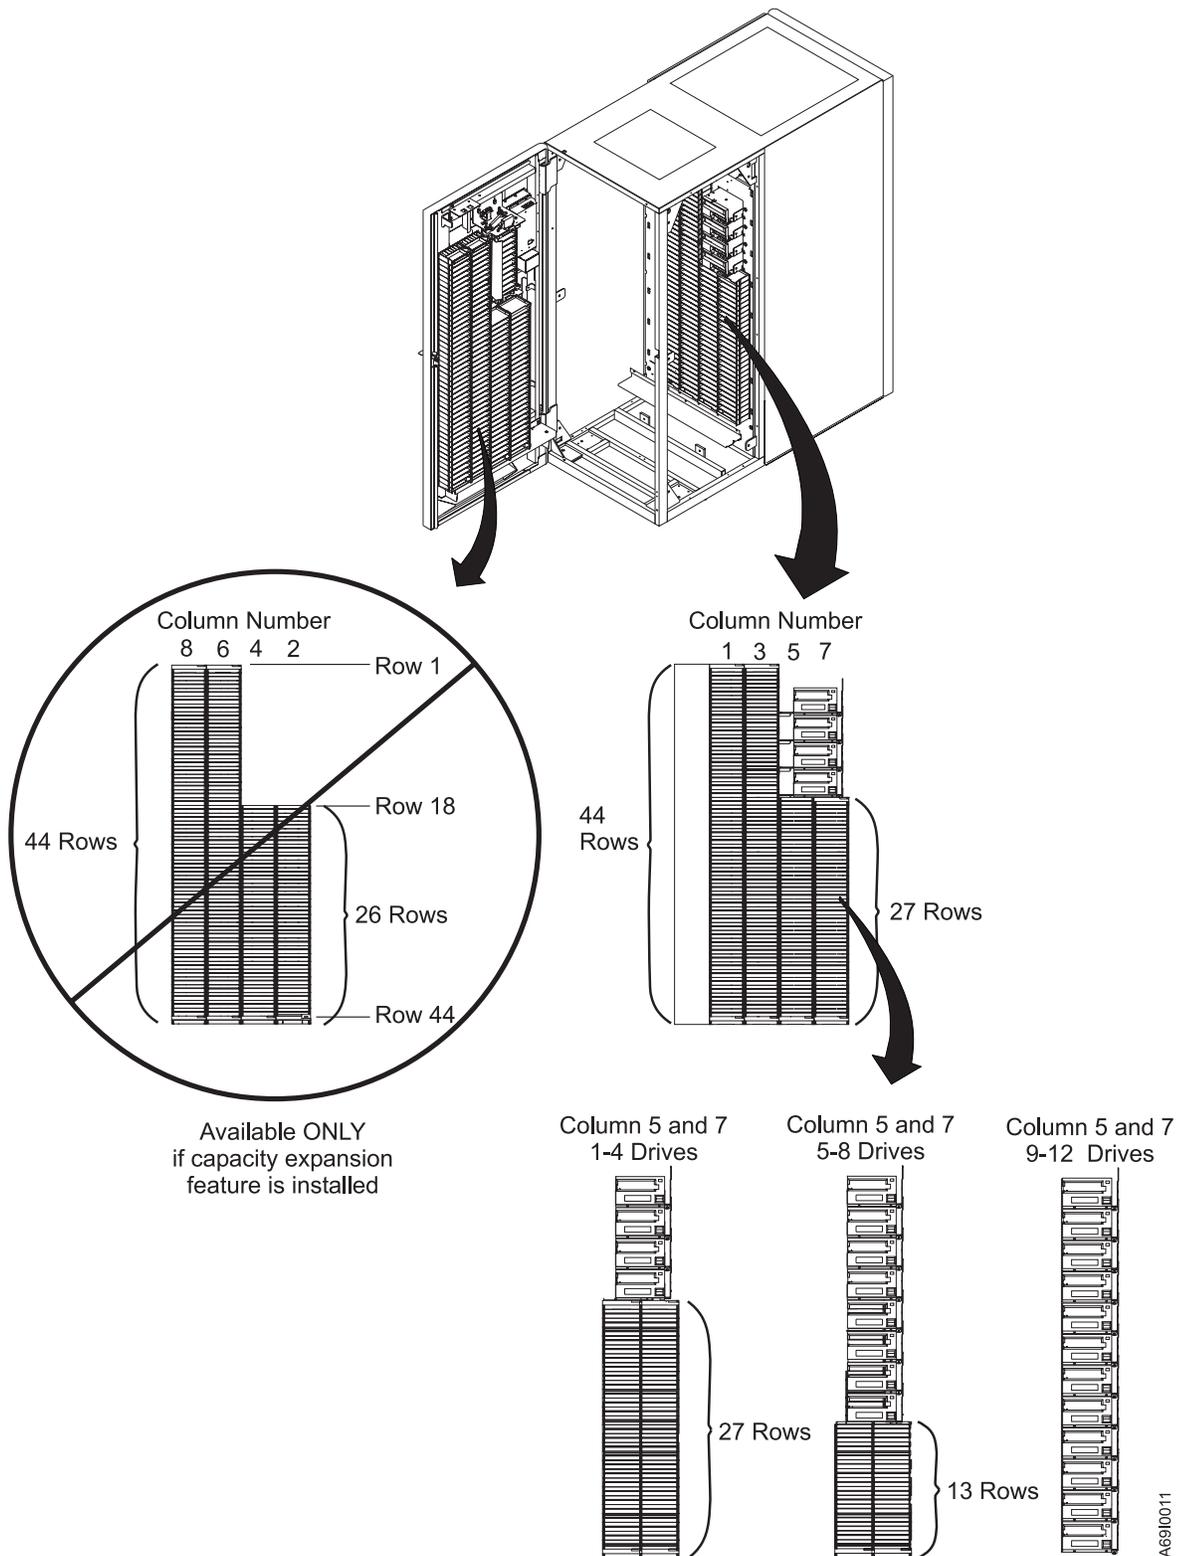
Storage Slots in Model L32 (Frame 1)

Figure 4. LTO Storage Slots Base Frame (L32). Use this numbering scheme to determine the physical ID (location) of each storage slot. The L32 door storage, depicted by the crossed out circle, is only available if the Capacity Expansion Feature is enabled. Door storage in columns 2 and 4 is not present if the optional, second I/O station is installed.

Represented as C_{xx}, where xx equals the column number. For each frame, the left frame wall column is column number 1. The column number increments in a zig-zag pattern, alternating between the frame wall and the door wall, and progressing from left to right. Thus, all column numbers on the frame wall are odd numbers, and all column numbers on the door wall are even numbers. The base frame (Model L32) has 8 columns; the expansion frame (Model D32, D42) has 10 columns. Refer to Figure 4 on page 18 for base frame, and Figure 5 on page 19 for expansion frames.

Note: Refer to Figure 4 on page 18. If the capacity expansion feature is NOT installed, the cartridge slots (shown in a crossed-out circle), on the front door of the base frame will NOT be accessible.

- ___ 7. Install the LTO CE Diagnostic Cartridge (P/N 19P0405) into column 1, row 1 (on the top left of the rear wall; see Figure 4 on page 18). Each column is identified with a numbered label located below the column. Rows are identified with labels located to the left of column 1.
- ___ 8. Move the cartridge accessor assembly to the left side of the base frame.
- ___ 9. Refer to Figure 29 on page 83. Place the level **3** on the right side of the base frame. Ensure that the base frame is level from front to back.

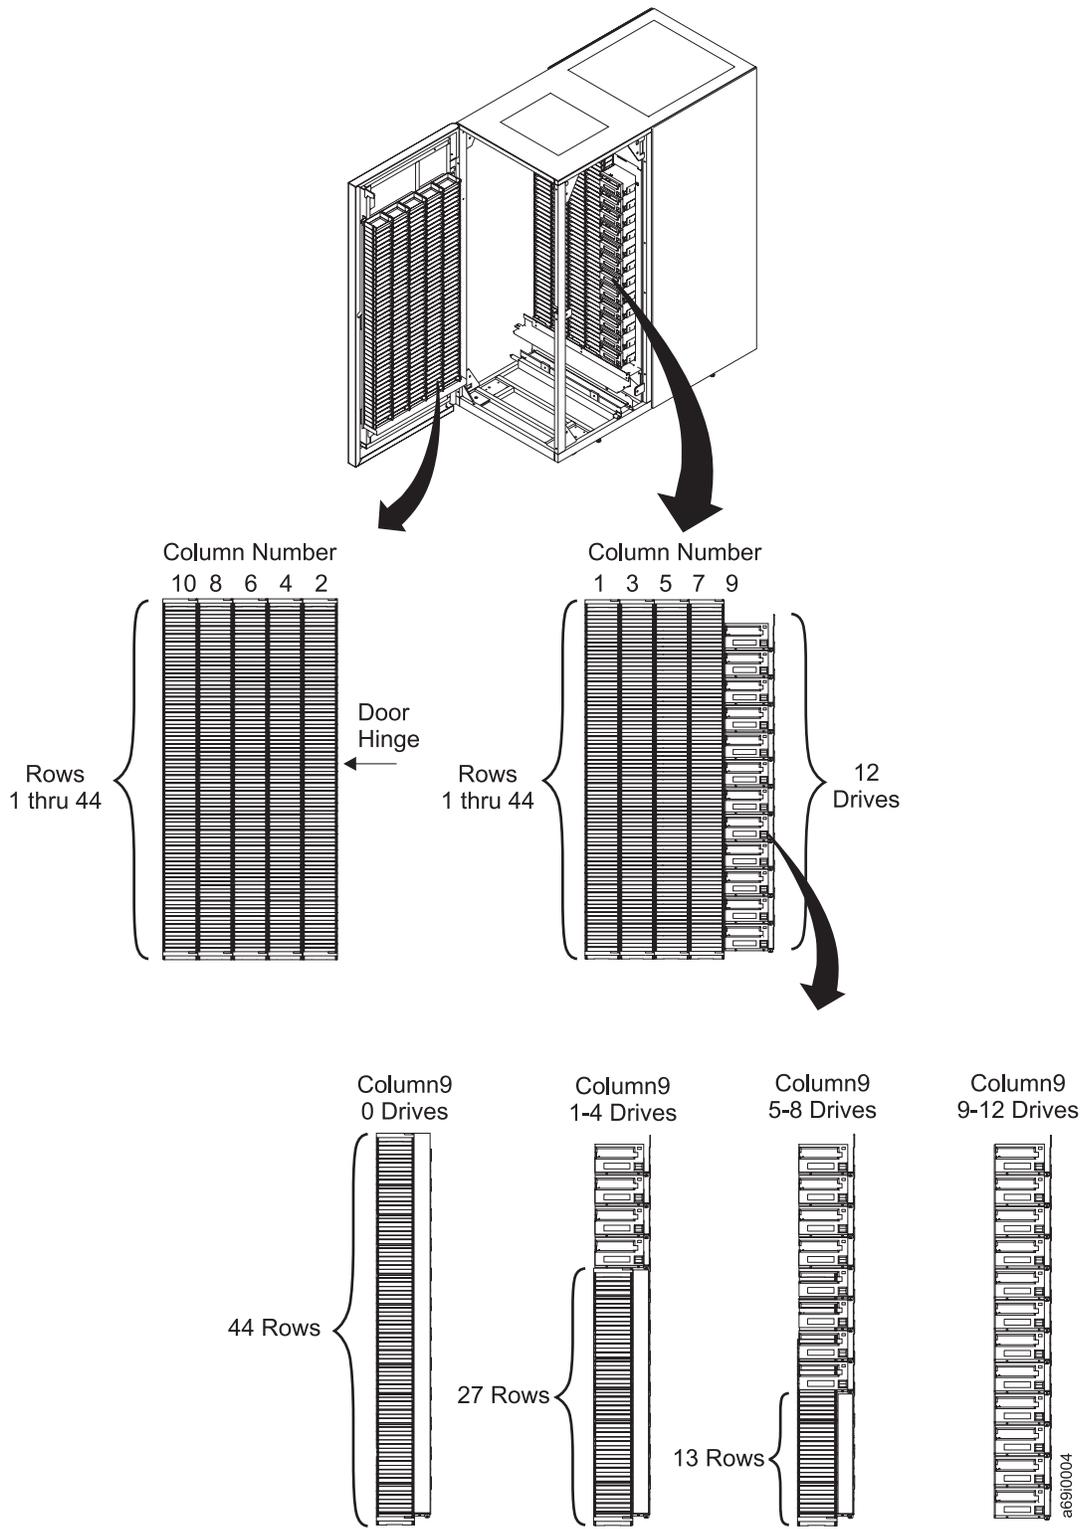
Storage Slots in Model D32 (Frame 2 to 6)

Figure 5. LTO Storage Slots Expansion Frames (D32). Use this numbering scheme to determine the physical ID (location) of each storage slot.

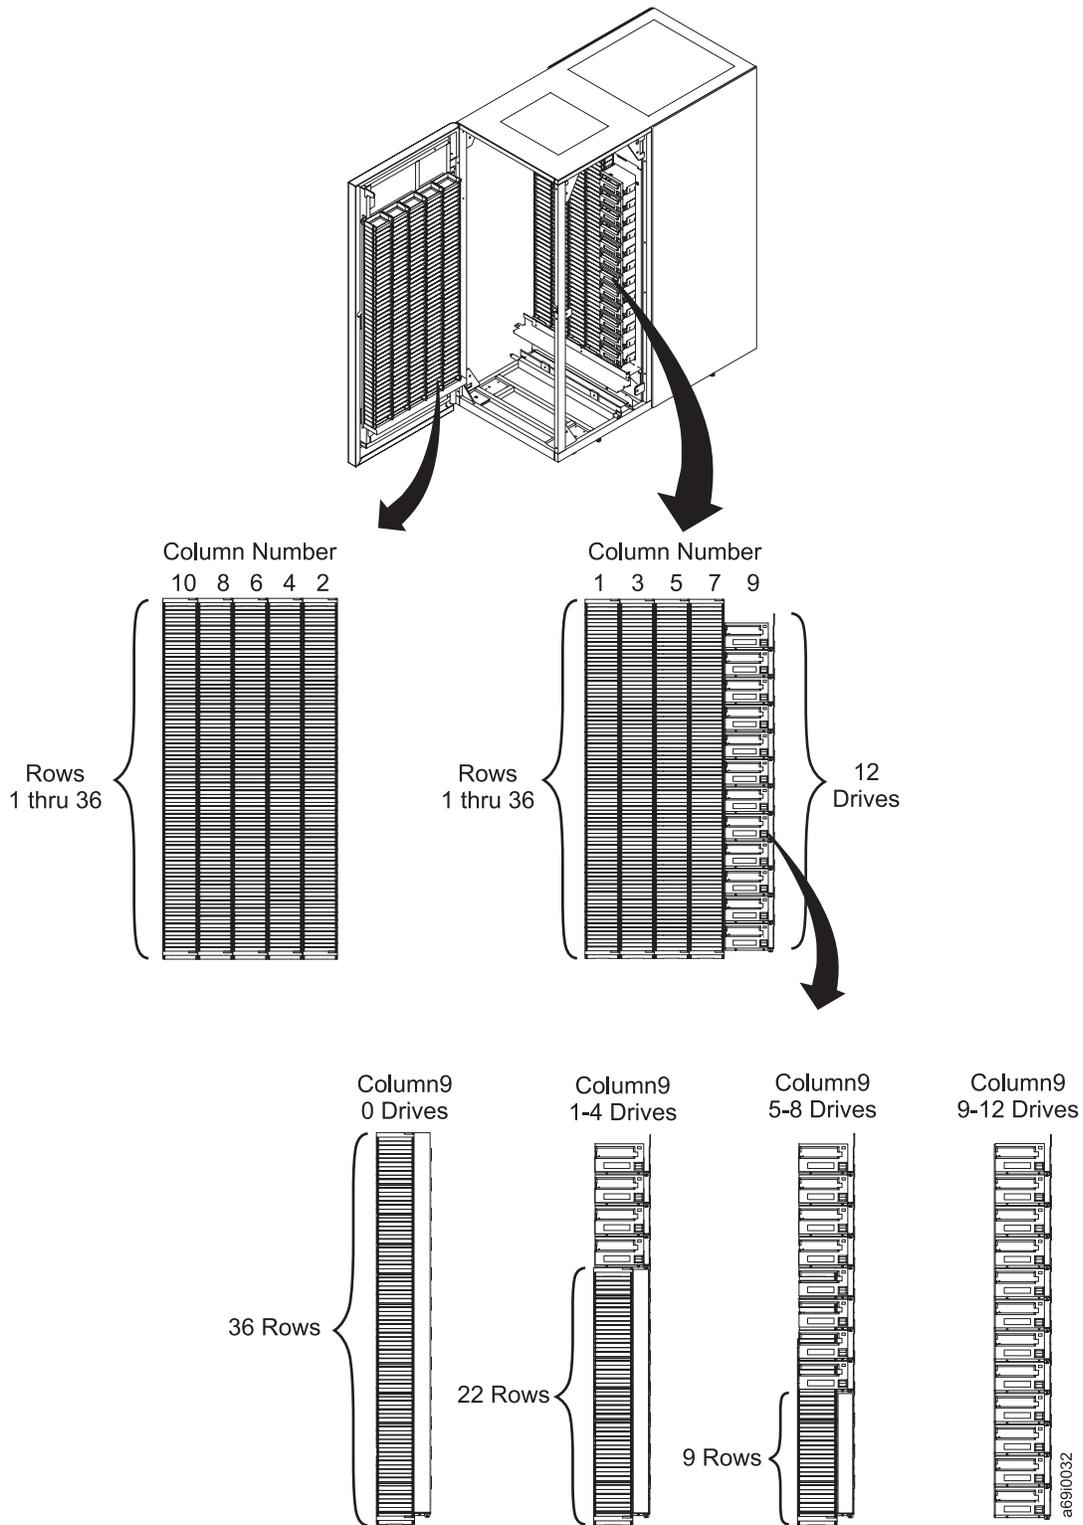
Storage Slots in Model D42 (Frame 2 to 6)

Figure 6. DLT-8000 Storage Slots Expansion Frames (D42). Use this numbering scheme to determine the physical ID (location) of each storage slot.

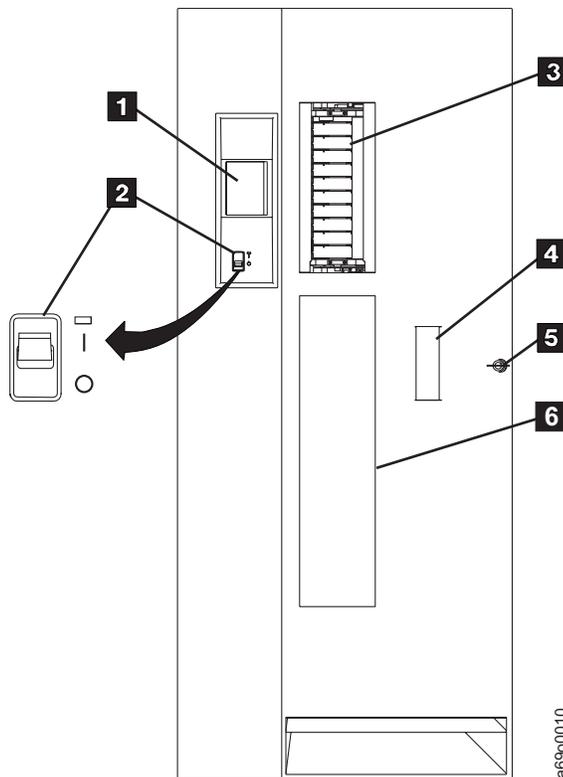
Located at the front of the base frame is the front door, shown in Figure 7. The door allows the service representative access to storage slots, rail system, accessor, and other components that may require service.

The operator panel **1** is mounted on the front door of the base frame (Model L32). Also located on the base frame door are the power switch **2** and input/output (I/O) Station **3**. A door handle **4** and a keylock (with key) **5** are included on the front door of all frames. To unlock and open the front door of any frame, insert the key into the keylock and turn it counterclockwise approximately 180°. Some customers order the library with an optional second (or lower) I/O station, which will be located in place of the blank panel **6**.

Figure 7. Base Frame Front Door

Note: The door of the I/O Station **3** is shown in an open position.

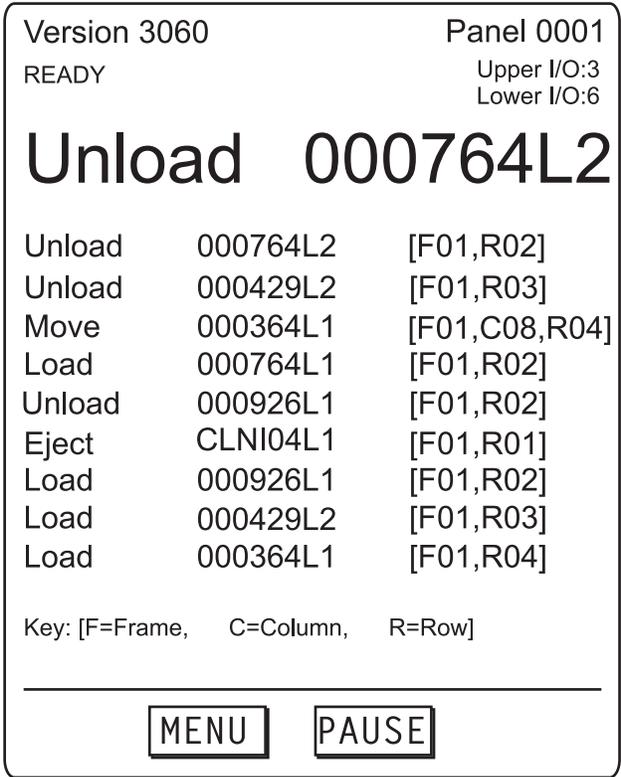
The operator panel controller facilitates communication between the accessor controller and the operator panel. It provides input and output to and from the LCD. It senses and locks the I/O Station. In addition, the LCD activity and service menus are executed in the operator panel controller, with support from the accessor controller and the drives (via the Media Changer controllers).

The operator panel connects to the accessor controllers and all Media Changer controllers via the Controller Area Network (CAN).

Figure 8. Operator Panel

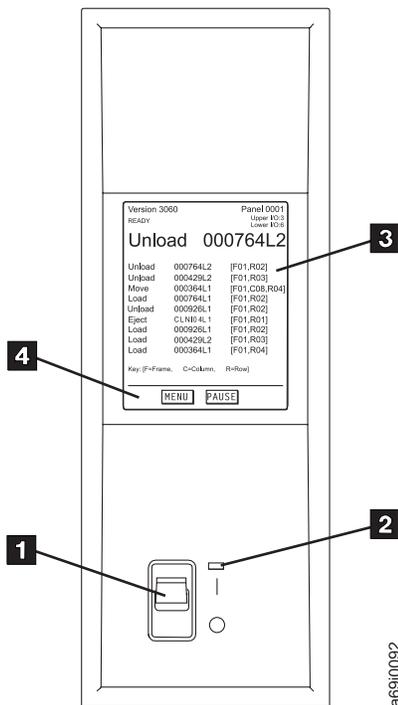
The Activity screen displays on the LCD of the operator panel when the library is Ready. It shows the current activity in a large font type and provides a history of preceding operations in a smaller font type. The operations are listed from top to bottom, with the most recent at the top and oldest at the bottom. The first line of smaller font types gives a detailed description of the current activity (for example, in the following sample Activity screen, a cartridge with a volume serial number (VOLSER) of 000764L1 was unloaded from the drive in frame 1, row 2).

Figure 9. Activity Screen

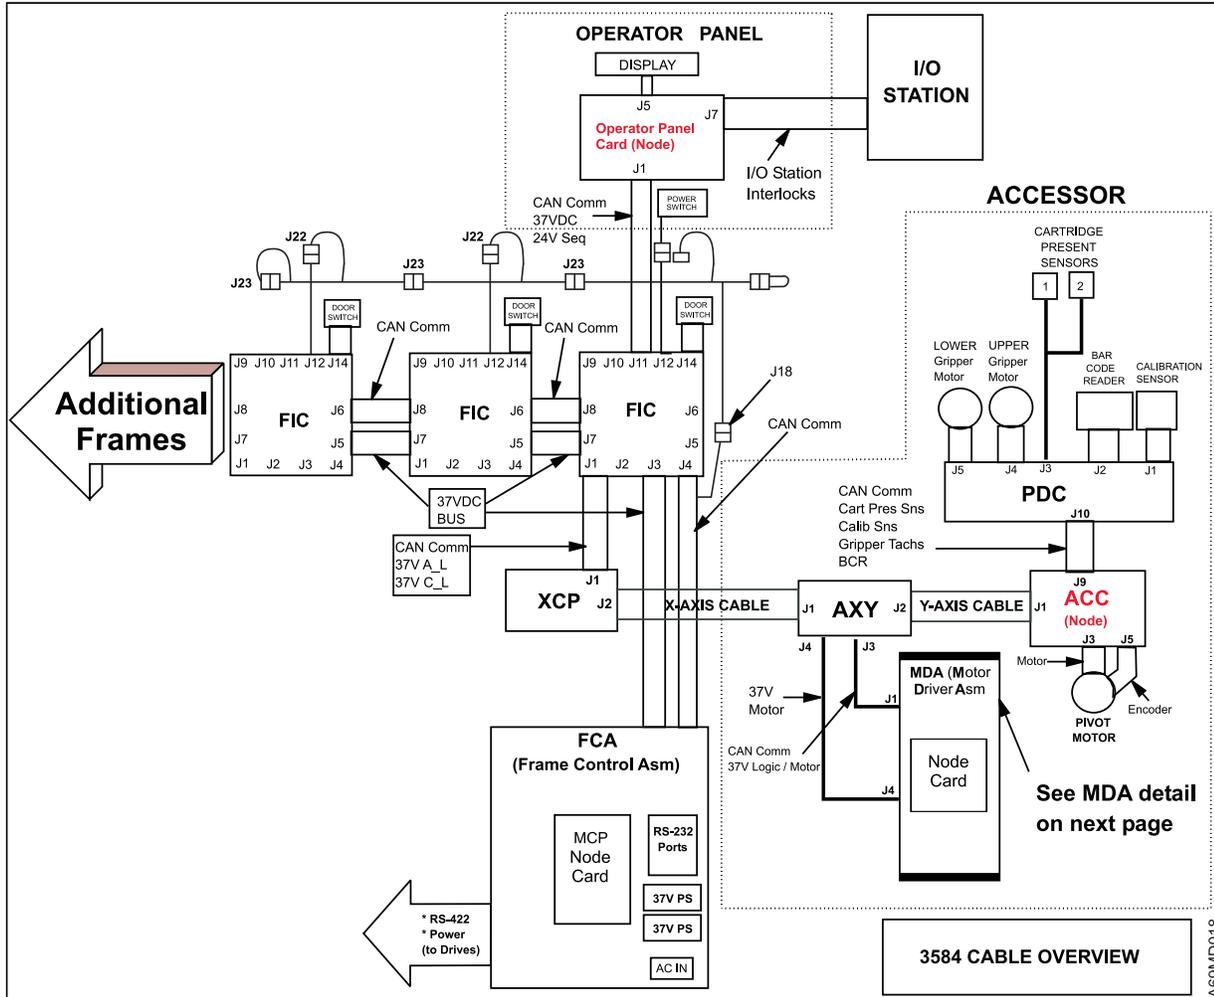
Figure 10 and Figure 11 on page 33 show an IBM TotalStorage UltraScalable Tape Library 3584 cable overview for the major components in a library. Figure 12 on page 34 shows a FRU block diagram that ties all the components together for a two-frame library containing a full complement of drives.

Figure 10. Cable Overview – Library

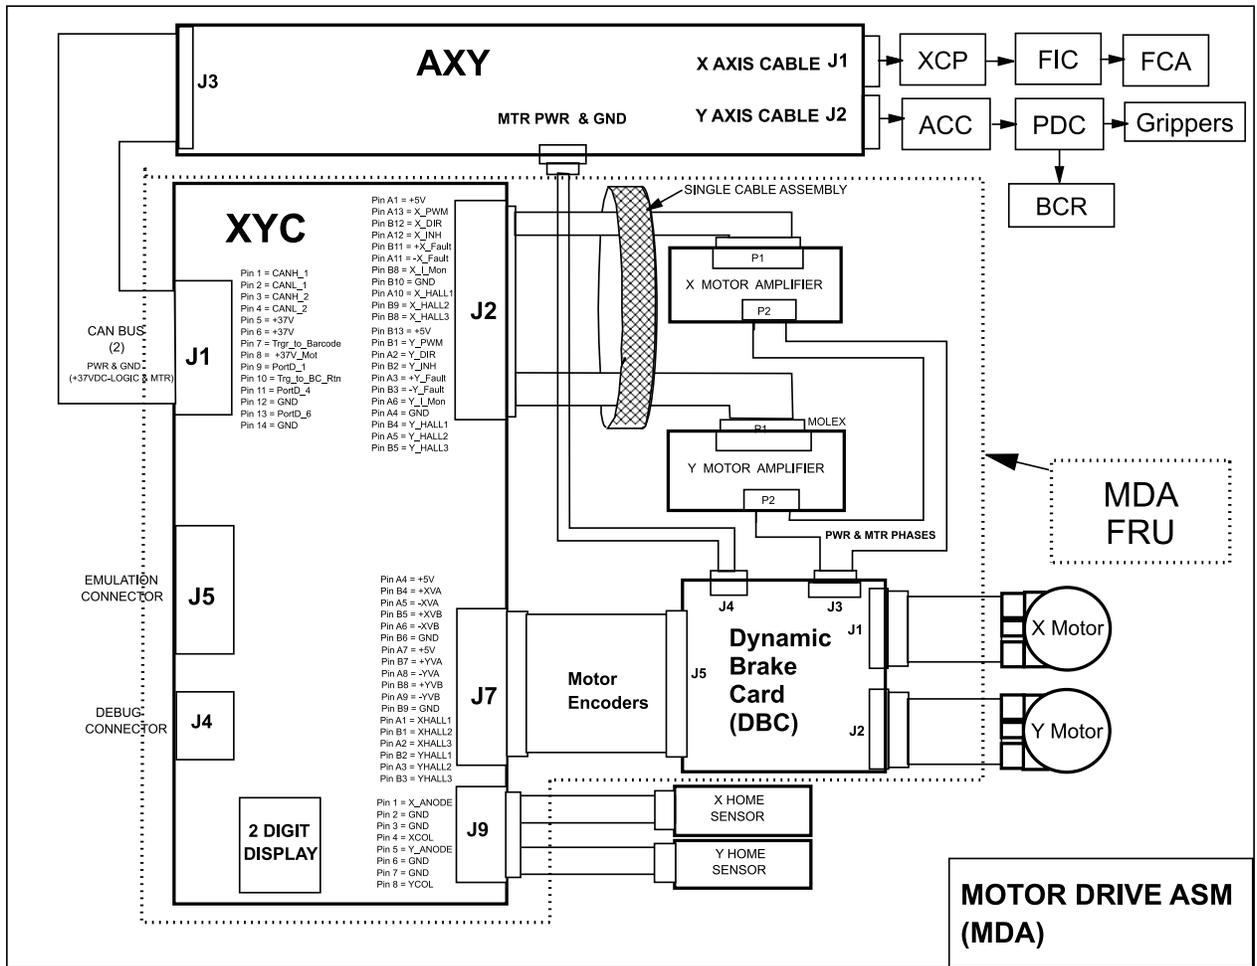
Figure 11. Cable Overview – Motor Drive Assembly

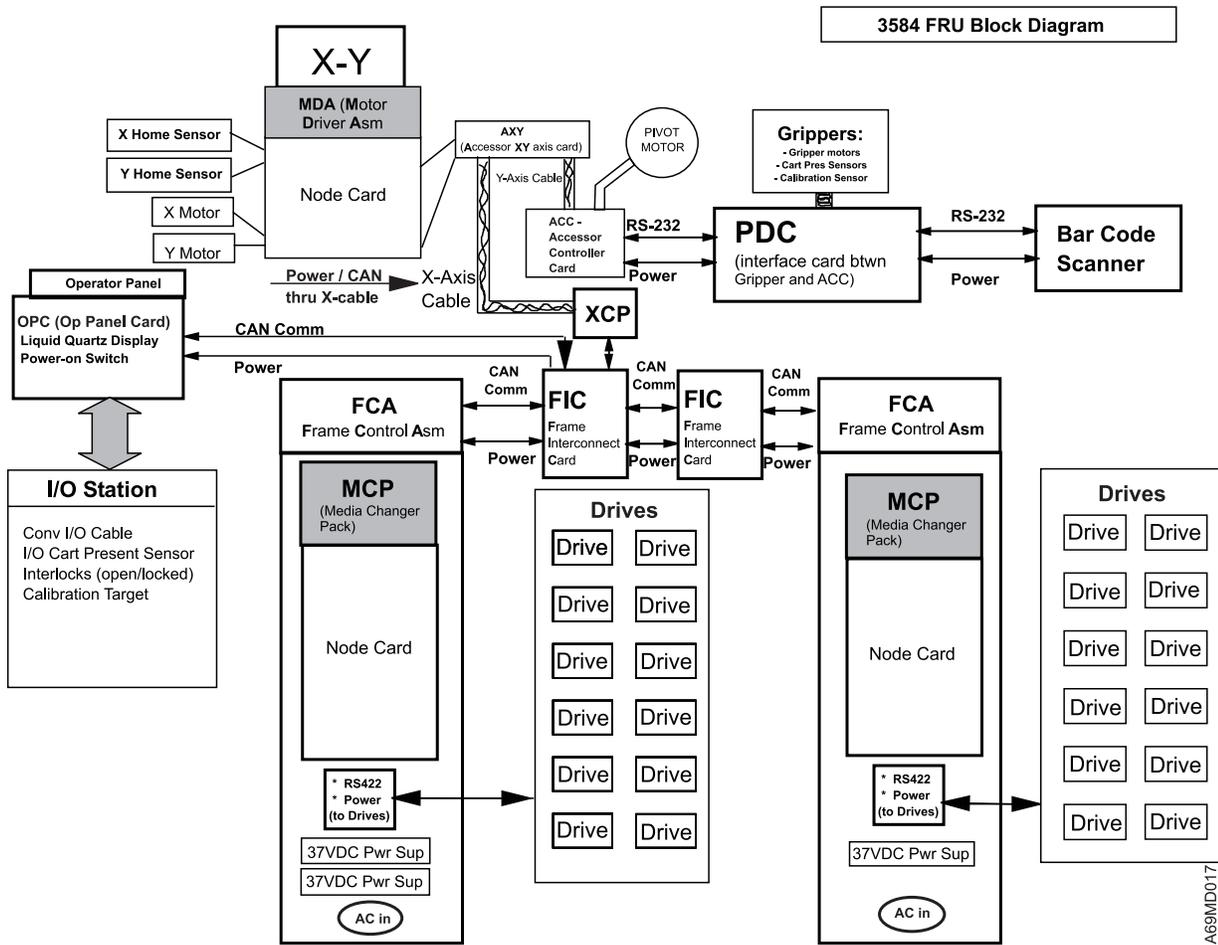
Figure 12. Cable Overview – FRU Block Diagram

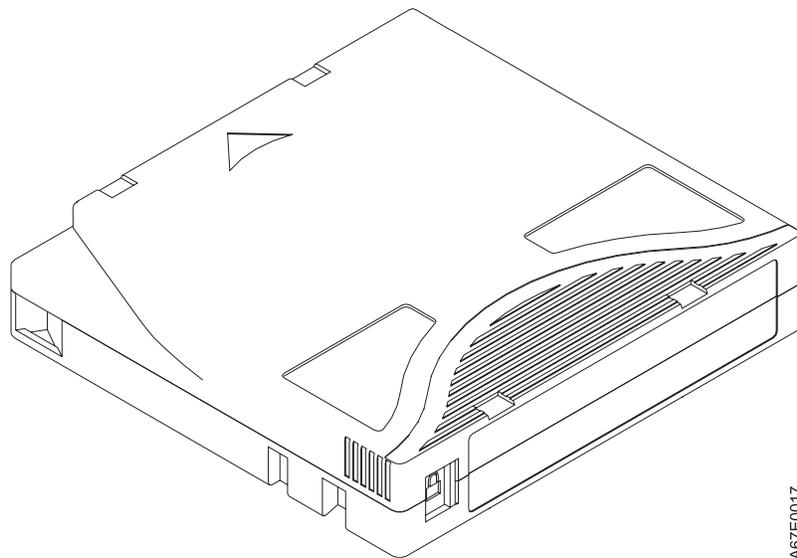
Figure 13 shows the IBM LTO Ultrium Data Cartridge.

Figure 13. IBM LTO Ultrium Tape Cartridge

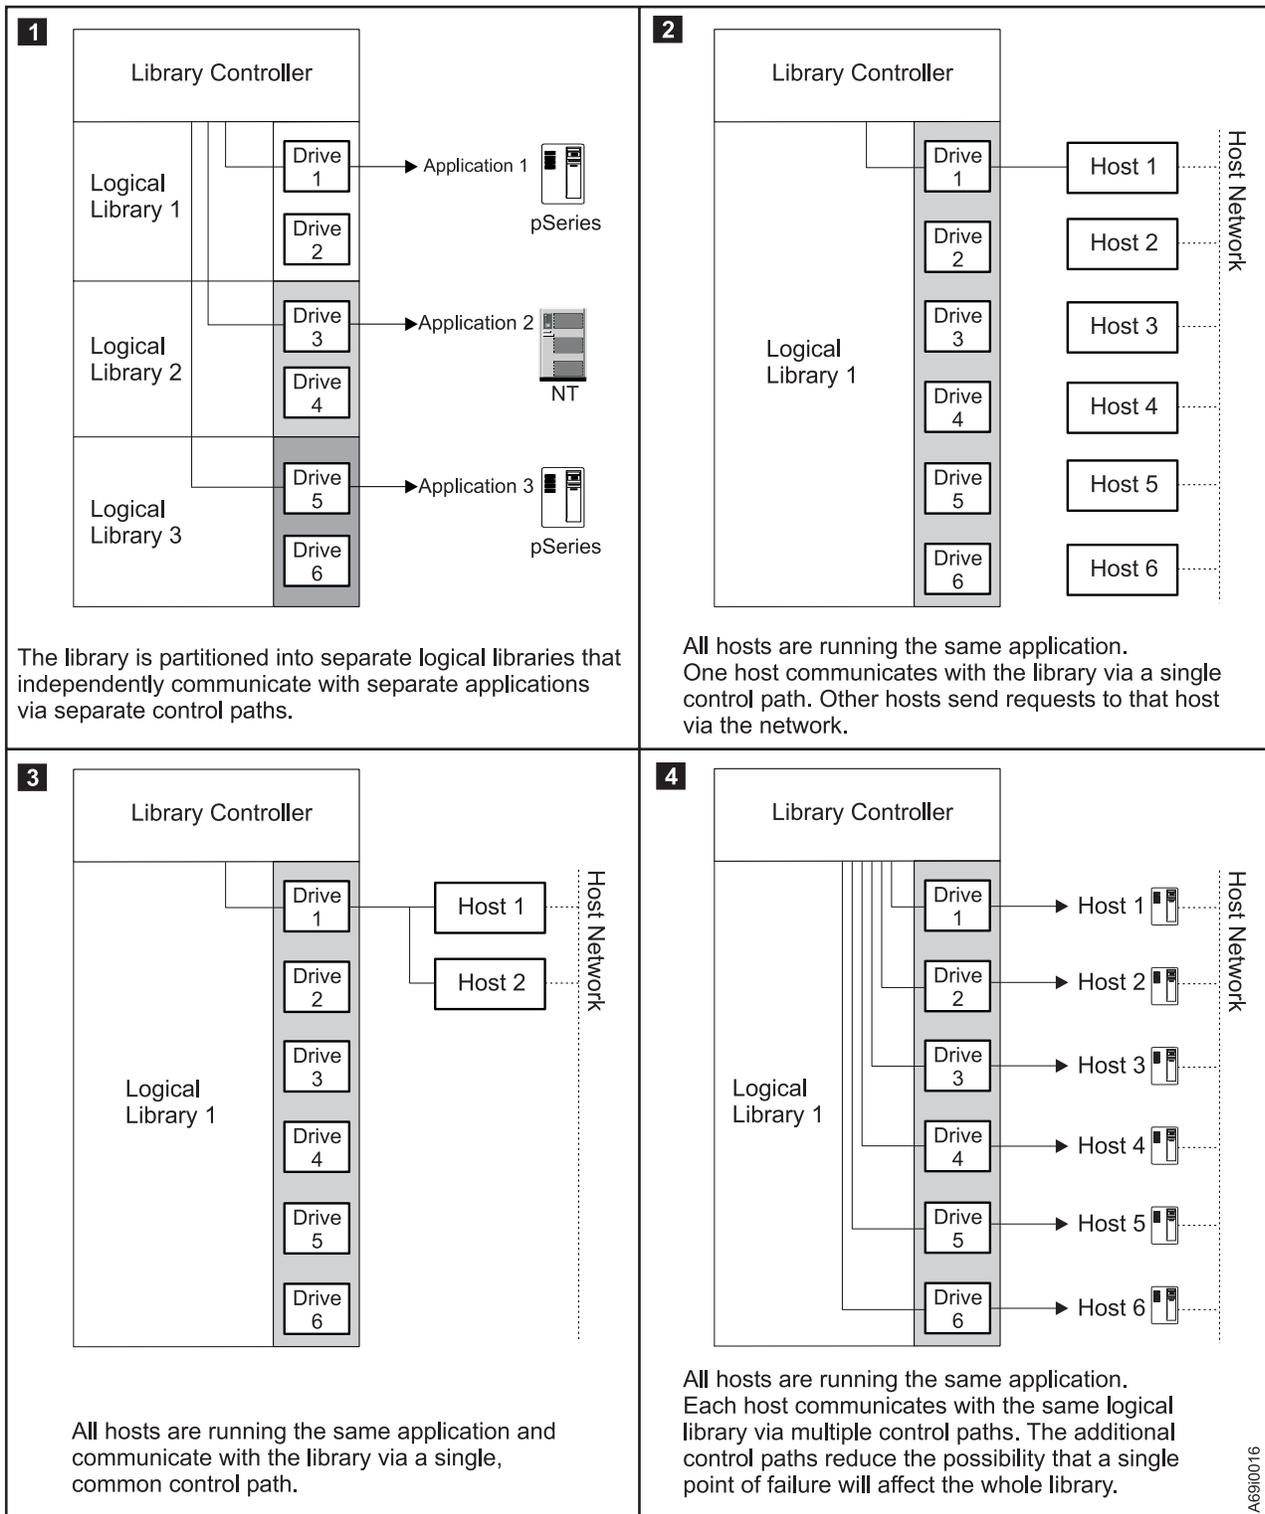
Figure 14. Sample Configurations

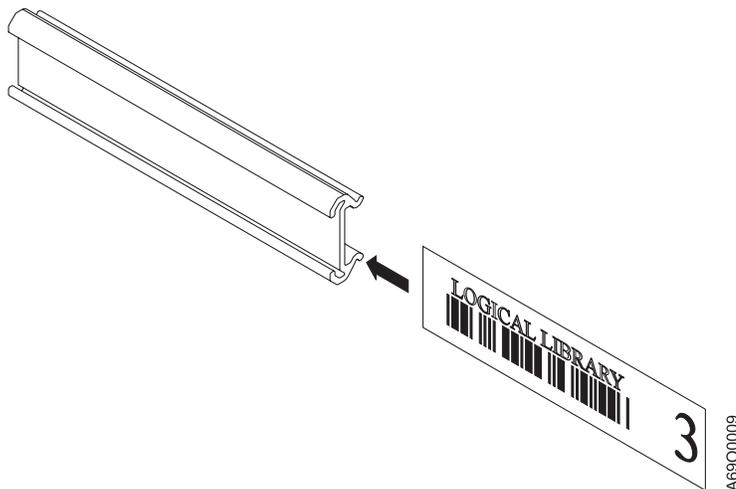
The customer may use logical library bar code labels to designate, then observe, the physical breakout of the logical libraries. Each IBM TotalStorage UltraScalable Tape Library 3584 comes with one sheet of 18 labels for each of 5 logical libraries and 6 holders for logical library labels. A sample label and holder are shown in Figure 15.

Figure 15. Sample Label and Holder

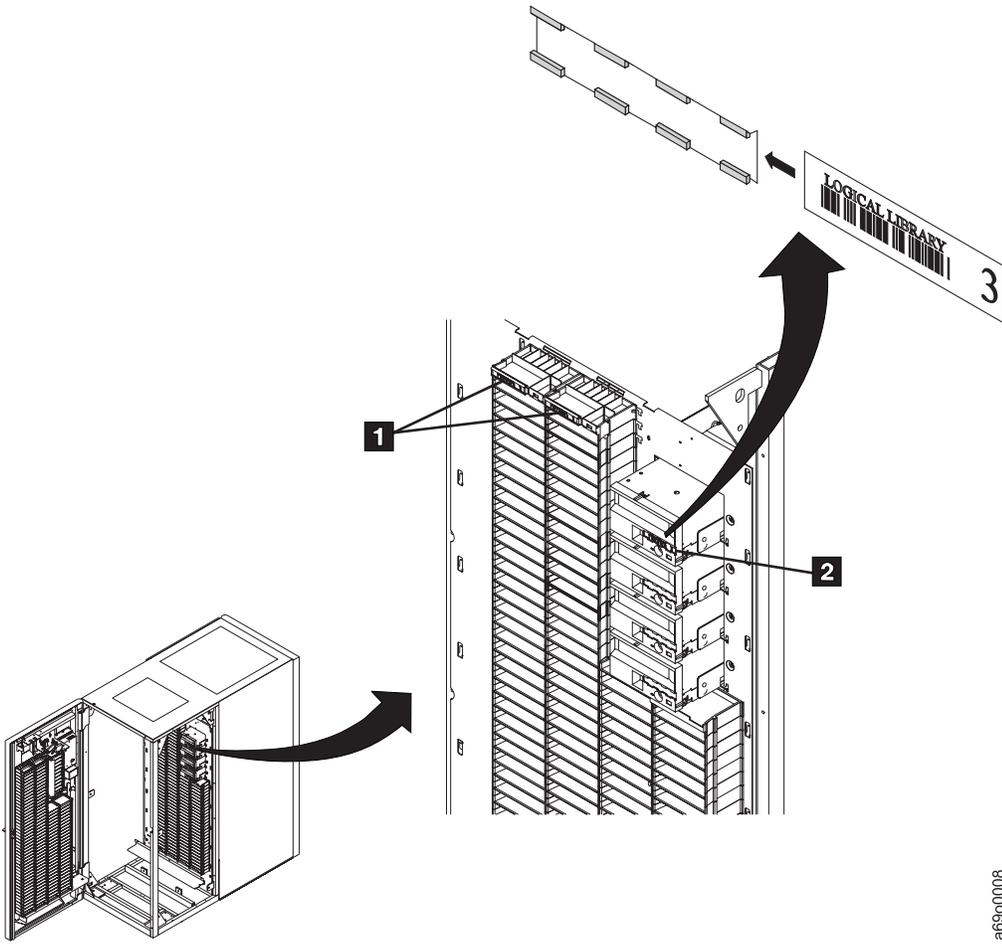
Examples of label and holder placements in the IBM TotalStorage UltraScalable Tape Library 3584 are shown in Figure 16 on page 42.

Figure 16. Sample Label and Holder Placement

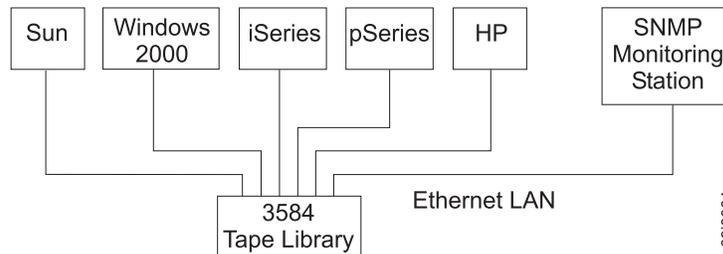
Occasionally, the library may encounter a situation that you want to know about, such as an open door that causes the library to stop. Because many servers can attach to the TotalStorage UltraScalable Tape Library 3584 by differing attachment methods, the library provides a standard TCP/IP protocol called Simple Network Management Protocol (SNMP) to send alerts about conditions (such as an opened door) over a TCP/IP LAN network to an SNMP monitoring station. These alerts are called SNMP traps. Using the information supplied in each SNMP trap, the monitoring station (together with customer-supplied software) can alert operations staff of possible problems or operator interventions that occur. Figure 17 shows the flow of SNMP traps over the Ethernet local area network (LAN) to an SNMP monitoring station.

Figure 17. The SNMP Messaging System. The TotalStorage UltraScalable Tape Library 3584 issues SNMP traps to a monitoring station.

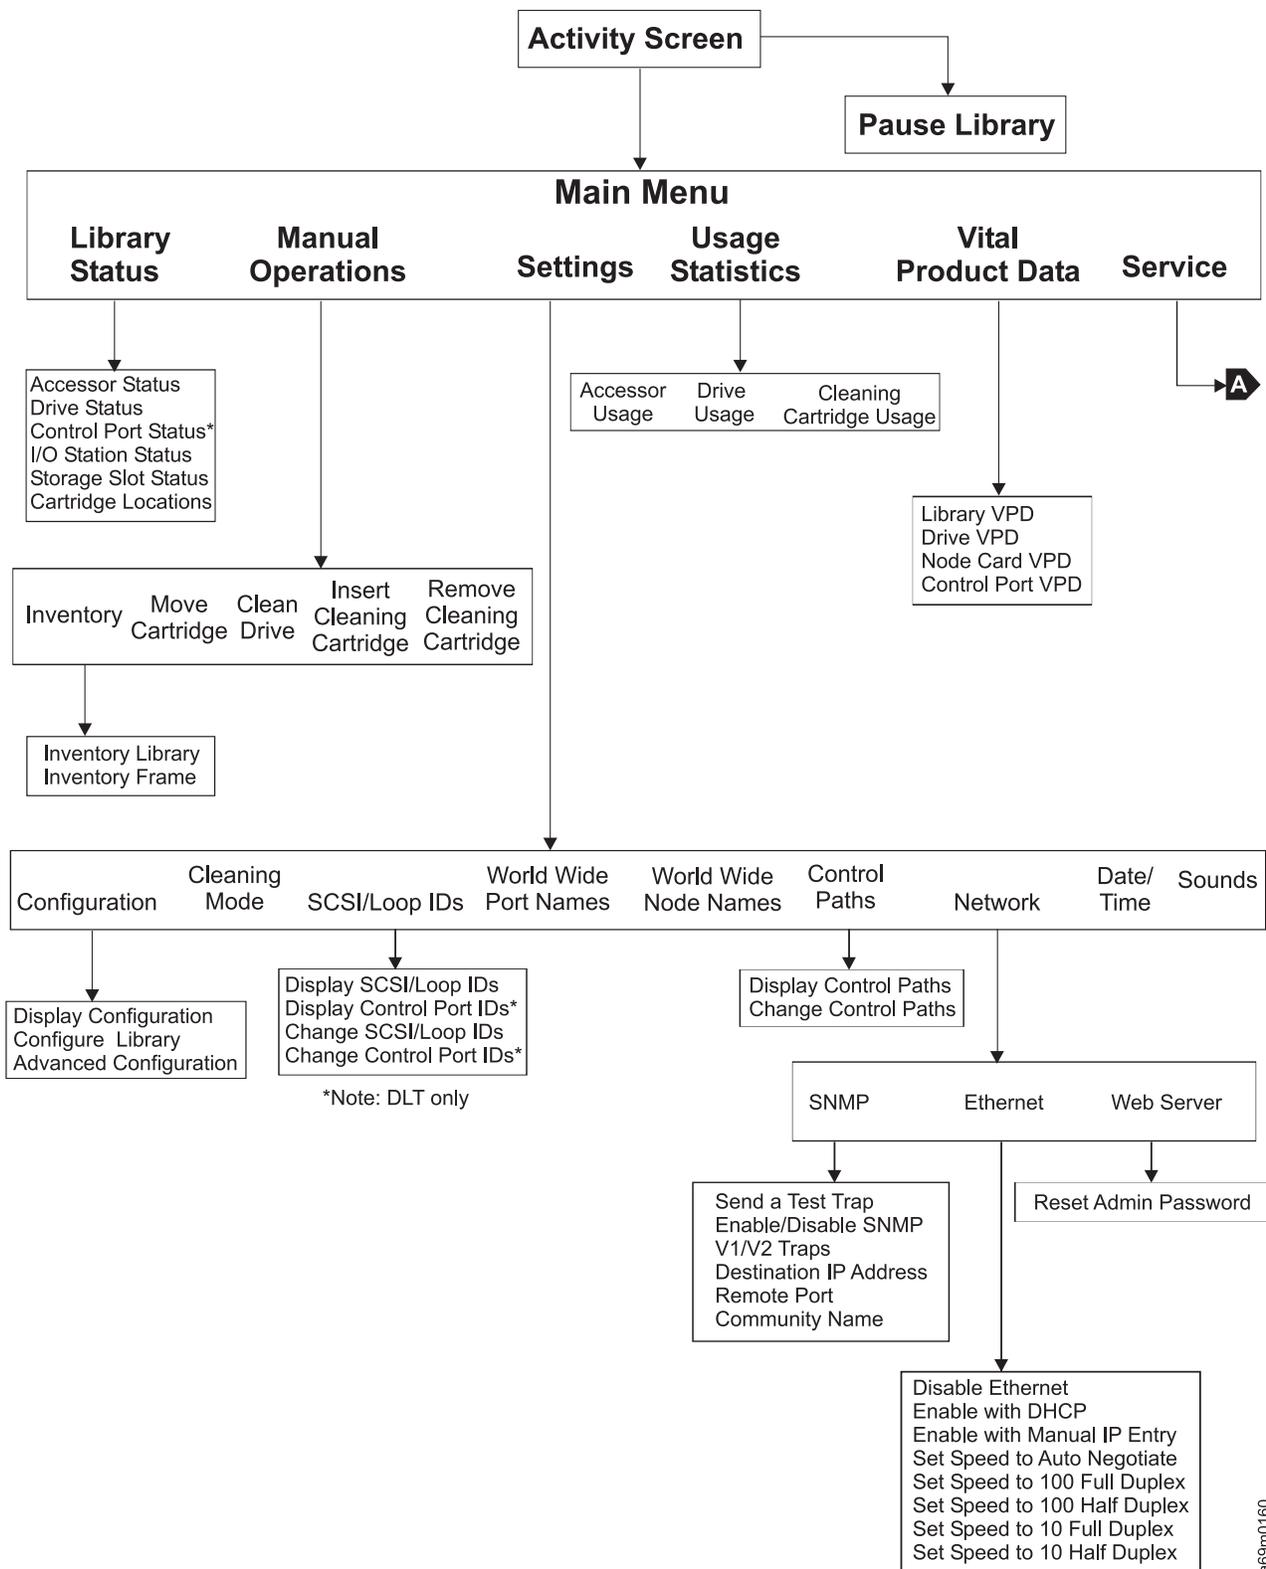
Figure 18 on page 60 provides an overview of operator functions. Figure 19 on page 61 and Figure 20 on page 62 together show an overview of service functions that are available to the service representative.

Figure 18. Operator Function Menu Tree
