IBM TotalStorage UltraScalable Tape Library 3584

Maintenance Information

Ninth Edition (June 2003)

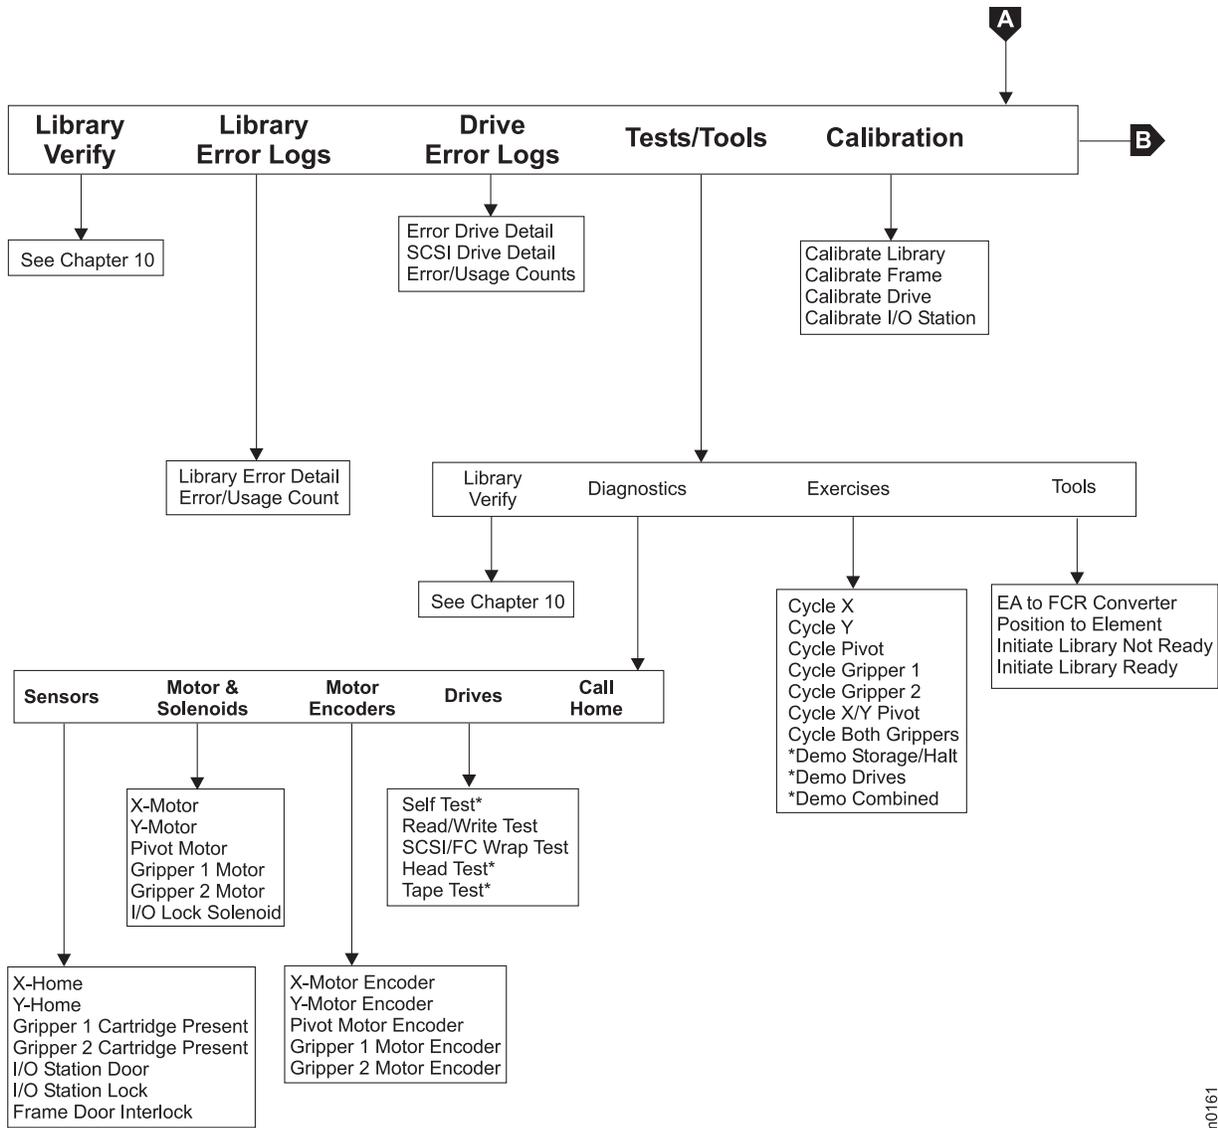
***Ultrium only**

Figure 19. Service Function Menu Tree

Figure 18 on page 60 provides an overview of operator functions. Figure 19 on page 61 and Figure 20 on page 62 together show an overview of service functions that are available to the service representative.

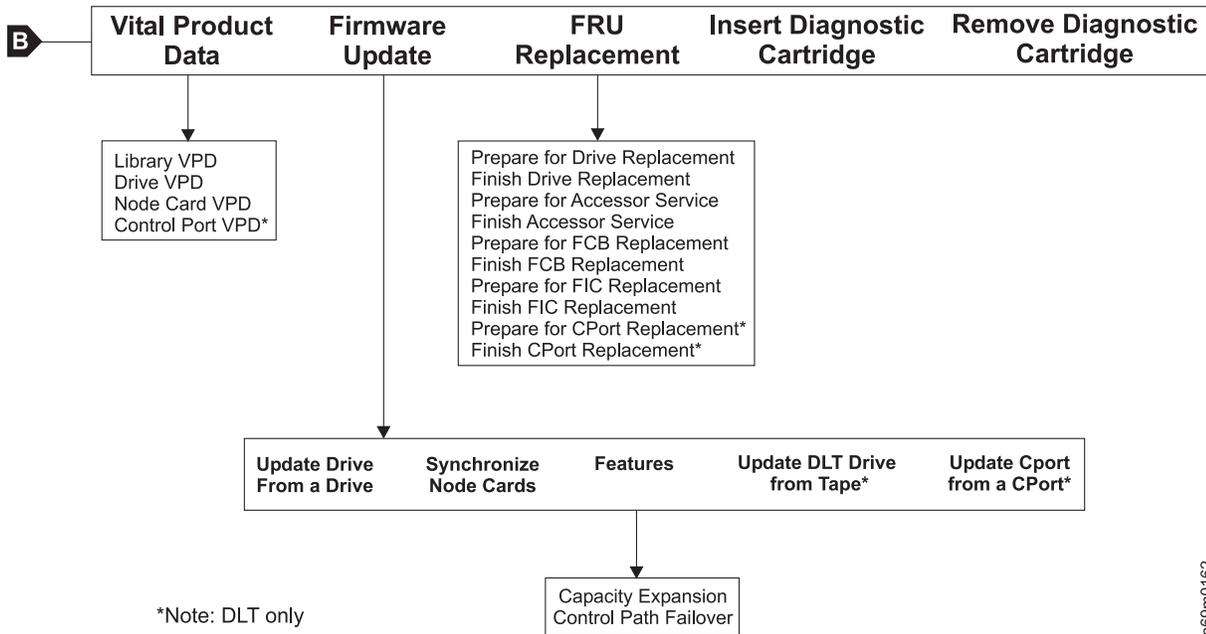
Figure 20. Service Function Menu Tree (Continued)

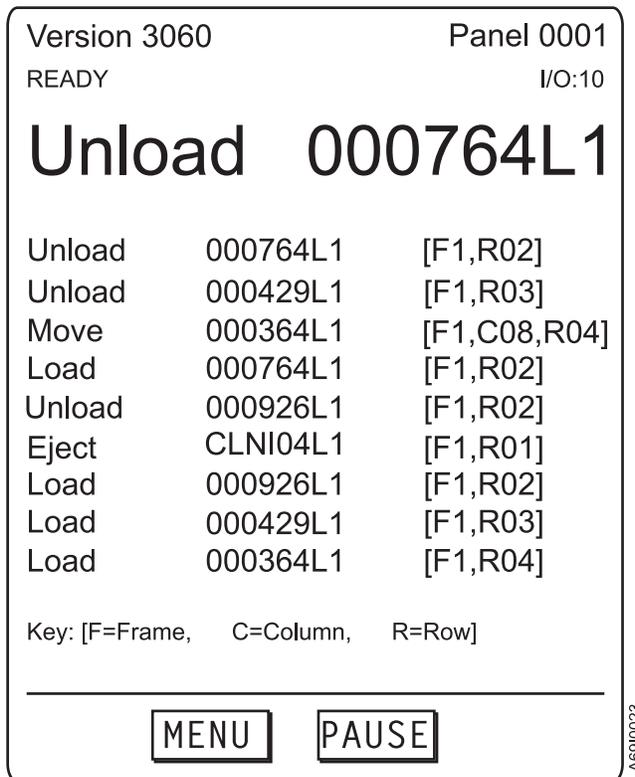
The Activity screen, that the operator sees during library operations will look similar to the example shown in Figure 21.

Figure 21. Activity Screen (Library Status Screen)

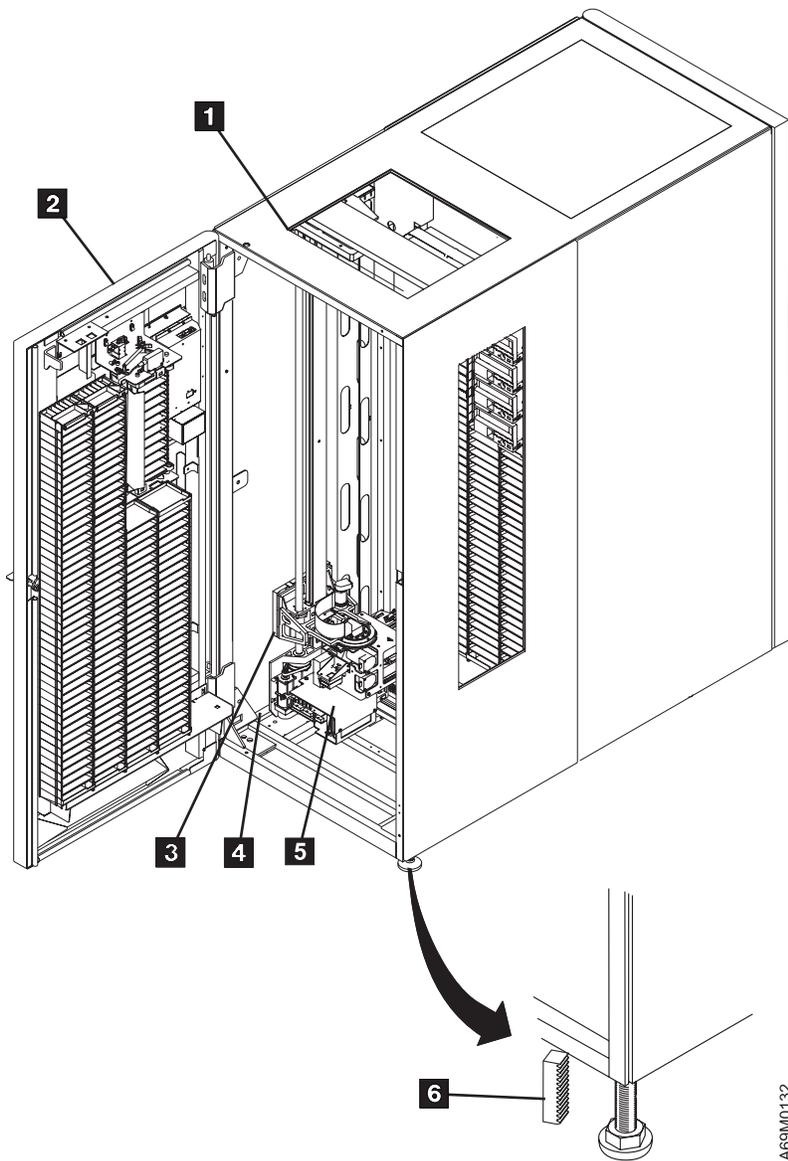
Note: When moving the picker assembly **3** vertically, lift the picker assembly from underneath the ACC card. To avoid damaging the gripper/pivot assembly, do not lift the picker assembly using the gripper.

Figure 28. Base Frame

Refer to Figure 28 on page 81 as you unpack the library:

- ___ 3. Move the base frame into position on the floor.
- ___ 4. Open the front door.
- ___ 5. Loosen the locknuts on the leveling pads and lower the leveling pads to the floor.
- ___ 6. Using the 5/16" hex bit (supplied with the base frame), adjust the leveling pads so that the clearance from the floor to the bottom of the frame is approximately 113 mm (4.5 in.) at all four corners of the base frame. The frame should be approximately level, and the casters must be off the floor. You may use the rack alignment tool P/N 50G0406 **6** as a floor-to-frame clearance gauge for your initial adjustment. The tool length is 84 mm (3.3 in.). Refer to Figure 28 on page 81.

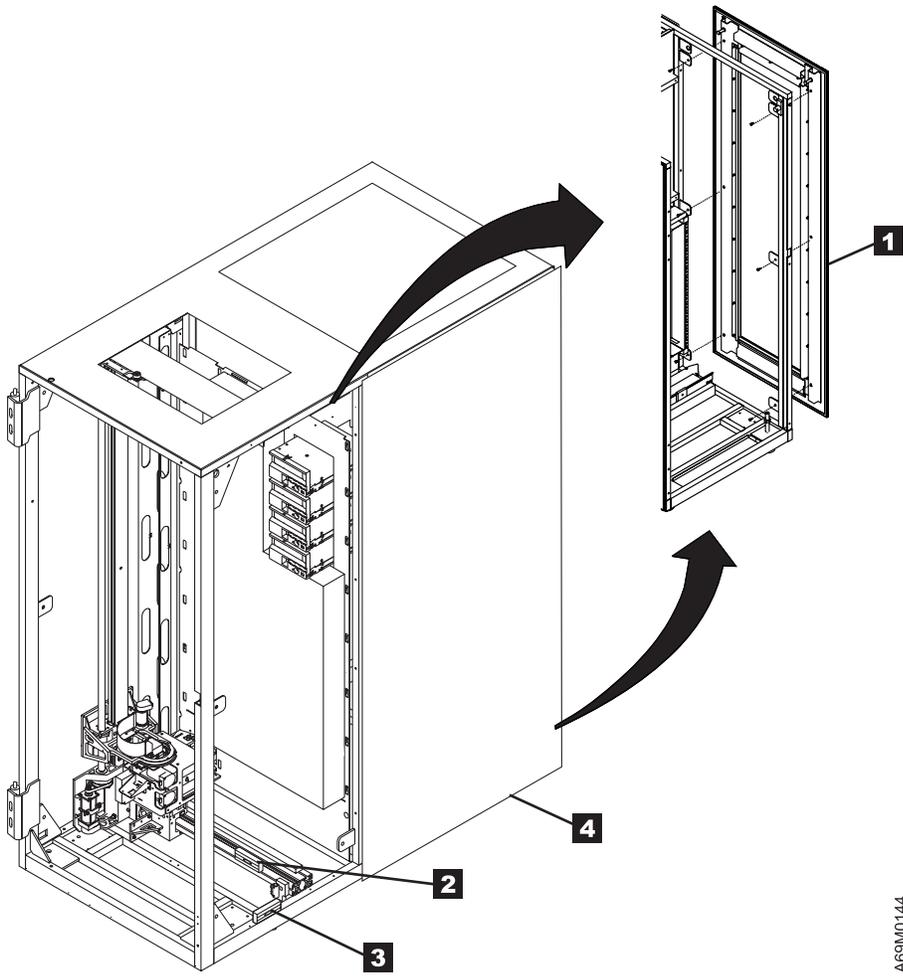
Figure 29. Leveling

- 4. See Figure 29 on page 83 and remove the right side cover **1** of the previous frame (if not already removed).

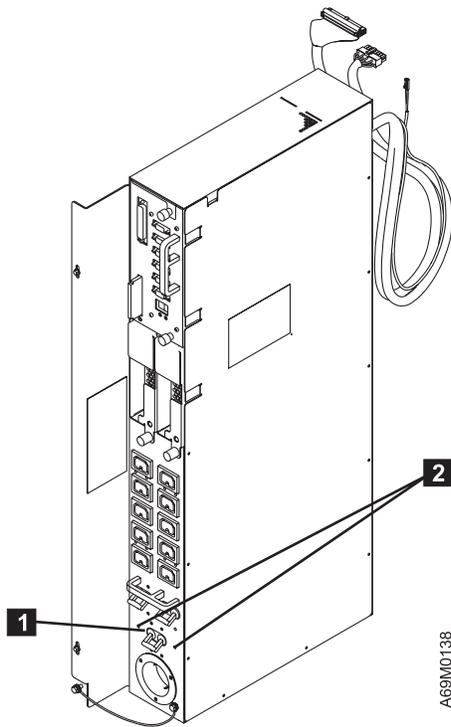
| **Note:** This will post an error 34A2 which should be ignored. When configuration is performed the library firmware will note that the L32 has only one PS and the D32 has one. After configuration is completed both power supplies will be enabled and no further errors will be generated.

Note: FC 1902 (Redundant 37V DC Power Supply) provides an additional (3rd or more) 37V DC power supply to the library. This Feature Code is intended for customers who wish to have this additional redundancy.

Figure 30. FCA Assembly

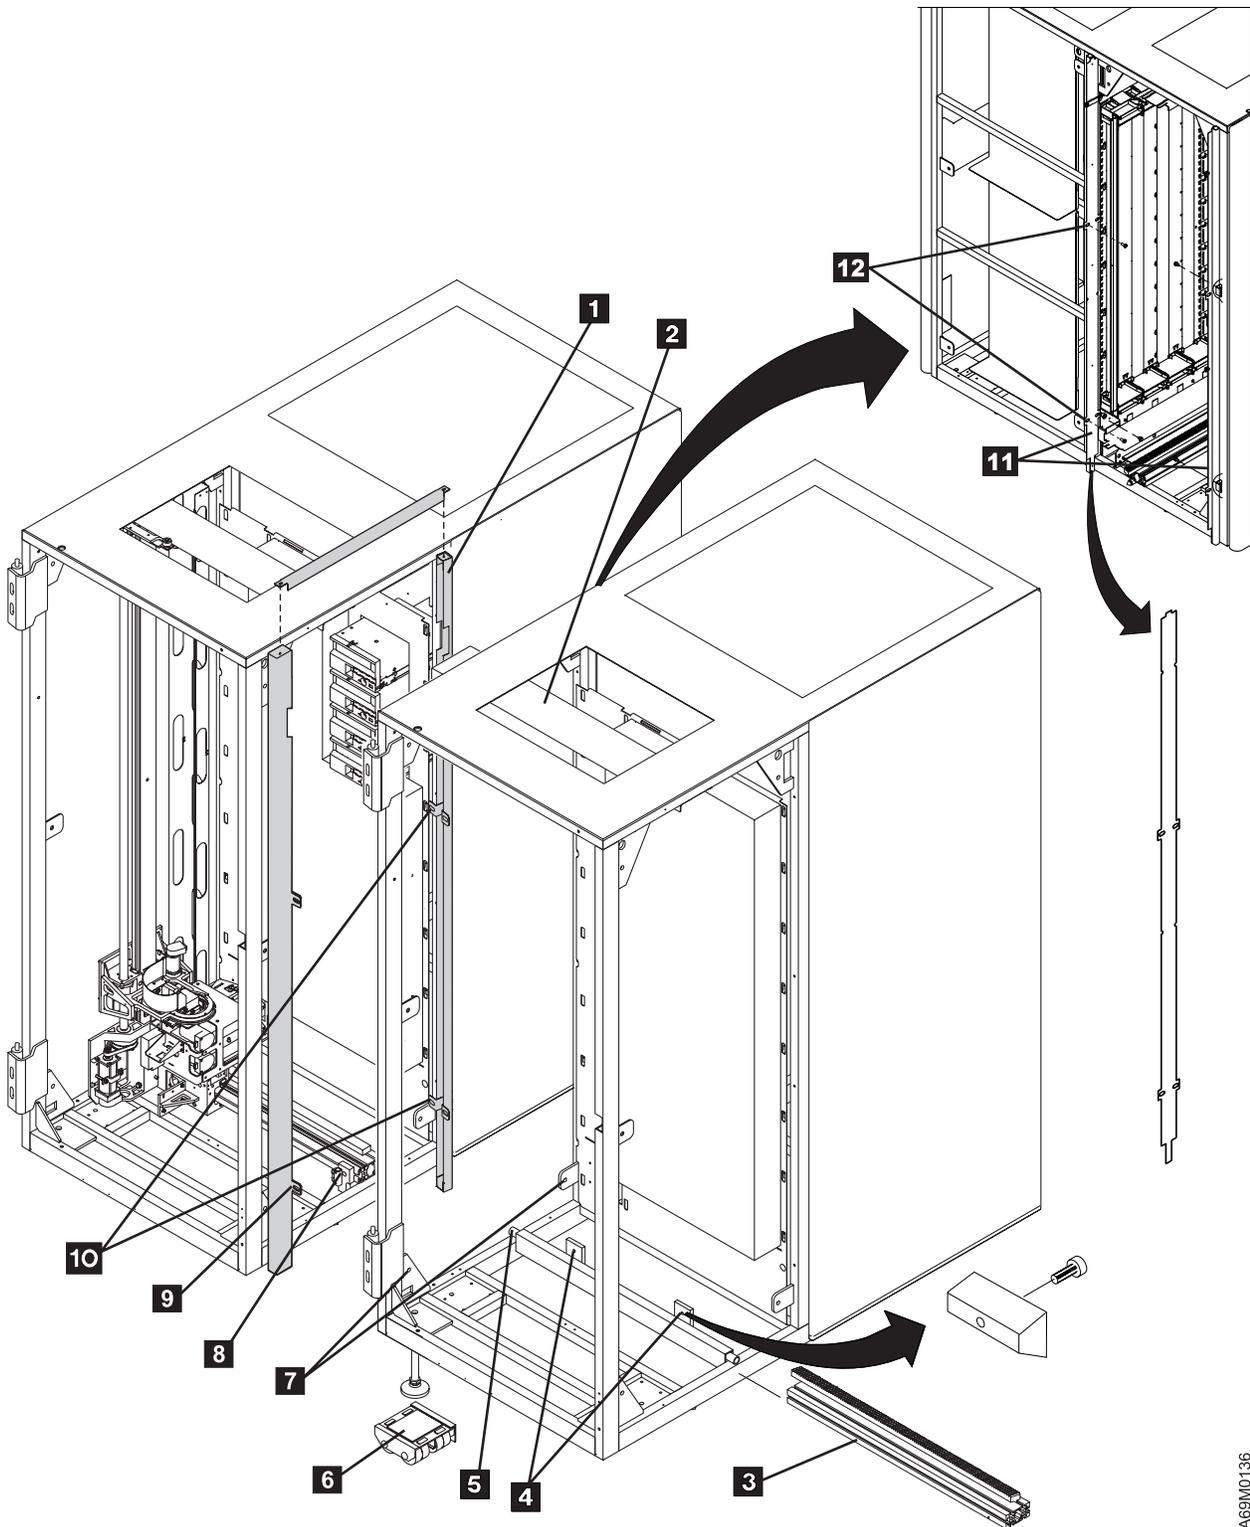
Figure 31. Frame-to-Frame Attachment (A). This figure will be repeated for the benefit of the CE.

- ___ 10. Refer to Figure 31 on page 86. Loosen the two short T-nuts **4** on the expansion frame and slide the lower X-rail **3** to the right about 15 cm (6 in.). This will prevent the rail from interfering when joining the two frames together. Retighten the two short T-nuts **4**.

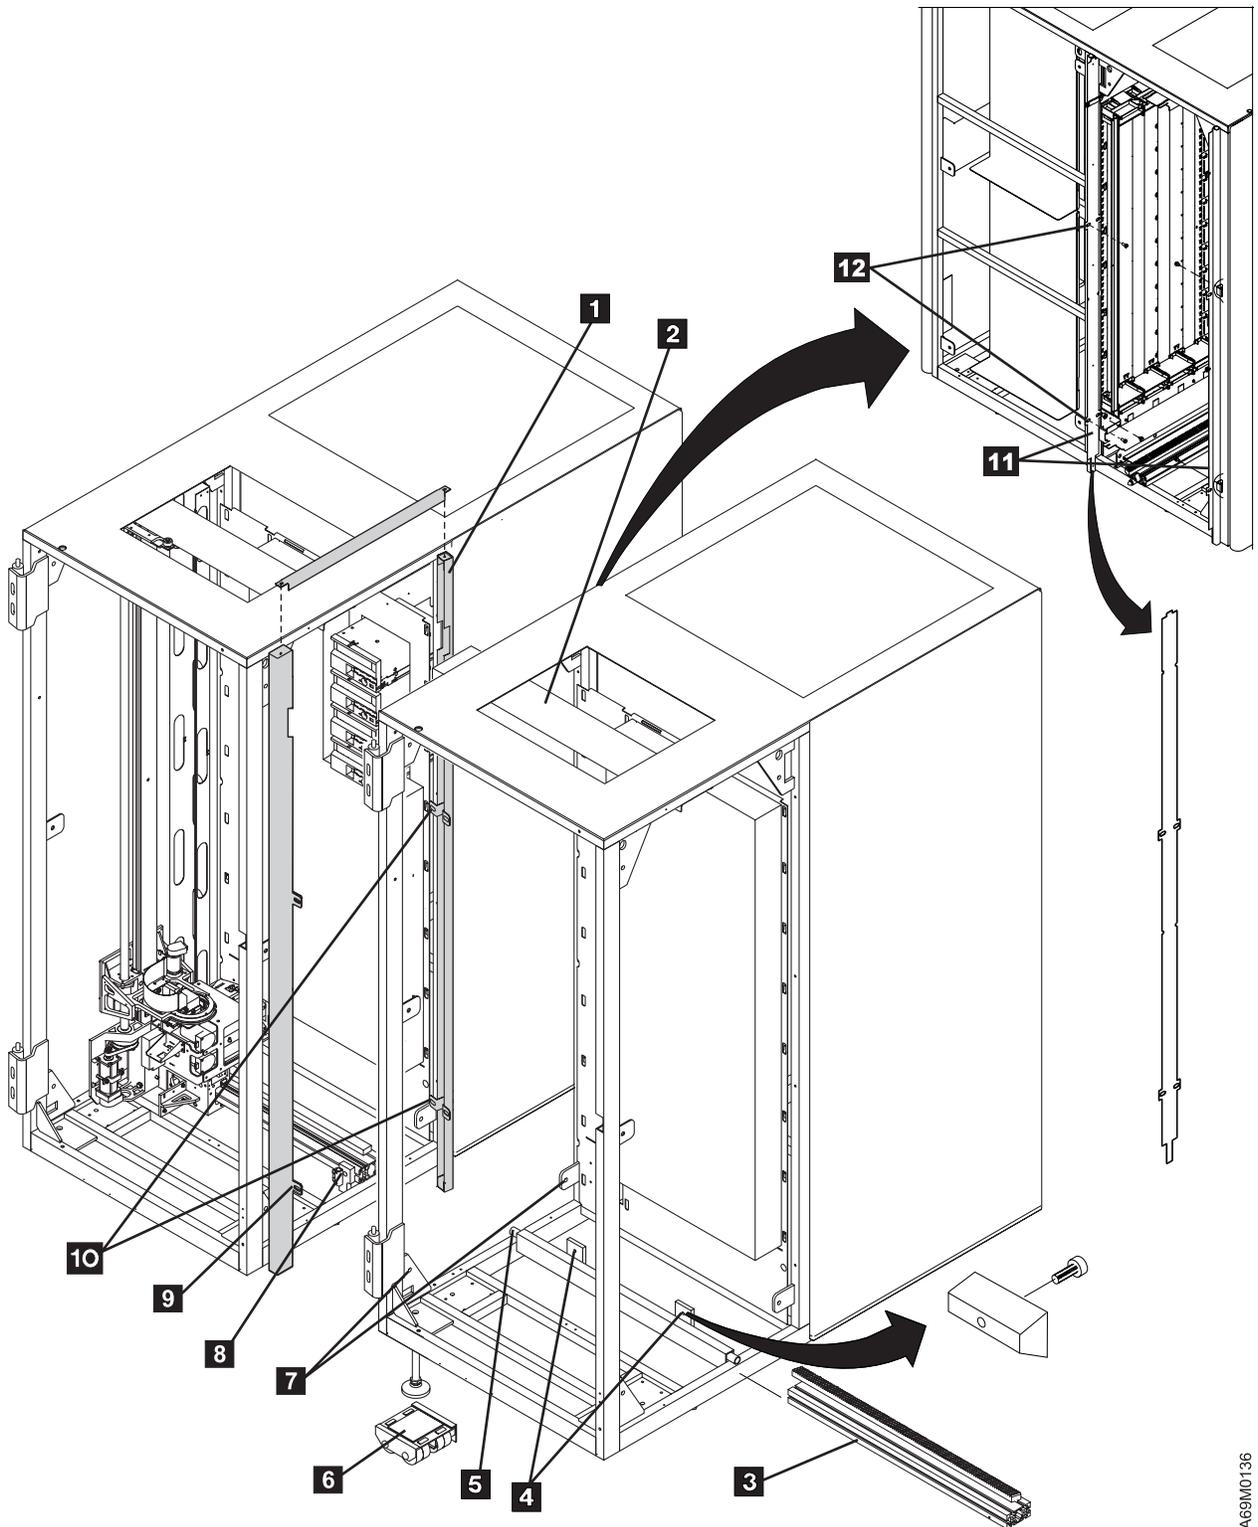
Figure 33. Frame-to-Frame Attachment (C). This figure is repeated for the benefit of the CE.

- ___ 17. Refer to Figure 33 on page 91. Carefully push the expansion frame against the previous frame until the alignment rod **5** is fully seated in the hole of the previous frame. The front cover of the frame you are installing should be parallel to the front cover of the previous frame.

- ___ 25. **Refer to Figure 33 on page 91.** Tighten the two M8 bolts located in bottom corners **7** of the accessor aisle until they are just snug. **Do not overtighten and bend the tabs.**

- ___ 53. Refer to Figure 33 on page 91 on earlier-style frames only, connect frame spacers **1** and **9** to the previous frame by installing screws into the frame spacer mounting slots **10**. On later-style frames only, connect frame spacers **11** to the previous frame by installing screws into the frame spacer mounting slots **12**.

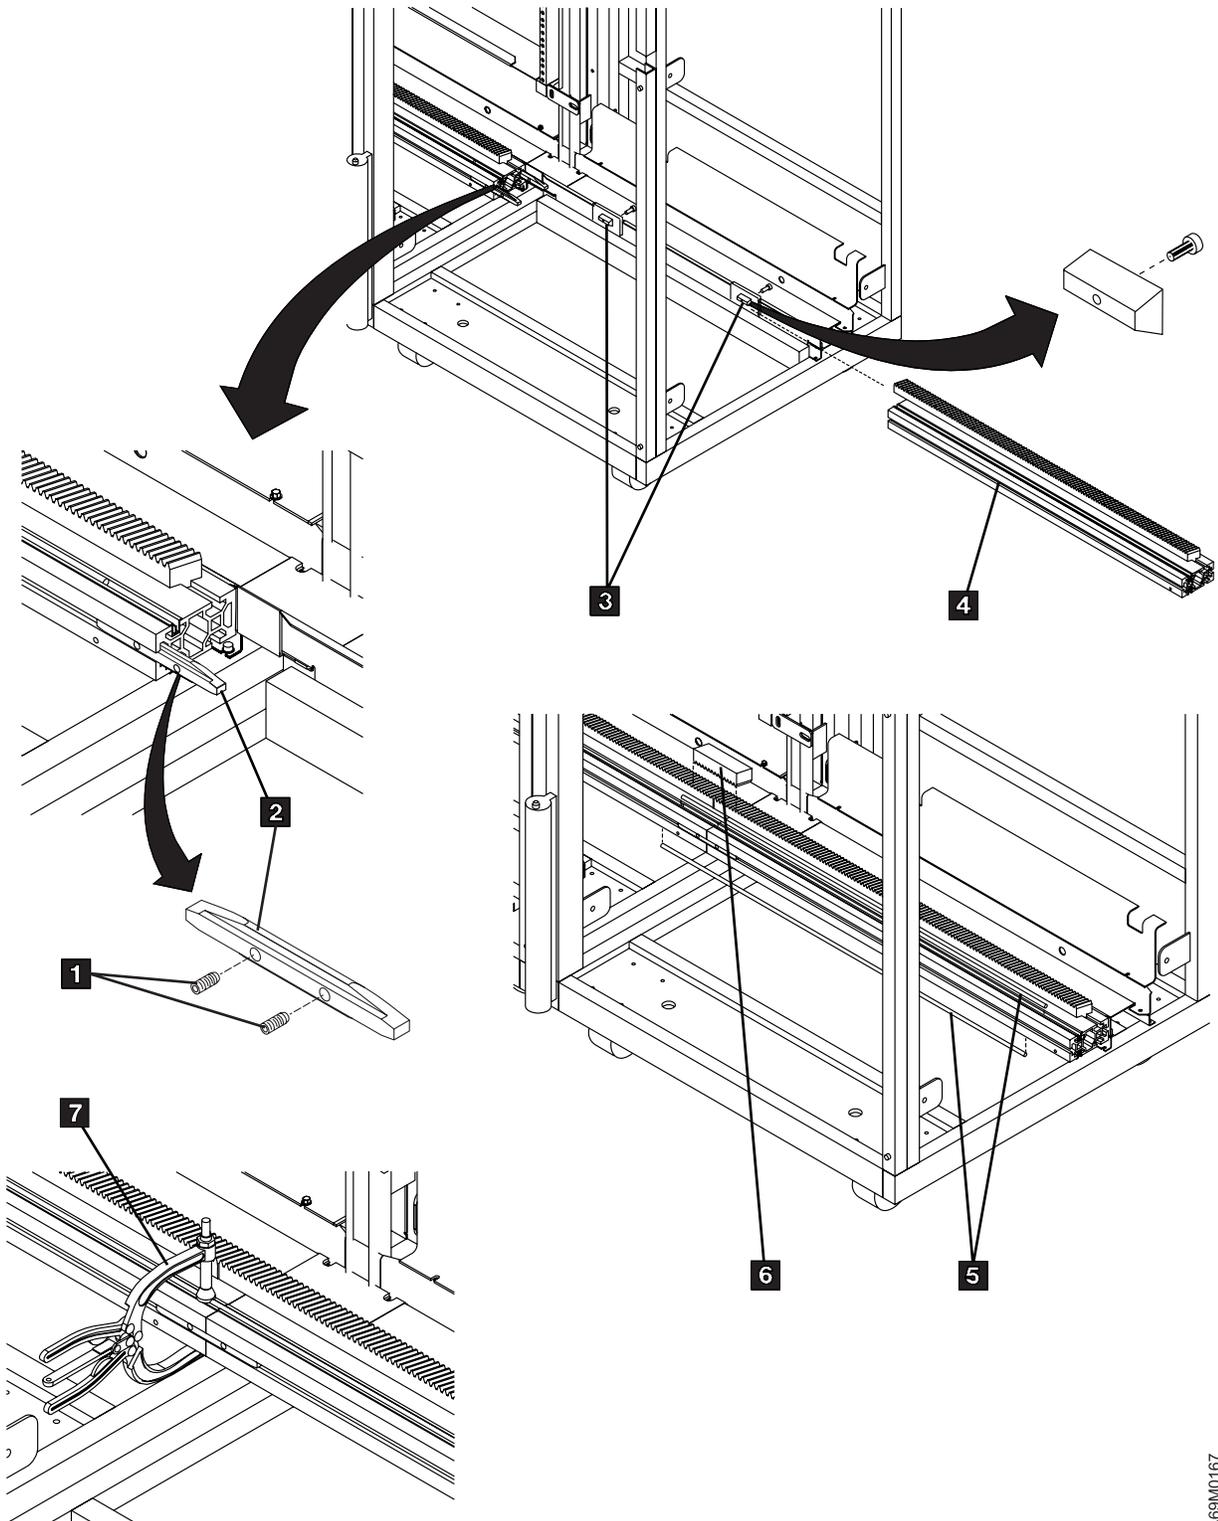
Figure 34. Base Frame with Expansion Frame

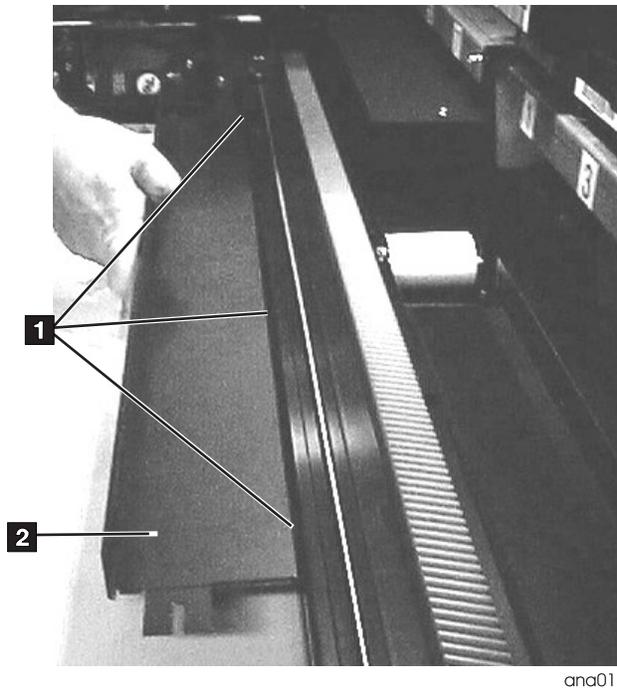
Figure 35. X-Rail Alignment Check

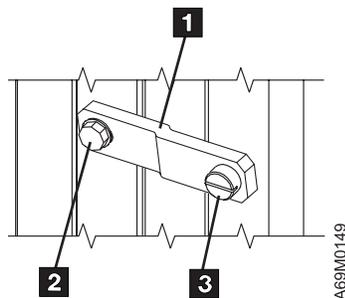
- ___ 51. Refer to Figure 36. Locate the three frame-to-frame attachment brackets **1** that are factory-mounted on the left side of the expansion frame. Locate screws **2** P/N 1624790 provided in the ship group. You will install them in the following steps.

Figure 36. Expansion Frame Attachment Bracket – Positioning

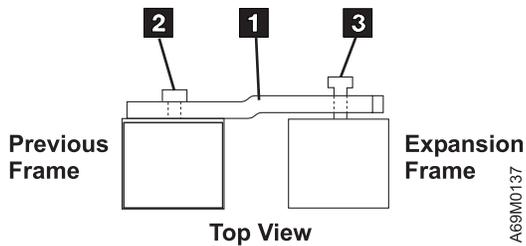
- ___ 52. Refer to Figure 37 on page 96. Connect a frame-to-frame attachment bracket **1** near the top of the front vertical frame, connecting the expansion frame to the previous frame.

- a. The slotted side of the bracket **1** must be on the previously-installed frame. **Note:** Factory installed.
- b. The screw **3** and bushing (or the shoulder screw on some machines) must be installed in the round hole. **Note:** Factory installed.
- c. The remaining screw **2** must be installed in the slotted hole.

Figure 37. Expansion Frame Attachment Bracket – Offset

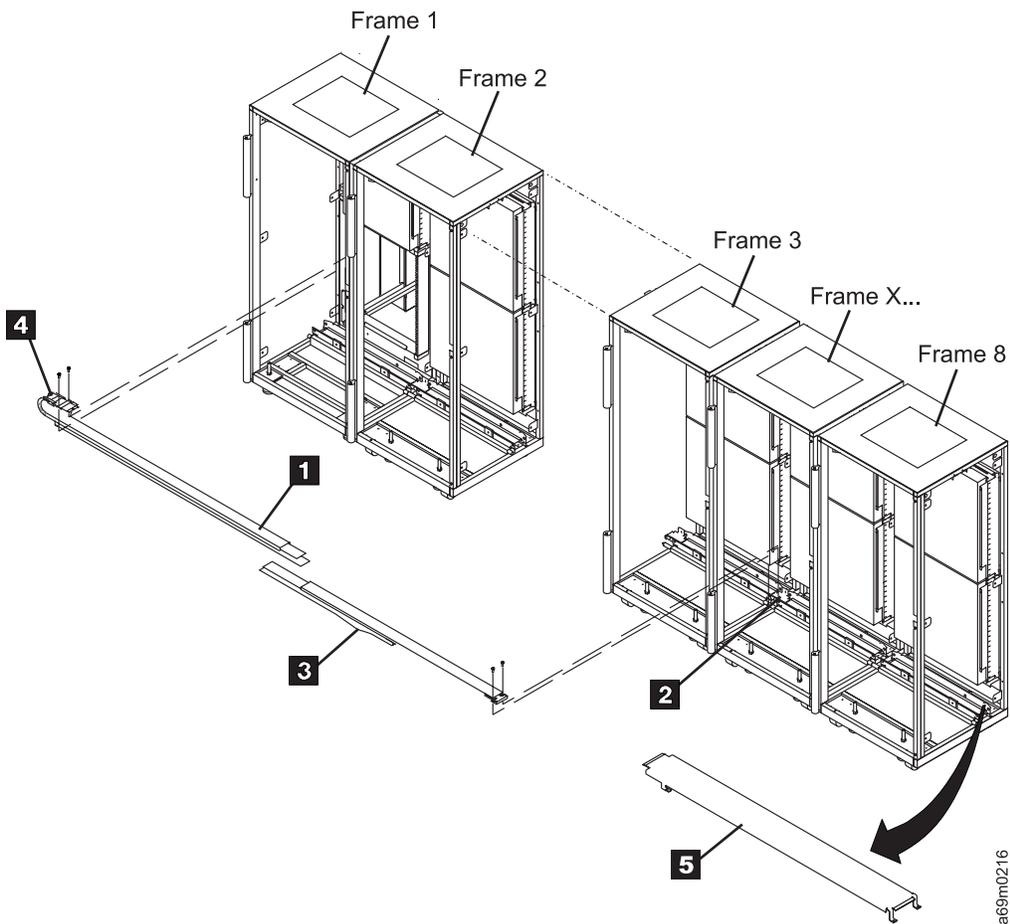
Figure 38. X-Cable Frame Attachment

- ___ 55. Refer to Figure 38 on page 97. Lay the X-axis cable **4** in the cable trough **2**. Position the end with the plastic track (plastic track up **1**) at the left end of frame 1, with the connector for the accessor AXY card protruding out the left end approximately 300 mm (12 in.).

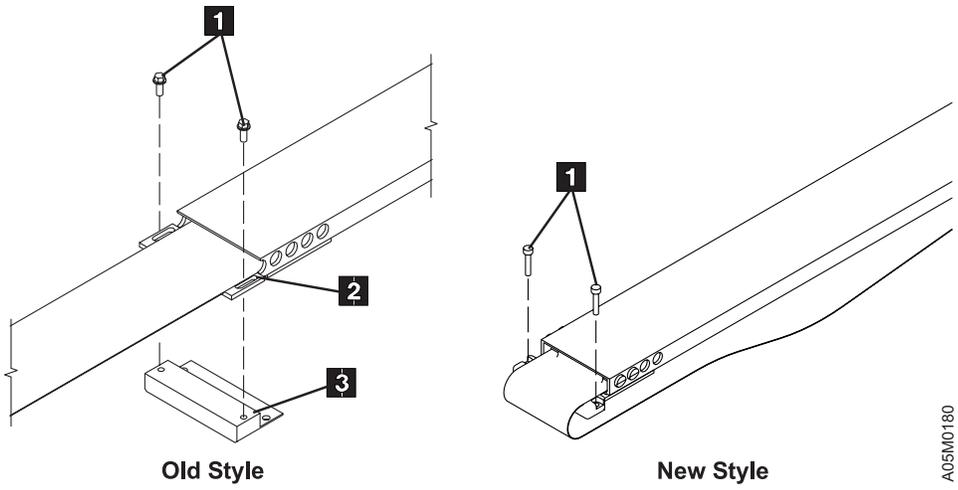
Figure 39. Cable Mounting (Old and New Style)

- ___ 58. Attach the mid-cable end of the cable track **5** to the trough by following these steps:
 - a. Refer to Figure 39 on page 98 and Figure 40 on page 99 to determine if you have the **OLD** or **NEW** style track cable.

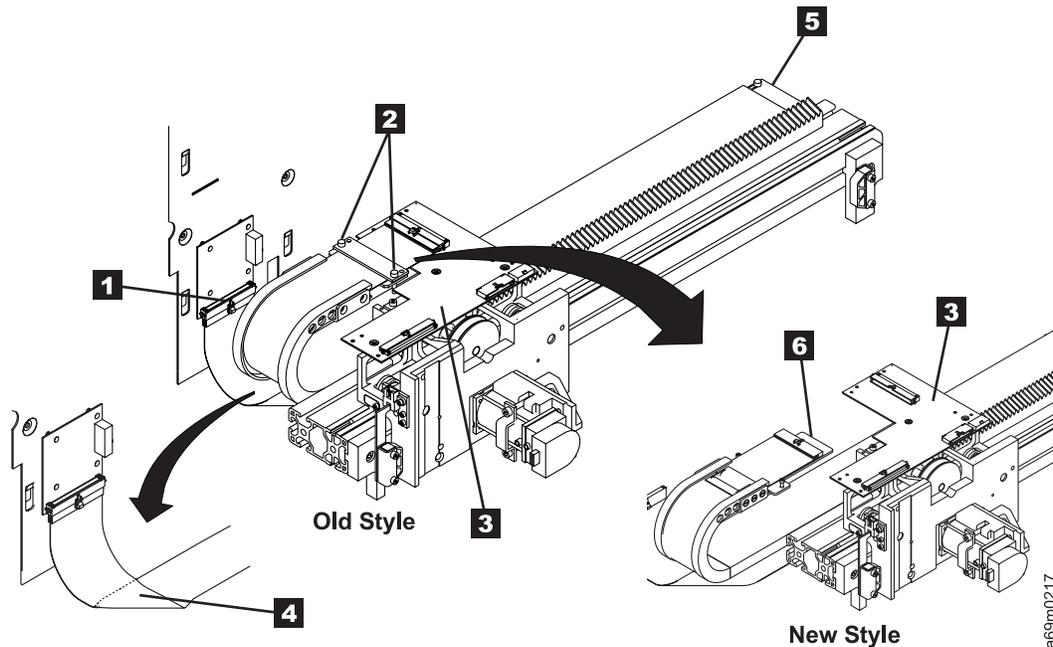
Figure 40. X-Cable to AXY Connections

- ___ 57. Refer to Figure 40 on page 99. Fold the XCP-card end of the X-axis cable **4** toward the rear wall (XCP card) and under the trough. Plug the cable into the XCP card **1**.

- ___ 60. Refer to Figure 40. Move the accessor over the X-axis cable. Loop the accessor end of the cable around the end of the accessor (as shown) and plug it into the AXY card **1**. On the **old style** cable, attach the X-axis cable bracket to the accessor with two screws **2** P/N 1621510. On the **new style** cable, slide the metal mounting plate **6** **under** the AXY card **3**. Plug the cable into the AXY card, then install two M3x10 screws **2** PN 05H1779 through the larger holes in the card and into the metal plate. Tighten screws securely.
- Track cable activities are now complete. Continue with the rest of the Installation.

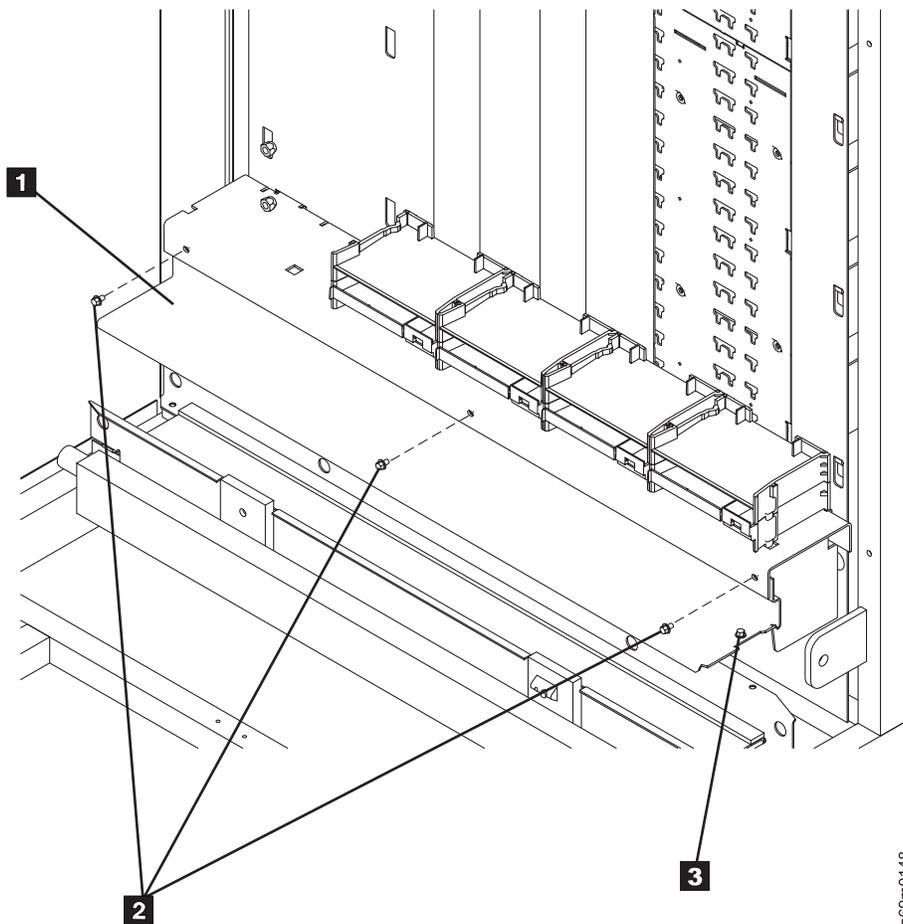
Figure 41. Cable Trough Cover

- ___ 62. See Figure 41. Use screws P/N 1624764 **2** to install the X-rail cable trough covers P/N 35L0192 (L32), P/N 35L0185 (D32 or D42) **1** .

Note: Early level trough covers connect to the previous trough cover with a short screw **3** . If you are installing an early level trough cover with a short screw **3** , ensure that the screw does not protrude below the trough cover since it could damage the X-axis flex cable. If it protrudes below the trough cover you must add a washer under the head of the screw to ensure it does not protrude below the trough cover. Later level trough covers will use a tab and slot to connect to the previous trough cover. No short screw **3** is needed for later level trough covers.

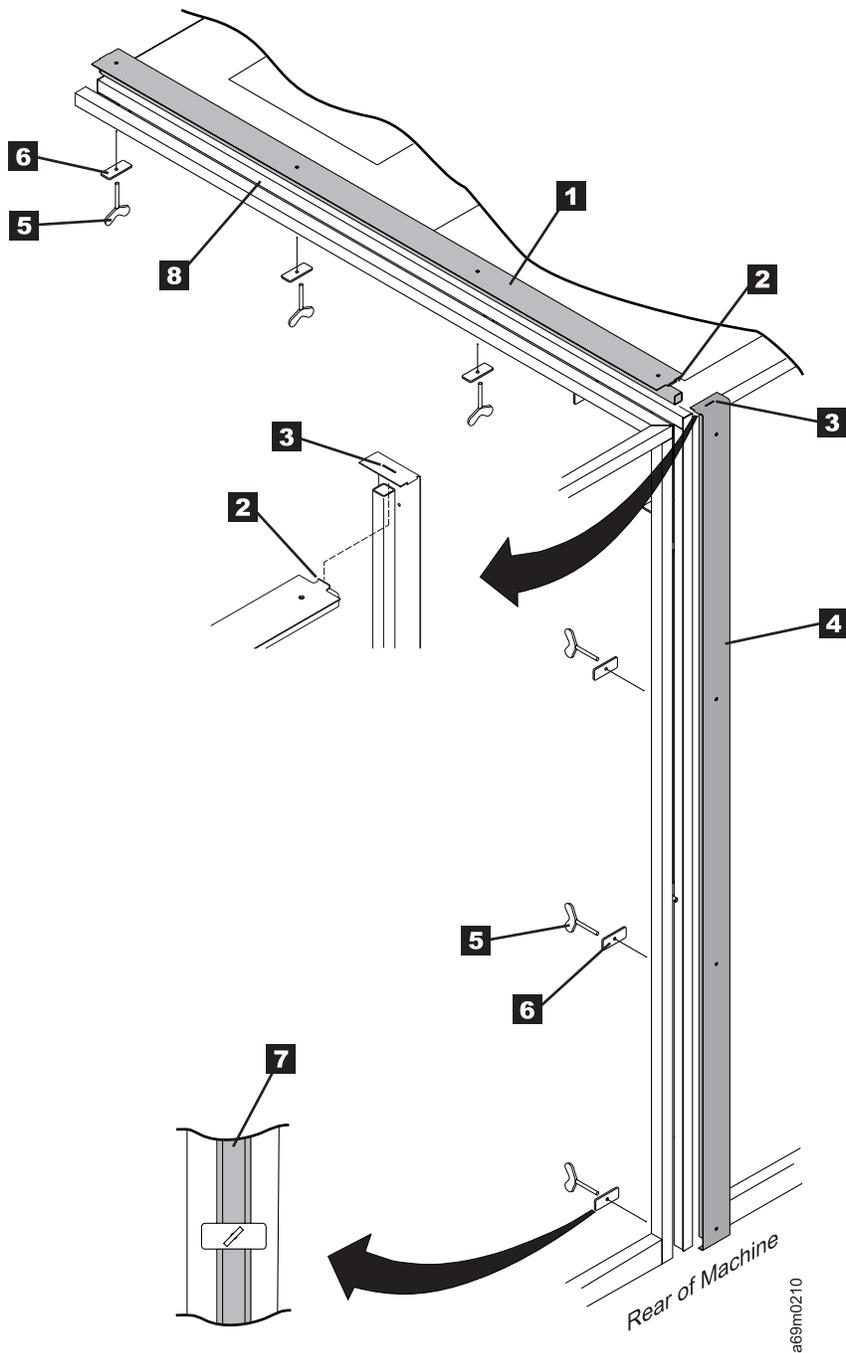
Figure 42. Expansion Frame Spacers

- ___ 63. If you installed a **later-style expansion frame**, refer to Figure 42 and use the following procedure to install two RFI seals:
- The RFI seals **1** and **4** were shipped with the retainer plates **6** and wing-screws **5** already installed.
 - Lay the top seal **1** in place between the frames **8**. Turn the retainer plates **6** so they drop between the frames.
 - On the rear seal **4**, remove the three retainer plates **6** and wing screws **5**.
 - Install the rear seal **4**, hooking the tab **2** on the top seal into the slot **3** on the rear seal.
 - Reinstall the three retainer plates **6** and wing-screws **5** in the rear seal as shown.

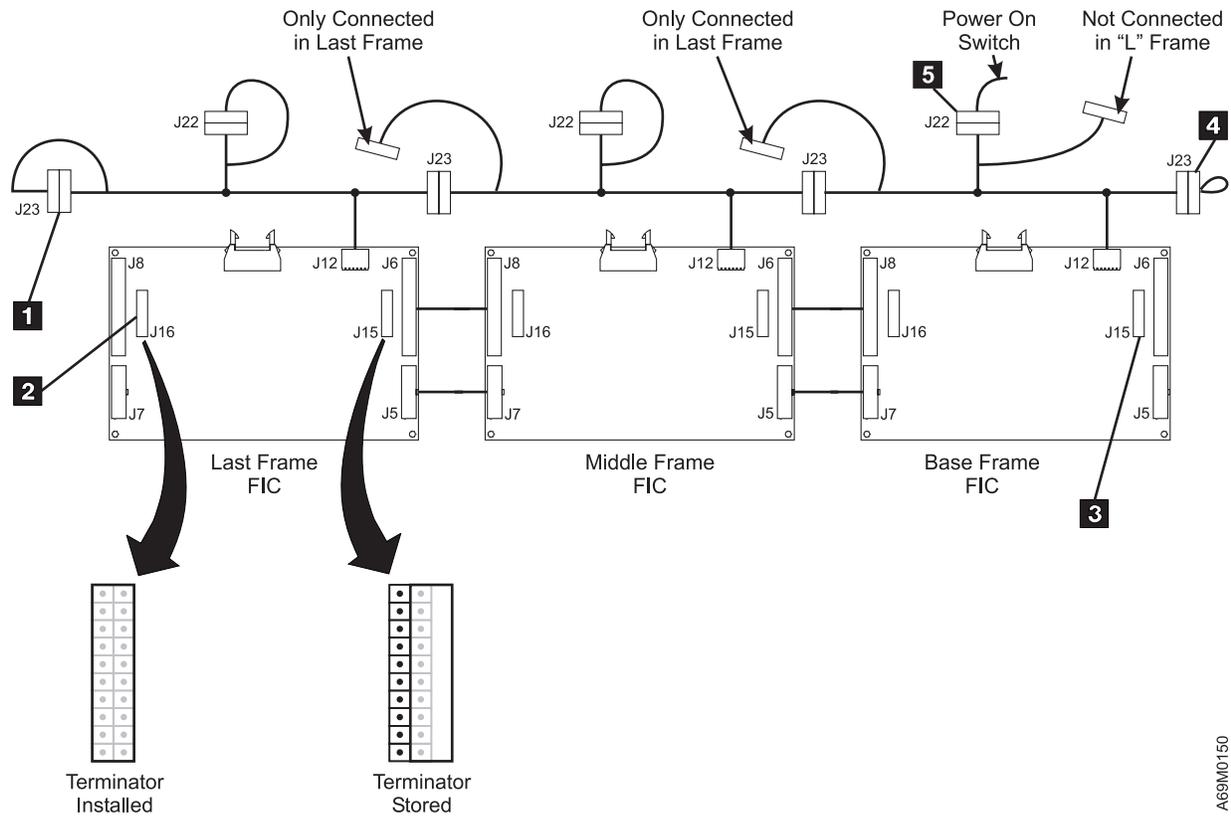
Figure 43. FIC Card Interface Cables Schematic. Three-Frame Example

- ___ 67. Refer to Figure 43 on page 103.
- ___ 68. Early-Style Frames: Thread the three (frame-to-frame) cables from the rear of the last frame (through the foam covered hole in the upper right corner of the frame bulkhead) to the front of the last frame.
- ___ 69. Thread the cables through the upper rear frame member into the previous frame and then into the rear of the previous frame. Continue threading cables from frame-to-frame, until all the frame cables are threaded.
- ___ 70. Later-Style Frames: Route and install the three (frame-to-frame) cables inside the rear of the frames (rather than out the accessor aisle and back in again).
- ___ 71. Connect interframe power cable from connector J5 of the FIC card in the rear of the last frame to J7 on the previous frame (for more details on FIC card connectors, see Figure 10 on page 32).

- ___ 73. Refer to Figure 43 on page 103. Connect interframe EPO cable connectors P23 on the previous frame.

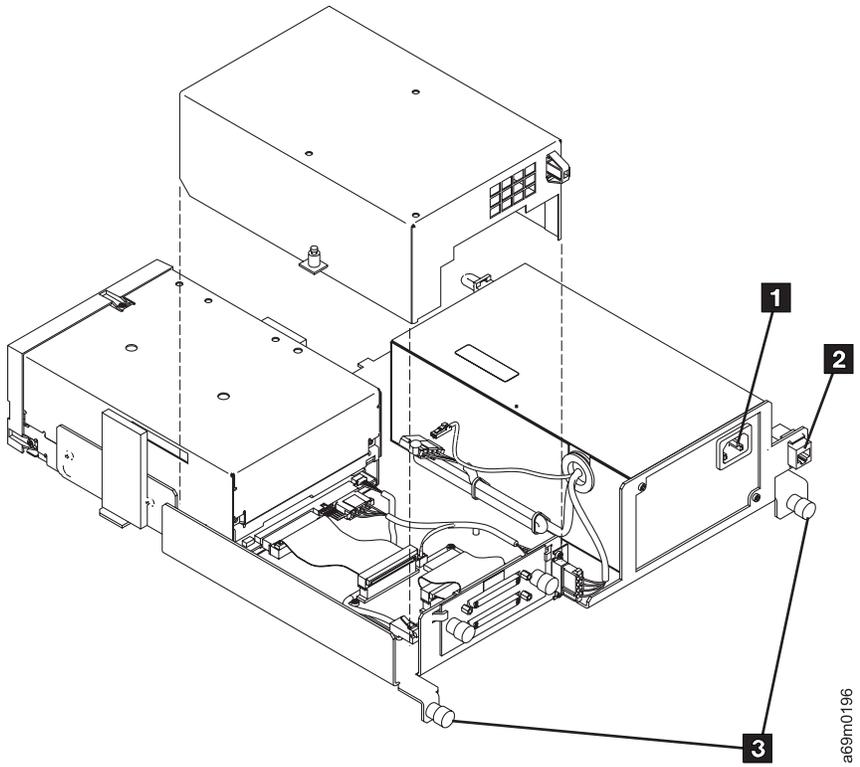
Figure 44. LTO SCSI Drive Tray Assembly

1. See Figure 44 on page 106 and Figure 45 on page 106. From the rear of the library, slide the drive assembly into the highest available drive location.

- Ensure that the tab at the front of the drive (the end opposite the cable-end) is seated into the slots in the bulkhead.
- Ensure that the drive tray is completely seated at both tabs before tightening the screws **3**; each tab should be flush to the frame. To prevent deforming the tabs, ensure the drive tray is not skewed before you begin to tighten the screws. Failure to properly install the drive will bend the tabs, and prevent the gripper assembly from picking a cartridge.
- Do NOT remove the drive safety flaps when installing drives. The safety flaps will pivot up out of the way.

2. Tighten the two screws **3**.
3. Repeat the previous steps to install the remaining LTO drive tray assemblies.
4. If all drives and drive types have been installed, go to “RS-422 Cables and Power Cables Installation” on page 111. If more drives are to be installed, go to the appropriate procedure in Table 19.

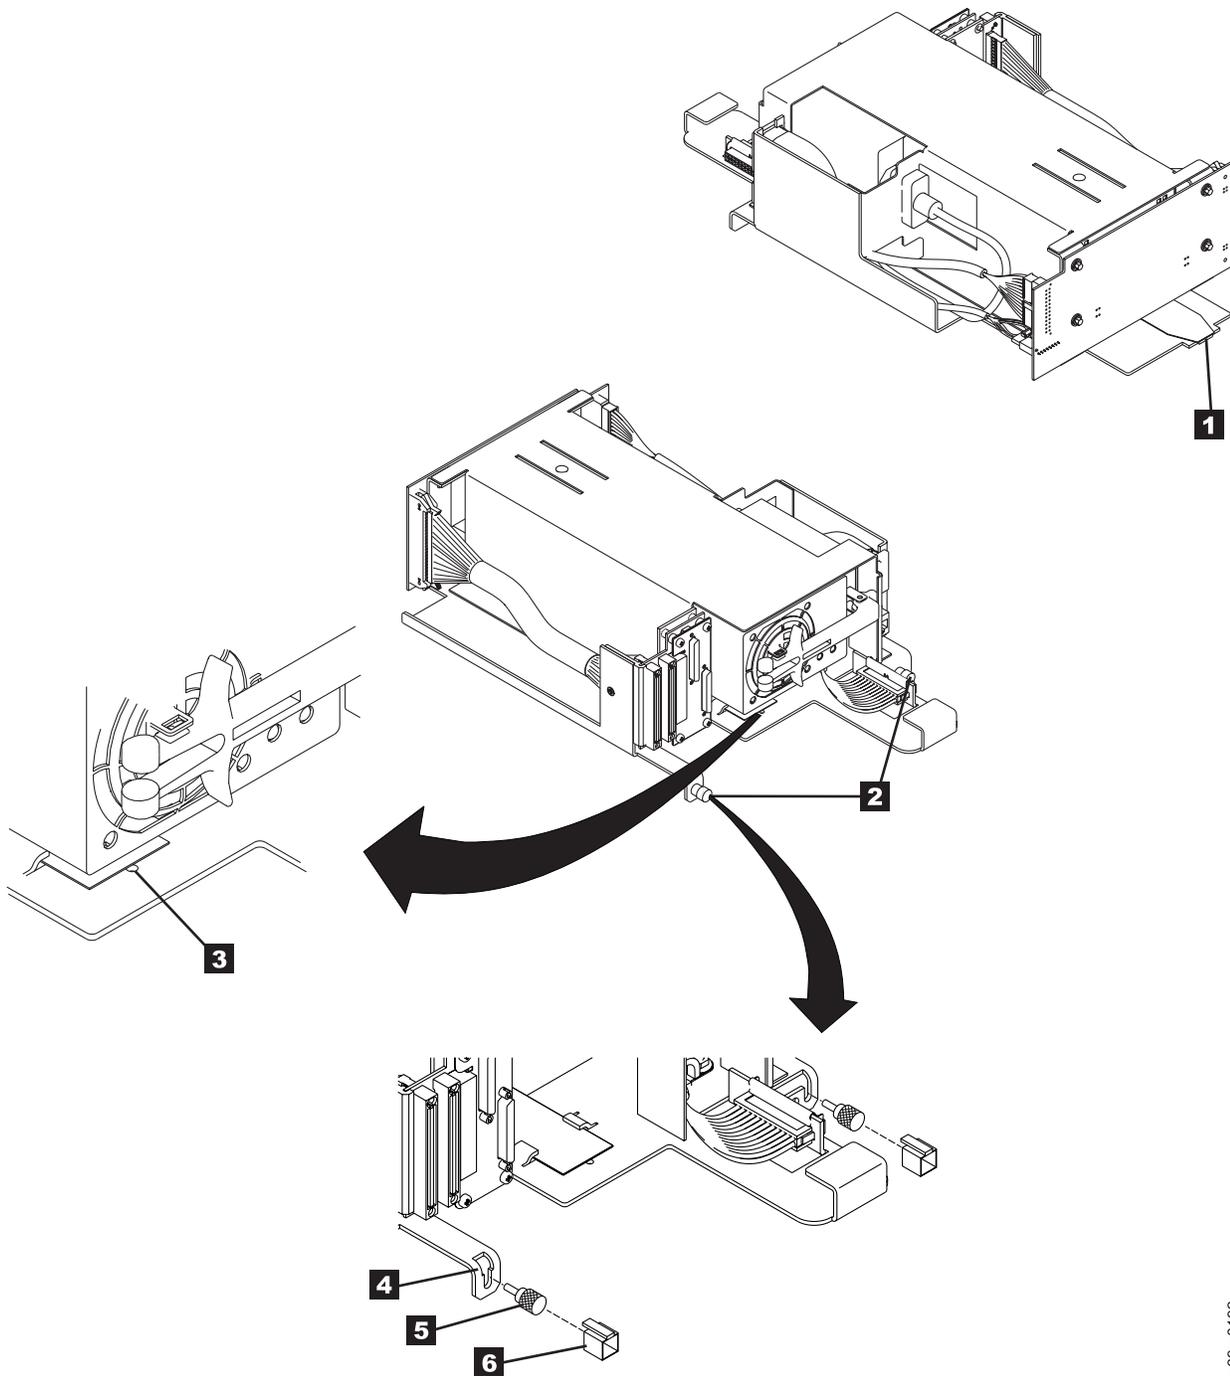
Figure 46. Fixed Tray

1. Slide in the fixed tray assembly, keeping it toward the right side. Ensure the front locating tab **1** on the tray assembly slides securely into the front slot in the frame (see Figure 46 on page 108).

Note: As the front locating tab seats into the slot in the frame, the indicator slide will move to partially cover the indicator hole **3**. If you see the indicator slide move toward the indicator hole (partially covering it), then the locating tab is positioned in the slot. If the indicator slide does not move, slide the front of the fixed tray assembly left or right until the locating tab slides into the slot.

- 2. Tighten both thumbscrews **2** to **fingertight only**. Do not overtighten these screws.
- 3. If your fixed tray has notches **4** near the thumbscrews, **5** slide the thumbscrew caps **6** over the screws until the tab slides completely into the notch.
- 4. See Figure 47 on page 109. Carefully slide the drive canister into the left side of the fixed tray assembly.
- 5. While holding the locking lever **2** **up** to ensure the tabs on both sides of the lever will clear the frame.
- 6. Grasp the drive canister handle **3**, and carefully but firmly push the drive into position. Ensure the connectors to the right correctly align and fully engage with the fixed tray connectors.

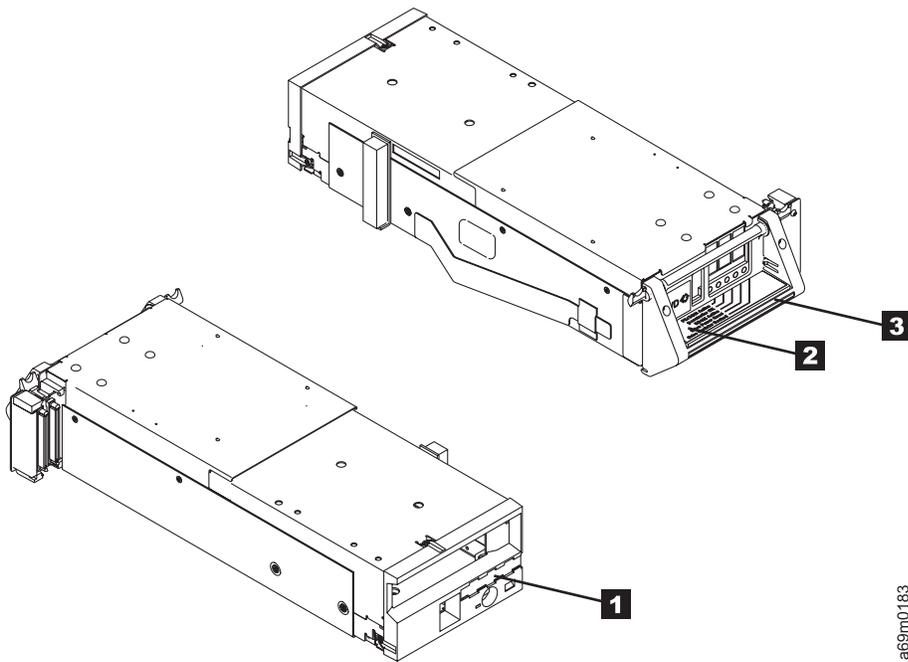
Figure 47. Drive Canister

- ___ 7. Lower the locking lever **2** until it snaps into place.

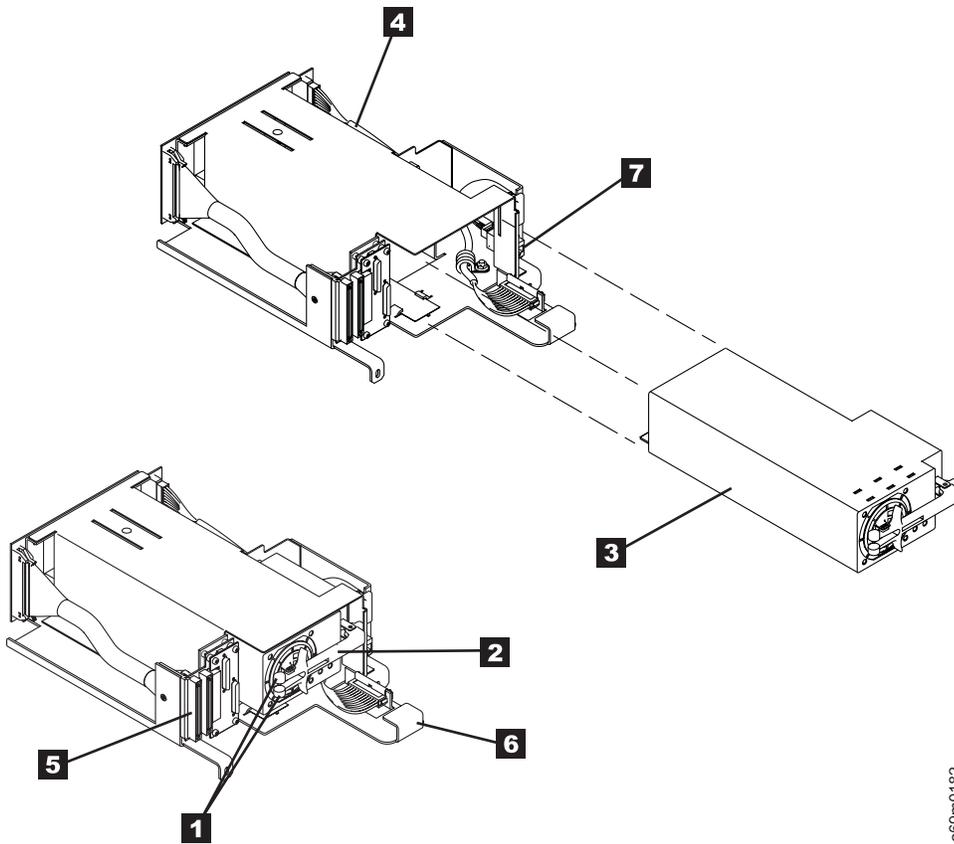
Figure 48. Hot Swap Power Supply

- ___ 8. See Figure 48 on page 110. Visually check to see if the hot swap power supply **3** is already installed in the fixed tray. If it is already installed, go to step “RS-422 Cables and Power Cables Installation” on page 111. If it is not installed, continue with the next step.
