IBM TotalStorage UltraScalable Tape Library 3584

Maintenance Information

Ninth Edition (June 2003)

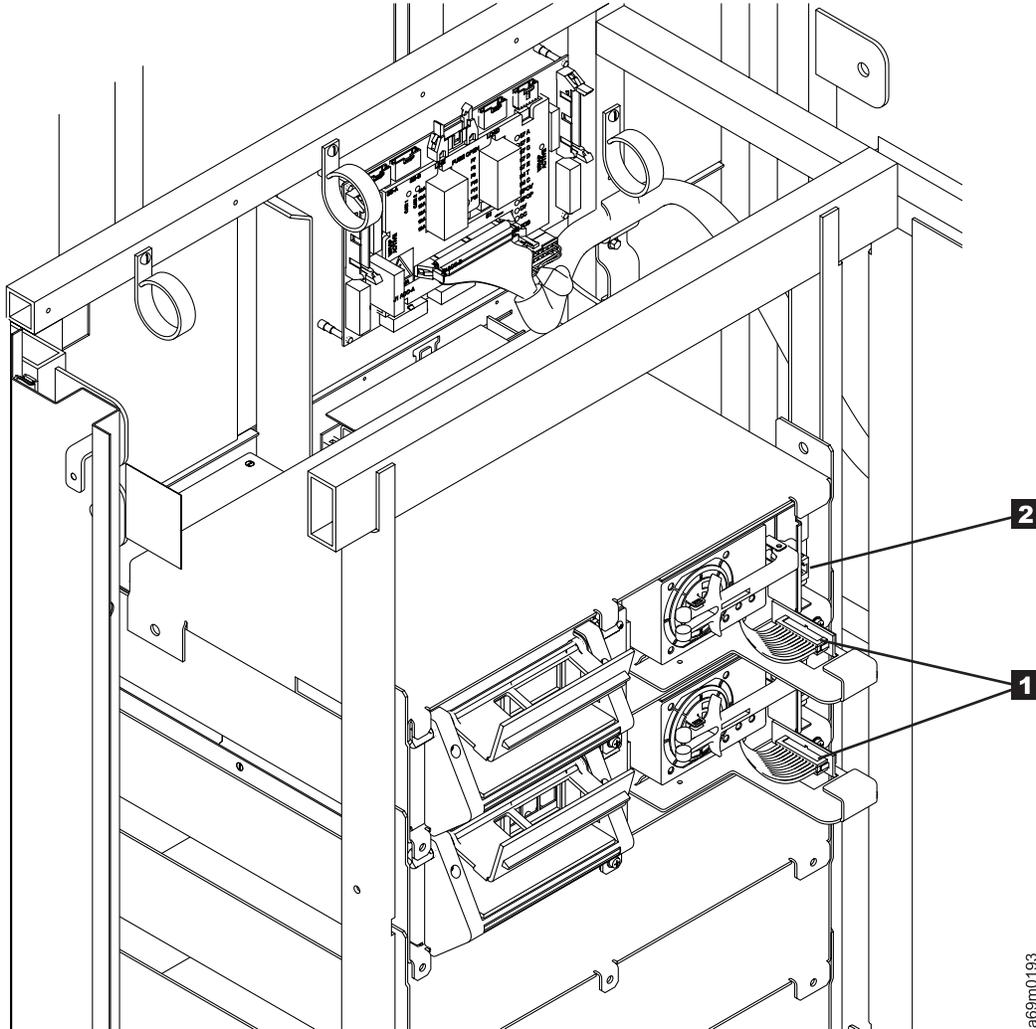
Figure 49. Cables and Power Cord

1. Connect the RS-422 cable to connector **2** on the right side of the drive tray or fixed tray assembly. If the drive tray or fixed tray is in Row 1 to 12, use the RS-422 cable attached to MCP connector J7. Be sure to use the connector labeled with the row number. For model D42 only, if the control port fixed tray is in Row 0, use the RS-422 cable that is attached to MCP connector J3.

3. Connect the bifurcated power cord on the right side **2** of the new fixed tray assembly (see Figure 49). This is depicted as **1** or **3** in Figure 50 on page 112. For canister devices, ensure you install the power cords exactly as shown in Figure 50 on page 112 to ensure optimum redundancy.
4. Go to “Drive Cabling” on page 113.

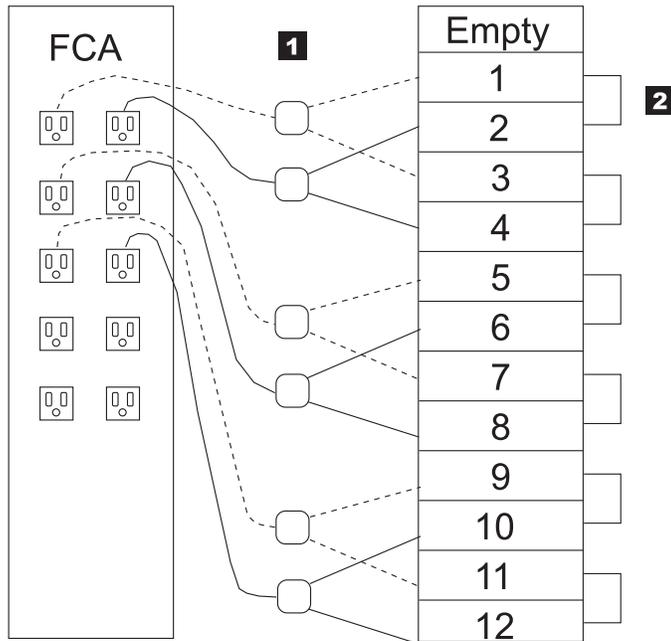
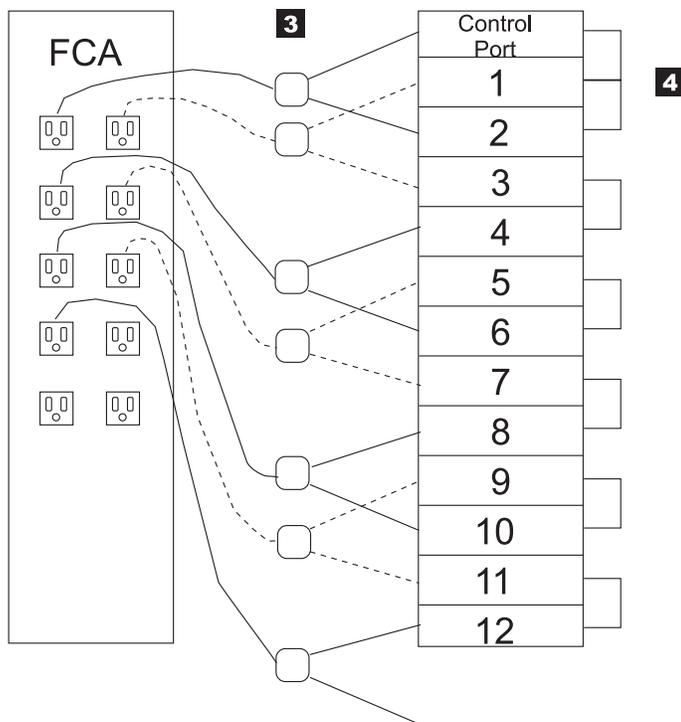
Figure 50. Redundant Power Cabling

2. For canister devices only, install the appropriate Redundant Power Supply power cables (19P1223) between the fixed trays **1**, depicted as **2** or **4** in Figure 50 on page 112.

L32/D32 - LTO Drive Redundant Power

D42 - DLT Drive Redundant Power

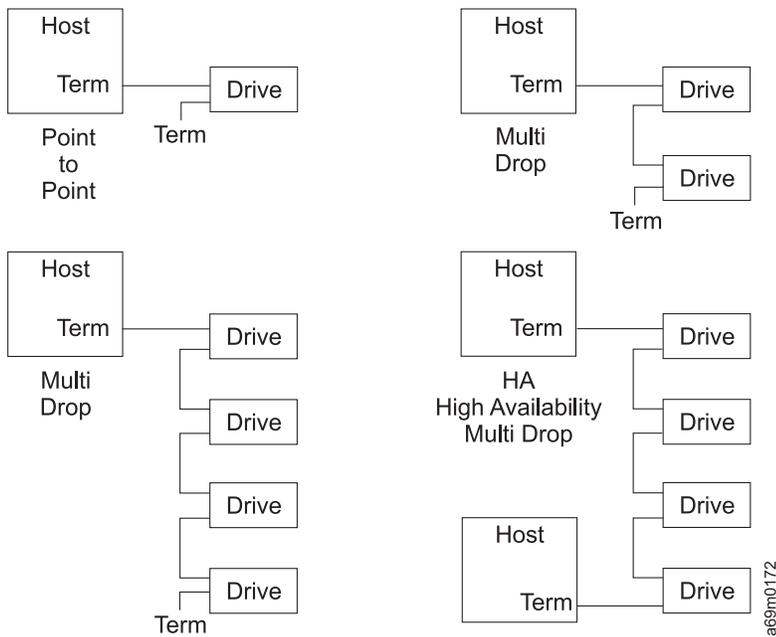
Figure 51. SCSI Interface Cables (Various Layouts)

- ___ 1. Consult with your customer and review the examples shown in Figure 51 on page 114. You will be attaching necessary SCSI cables and terminators in the following steps.

Attention: The following comments apply to Figure 51 on page 114.

- RS/6000 does not support High Availability (HA) on LVD devices.
 - An RS/6000 LVD adapter card does not allow you to remove termination. Using an external Y-cable and terminator will cause multiple termination problems.
 - The RS/6000 does not offer a VHDCI Y-cable.
 - Due to a SCSI-stub maximum-length limitation of 10 cm (3.9 in.), you cannot use an HD68-to-VHDCI interposer cable on a Y-cable.
- ___ 2. If the customer configuration requires more than one drive on each SCSI bus, install the appropriate SCSI drive-to-drive cables.

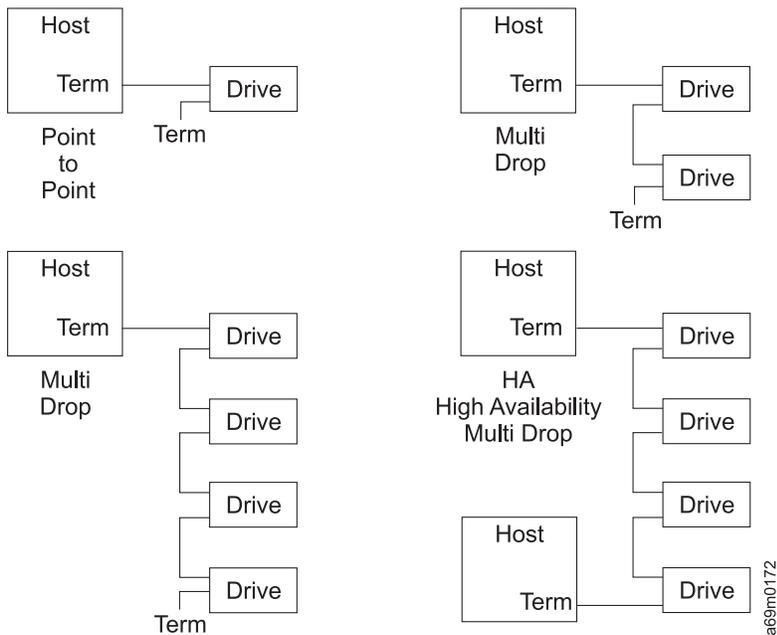
Figure 52. SCSI Interface Cables (Various Layouts)

- ___ 1. Consult with your customer and review the examples shown in Figure 52. You will be attaching necessary SCSI cables and terminators in the following steps.

Attention: The following comments apply to Figure 52.

- RS/6000 does not support High Availability (HA) on LVD devices.
- An RS/6000 LVD adapter card does not allow you to remove termination. Using an external Y-cable and terminator will cause multiple termination problems.
- The RS/6000 does not offer a VHDCI Y-cable.
- Due to a SCSI-stub maximum-length limitation of 10 cm (3.9 in.), you cannot use an HD68-to-VHDCI interposer cable on a Y-cable.

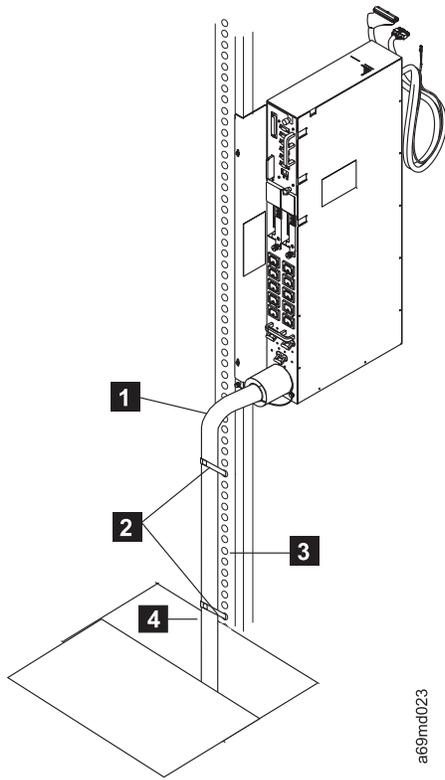
Figure 53. Securing 220V Power Cord

Note: In many countries, the end of the power cord that will connect to the customer receptacle comes without a plug. It is the customer’s responsibility to furnish this plug. The plug that connects to the Frame Control Assembly (FCA) is standard for all installations.
 - ___ 5. Refer to Figure 53 on page 117. For each frame being installed, secure each power cord **1** coming from the customer power source to the FCA with two plastic cable ties **2** (P/N 1159519), using the EIA holes to the left of the FCA **3**. Place one tie near the FCA [about 35.6 cm (14 in.)] below the FCA power receptacle and another near the bottom of the frame [about 20.3 cm (8 in.)], above the access hole **4** in the bottom of the frame.

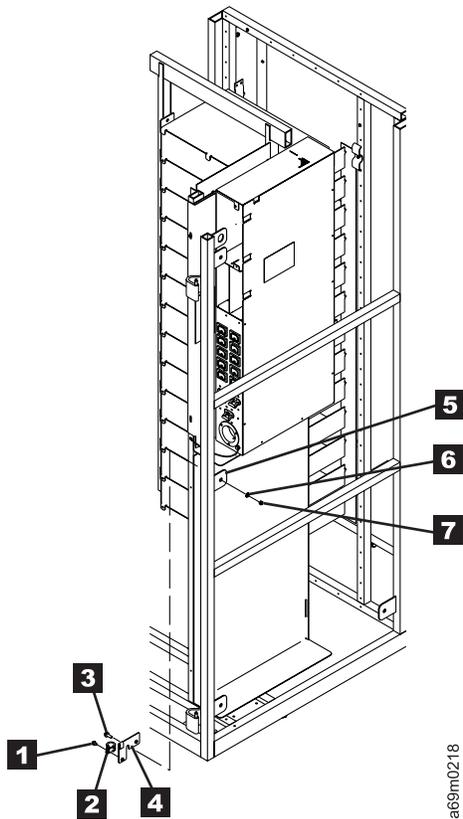
Figure 54. Securing 110V Power Cord

- ___ 6. If you are installing a 110V FCA (FC 1452 with SC 9951) a 110V power cord strain relief bracket must be installed. These parts are provided with the 110V FCA. See Figure 54 for the following steps:

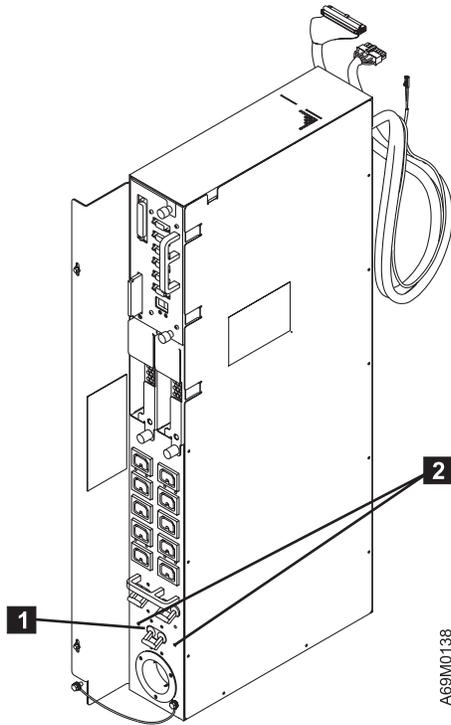
Figure 55. FCA Assembly

- ___ 11. Connect the AC power cords into the FCA receptacles in the rear of the base and any expansion frames. See Figure 55 on page 119.

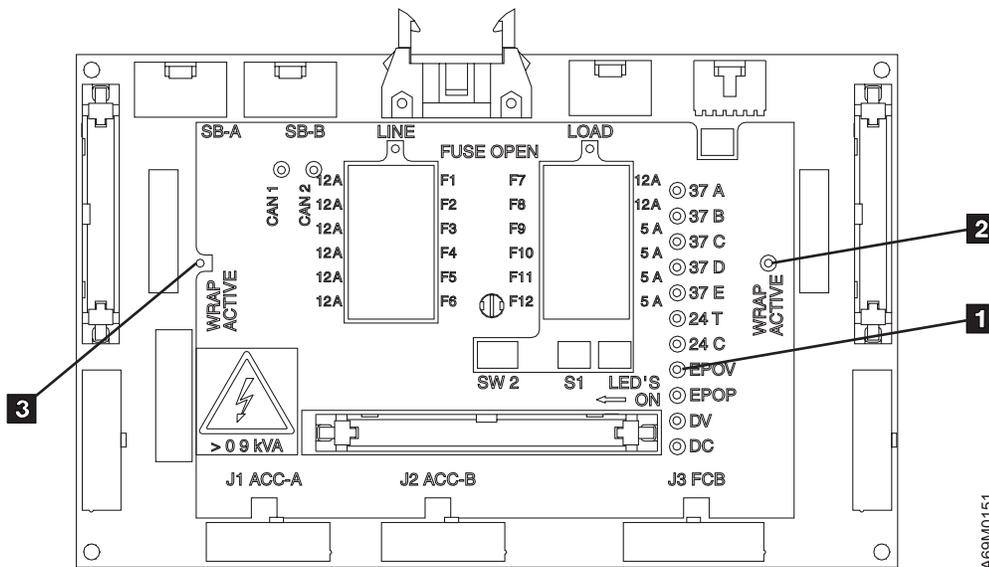
Figure 56. FIC Card Indicator Lights

- __ 12. Connect the power cords to the customer power receptacles.
- __ 13. Starting at the base frame, switch on all the FCA circuit protectors.
- __ 14. If the power and interframe cables are connected correctly:
 - Each FIC card's green LED EPOV **1** should be On.
 - The wrap active green LED **2** should be On in the base frame and Off in all other frames.
 - The wrap active green LED **3** should be On in the last frame and Off in all other frames. **3**.

Note: If this is a base frame only installation, both wrap active LEDs will be On.

If the green LEDs are not correct, recheck your cabling and the FIC card termination jumpers. If you do not find a problem, go to "Power Isolation MAP" on page 449 to correct the problem, and return here.

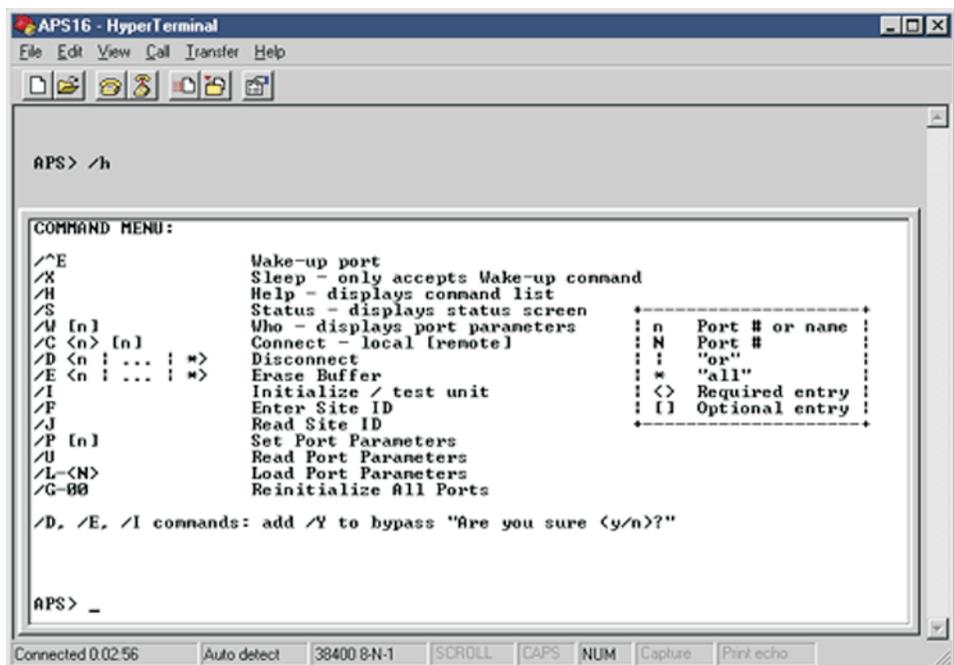
Figure 57. WTI Command Menu (FC2711)

17. At the APS> prompt, type **/h**, and press **Enter**. The Command menu displays.

Note: Your PC may default to a different font, so entries may not line up as neatly as is shown in Figure 57. This will not cause problems performing the procedure.

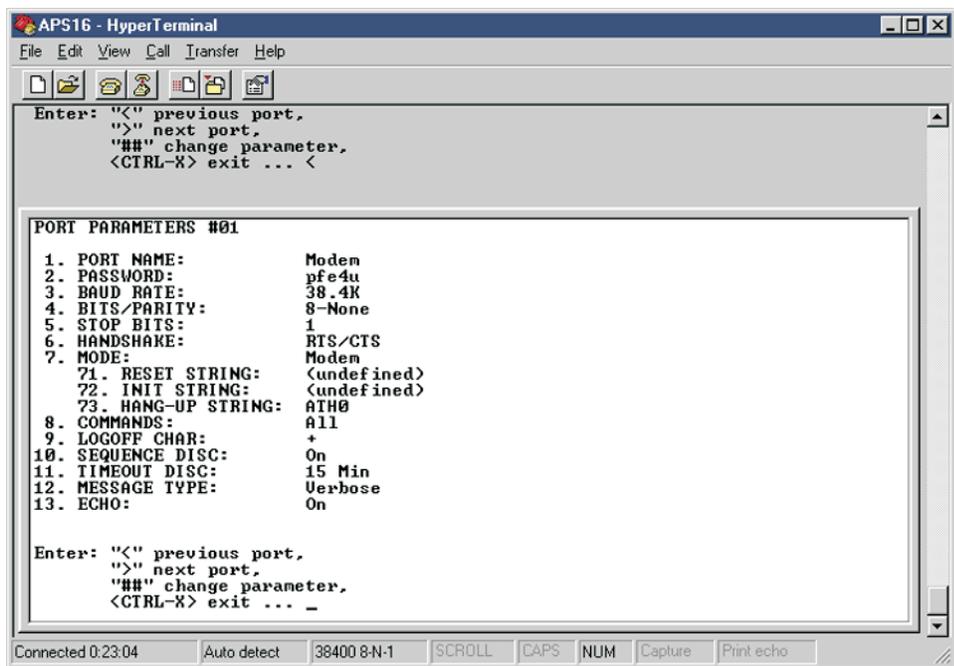
Figure 60. WTI Port Parameters #01 Screen (FC2711)

32. Verify that items 1 and 7 are set to 'Modem', item 2 is set to 'pfe4u' (or the customer password), items 71 and 72 are set to '(undefined)', and item 73 is set to 'ATH0.' If any of these items is not set correctly, set it again before you continue. The screen should look like Figure 60.

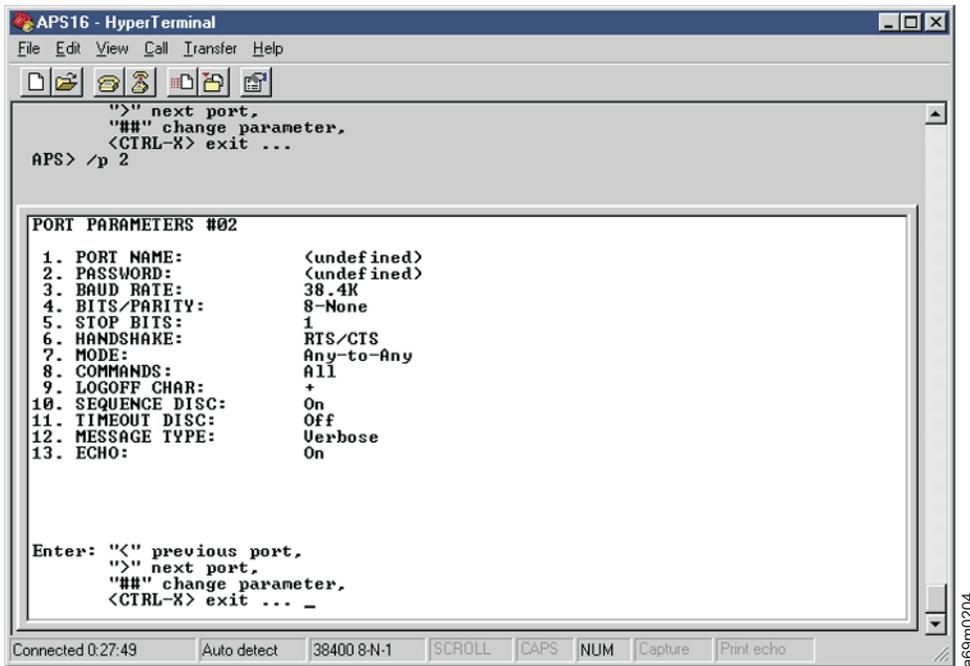
Figure 61. WTI Port Parameters #02 Screen (FC2711)

34. At the APS> prompt, type **/p n** (where n is the port number where a 3584 will be connected), and press **Enter** (example: /p 2). The Port Parameters screen displays.

35. Type **1**, and press **Enter** to select the PORT NAME option.
36. Type **IBM3584A** (or any other descriptive name the customer wants to call the first library - it must start with an alpha character, contain no blanks, and be no more than 8 characters long), and press **Enter**.
37. Press **Ctrl+X** to exit the Port Parameters screen.

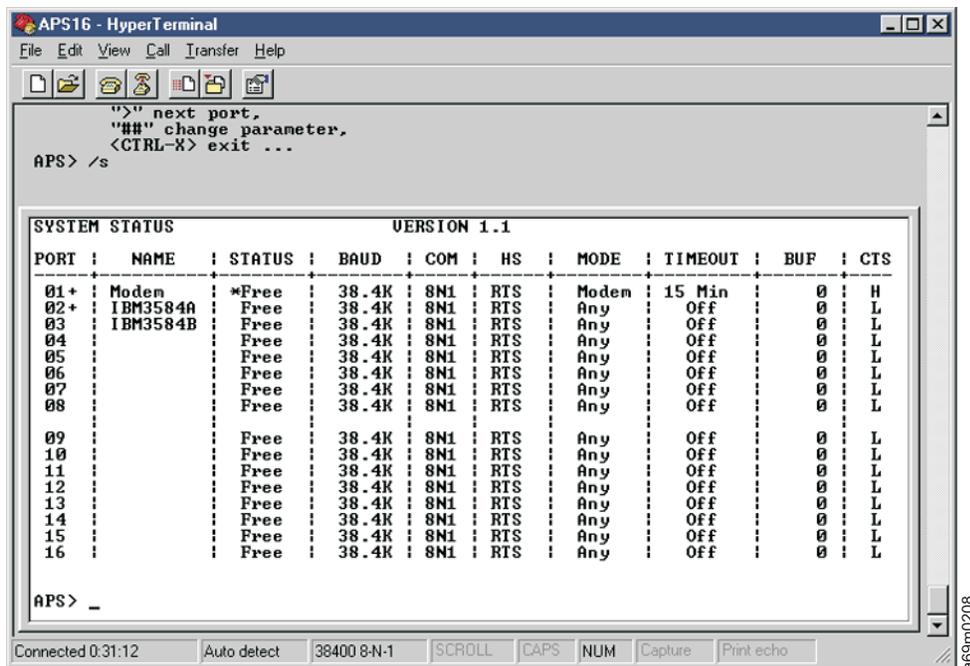
Figure 62. WTI System Status Screen - Second View (FC2711). Includes 'Status Name.'

- There could be more libraries attached.
- Customer descriptive names may be used in place of the library names in the following screen.

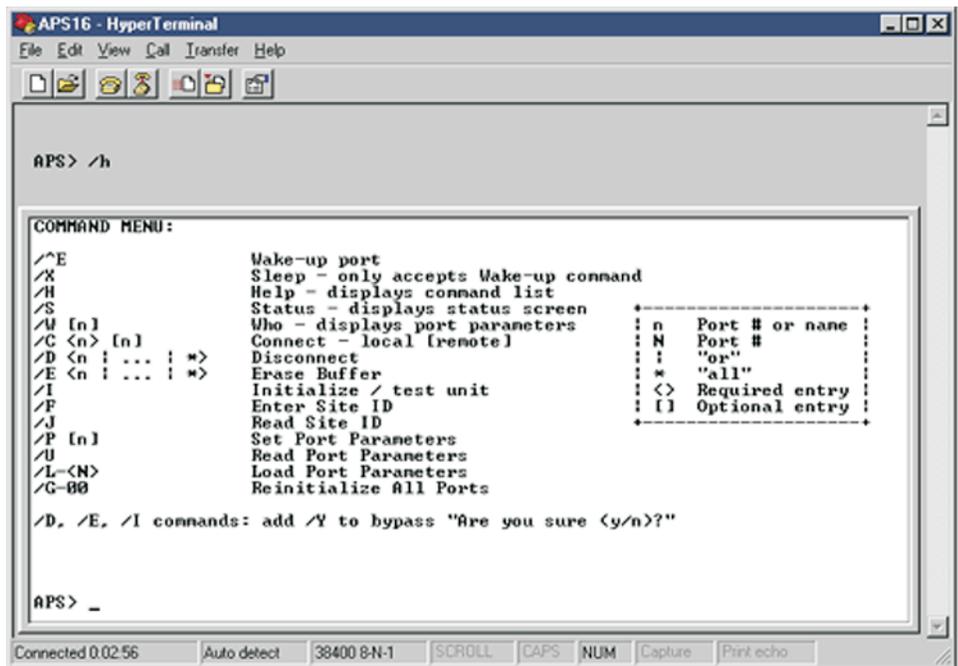
Figure 63. WTI Command Menu (FC2712)

- At the APS> prompt, type **/h**, and press **Enter**. The Command menu displays.

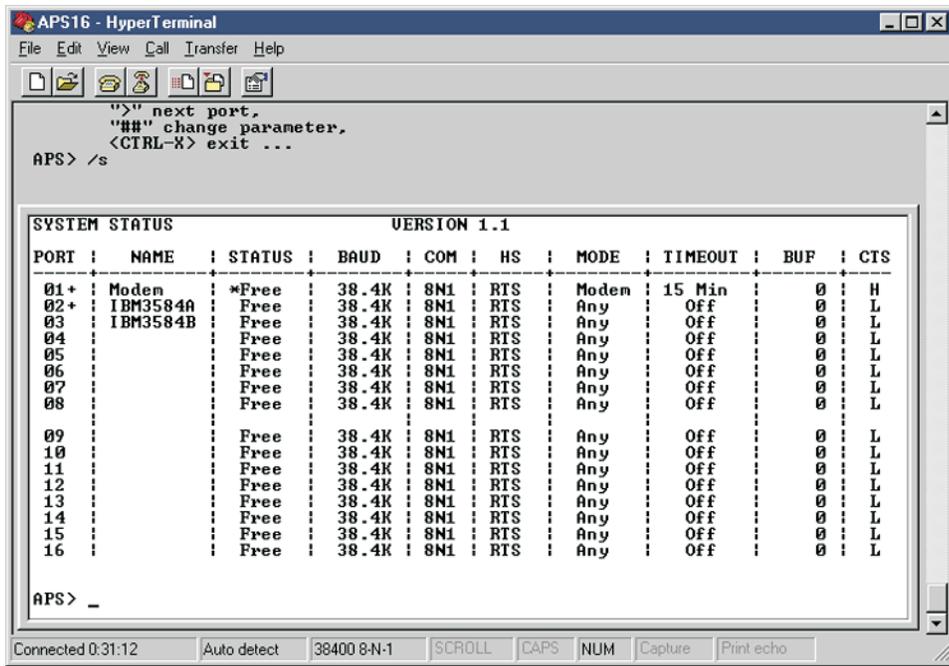
Figure 64. WTI System Status Screen (FC2712)

- At the APS> prompt, type **/s**, and press **Enter**. The System Status screen displays.

Note: Figure 64 assumes three 3584 libraries are already connected to the WTI switch. The number of ports that are in use and the port name of ports 2 - 16 may be different in your environment.

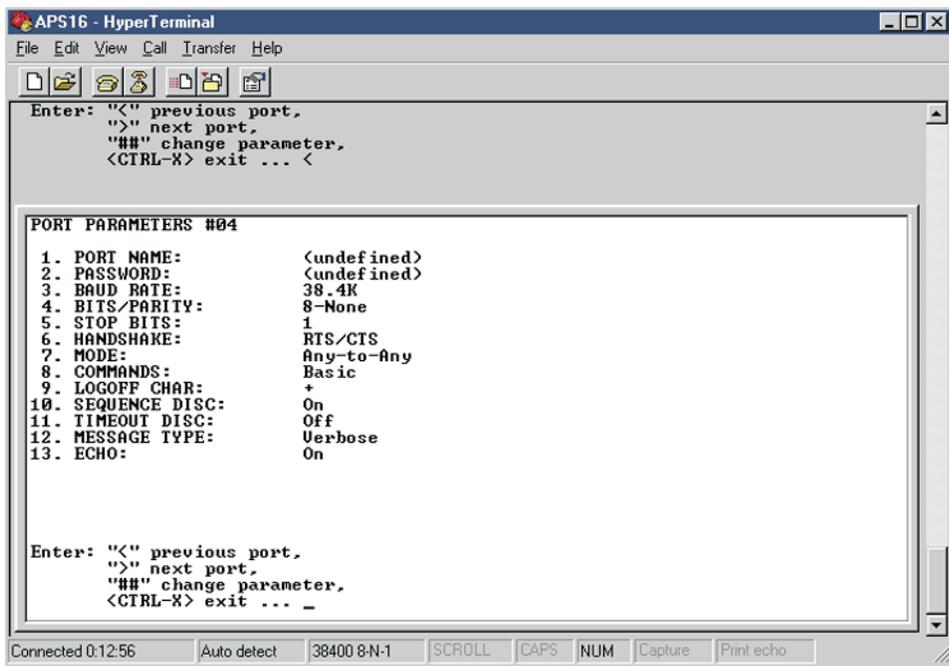
Figure 65. WTI Port Parameters Screen (FC2712)

13. Type **1**, and press **Enter** to select the PORT NAME option.
14. Type **IBM3584C** (or any other descriptive name the customer wants to call the first library; it must start with an alpha character, contain no blanks, and be no more than 8 characters long), and press **Enter**.
15. Press Ctrl+X to exit the Port Parameters screen.

Note: Leave all Port Parameters except for Port Name set to the defaults.

- At the APS> prompt, type /p n (where n is the next unused port number where a 3584 will be connected), and press **Enter** (example: /p 4). The Port Parameters screen displays.

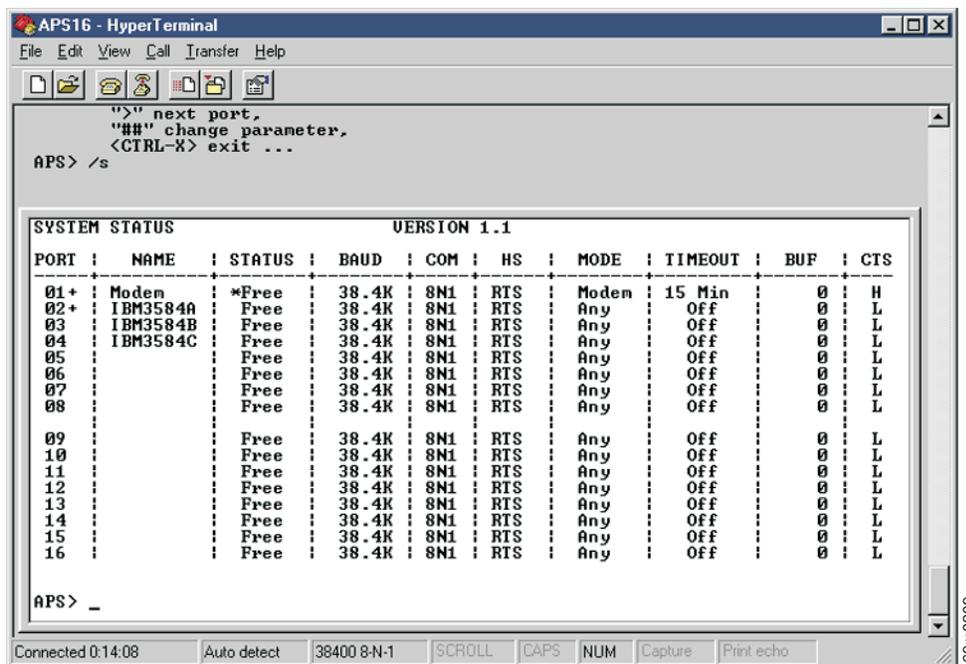
16. If you are adding more than one library to the WTI switch, repeat steps 12 on page 132 through 15, selecting the next port number until all ports that will be connected to 3584 libraries have been named.
17. Type **/s** and press **Enter** to display the System Status screen.
18. Verify that port 1 is named Modem, and any port from 2 - 16 that will be connected to a 3584 library is named with a unique descriptive name. If any port shows the wrong name, correct it before you continue. The screen should now be as follows (customer descriptive names may be used in place of the library names in the following screen):

Figure 66. WTI System Status Screen-Updated (FC2712)

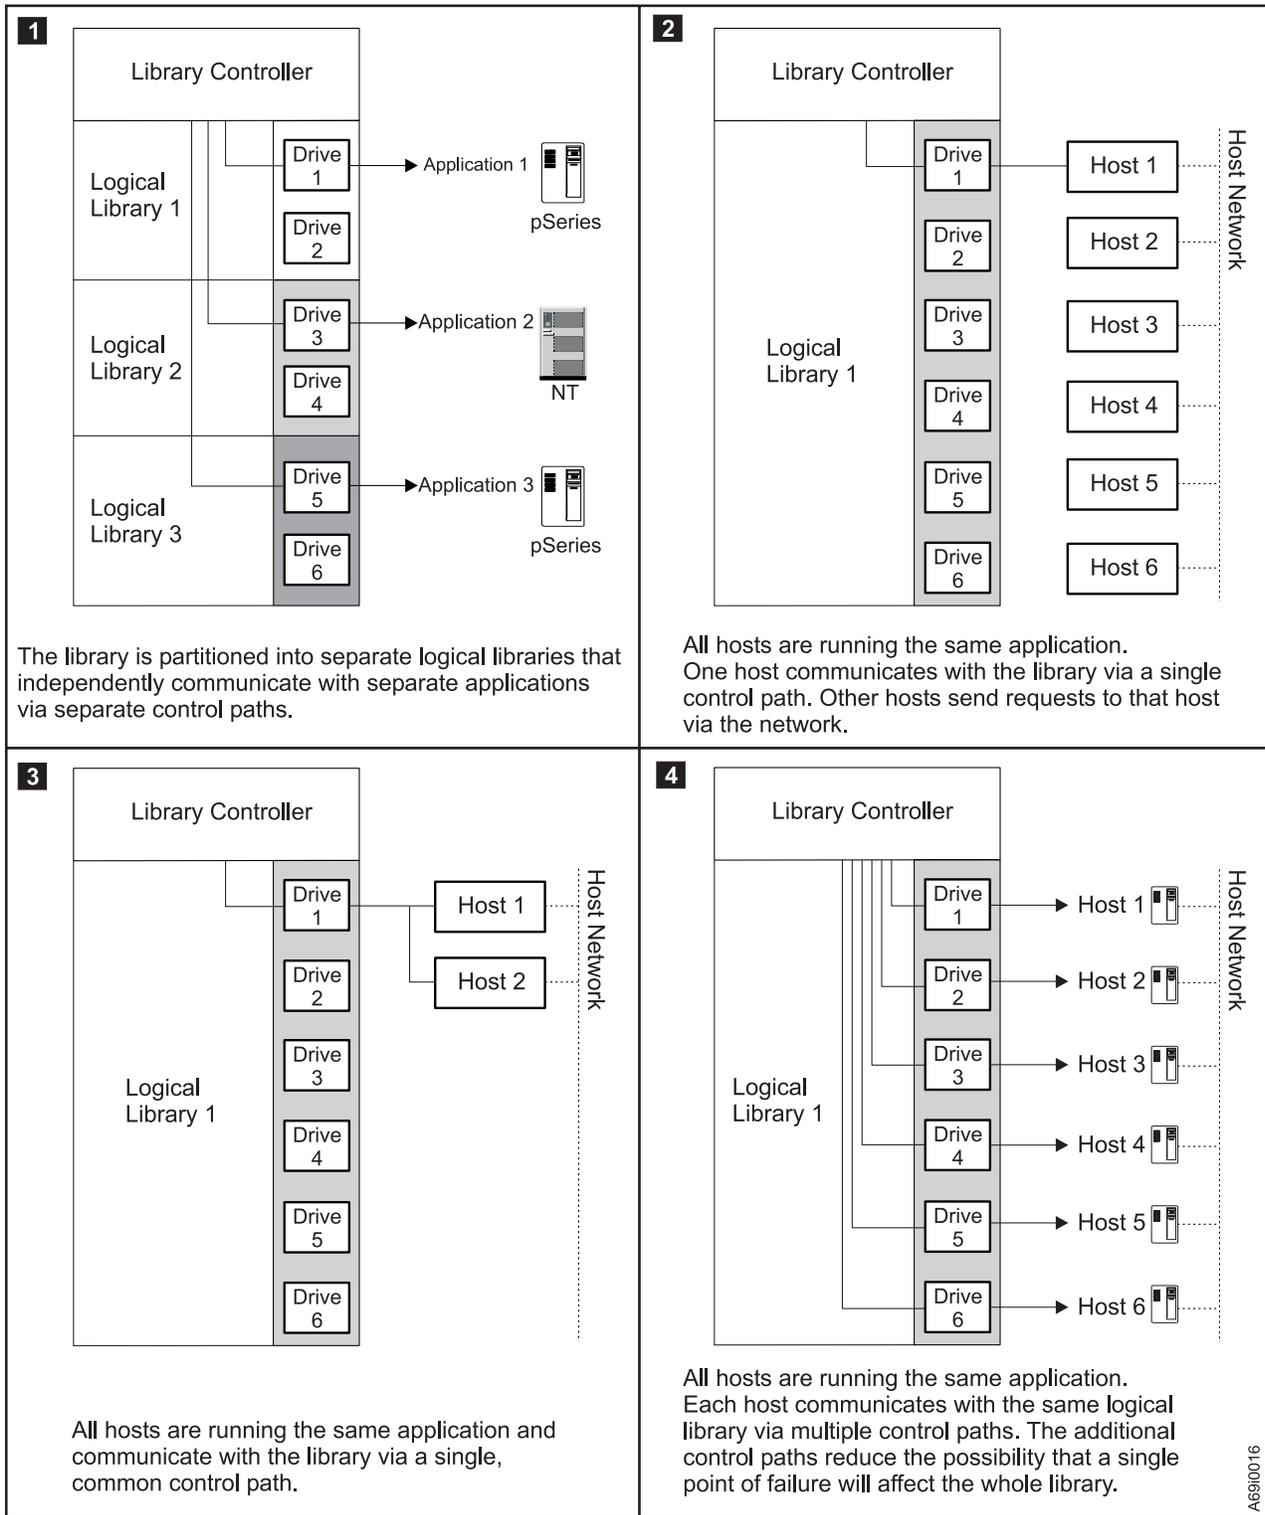
Figure 67. Cabling Examples

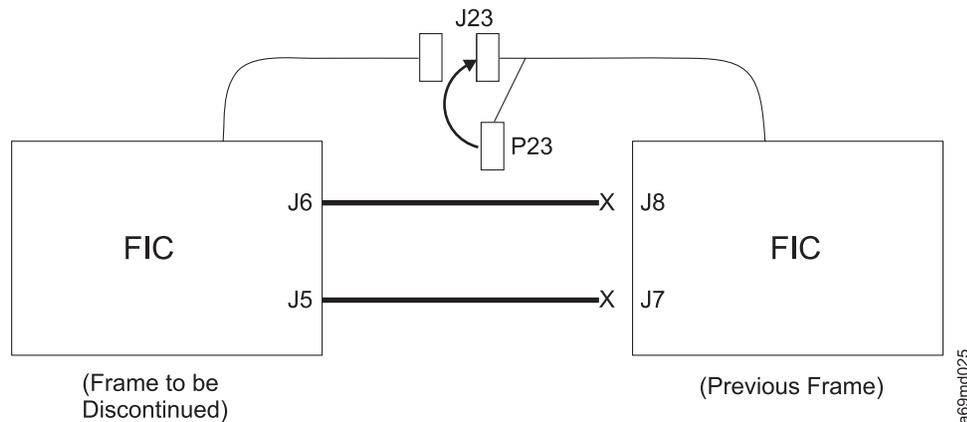
| Figure 68. FIC Connections

- | ___ 12. See Figure 68 for "Previous Frame" activities. Disconnect the interframe EPO cable at J23 and plug the tethered EPO jumper (P23) into J23 as shown. Disconnect J7 and J8 on the FIC. Now put all three cable ends into the frame that is being discontinued.

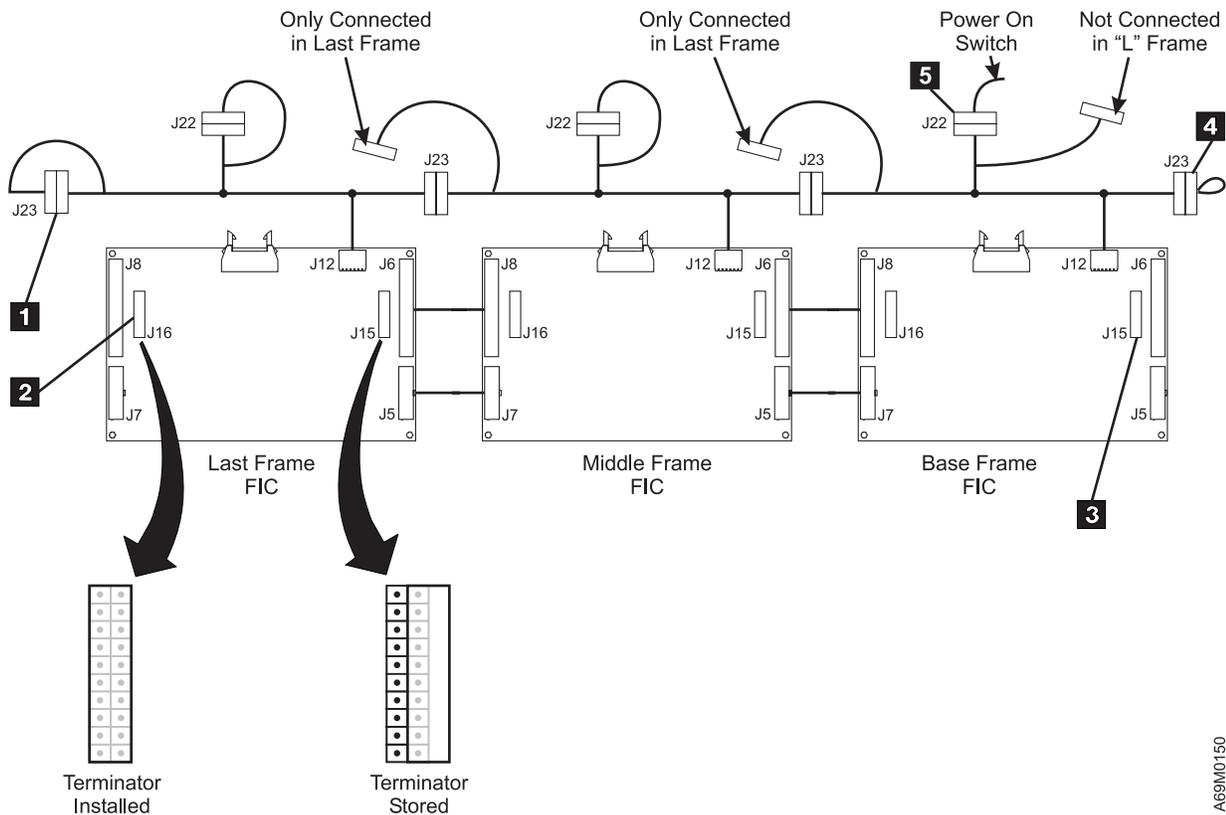
AG9M0150

Figure 69. FIC Card Interface Cables Schematic

| **Note:** If the library is NOT going to be discontinued, ensure that the terminators are reinstalled in the previous frame as shown in Figure 69 on page 140. If the library IS going to be discontinued, ensure that the terminators are reinstalled in the L32 base frame.

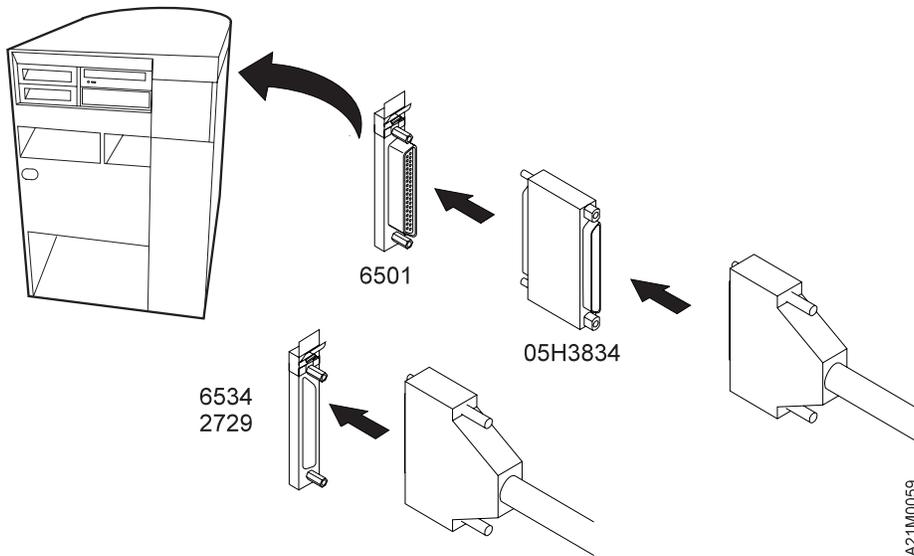
Figure 70 shows the connectors, and interposers that the AS/400 uses to attach to the tape library. Table 27 describes the connectors and interposers.

Figure 70. AS/400 SCSI Cable Attachment to Library. The controllers are identified by feature code; the interposers are identified by part number.

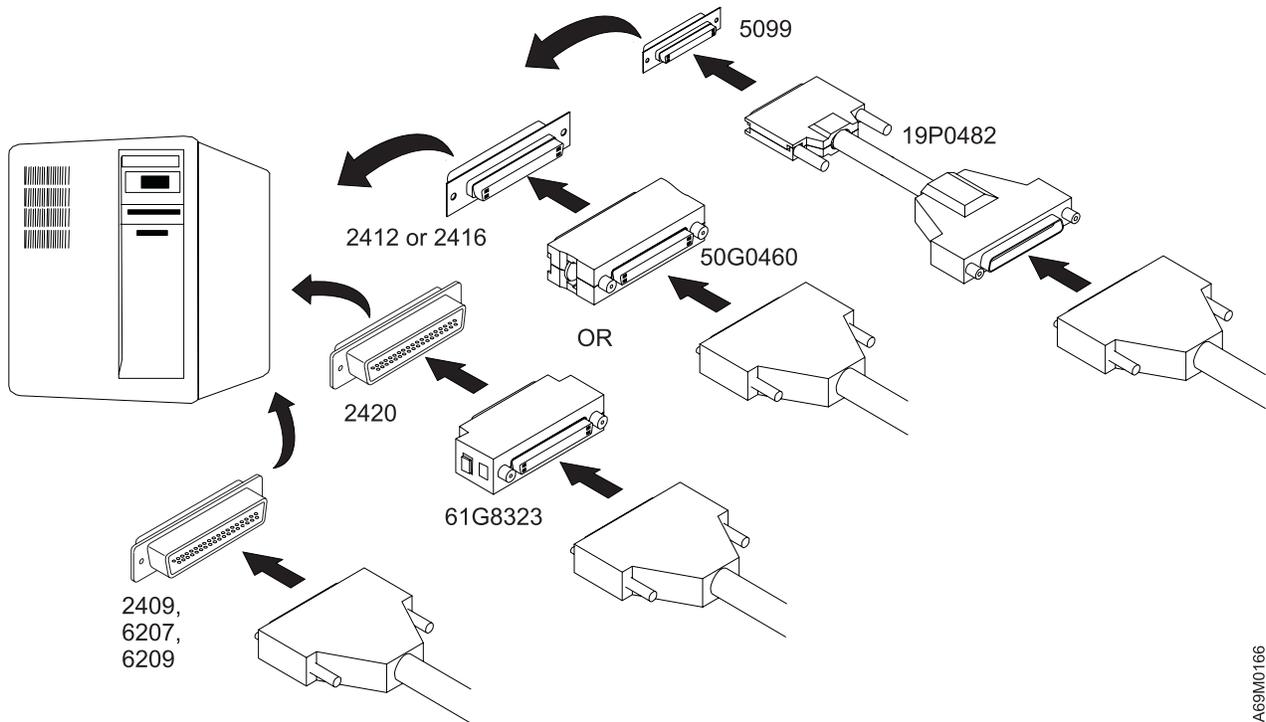
A69M0166

Figure 71 shows the SCSI connectors and interposers that the RS/6000 uses to attach to the tape library. Table 28 describes the connectors and interposers.

Figure 71. SCSI Cable Attachment of RS/6000 to Library. The adapters (and controller) are identified by feature code; the interposers are identified by part number.

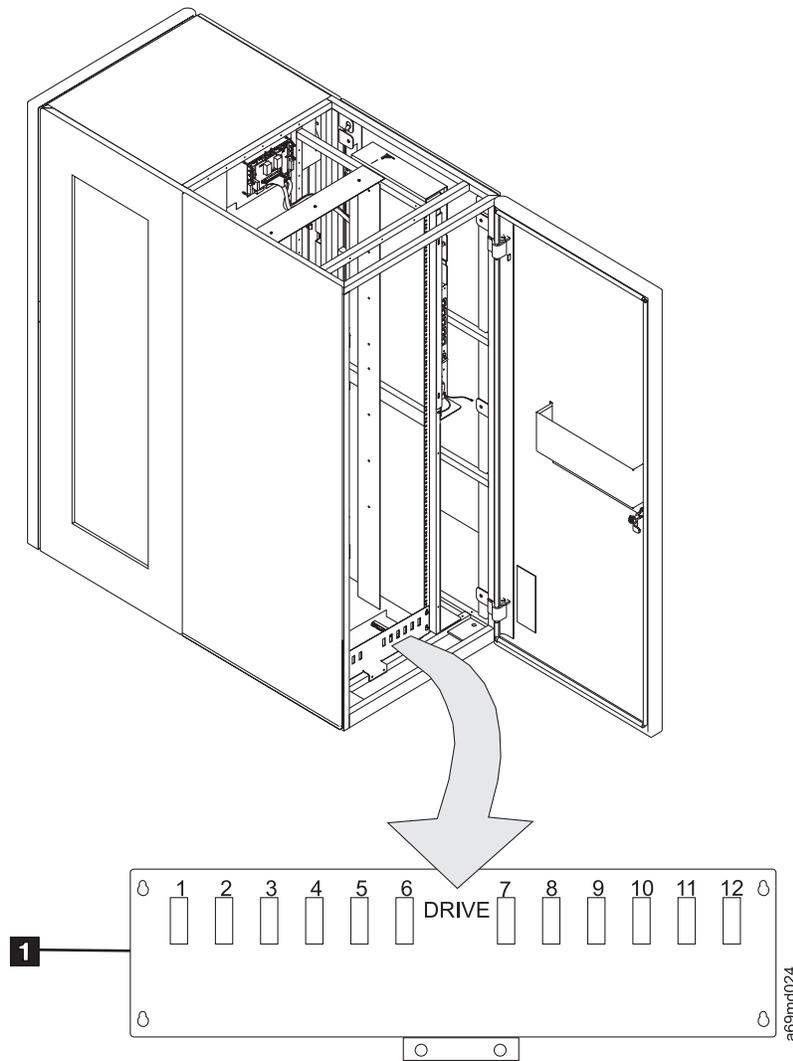
Figure 72. Fibre Channel Bulkhead

1. A customer who requires cable lengths greater than 61 m (200 ft) should contact IBM Site and Connectivity Services (I/T Consulting and Implementation Services in the U.S.A.) for custom cable system design and installation.
2. When installing LTO Fibre drives, a 2 m (6.6 ft) cable (P/N 11P2227) goes from the drive ports to an interposer connector on a bulkhead at the bottom of the frame. The customer's cable attaches to the other side of the bulkhead connector. See Figure 72 on page 155.

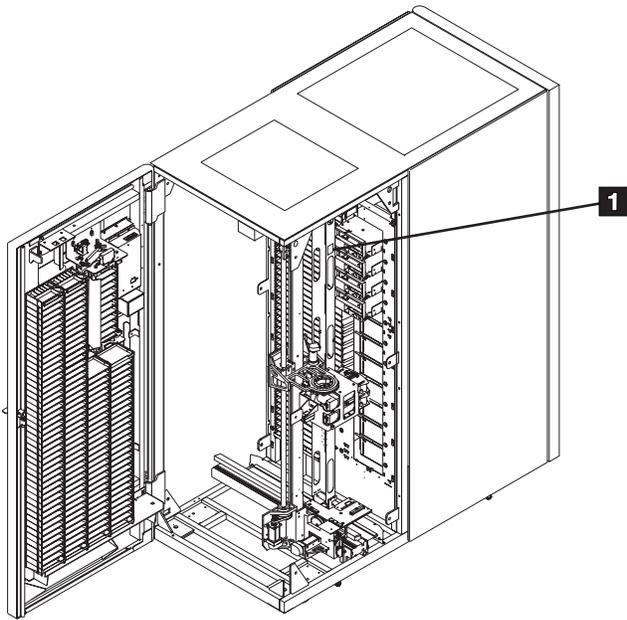
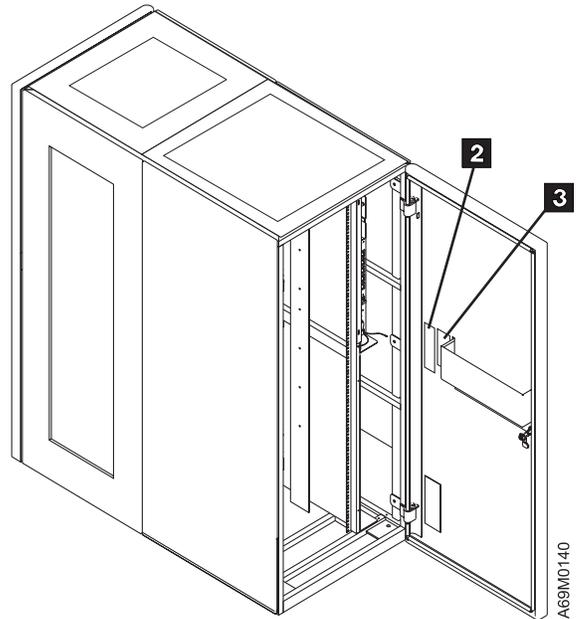
Figure 73 on page 165 shows the approximate locations of the following:

- 1 Class II laser caution label, bar code scanner

- 2** Current leakage caution label
- 3** Power cord label

Figure 73. Base Frame Safety Labels

Check that the labels are located where shown in Figure 73 on page 165. Make any necessary corrections. See Chapter 14, "Parts Catalog", on page 697 for part numbers of labels in the various languages.

Use Figure 73 on page 165 keys **2** through **3** for the locations of the safety labels in the expansion frames.

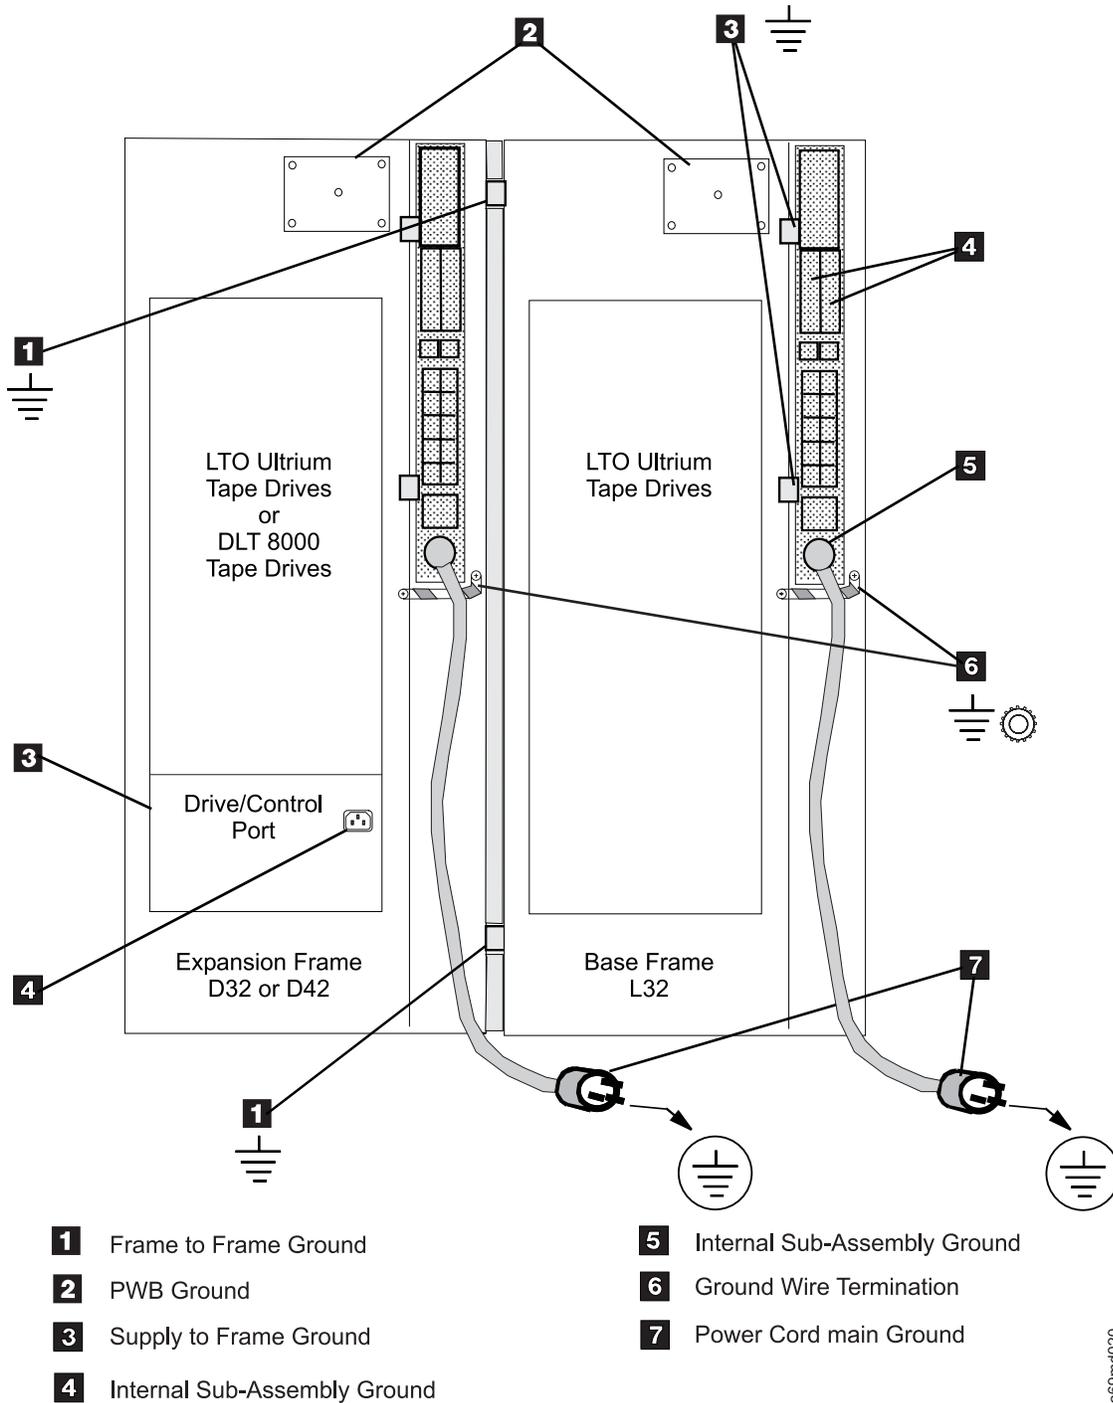
Figure 74. AC Grounding Diagram. (50 Hz and 60 Hz)

Refer to Figure 74 on page 167 as you perform the following safety checks.

- 4. The two screws with lock washers holding the yellow/green ground strap item **6** are tight. See Figure 74 on page 167.
- 5. The two mounting bolts **3** for each FCA are tight.

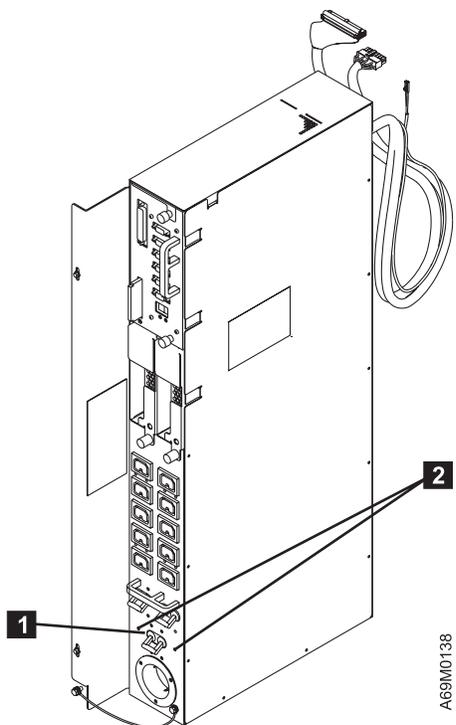
Figure 75 shows the frame control assembly (FCA), which is the power source for the library and drive components.

Figure 75. Frame Control Assembly (FCA)

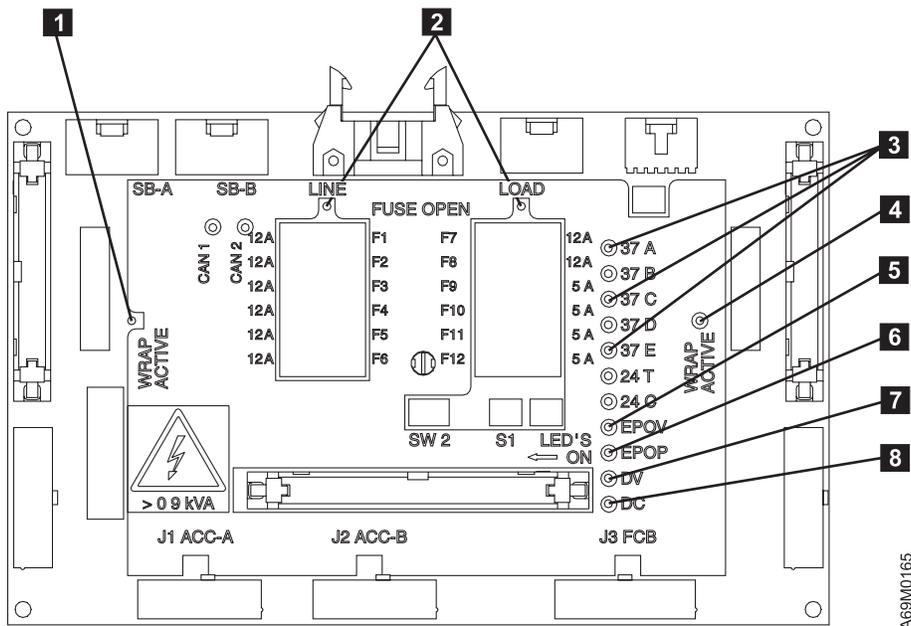
Refer to Figure 76 for the location and sequence of green LEDs on each FIC card as you perform this power-on check.

Figure 76. FIC Card Green Power LED Display

1. Set all three FCA circuit protectors (CPs) to OFF, and set the front library power switch to OFF (O).
2. Turn on the Main circuit protector above the line cord in each FCA and observe the green LEDs on each FIC card in each frame.

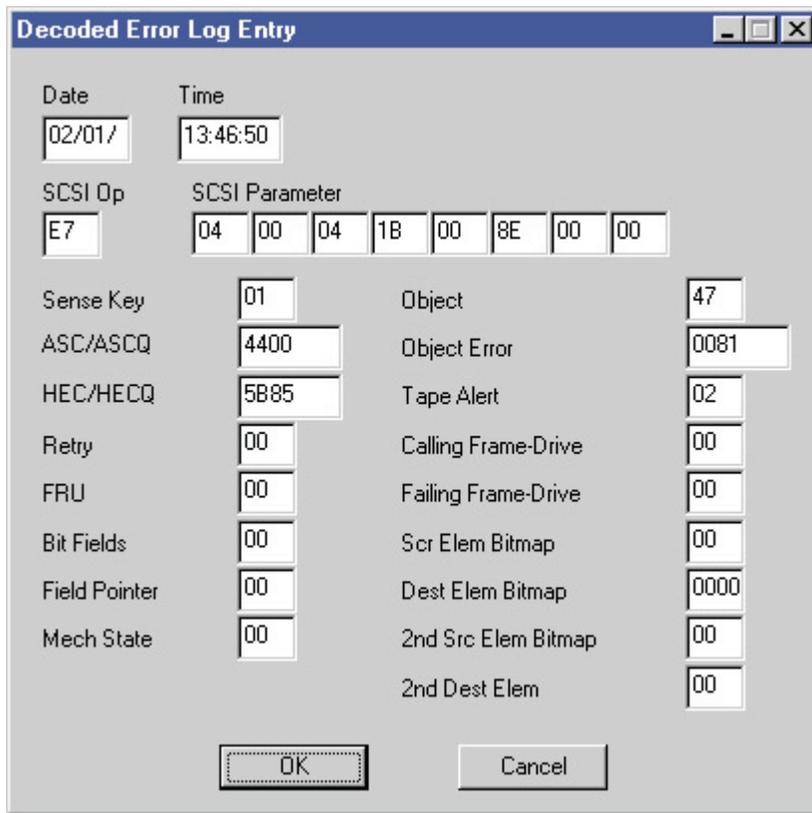
Figure 77 on page 443 provides an example of a typical screen you will get using CETool to view library error log data. For details on the procedure to gather the library error data, see “Viewing Error Log Entries” on page 505.

Figure 77. CETool Error Log Display Example

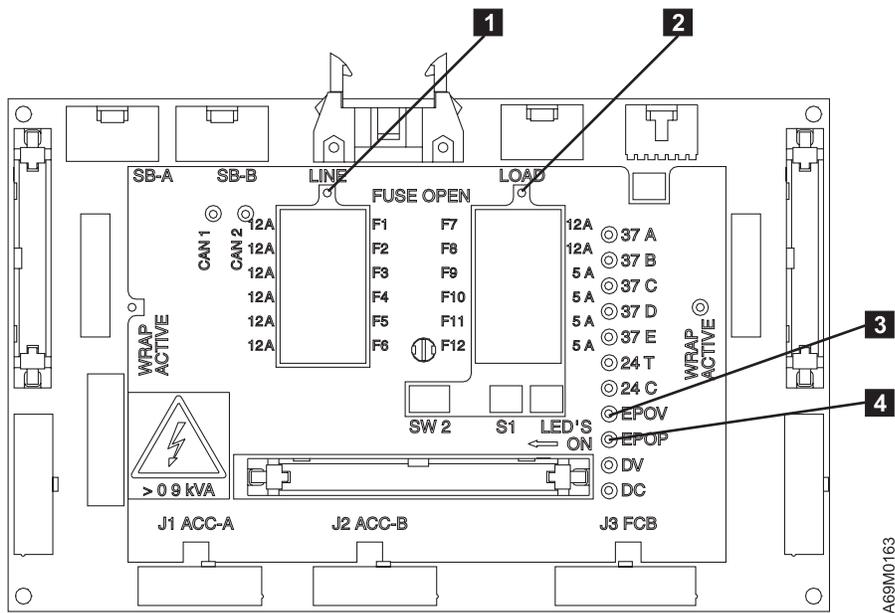
Figure 78. FIC Card Fuse Indicators

Visually check the EPOV indicator **3** on the FIC card in each frame (see Figure 78 on page 451).

Visually check the EPOP indicator **4** on the FIC card in each frame (see Figure 78 on page 451).
