IBM TotalStorage UltraScalable Tape Library 3584

Maintenance Information

Ninth Edition (June 2003)

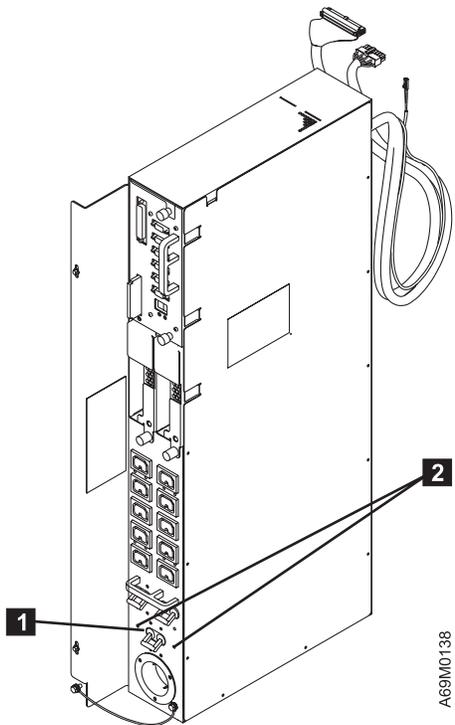
Figure 79. FCA 24 V dc Indicators

1. Ensure that all three circuit protectors **1** on the back of each installed FCA are ON (see Figure 79 on page 452).

2. Visually check the two 24 V dc indicators **2** on each installed FCA (see Figure 79 on page 452).

1. Refer to Figure 79 on page 452. Ensure that all three circuit protectors **1** on the FCA in the affected frame are ON.

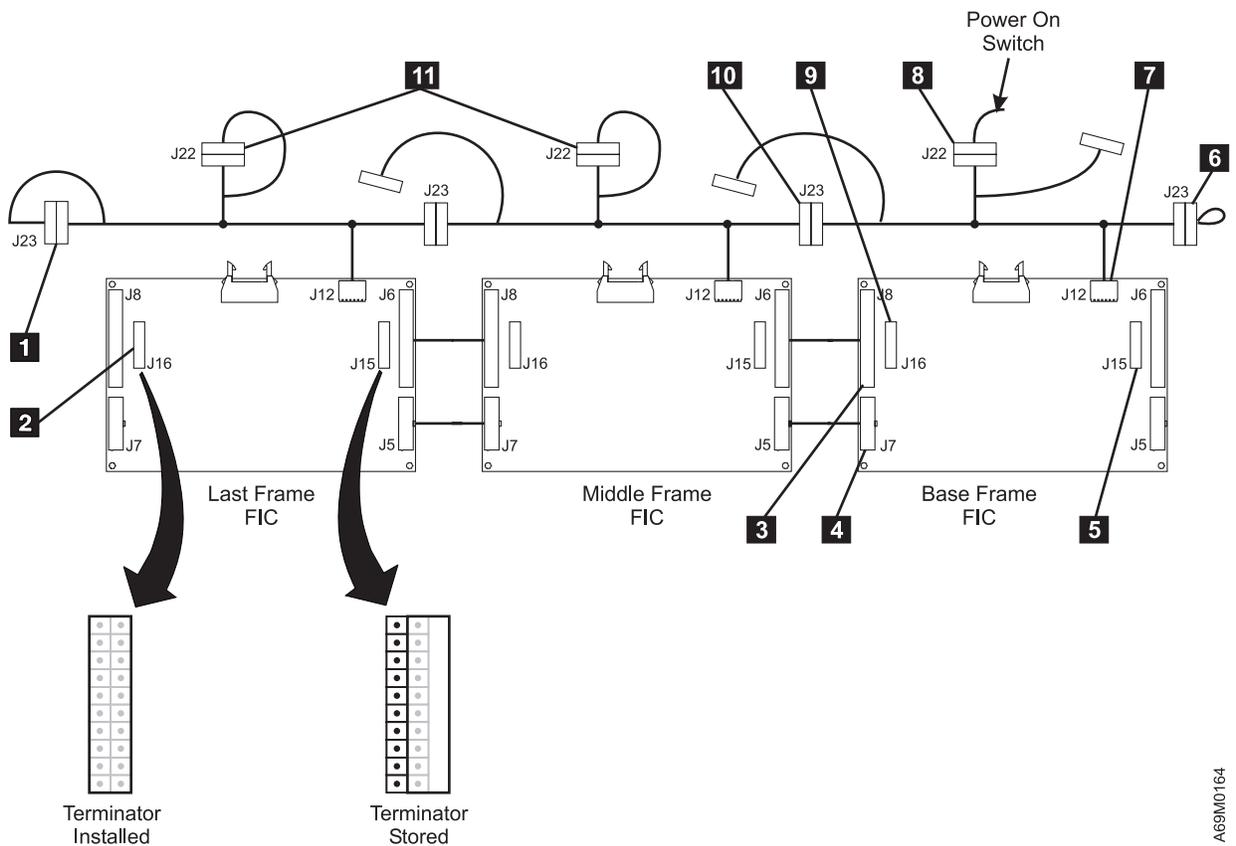
AG9M0164

Figure 80. FIC Card Connectors and Jumpers

Verify that the FIC wrap jumpers are installed correctly (see Figure 80 on page 455):

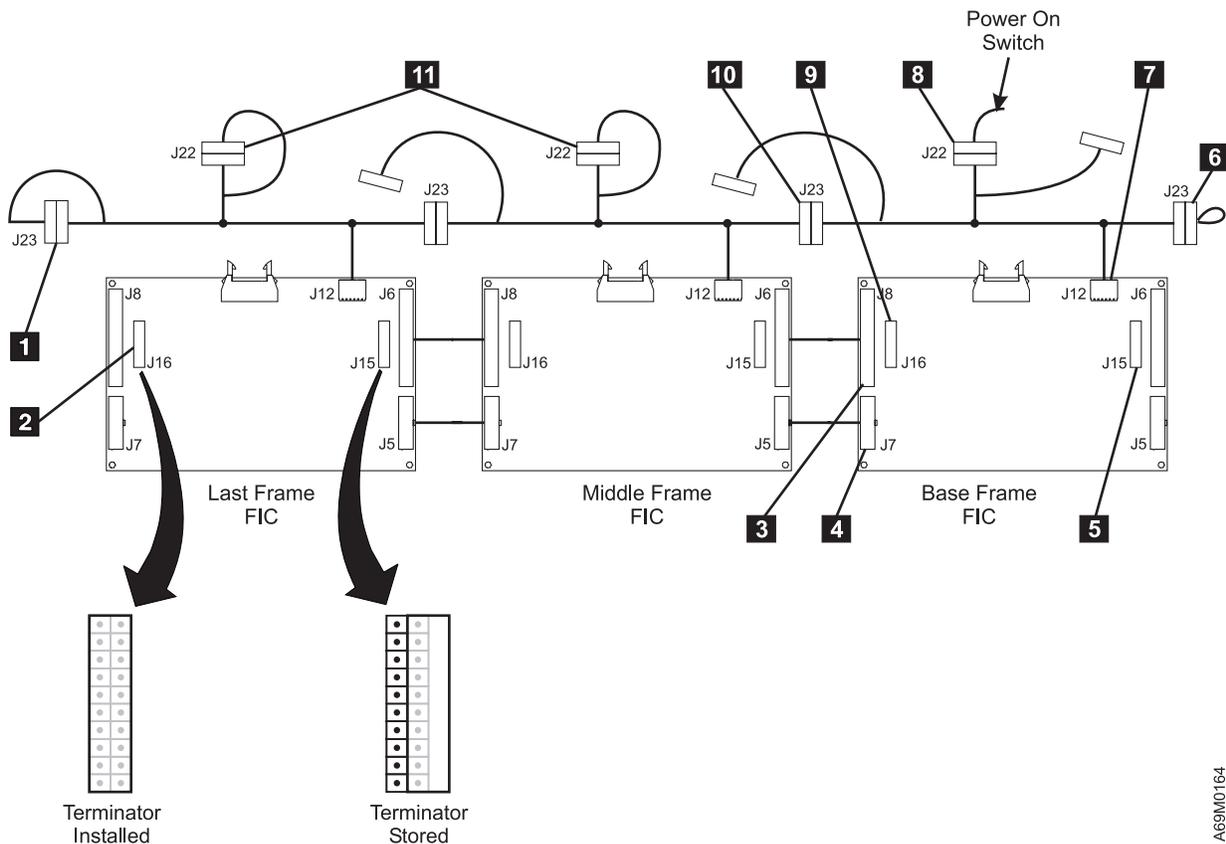
Figure 81. Placement of FIC Card when Emulating a Single Frame

3. Refer to Figure 81. Unplug the signal cable from the J8 connector **3** on the left side (as viewed from the rear) of the FIC card in frame 1.
4. Unplug the power cable from the J7 connector **4** on the left side of the FIC card in frame 1.
5. Unplug the frame 2 EPO cable (J23 connector **10**) from the left side of the frame 1 EPO cable.
6. Install the tethered jumper on the left end of the frame 1 EPO cable **10**.
7. Install the wrap jumper block (J16) **9** on the left side of the FIC card in frame 1.

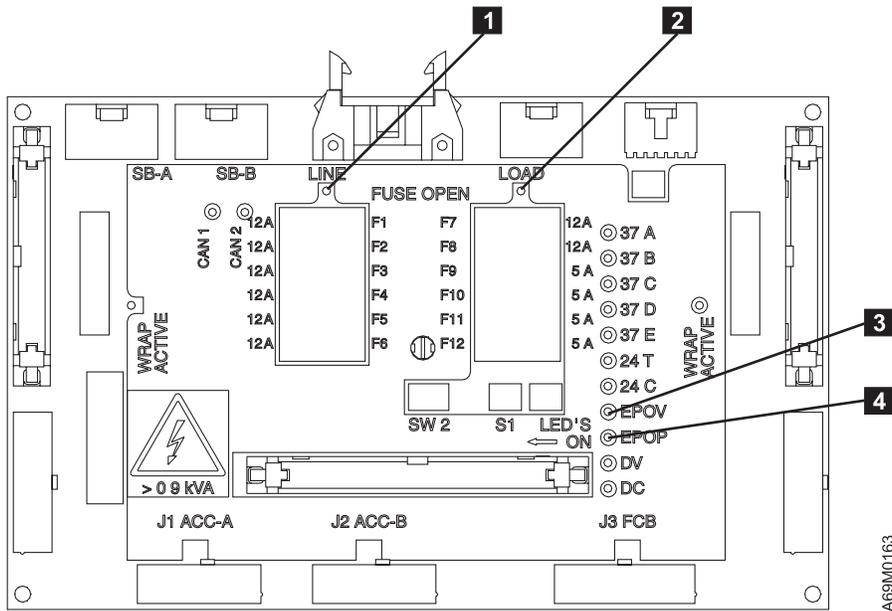
A69M0163

Figure 82. FIC Card EPOV and EPOP Indicators

Refer to Figure 82 on page 464. Visually check the EPOV and EPOP indicators **3** and **4** on the FIC in the affected frame.

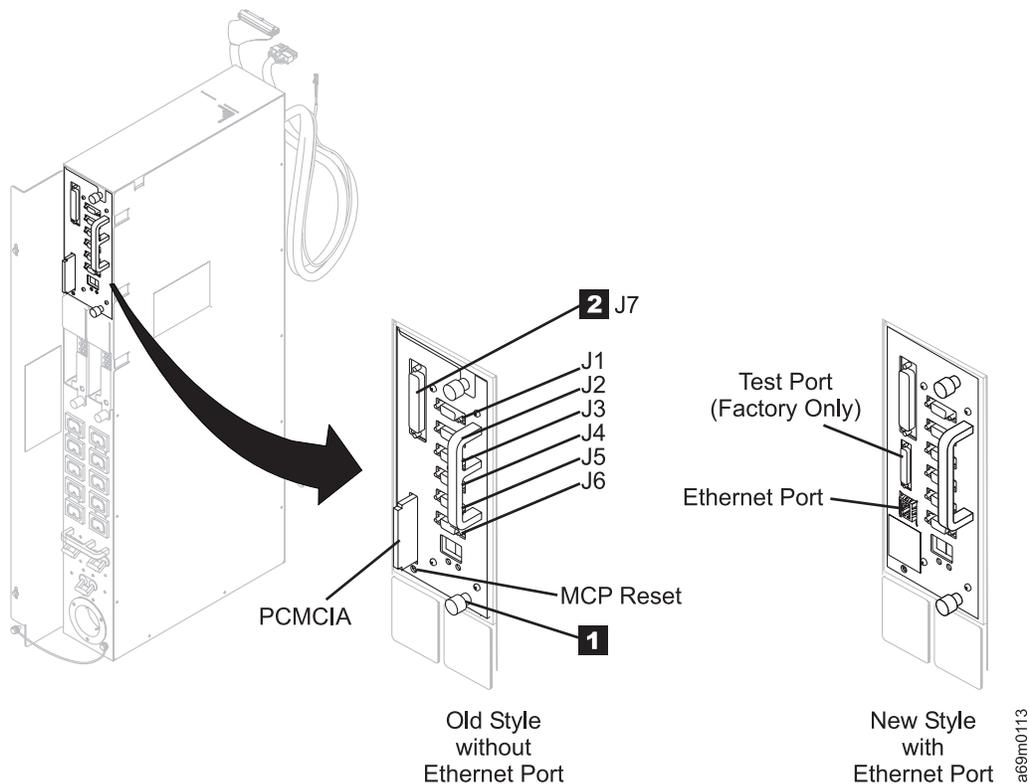
Figure 83. CETool J1 Connector

Note: When updating **library** microcode, you can connect to the J1 connector of **any** MCP on libraries with multiple MCPs. On libraries with multiple MCPs, you can connect to the J1 connector on any MCP, though you typically would connect it to the MCP in the base frame.

2. Set up a Short Cut (and icon on your Windows desktop) that you can click to run the program.
 - a. From the Windows desktop, select My Computer.
 - b. Select drive C: (or the drive onto which you downloaded the program), then find the folder to which you downloaded the file.
 - c. Right click on CETool.exe. A pulldown menu appears.
 - d. Select Create Shortcut. This creates a CETool shortcut in the same folder to which you downloaded the file.
 - e. Right click on this shortcut, hold down the right mouse button, drag it to the Windows desktop, and release the right mouse button.
 - f. Select Move Here. You now have a CETool shortcut on your desktop.
3. Using serial cable P/N 19P1061, connect the PC serial port to the MCP J1 connector.

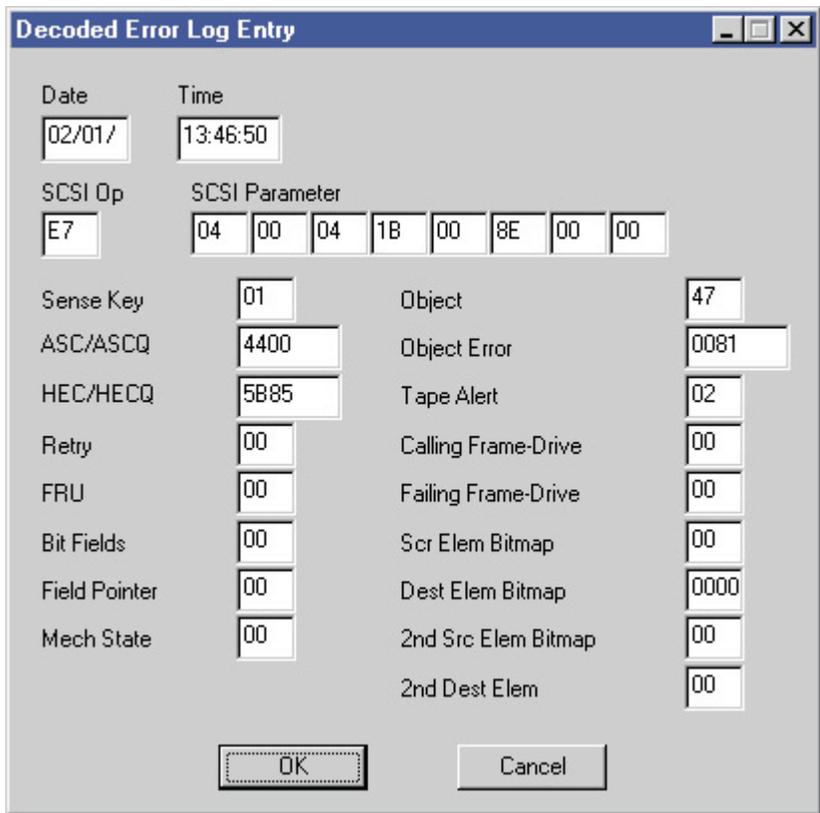
Figure 84. Error Log Screen Example

5. The resulting screen will display the errors in the log. The last non-zero entry is the most recent error.
6. Double click on the error log entry you wish to display.
7. The error log selected will look similar to Figure 84 on page 506.
8. For details on how to analyze the data in this screen, see “CETool Error Log Display Example” on page 442.

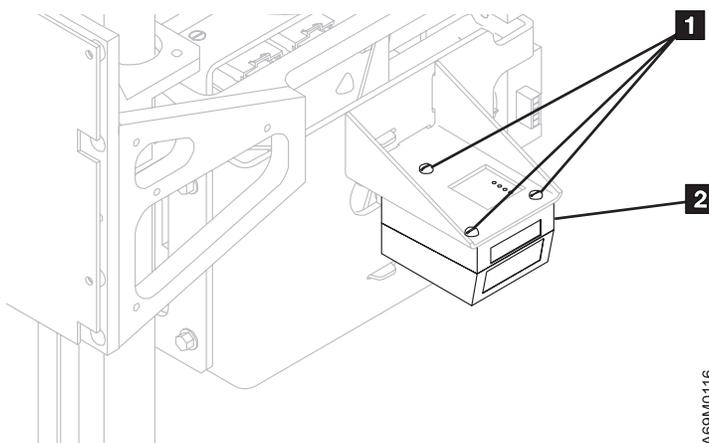
A69M0116

Figure 86. Bar Code Scanner Window

1. At the operator panel **Activity** screen, press [PAUSE].
2. When the library message indicates that the pause is activated, open the front door.
3. Check the cartridge labels for folds, missing pieces, tears or any extraneous markings, including smears or smudges along the length of the label.
4. If the labels are dirty or marked, clean the labels.
5. If a cartridge label needs to be replaced, the customer can order a kit containing enough replacement labels for 10 cartridges.
6. Clean the window of the bar code scanner **2**, using a lint-free cloth moistened with water. Two or three passes over the window area should clean the sensor.
7. Return to the procedure that sent you here; otherwise, go to “End of Call” on page 489.

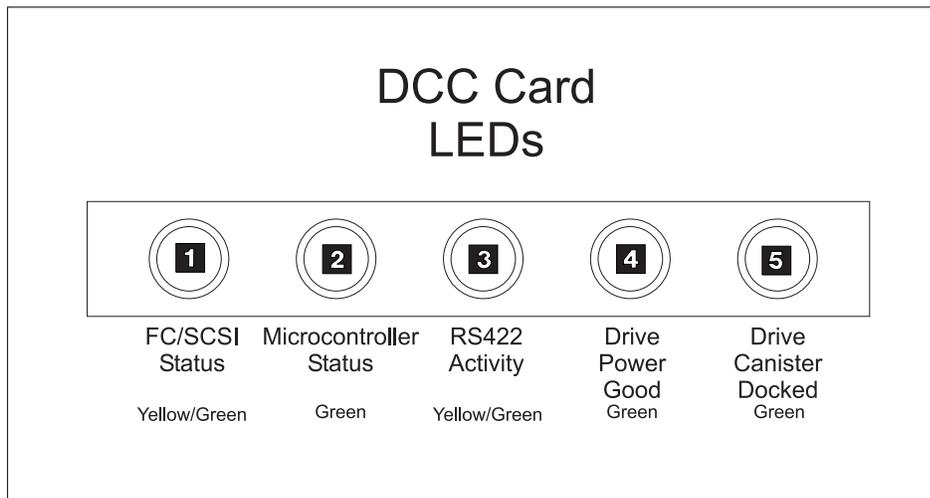
Each hot-swap drive canister and control port canister has a row of LEDs at the rear of the device. Figure 87 depicts the layout of the LEDs, and Figure 87 highlights the information you can learn from the LEDs. You can determine at a glance if a device is functioning correctly. If you determine that a service check points to a problem, consult with your customer before disrupting the job stream.

1. This service check may be performed without interrupting the customer job stream.
2. See Figure 87. View the LEDs on the rear of the canister. Locate the meanings of the LEDs in Table 61. The LEDs will mean something different for LTO SCSI, DLT SCSI, and LTO fibre drives.

Figure 87. Drive Canister LED Displays

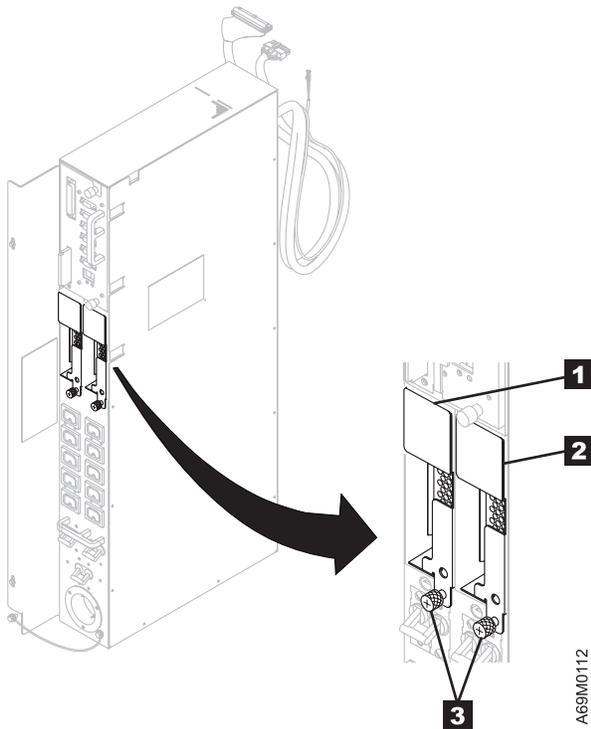
Figure 88. 37 V dc Power Supply Locations

Note: The reason these two cases are different is that the AC input power to both power supply bays in the FCA is tied together - the library code must either turn on AC power to both power supply bays or turn off AC power to both power supply bays. If there is only a single power supply in the FCA then the library code disables a power supply by turning off its AC power. But if there are two power supplies in the FCA, and one of them is being used, the unused power supply must have AC power applied (green LED). But the library code disables the output from the unused power supply, causing the yellow LED to turn on.

3. If both 37 V dc power supplies have failed, suspect the FCA.
4. Try swapping the two power supplies with each other. If the failure moves, suspect the 37 V dc power supply.
5. If the 37 V dc power supply failure remains in the original position after swapping the supplies, suspect the FCA.

See Figure 88 on page 545 for the location of these supplies.

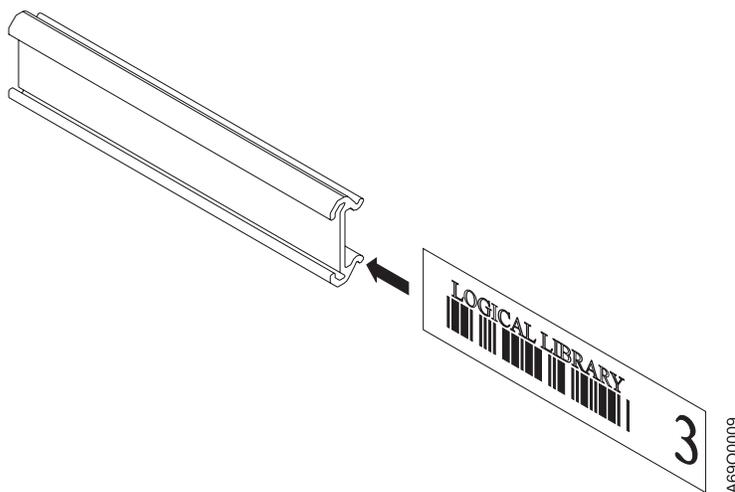
Figure 89. Sample Label and Holder

The customer may use logical library bar code labels to designate the physical breakout of logical libraries. Each IBM TotalStorage UltraScalable Tape Library 3584 comes with one sheet of 18 labels for each of five logical libraries and six holders for logical library labels. A sample label and holder are shown in Figure 89.

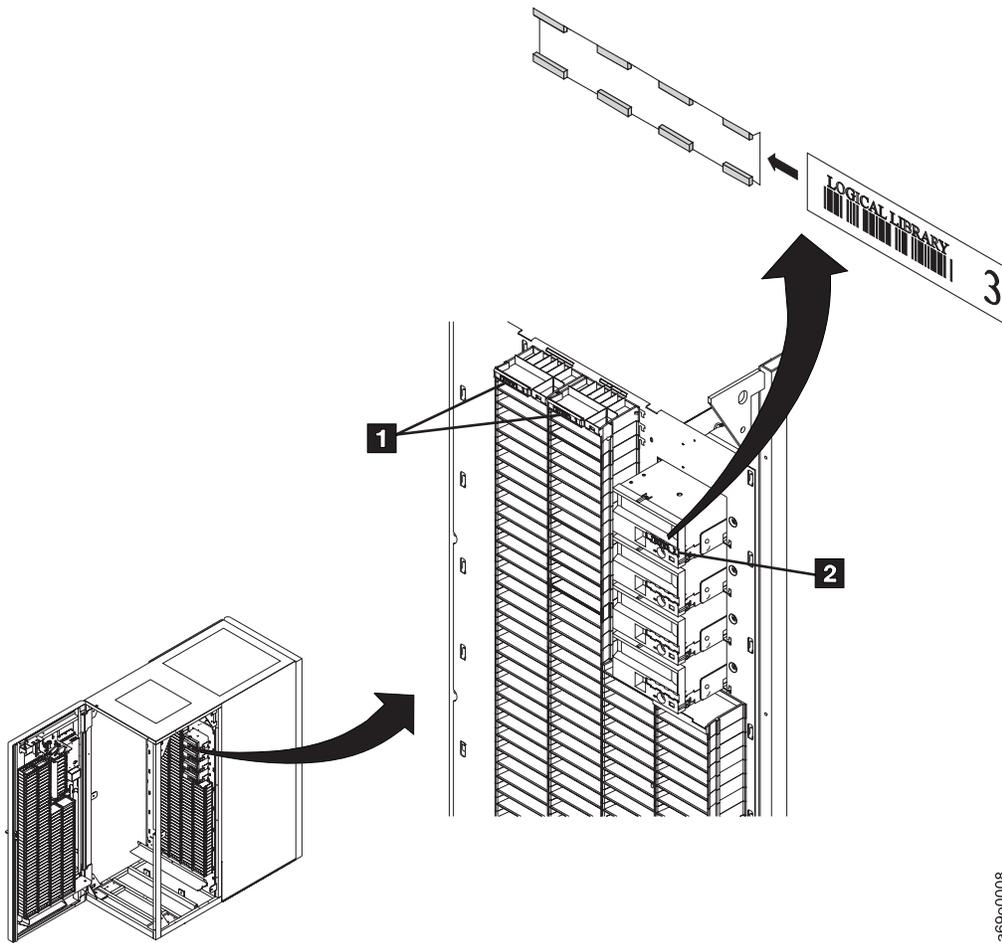
Figure 90. Sample Label and Holder Placement

1. At the operator panel **Activity** screen, press [PAUSE].
2. When the library message indicates that the pause is activated, open the front door.
3. Check the logical library labels **1** and **2** for folds, missing pieces, tears or any extraneous markings, including smears or smudges along the length of the label (see Figure 90 on page 549).
4. If the labels are dirty or marked, clean the labels.
5. If a label needs to be replaced, see Chapter 14, “Parts Catalog”, on page 697 for the part number.
6. If the labels are not damaged or dirty, clean the bar code scanner window with a lint-free cloth moistened with water. Two or three wipes over the window area should clean the sensor. For bar code scanner location, see “Bar Code Scanner” on page 554.

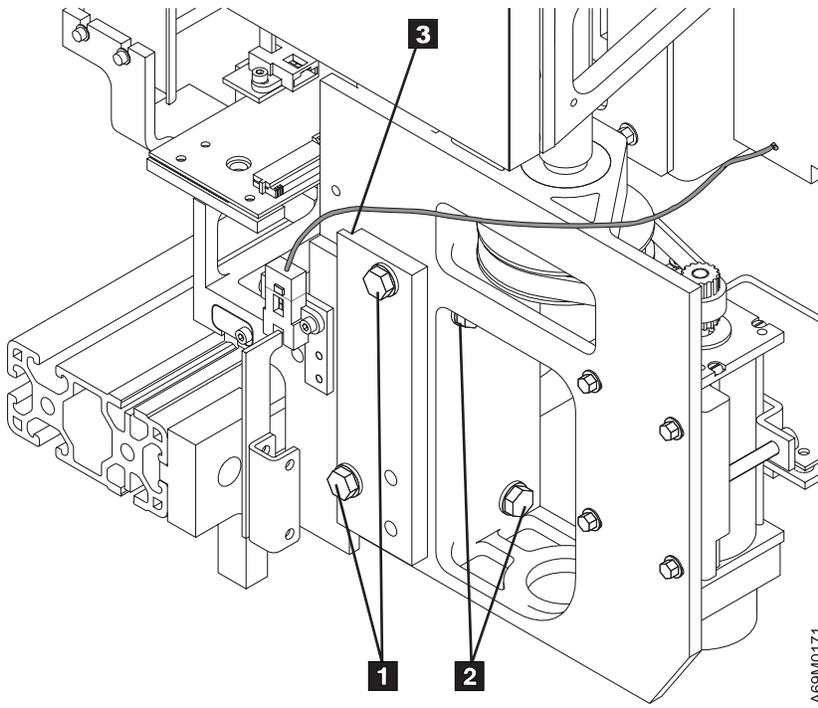
Figure 91. Y-Axis Mast – Bolts

5. Check the Y-axis flex cable for wear or damage.
6. Check the screws to ensure they are tight. The bolts and screws that secure the Y-axis mast assembly to the X-axis carrier must be tightened in the correct sequence.

Attention: The Y-axis mast will be deformed if the screws **1** are over tightened.

- a. Snug, but do not tighten the four screws.
 - b. Carefully tighten the two screws on the left side **1**.
 - c. Tighten the two bolts on the front **2**.
7. If you find a problem, use the FRU list at the beginning of this check. Exchange FRUs one at a time.
8. Close the front door.
9. Complete the accessor servicing (see “Service Procedures” on page 535).
10. Perform the “Library Verify Test” on page 507.
11. Return to the procedure that sent you here; otherwise, go to “End of Call” on page 489.

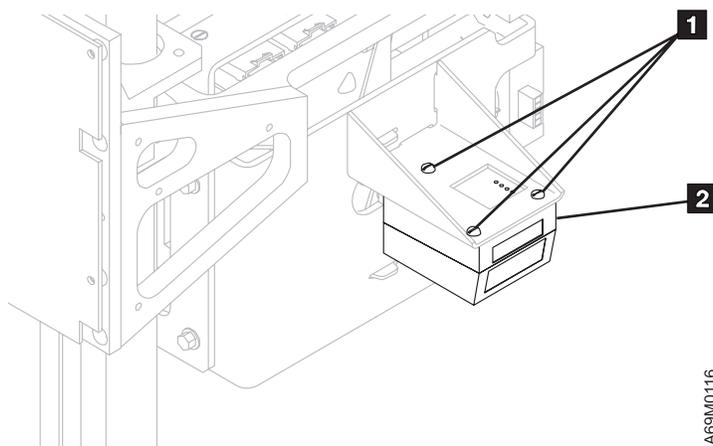
Figure 92. Bar Code Scanner

1. Reverse the removal procedure.
2. Close the front door.
3. Complete the accessor servicing (see “Service Procedures” on page 535).
4. Perform the “Library Verify Test” on page 507, using the **no drives** selection.
5. Return to the procedure that sent you here; otherwise, go to “End of Call” on page 489.

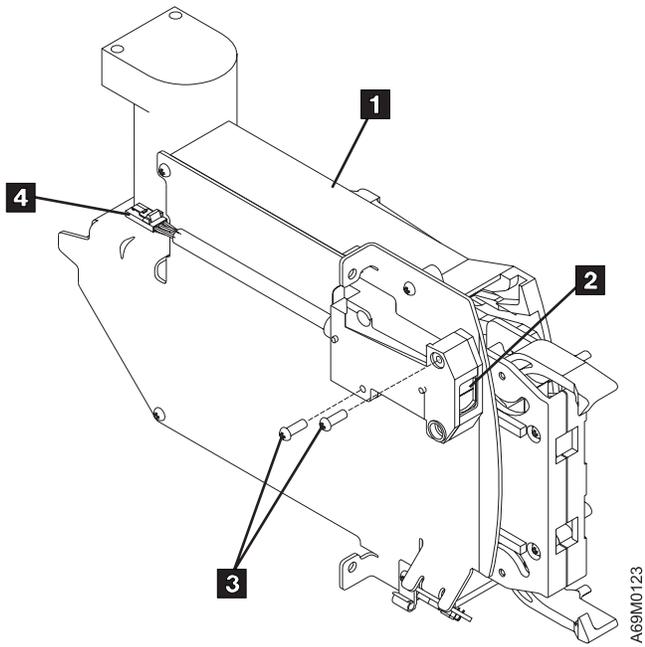
Figure 93. Calibration Sensor

Note: This FRU is factory-adjusted. The complete assembly must be replaced.

1. Reverse the removal procedure.
2. Close the front door.
3. Complete the accessor servicing (see “Service Procedures” on page 535).
4. Perform a library calibration (see “Library Calibration” on page 530).
5. Perform the “Library Verify Test” on page 507, using the **no drives** selection.
6. Return to the procedure that sent you here; otherwise, go to “End of Call” on page 489.

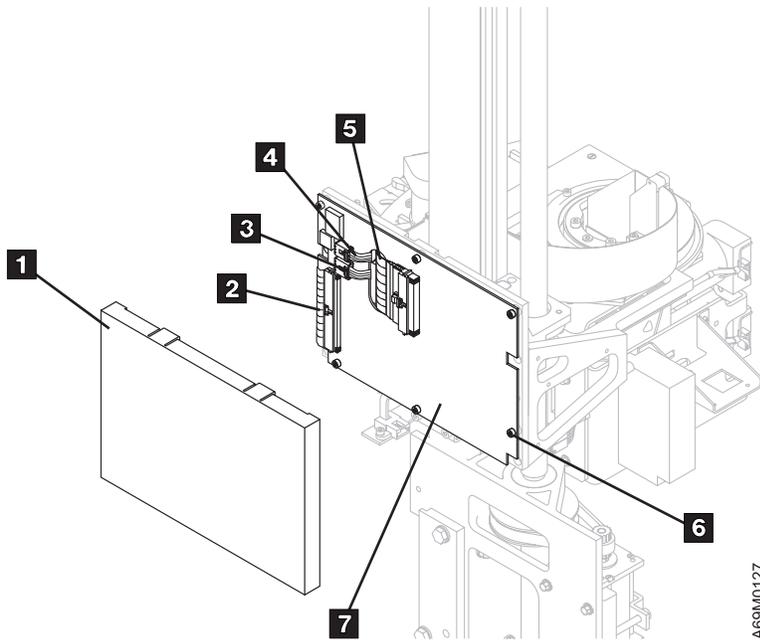
Figure 94. ACC Card

4. Remove the ACC card cover **1** by unsnapping it from the card (see Figure 94 on page 559).
5. Remove the following cables from the ACC card:
 - **2** Y-Axis flex cable

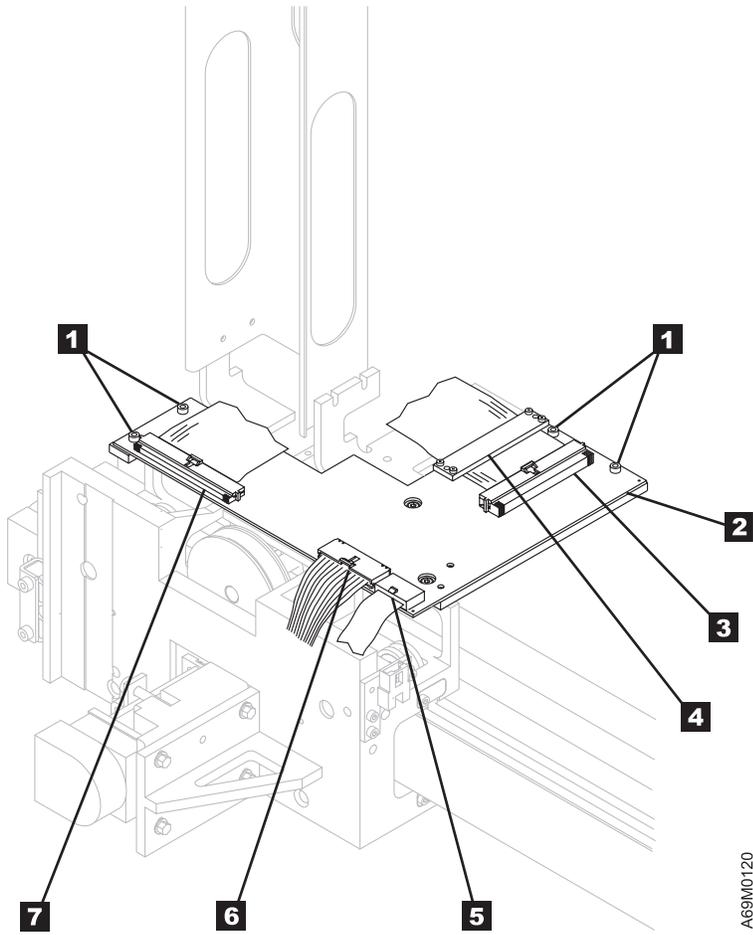
Figure 95. AXY Card

1. Prepare the accessor for servicing (see “Service Procedures” on page 535).
2. Move the X-axis assembly to a convenient position, then raise the lift mechanism. To support the mechanism, insert a hex wrench or screwdriver into the Y-axis mast access hole located halfway up the assembly.
3. Remove the X-axis cable trough cover (see **1** on Figure 41 on page 100).
4. Refer to Figure 95 on page 561 and locate the AXY card **2**, which is mounted on the X-axis assembly.
5. Locate the flat cable clamp **4**. Remove the two center screws that secure the clamp to the AXY card and in turn to the X-axis. Remove the four screws that secure the clamp to the flat cable.
6. Remove the four cables **3** through **7**.
7. Remove the four screws **1** (two shown).
8. Remove the AXY card.

1. Reverse the removal procedure.
2. Ensure that the hex wrench or screwdriver inserted into the Y-axis access hole is removed.
3. Close the front door.
4. Complete the accessor servicing (see “Service Procedures” on page 535).
5. Perform the “Library Verify Test” on page 507, using the **no drives** selection.
6. Return to the procedure that sent you here; otherwise, go to “End of Call” on page 489.

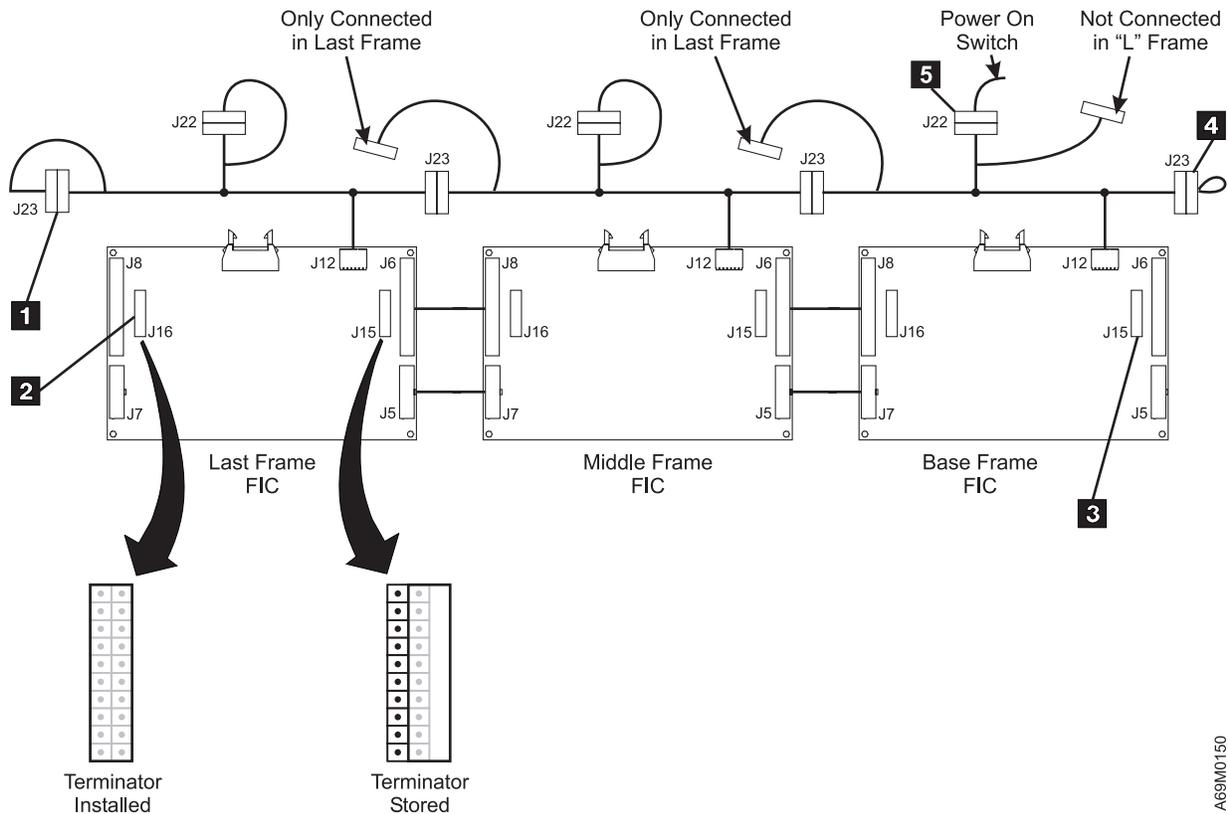
Figure 96. FIC Card Power Cable Tethered Jumper

1. Perform the procedure in “Prepare for FIC Replacement” on page 536.
2. Refer to Figure 96 on page 563 and, ensure that jumpers **1** and **4** are installed on each end of the EPO cable.
3. If you are going to replace a cable, refer to Figure 96 on page 563 and Table 62 on page 563. Replace the cable.
4. From the rear of the frame that contains the FIC card you want to replace, remove the cables that are plugged into that FIC card. Table 62 on page 563 shows which connectors are used and where each cable goes.

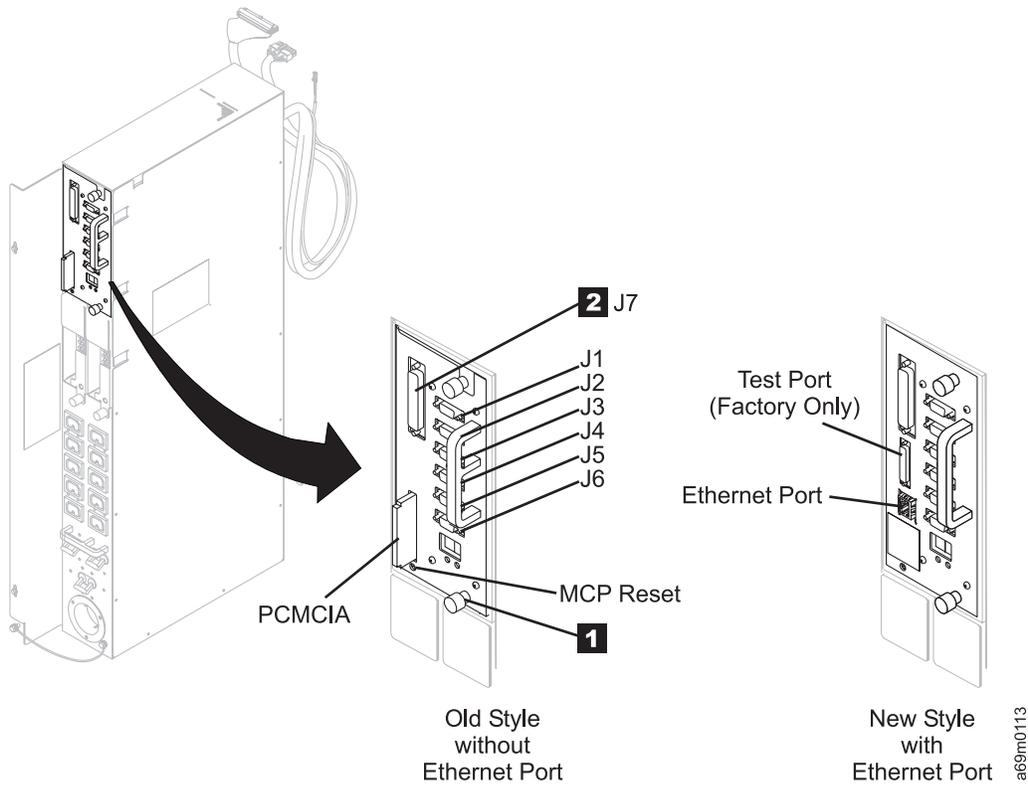
Figure 97. Media Changer Pack

3. Refer to Figure 97 on page 565 and loosen the two knurled screws **1** that hold the MCP to the FCA.
4. Slide the MCP out about 50 mm (2.0 in.).
5. Remove all cables from the MCP.
 - RS-422 connector **2** at J7
 - RS-422 connector at J3 (control port only)
 - CE cable at J1 (if cable is present)
 - Modem at J6 (if installed)
 - Ethernet (on new style MCP)
6. Remove the MCP from the FCA.

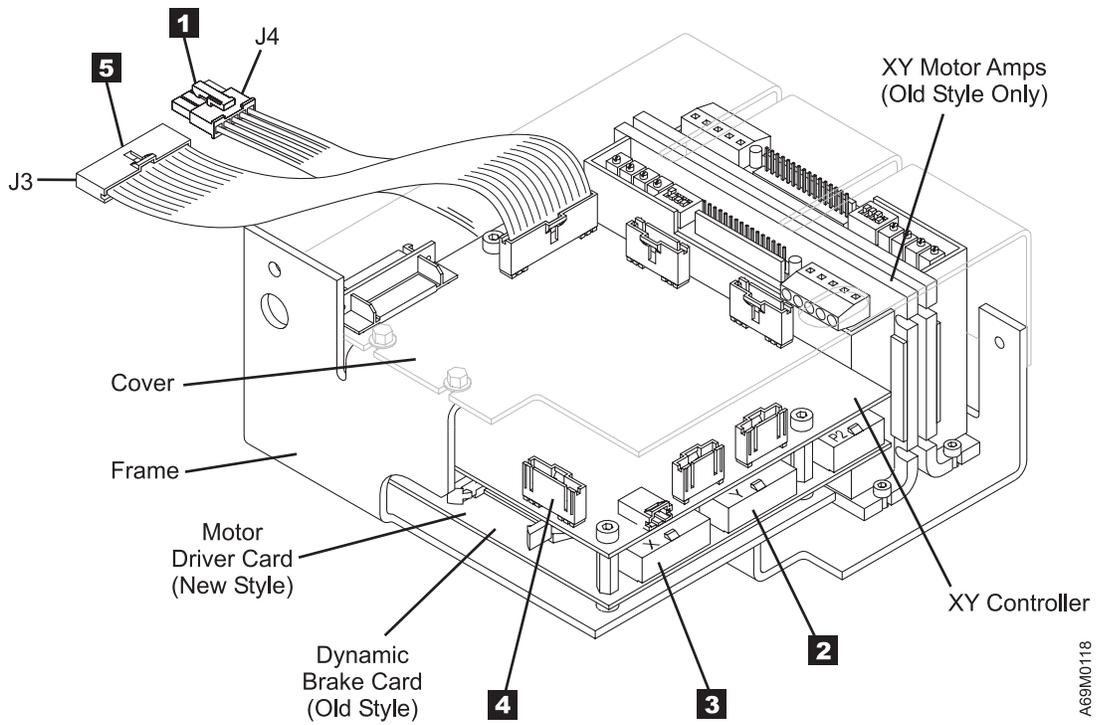
Figure 98. MDA Cabling. (Shown from front, with phantom view of cover, for clarity)

1. Prepare the accessor for servicing (see “Service Procedures” on page 535).
2. Raise the dual gripper assembly up the Y-axis mast and insert a hex wrench or screwdriver through the Y-axis mast access hole.
3. The MDA is located on the Y-axis assembly, near the bottom of the assembly. Refer to Figure 99 on page 567, and loosen the four screws **1** to remove the cover. **Note:** The new style MDA has only two screws on each side of the cover.
4. Refer to Figure 98 on page 567 and remove five cables **1** through **5**, attached to the MDA.

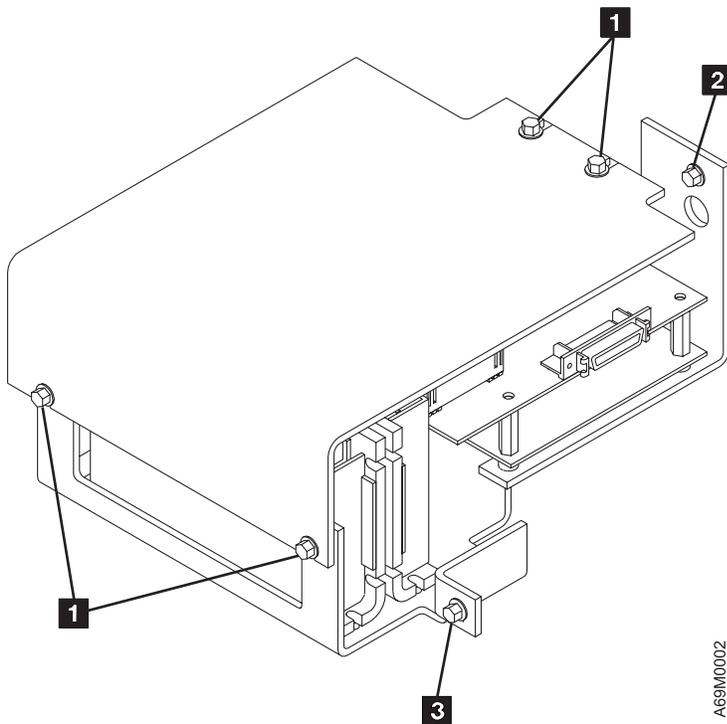
Figure 99. Motor Driver Assembly (MDA). (Shown with cover installed)

Note: The motor driver assembly (MDA) is mounted on the bottom of the accessor, and contains the dynamic brake card, the XY controller, and the XY motor amps. The MDA controls X and Y motor movement, dynamic braking, and other motor controls. The entire MDA is a FRU and cannot be broken down any further to individual components.

5. Refer to Figure 99 on page 567. Remove bolt **2** and bolt **3** to remove the MDA from the Y-axis assembly.

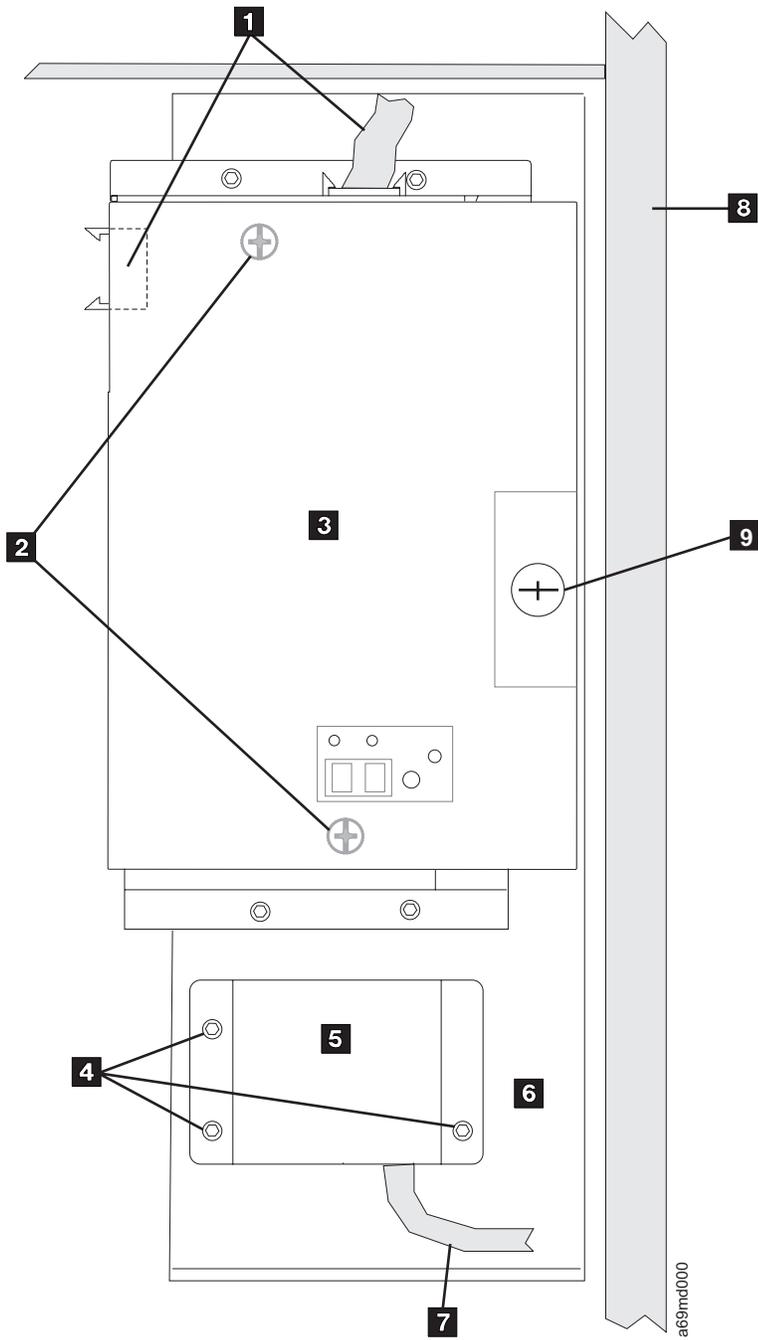
Figure 100. Operator Panel. (Viewed from rear of front door)

5. Refer to Figure 100 on page 570 and remove the connector **1** at the top of the Operator Panel. This cable goes to the FIC card and must be removed before you unplug other cables as part of the removal/replace procedure.

- Note:** Be sure to plug the top cable **1** which supplies power from the FIC card **last**.
2. If the new OPC firmware is at a lower level than the rest of the node cards, the firmware in the OPC will be updated automatically. The OPC 2-character display will flash 0E 0x or 0F 0x while microcode is being synchronized. Wait for this process to complete before you continue.
 3. The later style operator panels have a pot **9** to adjust the contrast of the display screen.
 4. Close the front door.
 5. The library will perform a rezero, then a calibration.
 6. Perform the “Library Verify Test” on page 507, using the **no drives** selection.
 7. Make the library **Ready** to the host.
 8. Return to the procedure that sent you here; otherwise, go to “End of Call” on page 489.

When working with the XIO card, always remove the operator panel assembly cable first or attach it last to prevent damaging the operator panel (see item 1 in Figure 100 on page 570).

1. Open the door of the base frame (L32).
2. From the back side of the base frame front door, disconnect the cable from the operator panel assembly (see item 1 in Figure 100 on page 570).
3. Remove the three screws **3** to remove the plastic cover **2**.
4. Remove the operator panel assembly cable.
5. Disconnect the three cables **4** from the XIO card **1**.
6. Lift the XIO card **1** off the pins to remove it from the door.

When reattaching cables to the XIO card, ensure you reconnect the cable from the operator panel assembly to the XIO card last (see item 1 in Figure 100 on page 570).

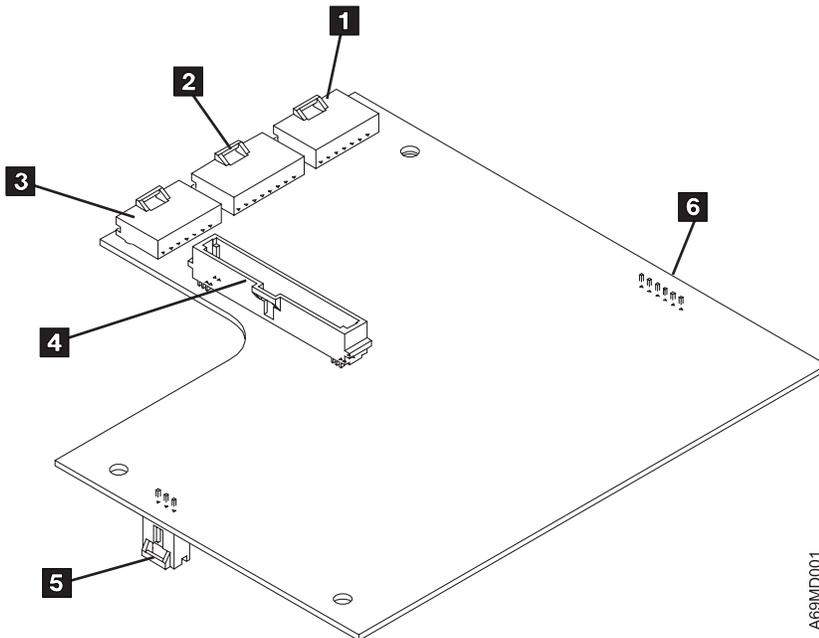
Figure 101. PDC Card Cables

1. Prepare the accessor for servicing (see “Service Procedures” on page 535).
2. Turn the gripper assembly to a convenient position.
3. Remove the dual gripper assembly. See “Gripper Assembly, Dual” on page 622, then return here.
4. Remove the upper gripper assembly. See “Gripper Assembly, Single (New Style)” on page 624, then return here.
5. Refer to Figure 101 to remove any remaining cables on the PDC card.
6. Refer to Figure 102 on page 573, and remove five screws **2**.
7. Remove the PDC card **1**.

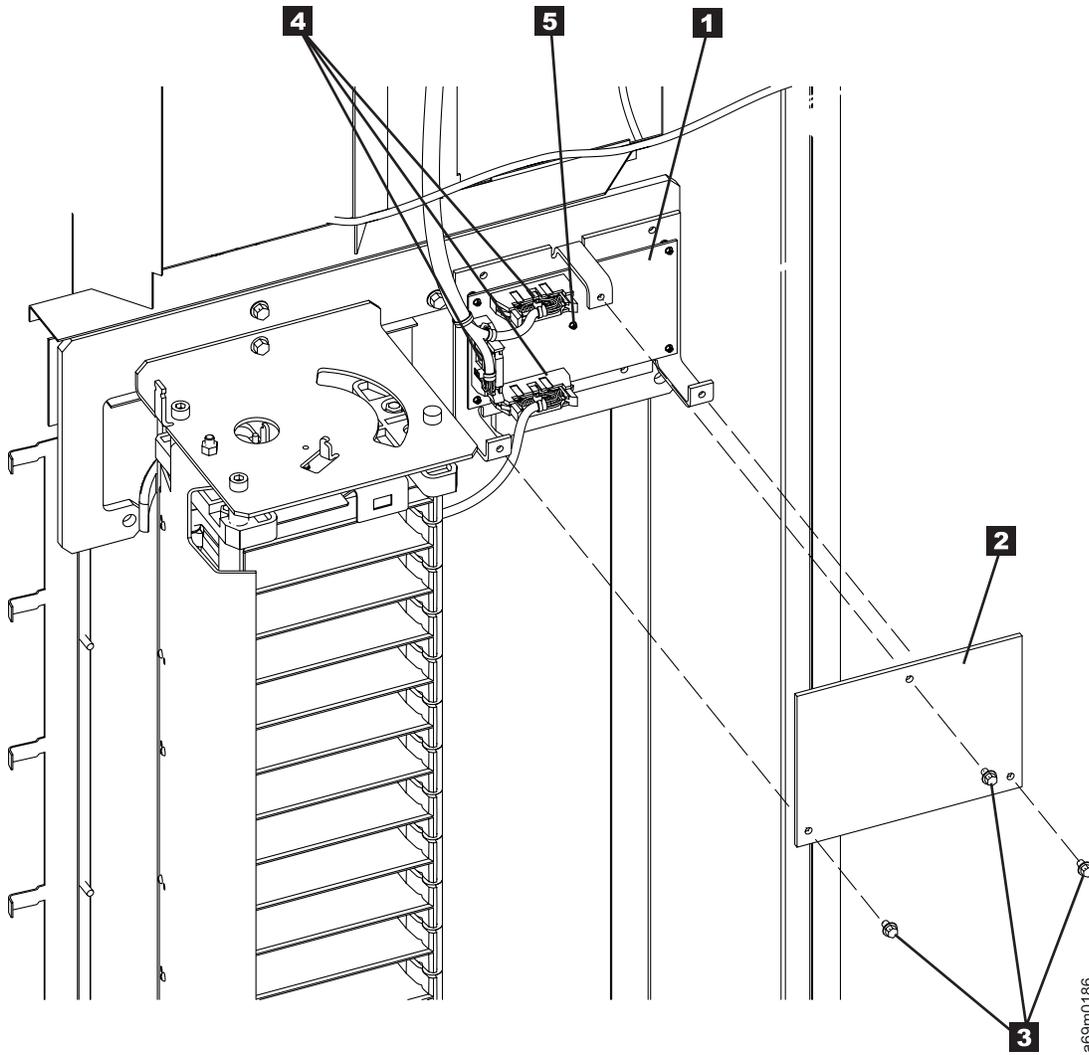
Figure 104. XIO Card

1. Reverse the removal procedure, noting the following:
 - The cable from the bottom of the lower I/O station connects to the lower connector of the XIO card.
 - The cable from the top of the upper I/O station connects to the middle connector of the XIO card.
 - The cable from the operator panel connects to the top connector of the XIO card.
2. Reconnect all XIO cables and connectors.
3. Reconnect the operator panel cable.
4. Close the front door.
5. Perform an I/O station calibration (see “Library Calibration” on page 530).
6. Perform the “Library Verify Test” on page 507, using the **no drives** selection.
7. Return to the procedure that sent you here; otherwise, go to “End of Call” on page 489.

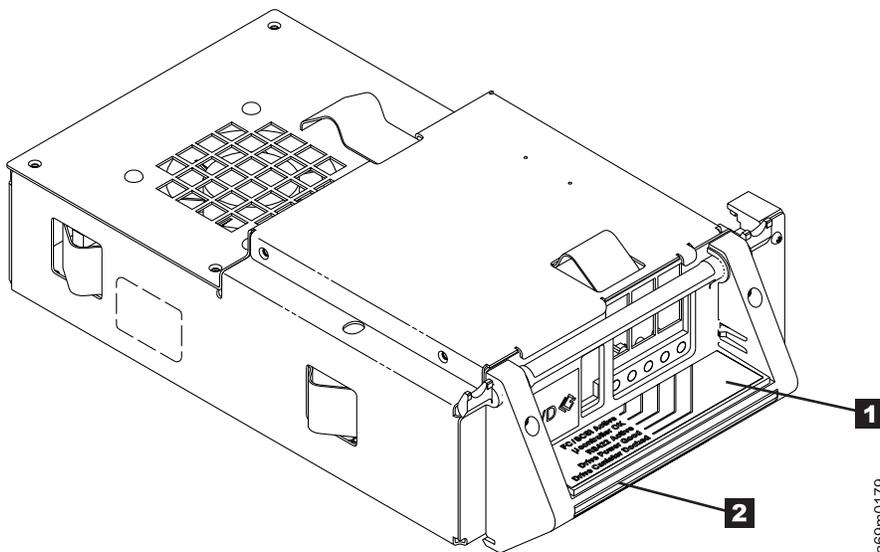
Figure 105. Control Port – SCSI

2. Prepare the control port for replacement (see “Service Procedures” on page 535).
3. Open the rear door of the frame containing the control port canister.
4. Refer to Figure 105. Use your fingers to push up on the locking lever **1** from the underside of the control port canister until it unlatches.
5. While holding the locking lever up, grasp the control port canister handle **2**. Firmly pull back on the handle enough to disengage the control port canister.
6. Use your other hand to support the control port canister from the underside, as you remove the control port canister from the fixed tray assembly.

1. Carefully slide the new control port canister into the fixed tray assembly.
2. Hold up the locking lever **1** to ensure the tabs on both sides of the lever will clear the frame.
3. Grasp the control port canister handle **2**, and carefully but firmly push the control port into position. Ensure that the connectors correctly align and fully engage with the fixed tray connectors.
4. Lower the locking lever **1** until it snaps into place.

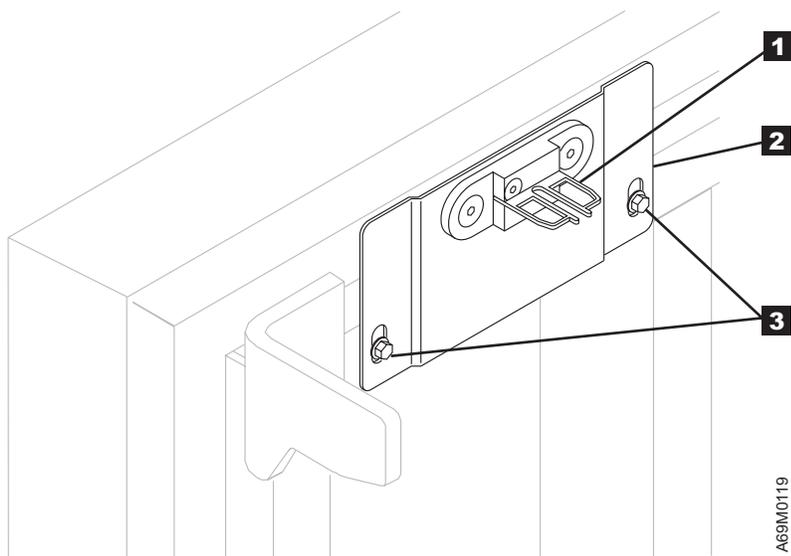
Figure 107. Door Interlock Actuator

1. Reverse the removal procedure.
2. When replacing this assembly it must be adjusted so that the actuator **1** enters the door interlock switch assembly fully, without binds or interference. Tighten the holding screws **3** so that the door closes easily without any binds or interference with the door interlock switch assembly.
3. Close the front door.
4. Complete accessor servicing (see “Service Procedures” on page 535).
5. Ensure that the door interlock is working (detects when the door has been opened). This may require adjustment of the door interlock actuator.
6. Return to the procedure that sent you here; otherwise, go to “End of Call” on page 489.

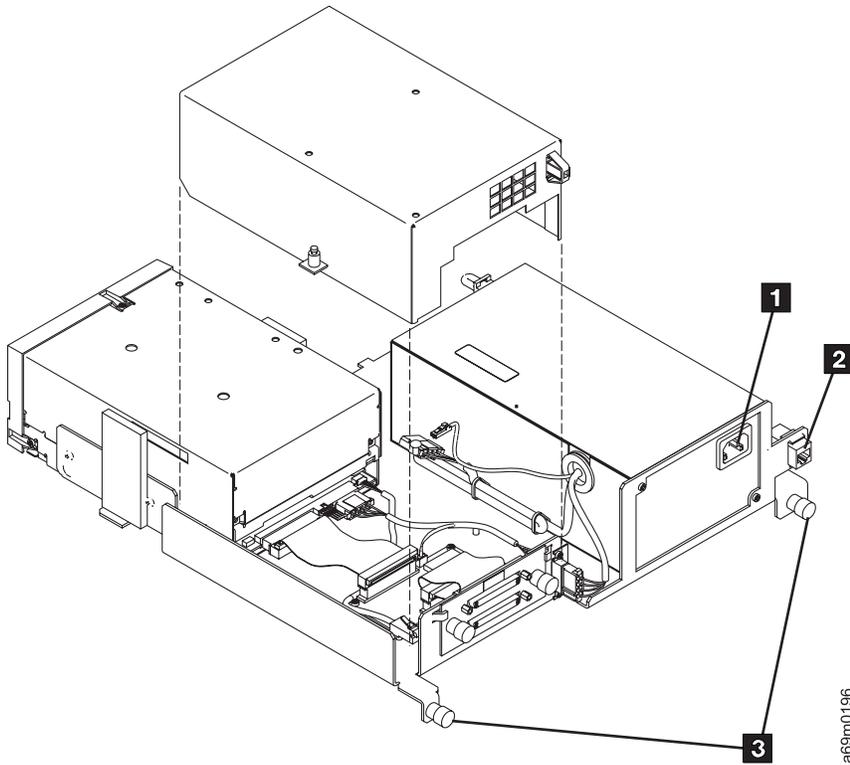
Figure 109. SCSI Drive Tray Assembly – Rear View

2. Prepare for drive replacement (see “Service Procedures” on page 535).
 3. Open the rear door in the frame containing the drive.
 4. Refer to Figure 109 on page 586. Unplug the AC power cable **1** from the back of the drive tray.

- If a logical library label holder is attached to the old drive, remove it and install it on the new drive.
- The drive safety flaps must **NOT** be removed when installing the drives. The safety flaps will pivot out of the way when the drive is installed.

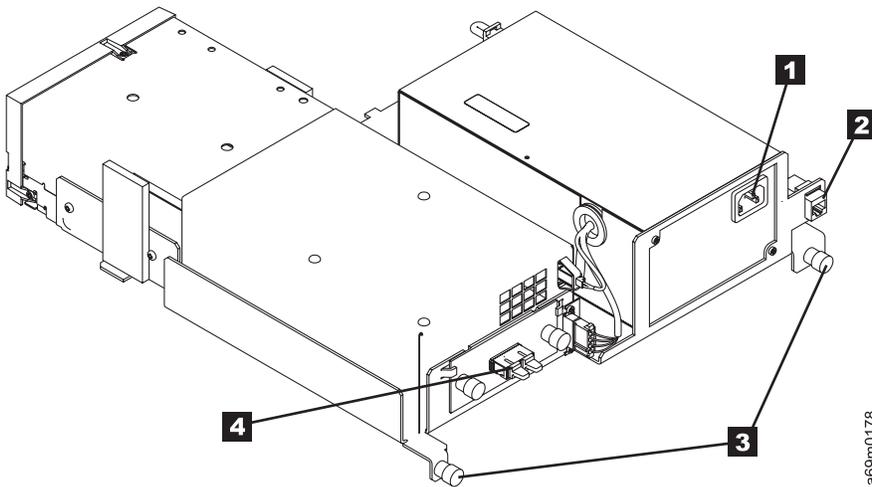
Figure 110. Drive Tray Assembly – LTO Fibre

3. Open the rear door in the frame containing the drive.
 4. Refer to Figure 110 on page 588. Unplug the AC power cable **1** from the back of the drive tray.

- If a logical library label holder is attached to the old drive, remove it and install it on the new drive.
- The drive safety flaps must **NOT** be removed when installing the drives. The safety flaps will pivot up out of the way when the drive is installed.
- If you are copying drive microcode either **to** or **from** a control port drive, the drive and its entire logical library string of drives will be unavailable to the library until the microcode update is complete.
