IBM TotalStorage UltraScalable Tape Library 3584

Maintenance Information

Ninth Edition (June 2003)

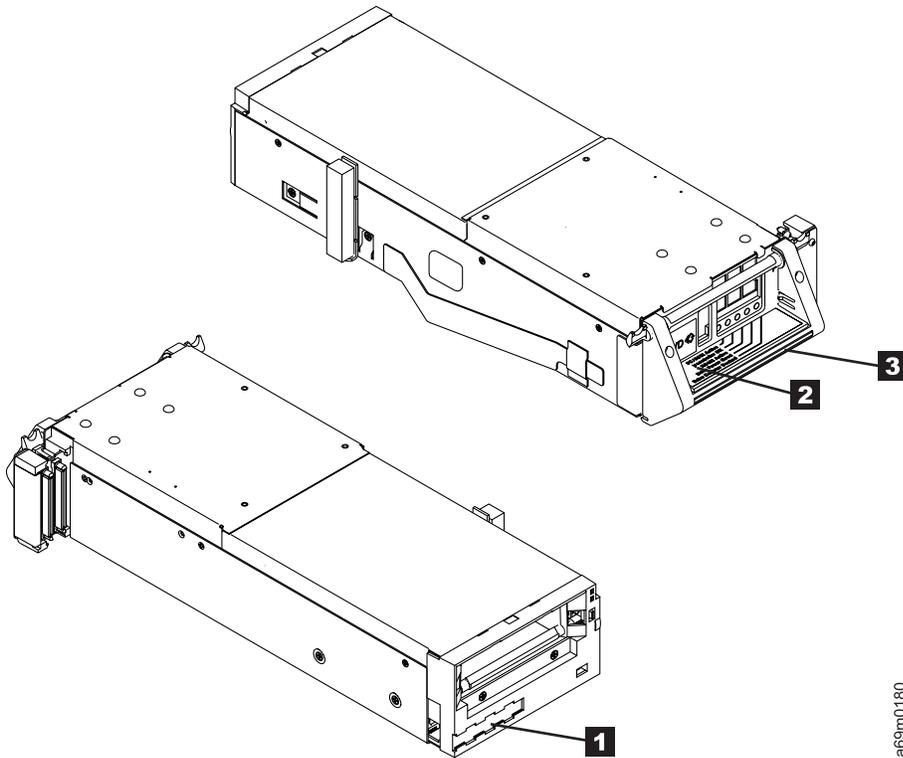
Figure 111. Drive Tray Canister – DLT-8000 SCSI Hot Swap

1. Notify the customer that you will be taking a drive or drives out of operation. Ask the customer to vary offline all the drives on the same SCSI bus.
2. Prepare for drive replacement (see “Service Procedures” on page 535).
3. Open the rear door of the frame containing the drive canister.
4. Refer to Figure 111 on page 591. Use your fingers to push up on the locking lever **2** from the underside of the drive canister until it unlatches.
5. While holding the locking lever up, grasp the drive canister handle **3**. Firmly pull back on the handle enough to disengage the drive canister.
6. Use your other hand to support the drive canister from the underside, as you remove the drive canister.
7. If there is a stuck cartridge in the drive, go to “From a DLT-8000 Drive” on page 676. If not, complete the drive replacement.

1. Carefully slide the drive canister into the fixed tray assembly.
2. Hold the locking lever **2** up to ensure the tabs on both sides of the lever will clear the frame.
3. Grasp the drive canister handle **3**, and carefully but firmly push the drive into position. Ensure that the connectors to the right correctly align and fully engage with the fixed tray connectors.
4. Lower the locking lever **2** until it snaps into place.

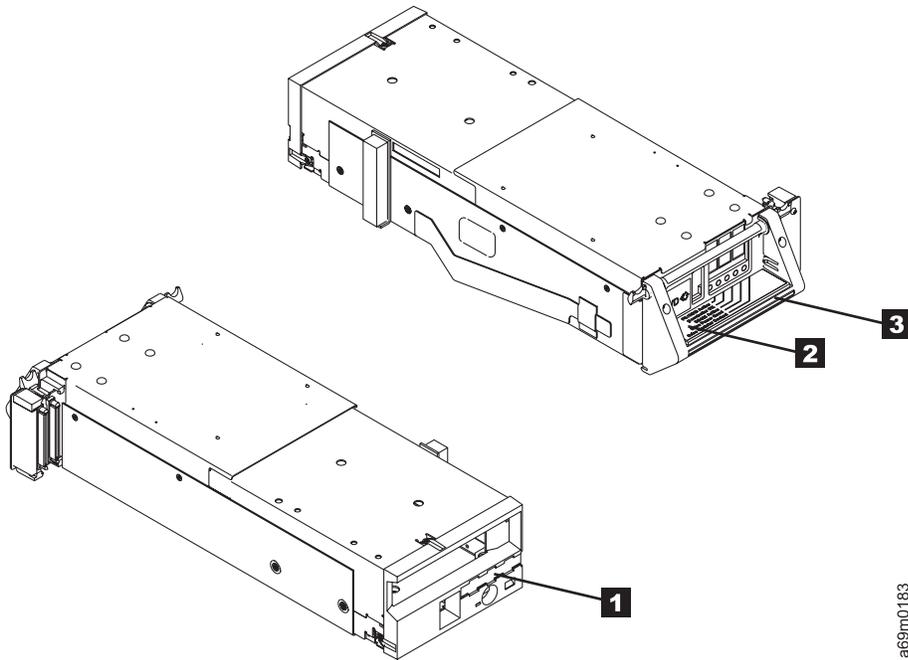
Figure 112. Drive Canister Assembly– LTO SCSI Hot Swap

1. Carefully slide the drive canister into the fixed tray assembly.
2. Hold the locking lever **2** up to ensure the tabs on both sides of the lever will clear the frame.
3. Grasp the drive canister handle **3**, and carefully but firmly push the drive into position. Ensure that the connectors to the right correctly align and fully engage with the fixed tray connectors.
4. Lower the locking lever **2** until it snaps into place.

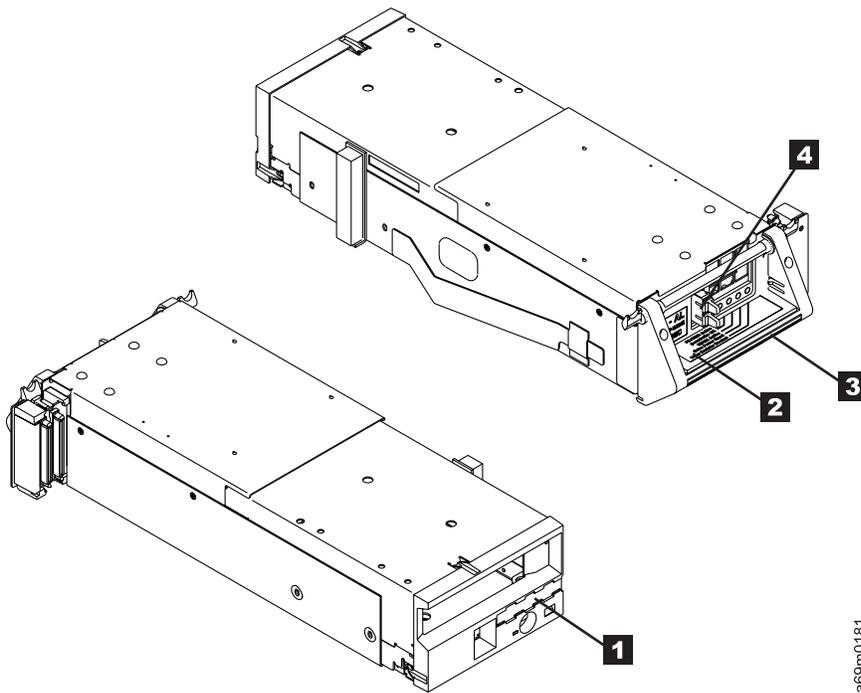
Figure 113. Drive Canister Assembly– LTO Fibre Hot Swap

3. Open the rear door of the frame containing the drive.
 4. Refer to Figure 113 on page 595. Unplug the fibre cable **4**.
 5. While holding up the locking lever **2**, grasp the drive canister handle **3**. Firmly pull back on the handle enough to disengage the drive canister.

1. Carefully slide the drive canister into the fixed tray assembly.
2. Hold the locking lever **2** up to ensure the tabs on both sides of the lever will clear the frame.
3. Grasp the drive canister handle **3**, and carefully but firmly push the drive into position. Ensure that the connectors to the right correctly align and fully engage with the fixed tray connectors.
4. Lower the locking lever **2** until it snaps into place.
5. Replug the fibre cable.

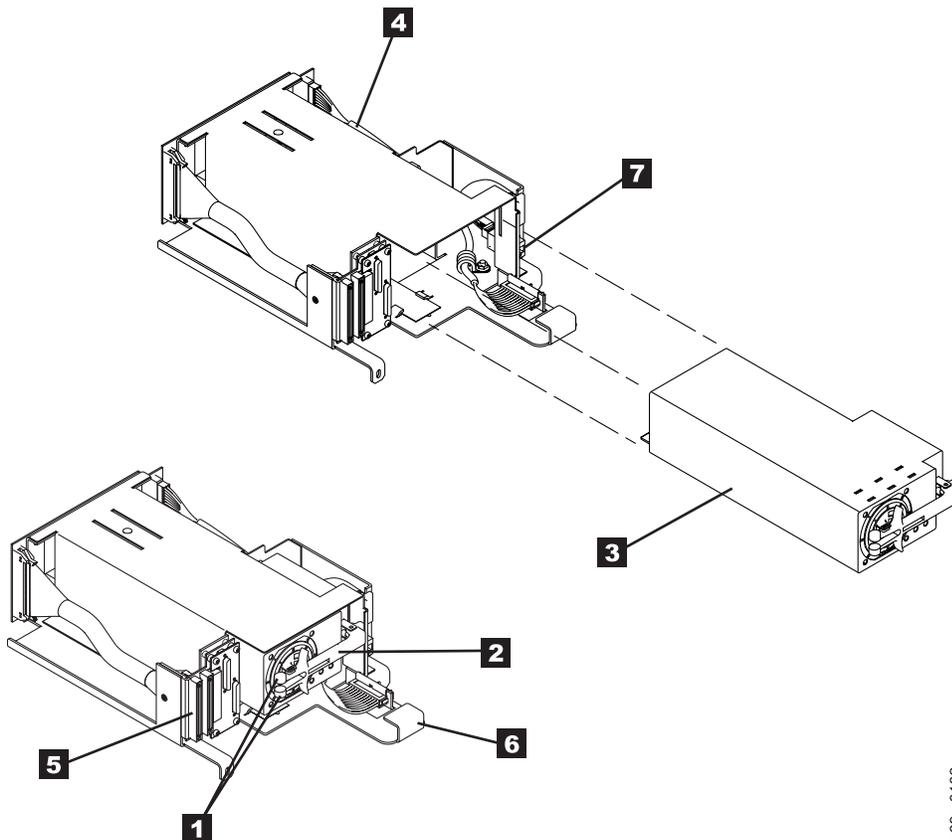
Figure 114. Redundant Power Supply – Hot Swap

1. Carefully slide the power supply canister **3** into the fixed tray assembly **4**.

2. Pinch together the locking arms **1** and slide in the power supply **3**, as you use the locking arm assembly **2** as a lever to move the power supply canister **3** into the locked position.

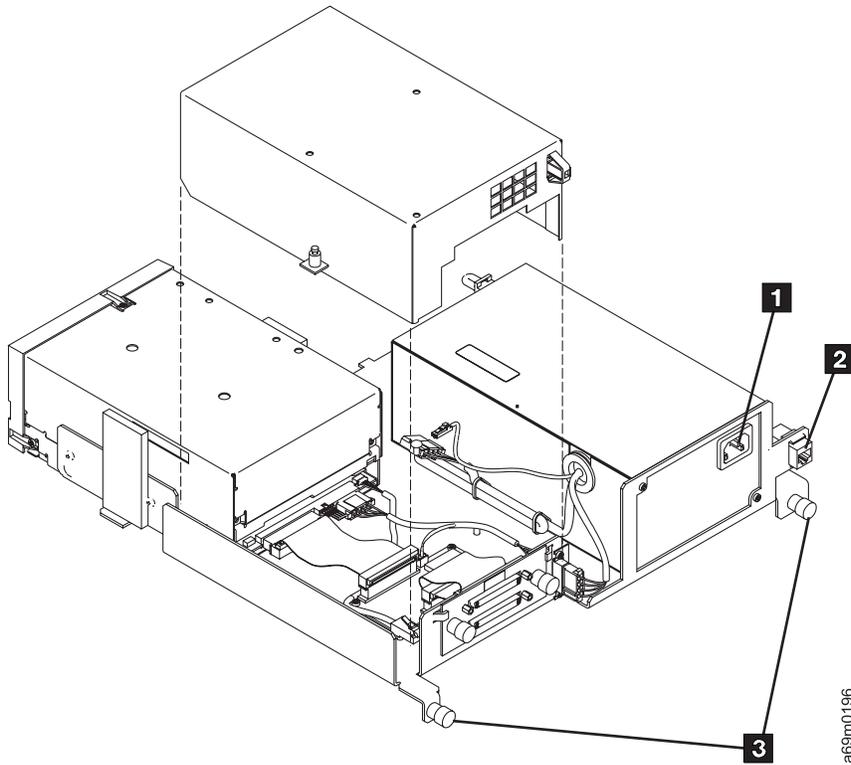
Figure 115. Unplugging AC Power Cables

2. Prepare for drive replacement (see “Service Procedures” on page 535).
 3. Open the rear door in the frame containing the drive.
 4. Unplug the AC power cable **1** from the back of the drive tray.

5. Unplug the RS-422 cable **2** from the back of the drive tray.
6. Unplug the SCSI cables (and terminator, if installed) from the back of the drive tray.
7. Loosen the screws **3** to remove the drive tray.
8. If there is a stuck cartridge in the drive, go to “From an LTO Drive When Cartridge is Stuck in Loader” on page 679. If not, complete the drive replacement.

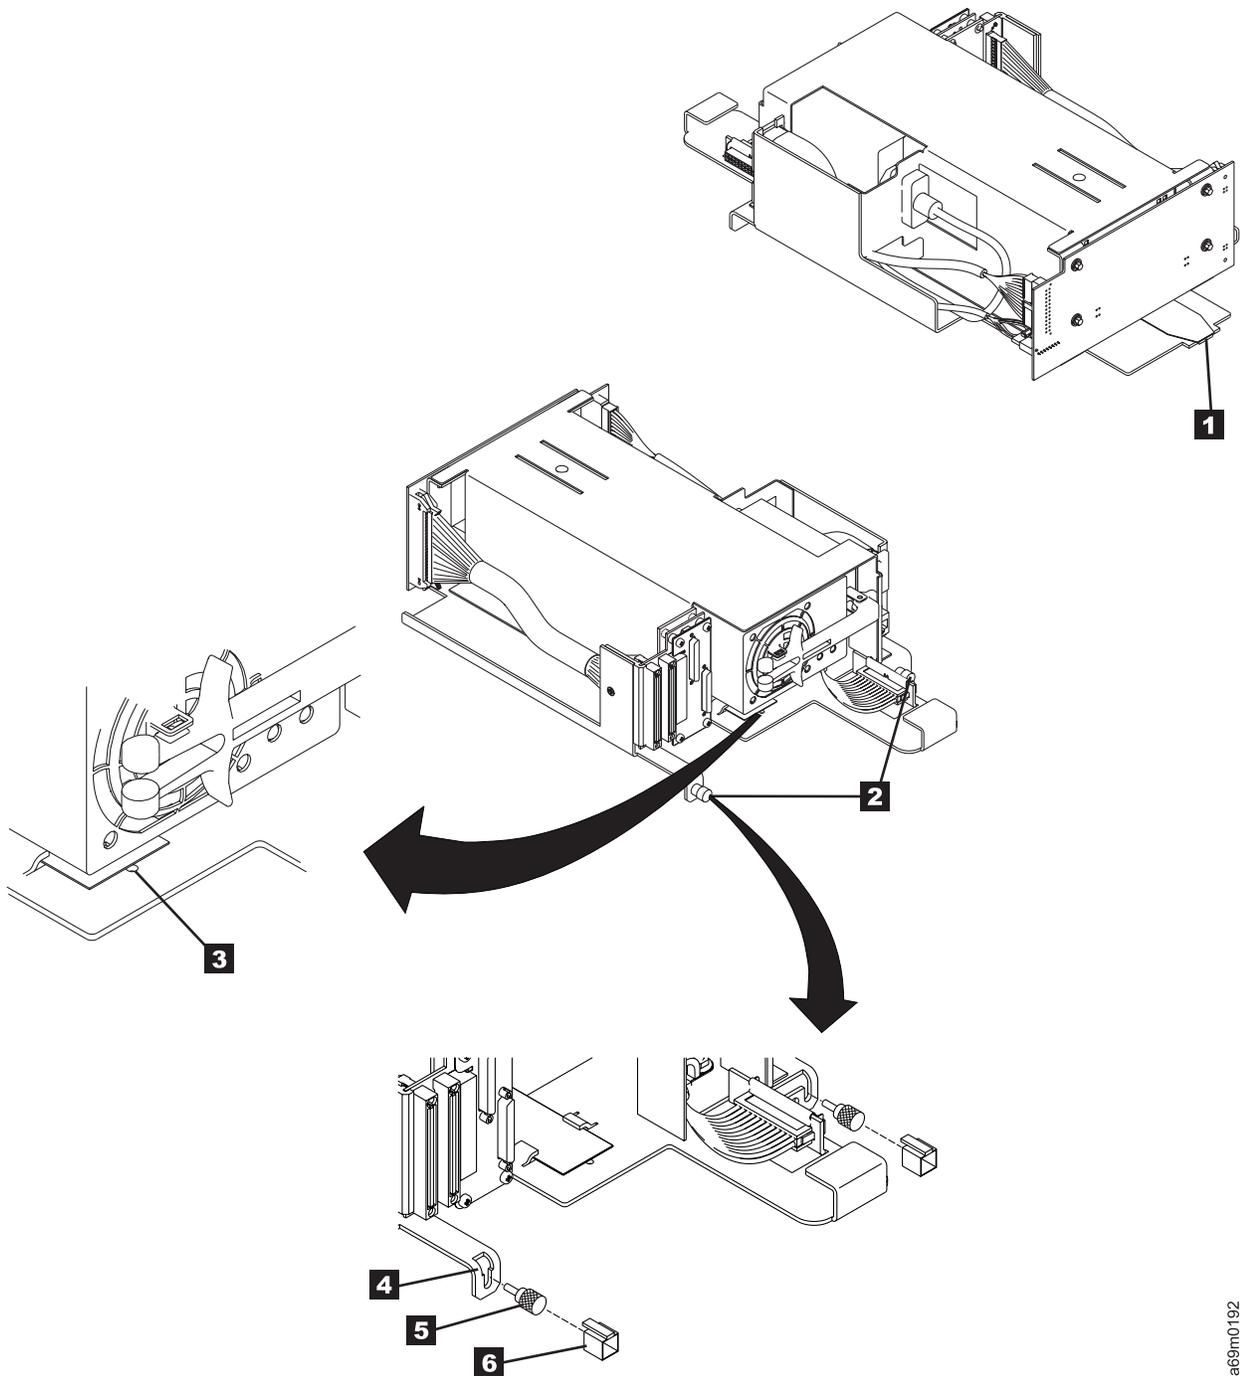
Figure 116. Fixed Tray

1. Slide in the fixed drive tray assembly, keeping it toward the right side. Ensure the front locating tab **1** on the tray assembly slides securely into the front slot in the frame (see Figure 116 on page 600).

Note: As the front locating tab seats into the slot in the frame, the indicator slide will move to partially cover the indicator hole **3**. If you see the indicator slide move toward the indicator hole (partially covering it), then the locating tab is positioned in the slot. If the indicator slide does **not** move, slide the front of the fixed tray assembly left or right until the locating tab slides into the slot.

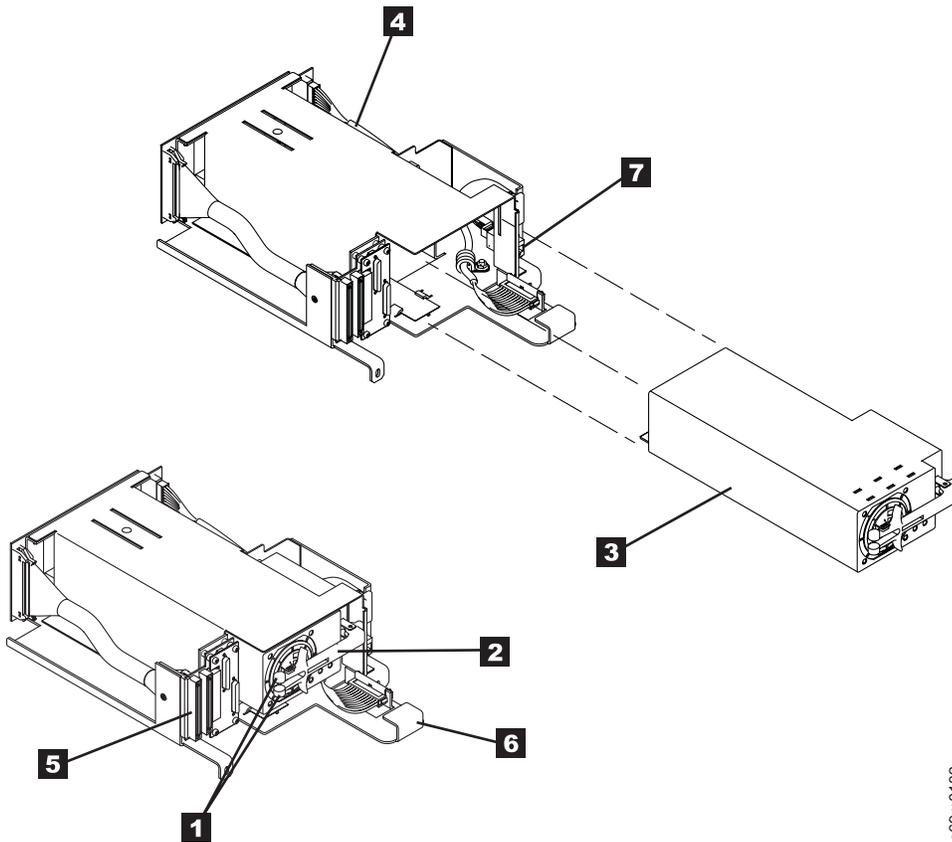
Figure 118. Hot Swap Power Supply

- Pivot locking arm assembly **2** outward.

- Firmly slide the power supply **3** into the fixed tray assembly.
- Swing the locking arm to the left while you pinch the two locking tabs **1** together, securing the arm in place.

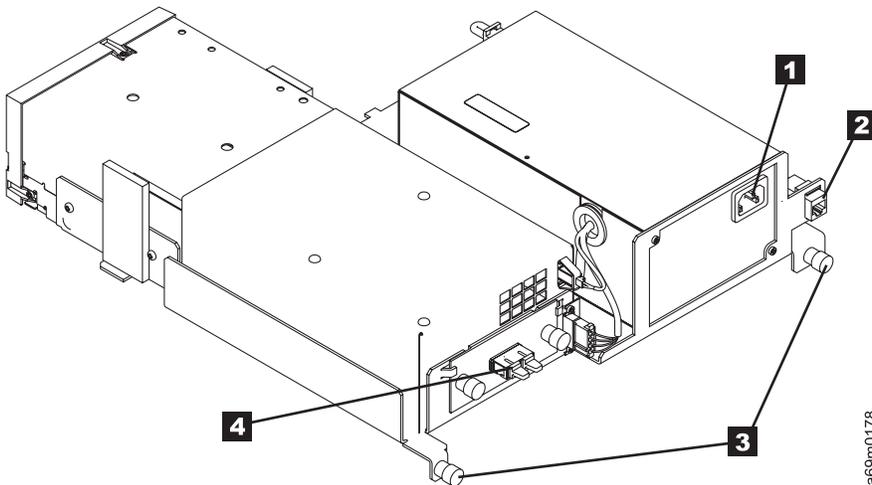
Figure 120. Drive Tray Assembly—LTO Fibre

2. Prepare for drive replacement (see “Service Procedures” on page 535).
 3. Open the rear door in the frame containing the drive.
 4. Unplug the AC power cable **1** from the back of the drive tray.

5. Unplug the RS-422 cable **2** from the back of the drive tray.
6. Unplug the fibre cable **4**.
7. Loosen the screws **3** to remove the drive tray.
8. If there is a stuck cartridge in the drive, go to “From an LTO Drive When Cartridge is Stuck in Loader” on page 679. If not, complete the drive replacement.

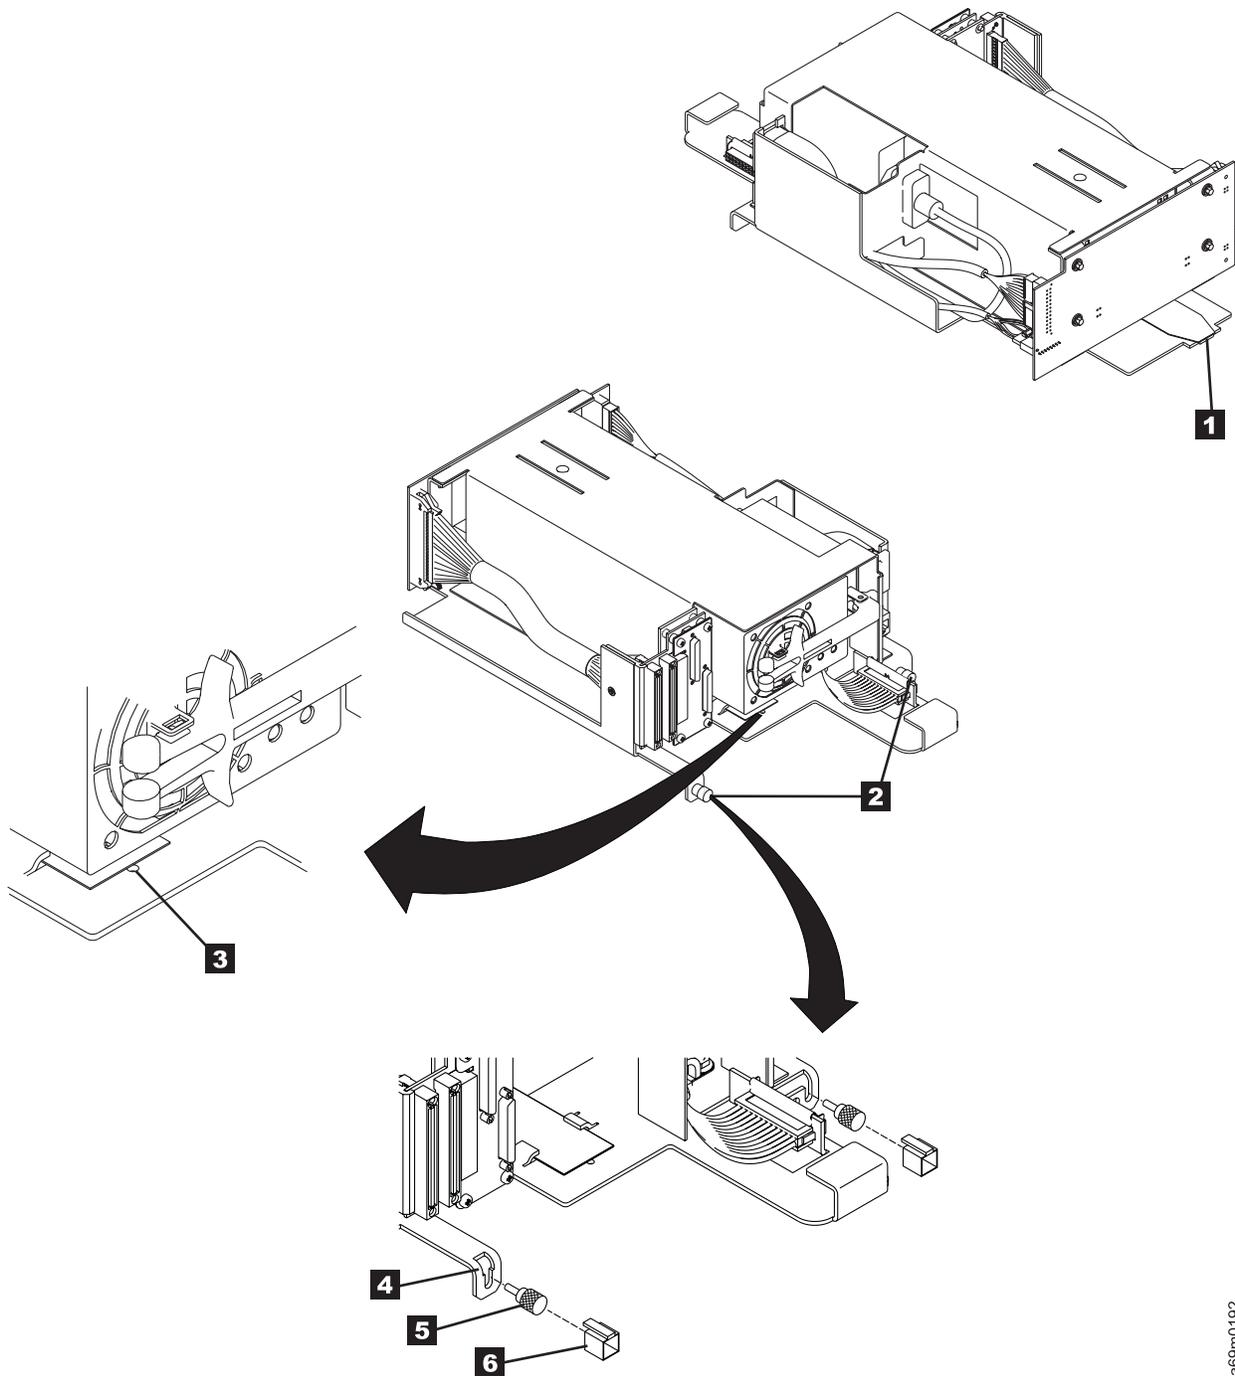
Figure 121. Fixed Tray

1. Slide in the fixed tray assembly, keeping it toward the right side. Ensure the front locating tab **1** on the tray assembly slides securely into the front slot in the frame.

Note: As the front locating tab seats into the slot in the frame, the indicator slide will move to partially cover the indicator hole **3**. If you see the indicator slide move toward the indicator hole (partially covering it), then the locating tab is positioned in the slot. If the indicator slide does **not** move, slide the front of the fixed tray assembly left or right until the locating tab slides into the slot.

2. Tighten both thumbscrews **2** to be **fingertight only**. Do not overtighten these screws.
3. If your fixed tray has notches **4** near the thumbscrews, secure the tray with two knurled thumbscrews **5**. Slide the thumbscrew caps **6** over the screws until the tab slides all the way into the notch.

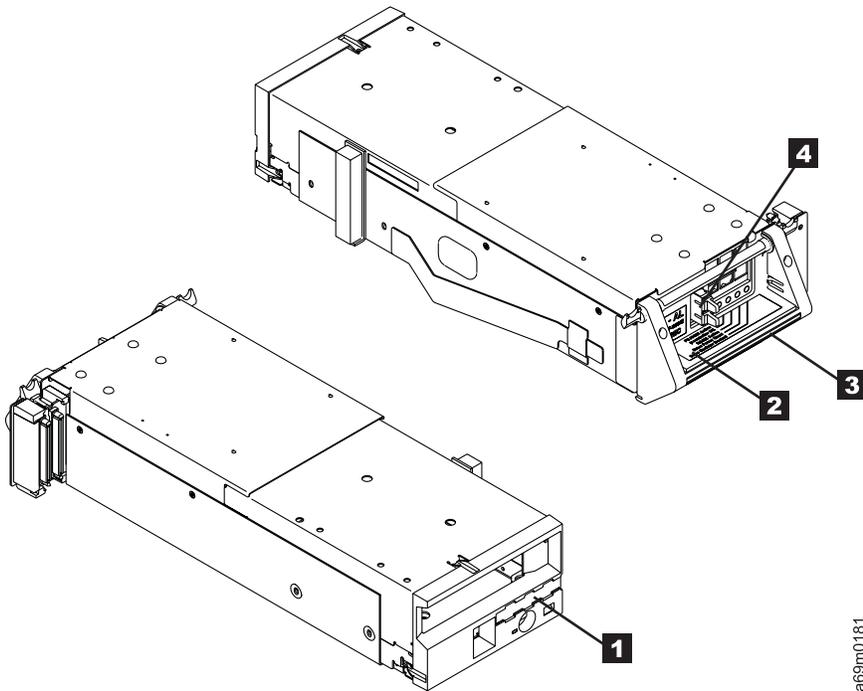
Figure 122. LTO Fibre Drive Canister

- If a logical library label **1** is installed on the old drive, remove it and install it on the new drive (see Figure 122).
 - The drive safety flaps must NOT be removed when installing the drives. The safety flaps will pivot up out of the way when the drive is installed.
4. Carefully slide the drive canister into the left side of the fixed tray assembly.
 5. Hold the locking lever **2** **up** to ensure the tabs on both sides of the lever will clear the frame (see Figure 122).
 6. Grasp the drive canister handle **3**, and carefully but firmly push the drive into position. Ensure the connectors to the right correctly align and fully engage with the fixed tray connectors.
 7. Lower the locking lever **2** until it snaps in place.

11. Reconnect the fibre cable **4** (see Figure 122 on page 608).
12. Reconnect the RS-422 connector **7** on the right side of the fixed tray assembly (see Figure 123).

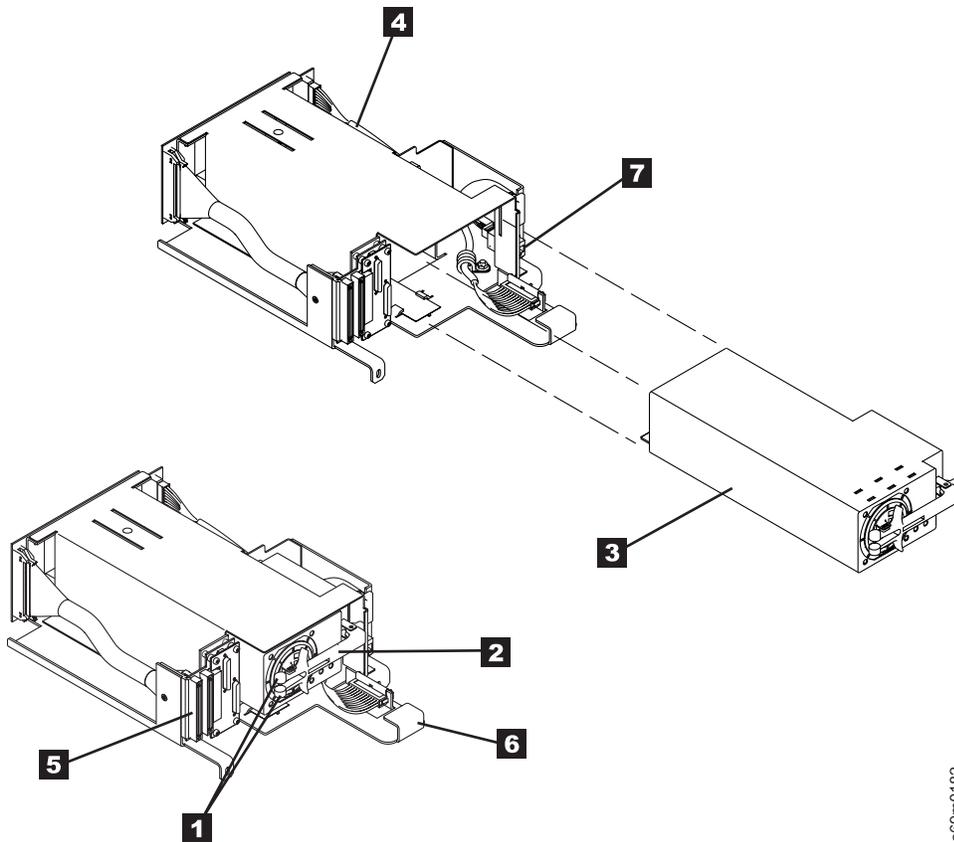
Figure 123. Hot Swap Power Supply

8. Pivot locking arm assembly **2** outward (see Figure 123 on page 609).

- ___ 7. If you installed SCSI drives, attach the external (drive to host) SCSI cables to the drives and host SCSI adapters. If connecting to a fixed tray (used with drive canisters), route the cables through the fixed tray cable guide **6** in (see Figure 123 on page 609). Secure the cables by using the strain relief clamps that are located on the side wall.

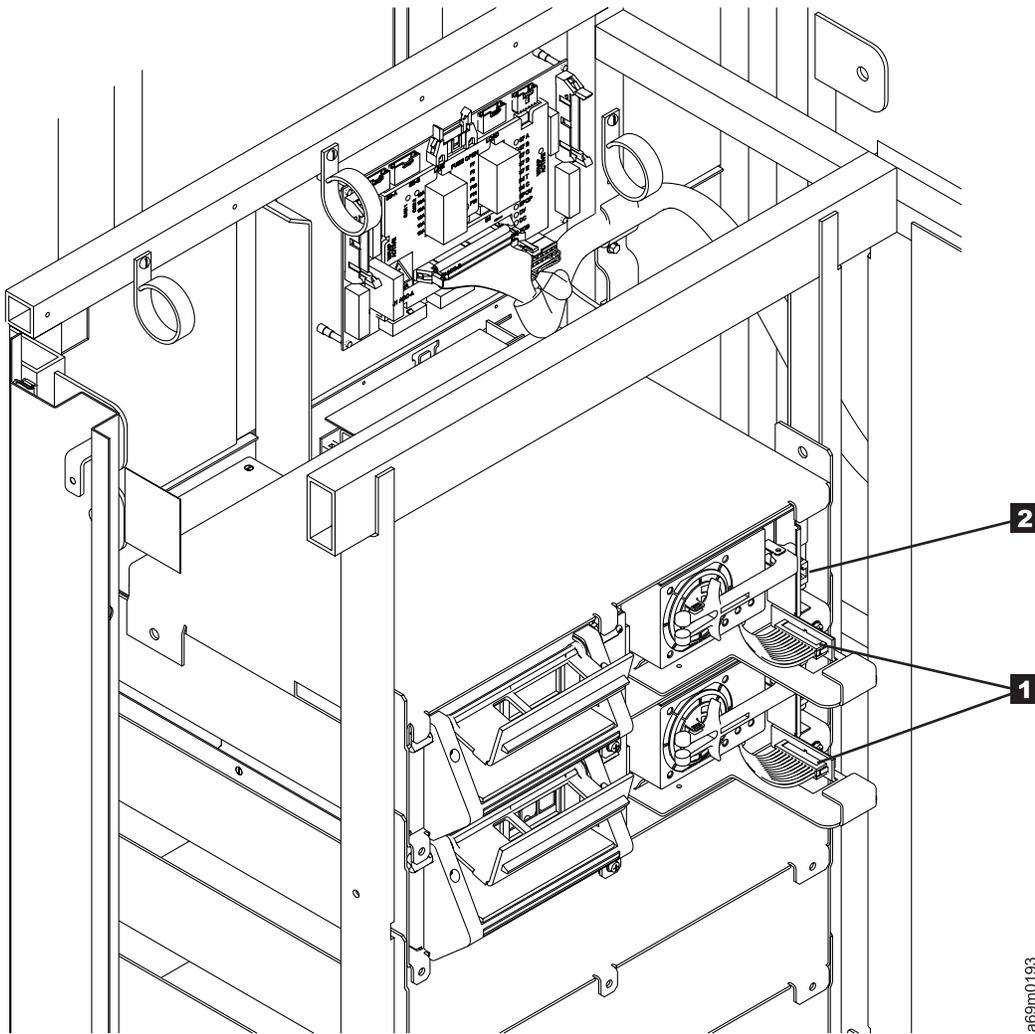
Figure 124. Cables and Power Cord

13. If there is another hot-swap drive in a position adjacent to this newly-installed drive, install a Redundant Power Supply power cable between the two hot-swap drive trays **1**, as shown (see Figure 124).
14. Reconnect the bifurcated power cord on the right side **2** of the new fixed tray assembly.
15. After applying power to a drive canister, wait at least 3 minutes before continuing. This will ensure that the library has time to automatically configure and calibrate the drive.

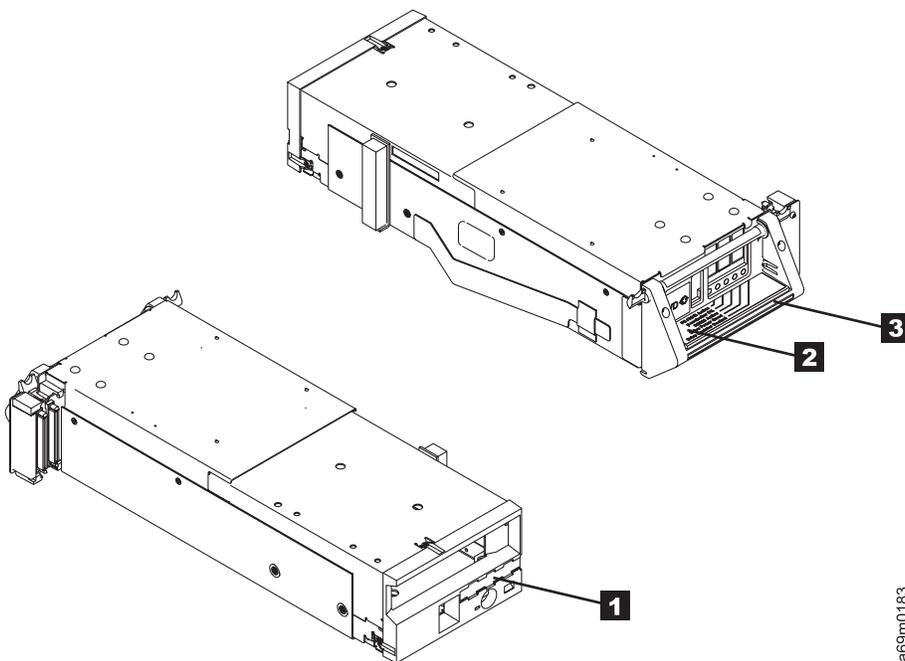
Figure 125. Drive Canister

4. While holding up the locking lever **2**, grasp the drive canister handle **3**. Firmly pull back on the handle enough to disengage the drive canister (see Figure 125).
5. Remove the hot swap power supply by pinching the locking tabs **1** together, and pivot the locking arm **2** outward (see Figure 126 on page 613).

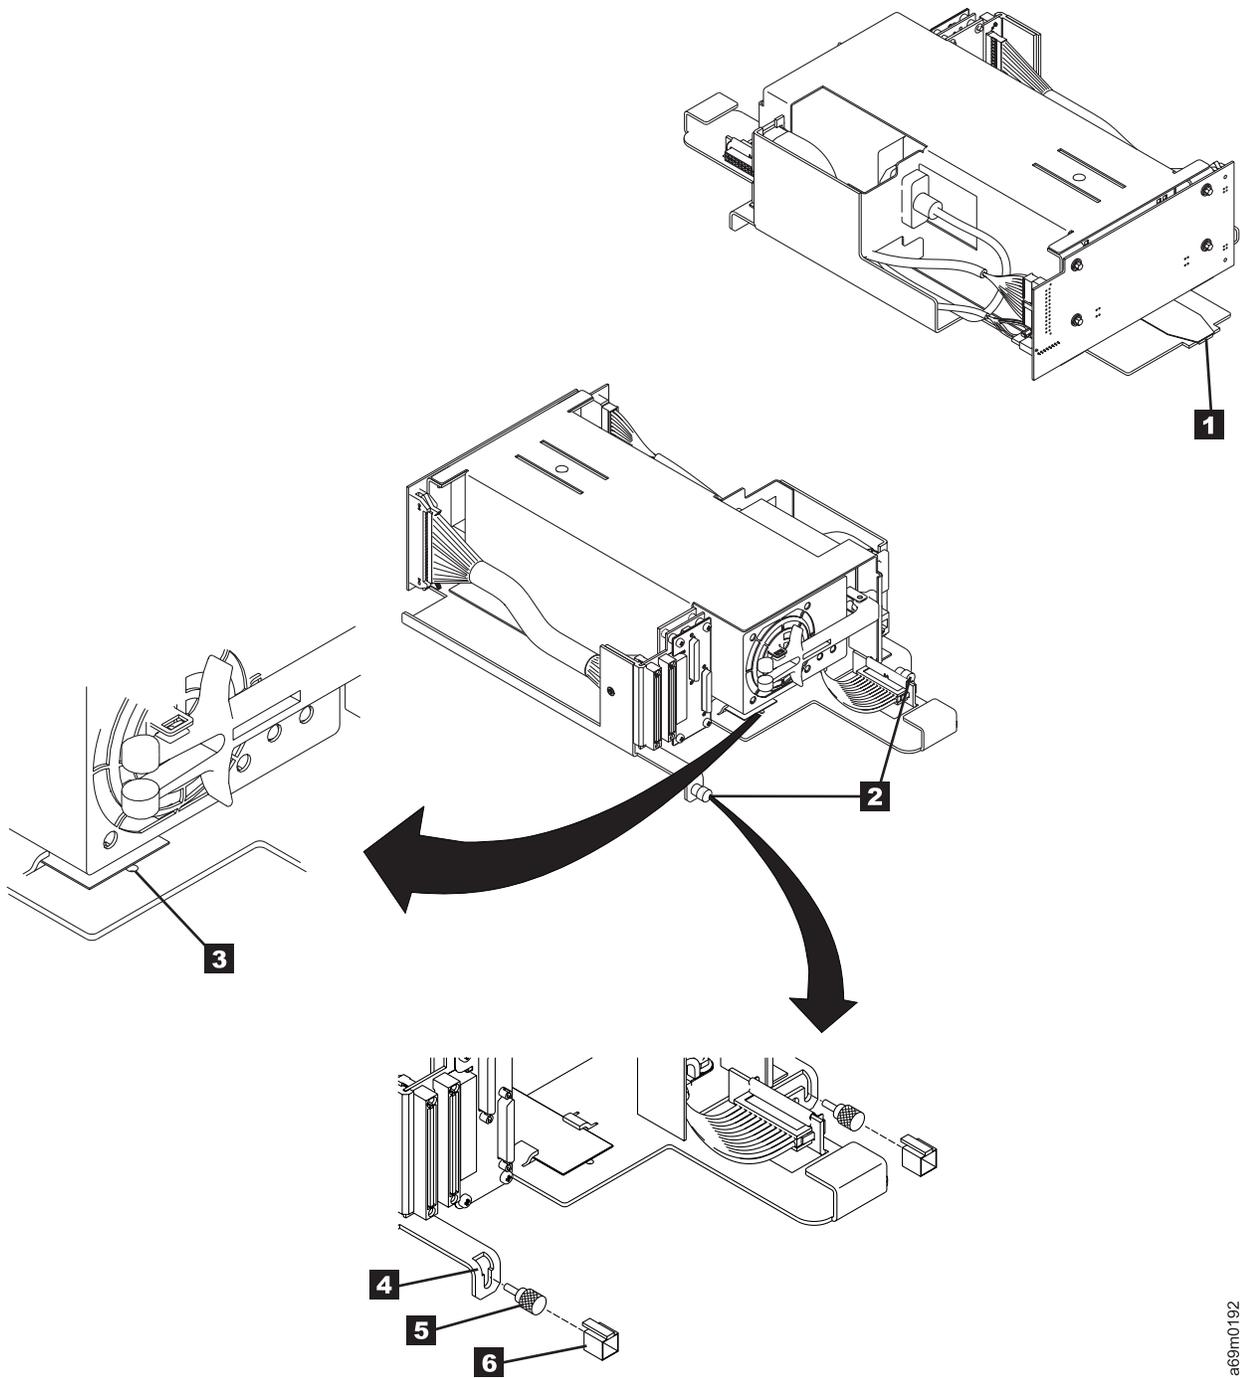
Figure 127. Fixed Tray

1. Slide in the fixed ray assembly, keeping it toward the right side. Ensure the front locating tab **1** on the tray assembly slides securely into the front slot in the frame (see Figure 127 on page 614).

Note: As the front locating tab seats into the slot in the frame, the indicator slide will move to partially cover the indicator hole **3**. If you see the indicator slide move toward the indicator hole (partially covering it), then the locating tab is positioned in the slot. If the indicator slide does not move, slide the front of the fixed tray assembly left or right until the locating tab slides into the slot.

6. Use the locking arm to remove the power supply.
7. Unplug the SCSI cables (and terminator, if installed) or fibre channel cables.
8. Disconnect the RS-422 and power cable from the fixed tray assembly.
9. Refer to Figure 127 on page 614. Slide both thumbscrew locks **6** (if present) to the rear and remove them. Then loosen both thumbscrews **2** on the fixed tray assembly and slide it out of the machine.

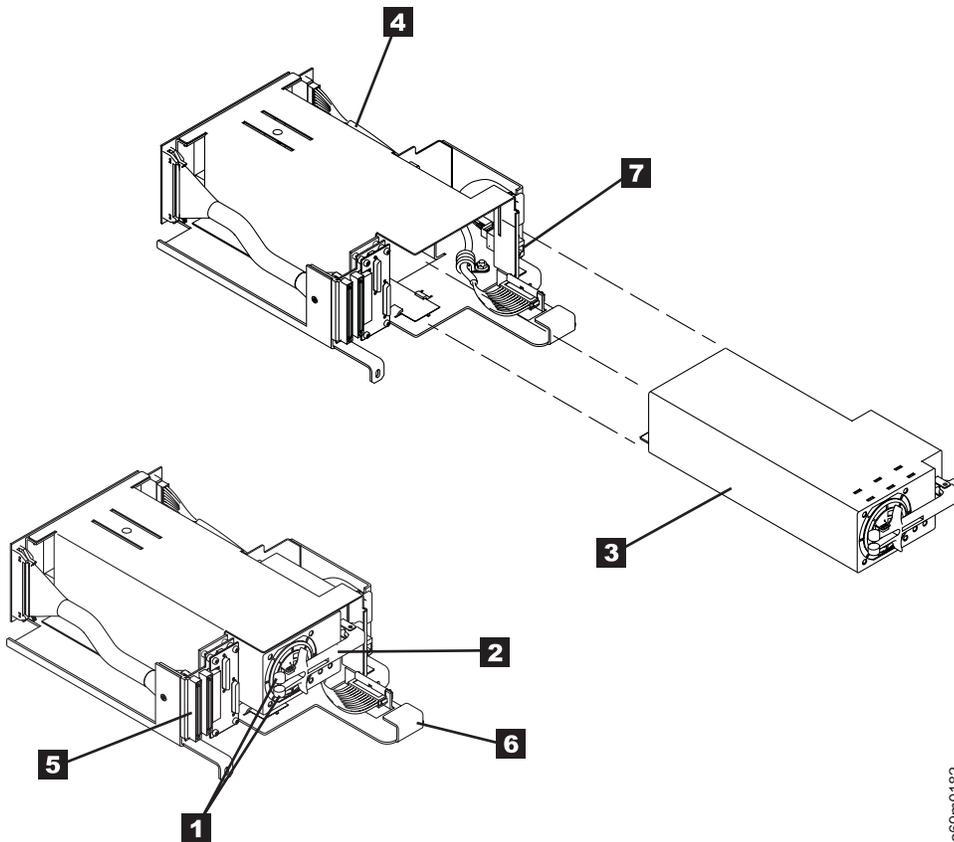
Figure 129. Hot Swap Power Supply

8. Pivot locking arm assembly **2** outward (see Figure 129 on page 616).

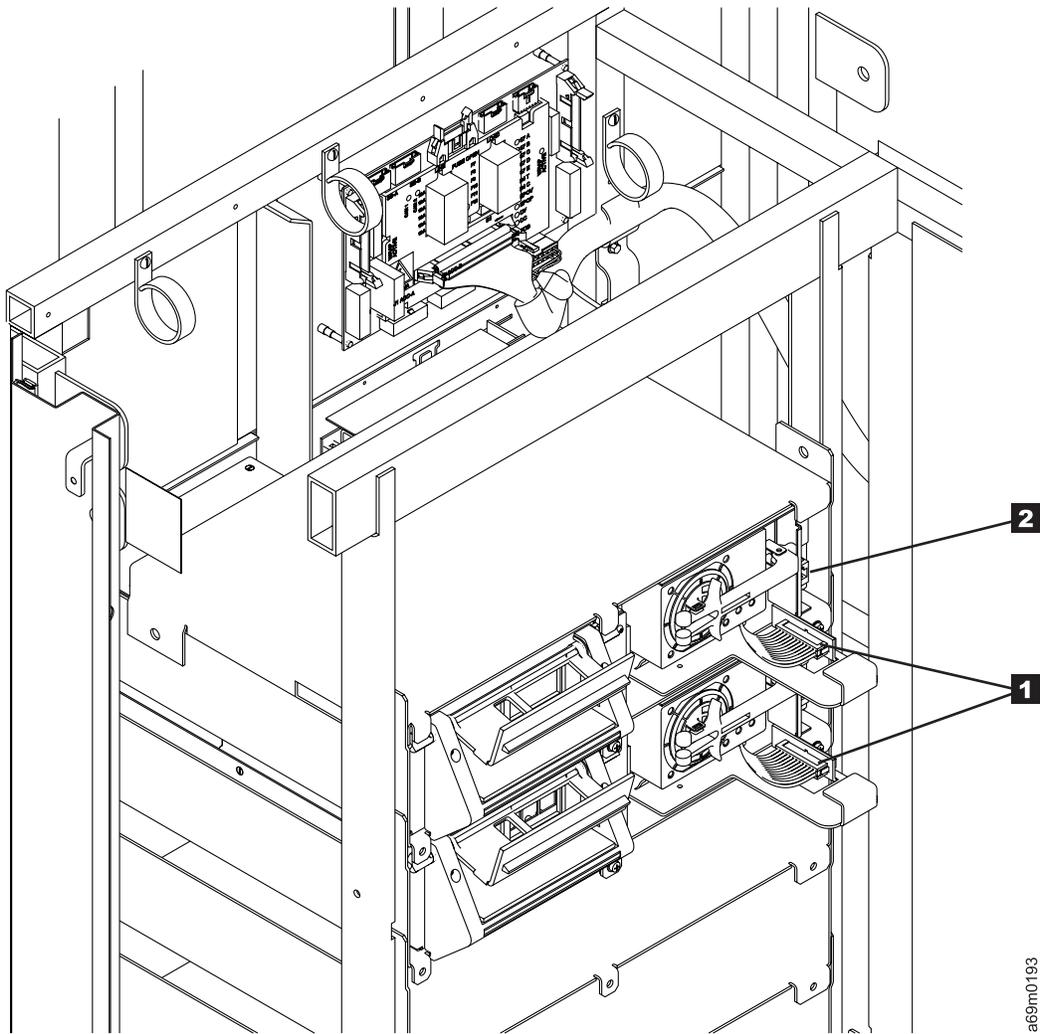
Figure 130. Cables and Power Cord

11. Reinstall the SCSI or fibre channel cables that were removed earlier (see Figure 130 on page 617).
12. If this is a SCSI installation, re-install any terminator or interposer removed earlier.
13. Reroute all cables into their appropriate strain-relief brackets to provide support.
14. Reconnect the RS-422 connector **7** on the right side of the new fixed tray assembly.

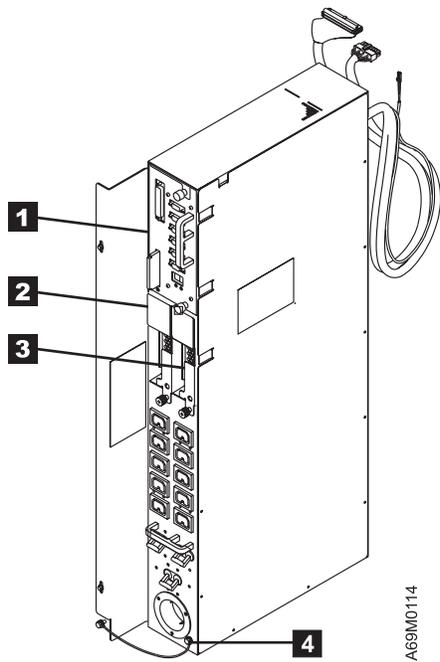
Figure 131. Frame Control Assembly

5. Disconnect the power cable located at the bottom of the FCA.
6. Disconnect the power and signal cables connecting the FCA to the FIC card and EPO cable.
7. Disconnect ground jumper **4** at the FCA.
8. Remove the power cables (from the FCA end) that go to the drives.
9. Loosen and remove the two knurled screws to remove the MCP Assembly **1**.
10. Remove the one or two 37 V dc power supplies **2** and **3** from the FCA.

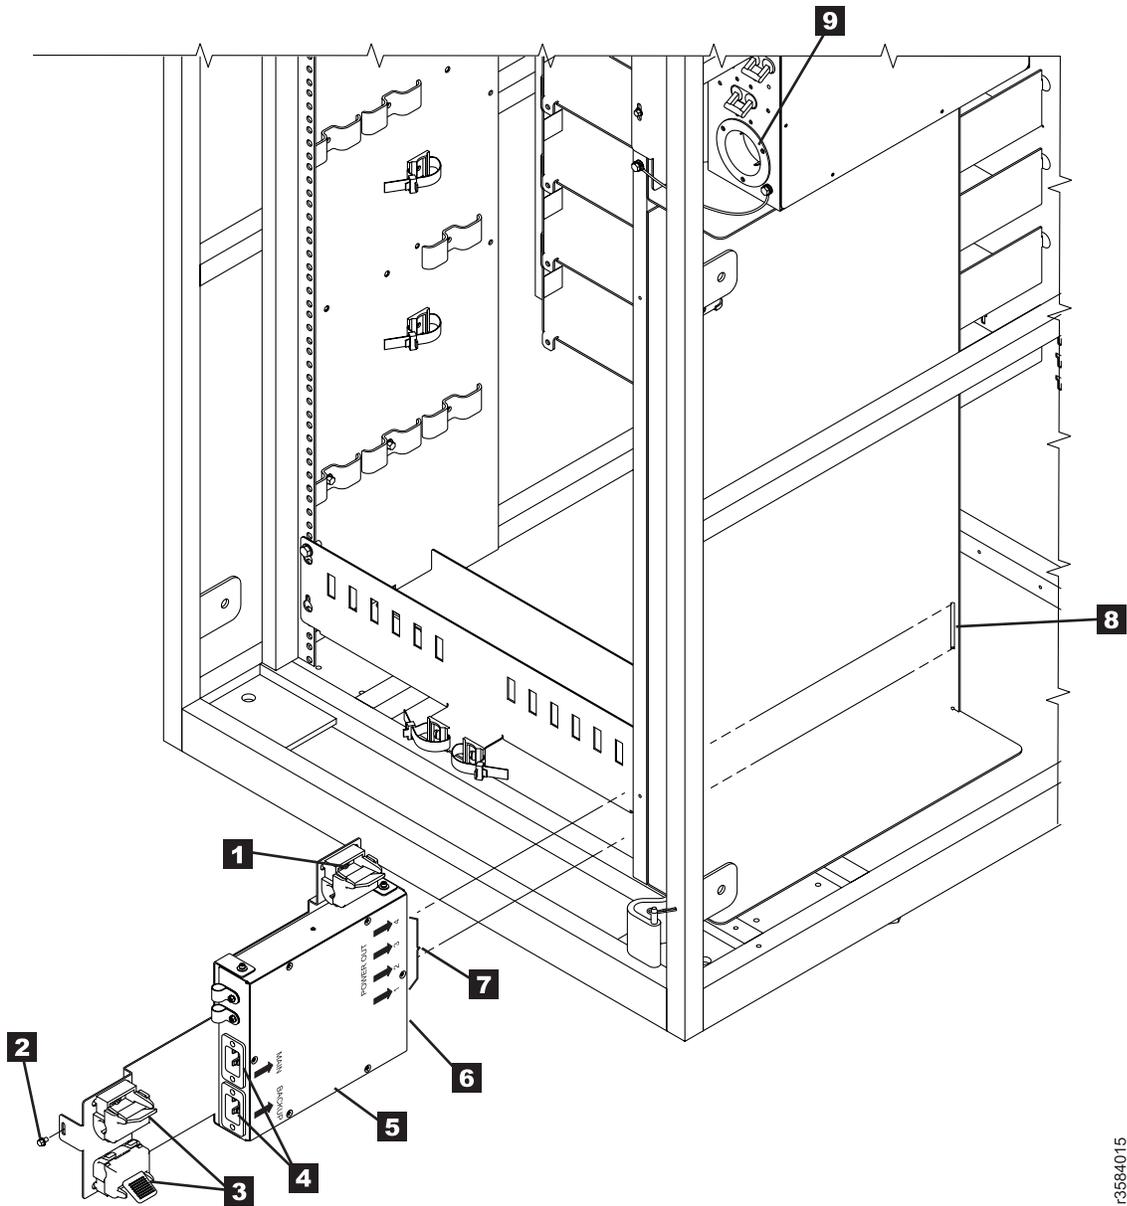
Figure 132. Power Distribution Unit

5. See Figure 132 on page 621.
6. Open both power cord cable clamps **3** and unplug the MAIN and BACKUP power cords **4**. (Be sure to label which one is which).

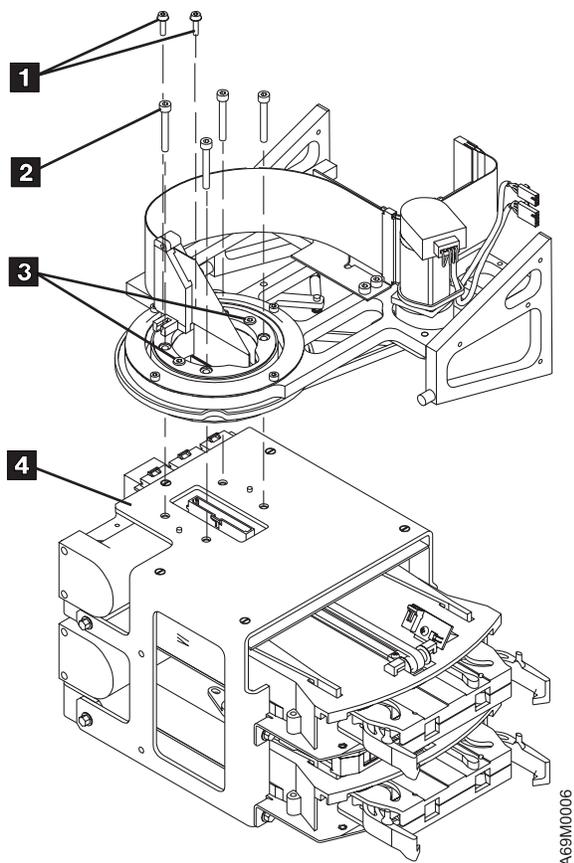
Figure 133. Dual Gripper Assembly

1. Prepare the accessor for servicing (see “Service Procedures” on page 535).
2. Refer to Figure 133 on page 623. Remove the two screws **1**, and unplug the cable between the pivot assembly and the PDC card.

Note: Do not loosen or remove the two screws **3**.

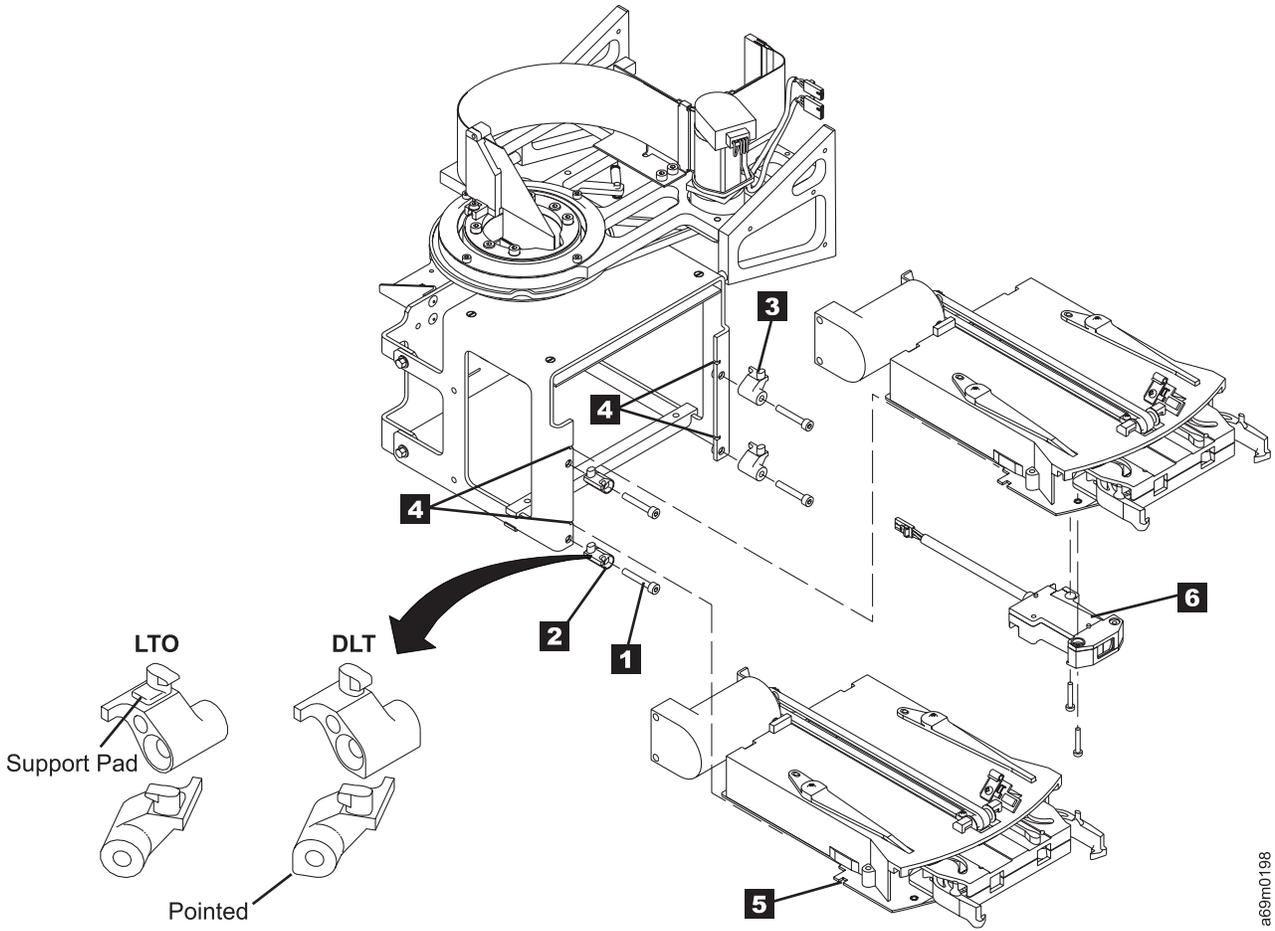
Figure 134. Single Gripper Assembly (New Style)

- Each set of blocks (for LTO and DLT) is designed to be used on either side of the gripper.
 - To ensure you install the correct mounting blocks, Figure 134 on page 626 depicts the following differences between the LTO and the DLT mounting blocks:

If your library has the old style gripper (refer to Figure 135 on page 628), and you are replacing it with another old style gripper, use the procedure at “Gripper Assembly, Single (Old Style)” on page 627. If your library has the new style gripper (refer to Figure 134 on page 626), continue with this procedure.

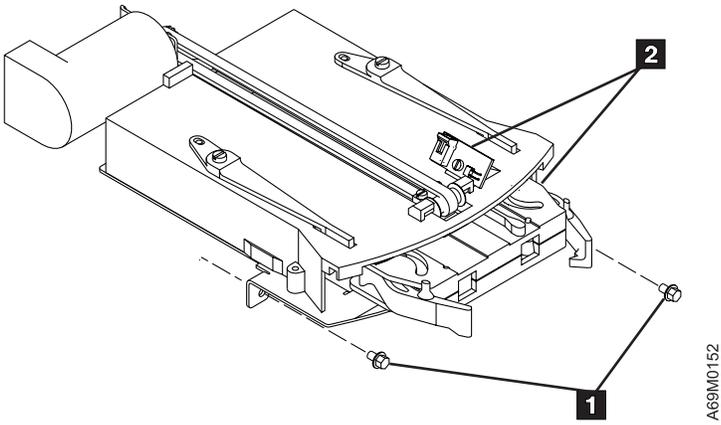
Figure 135. Single Gripper Assembly (Old Style)

1. If the upper gripper is being replaced, re-install the calibration sensor on the new gripper assembly.
2. Reverse the removal procedures.
3. Close the front door.
4. Complete the accessor servicing (see “Service Procedures” on page 535).
5. Perform a library calibration (see “Library Calibration” on page 530).
6. Perform the “Library Verify Test” on page 507, using the **no drives** selection.
7. Return to the procedure that sent you here; otherwise, go to “End of Call” on page 489.
