IBM TotalStorage UltraScalable Tape Library 3584

Maintenance Information

Ninth Edition (June 2003)

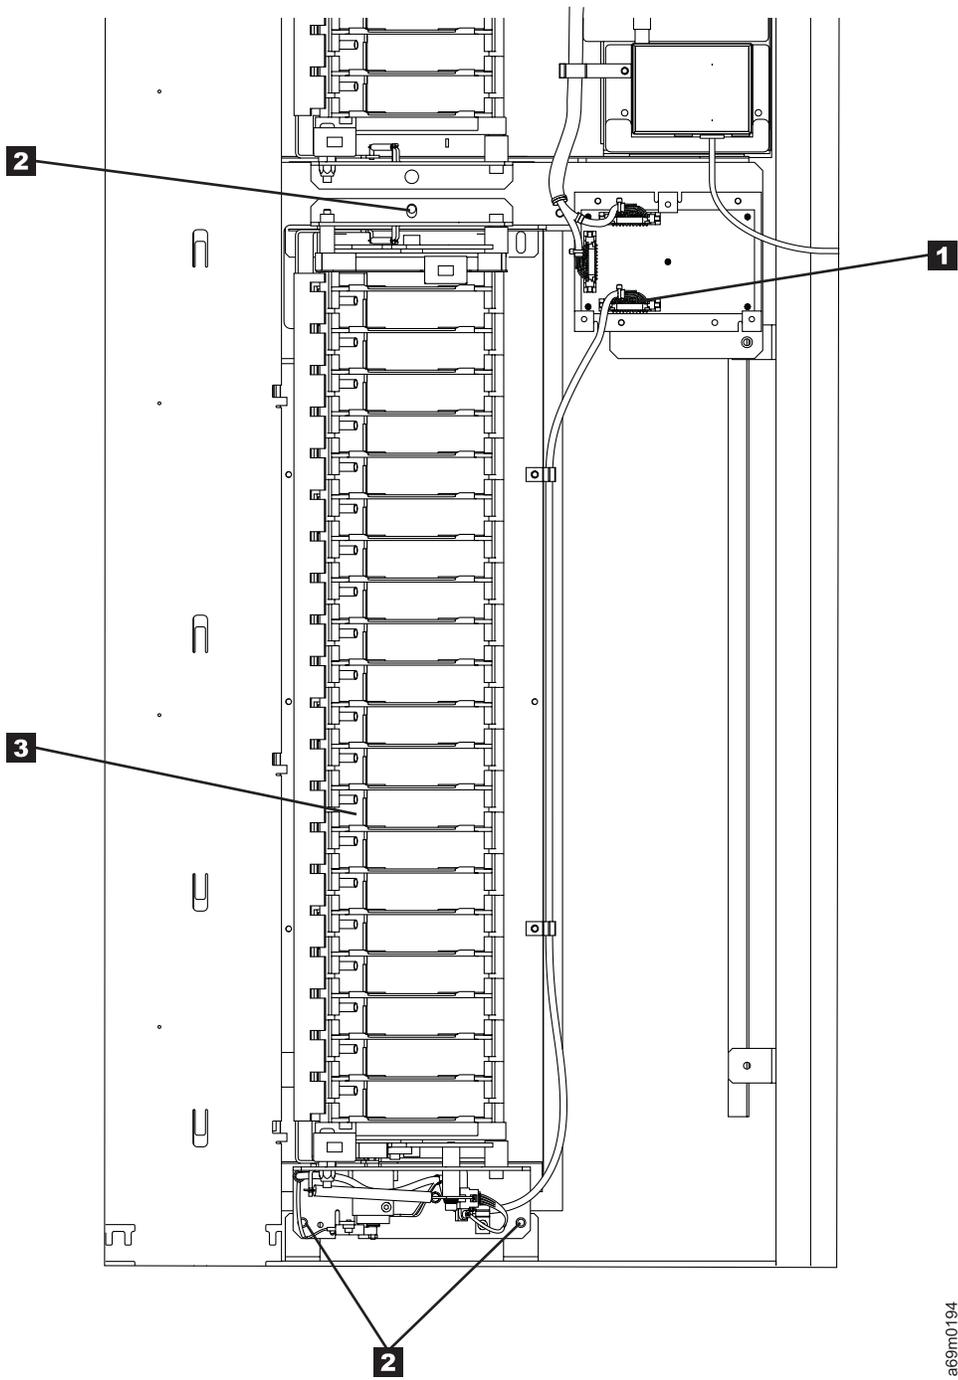
Figure 136. I/O Station, Lower

1. Reverse the removal procedure.
2. Open and close the I/O station several times to ensure that there is no interference between the front door and the I/O station. Ensure there is no binding.
3. Close the base frame front door.
4. Complete the accessor servicing (see “Service Procedures” on page 535).
5. Perform an I/O station calibration (see “Library Calibration” on page 530).
6. Perform the “Library Verify Test” on page 507, using the **no drives** selection.
7. Return to the procedure that sent you here; otherwise, go to “End of Call” on page 489.

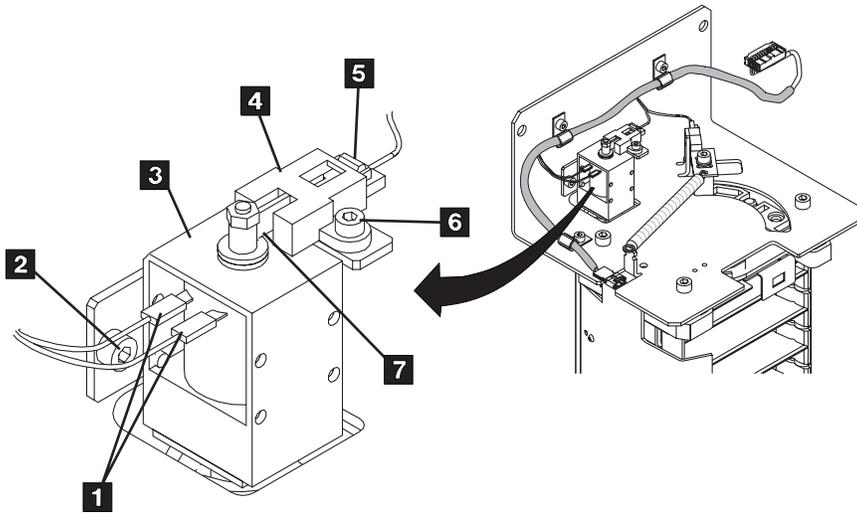
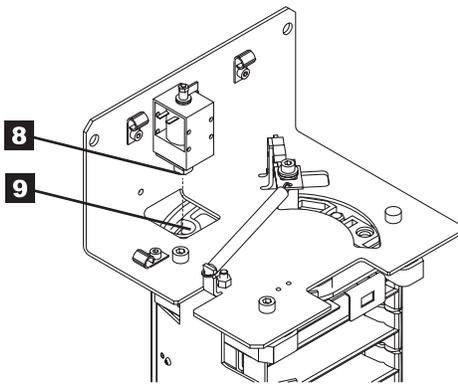
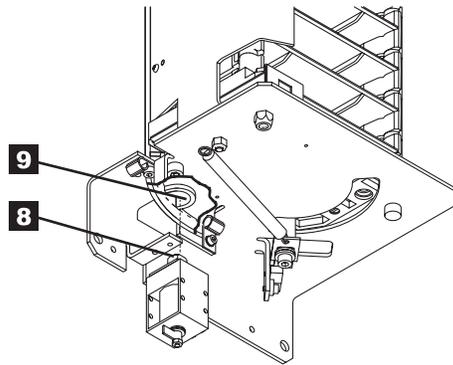
1. Reverse the removal procedure.
2. Ensure that the I/O station door locked solenoid flag **7** will move within the slot of the I/O station door locked sensor **4** when the solenoid is active (door locked). To check, close the I/O station door and manually move the solenoid flag **down**, simulating a locked position. Also, ensure the solenoid locking plunger **8** fits into the locking cavity **9** without binding. Return the solenoid flag to the **up** position. It should detent into the locked sensor slot without making contact with the sensor. Adjust the sensor, as needed.
3. Close the front door.
4. Complete the accessor servicing (see “Service Procedures” on page 535).
5. Perform the “Library Verify Test” on page 507, using the **no drives** selection.
6. Return to the procedure that sent you here; otherwise, go to “End of Call” on page 489.

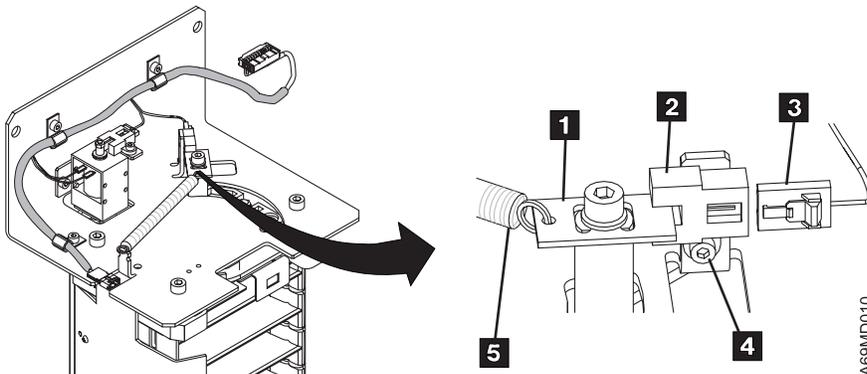
Figure 139. I/O Station Door Sensor

1. Reverse the removal procedure.
2. Adjust the sensor **2** so that the flag **1** is positioned midway in the sensor slot, and does not contact the sensor when the door is closed.
3. Close the front door.
4. Complete the accessor servicing (see “Service Procedures” on page 535).
5. Perform the “Library Verify Test” on page 507, using the **no drives** selection.
6. Return to the procedure that sent you here; otherwise, go to “End of Call” on page 489.

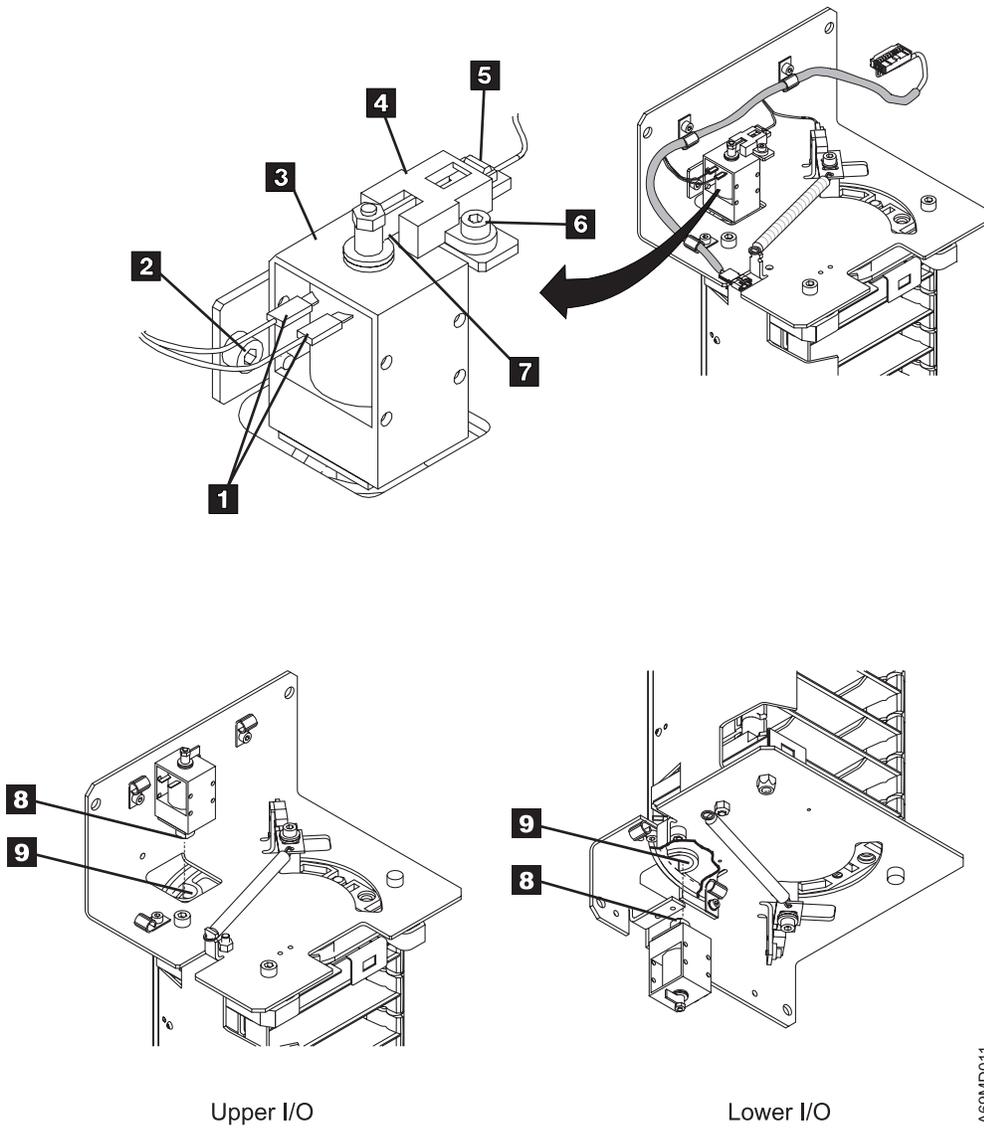
Figure 140. I/O Station Door Solenoid Sensor

1. Reverse the removal procedure.
2. Adjust the sensor so that the flag **7** is positioned midway in the sensor slot, and does not contact the sensor when the door is locked.
3. Close the front door.
4. Complete the accessor servicing (see “Service Procedures” on page 535).
5. Perform the “Library Verify Test” on page 507, with **no drives** selected.
6. Return to the procedure that sent you here; otherwise, go to “End of Call” on page 489.

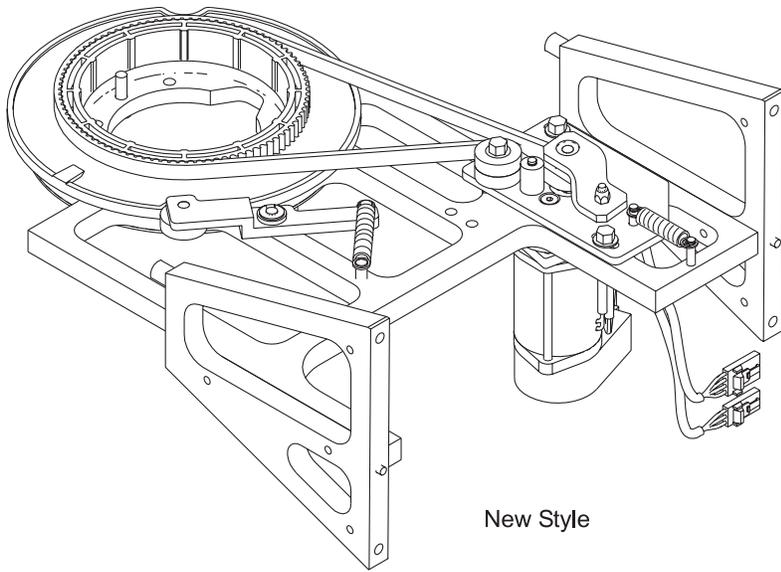
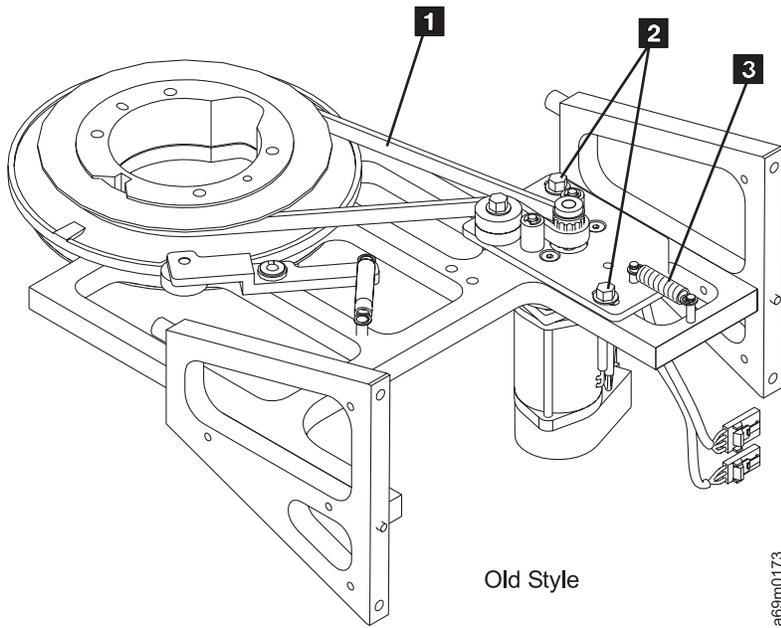
Note: Install the spring **3**, then tighten the screws **2**.

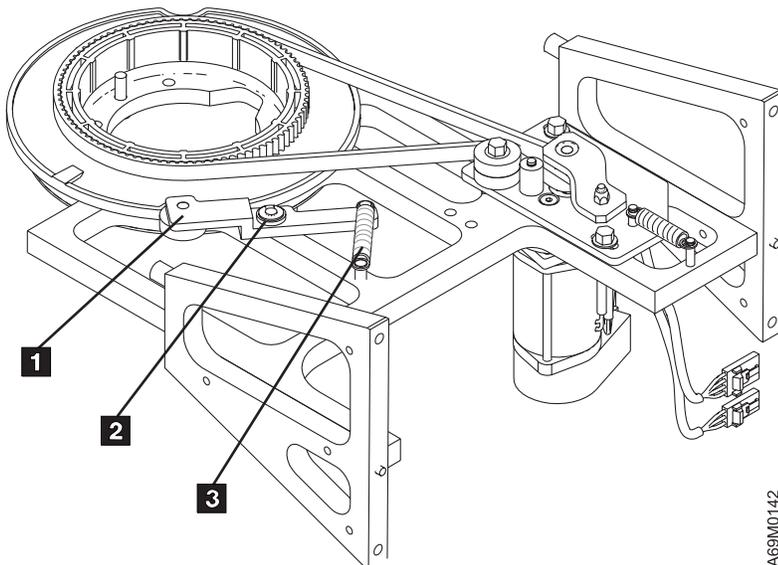
Figure 143. Pivot Detent Arm and Spring. (New style - viewed from bottom)

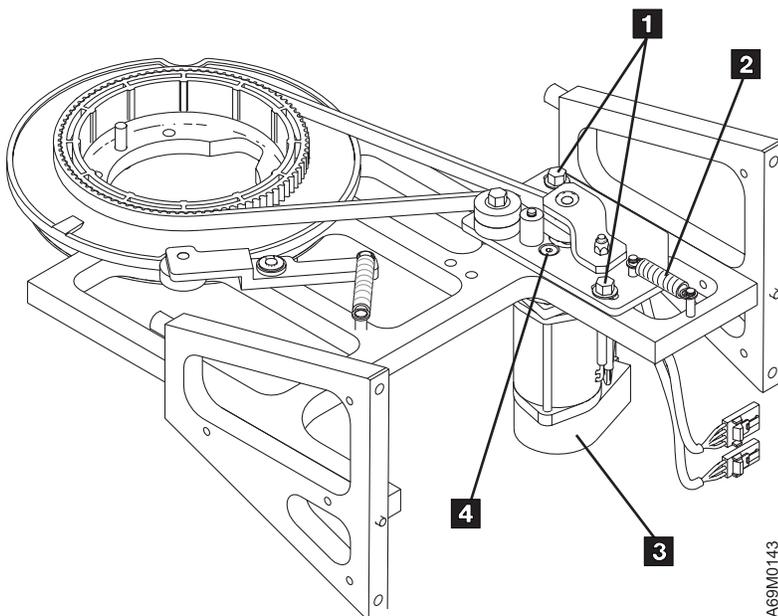
Figure 145. Pivot Motor and Belt (New Style). (Viewed from bottom)

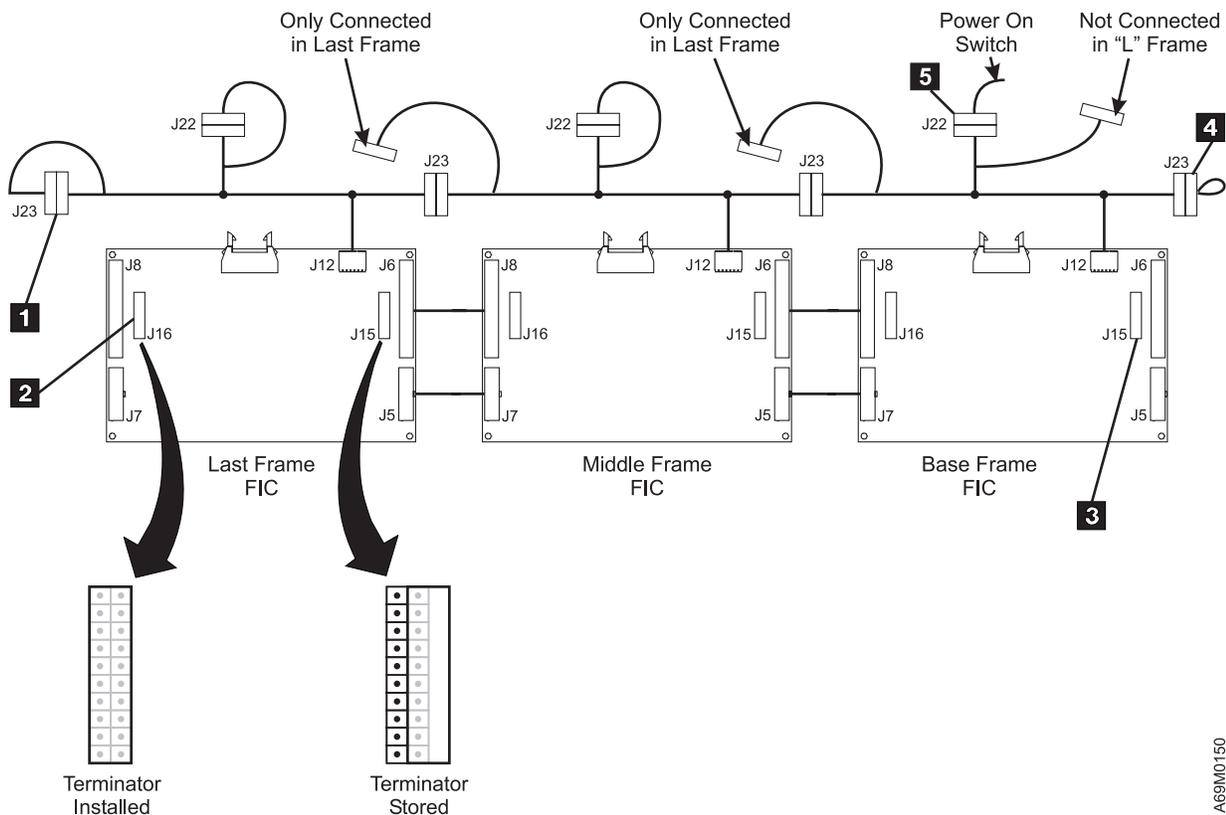
Figure 147. Frame Interconnect Cables

3. Open the front and rear doors.
4. Refer to Figure 147. Disconnect cable connector J22 **5** (in the base frame) that leads to the back of the power switch **7** on Figure 148 on page 647.
5. Remove the cable from the clamps.
6. Refer to Figure 148 on page 647 to remove the three mounting screws **4**.
7. Remove the power switch **5**.

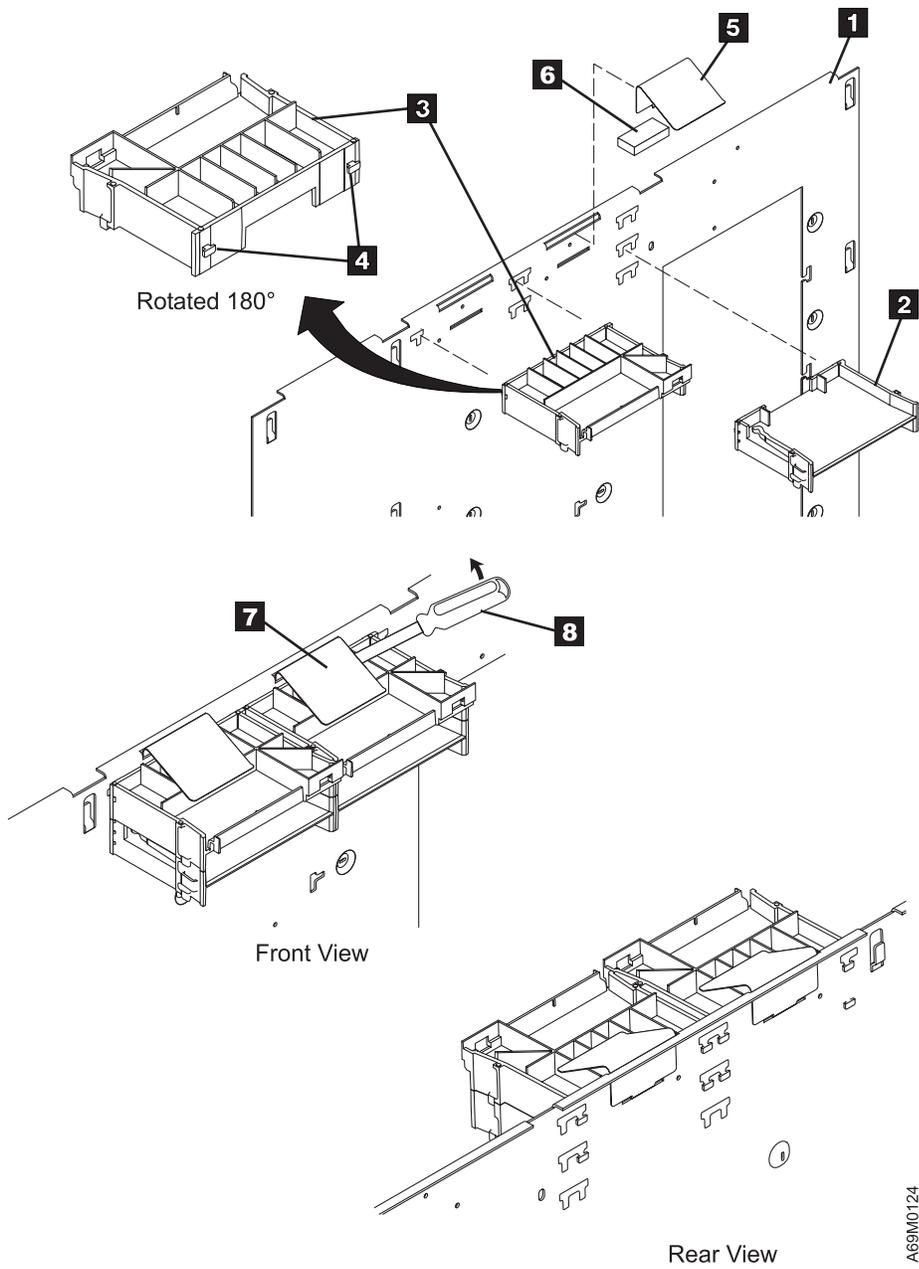
Figure 149. Top Cell Tray and Cartridge Cell Tray

3. Refer to Figure 149 on page 649 for the pictorial of a top cell tray **3** and a cartridge cell tray **2**. Each tray is held in place by two tabs **4** on the rear of each tray and by holes in the rear frame firewall **1**. The spring **5** and the foam pad **6** at the top of the top cell tray applies pressure on the entire cell tray row to keep them in place during normal operation. The portions of Figure 149 on page 649 marked Front View and Rear View show how the spring must be installed to retain tension on the top tray.

6. **LTO or DLT Cells**
If a cartridge cell tray **2** needs to be changed, remove the top cell tray, and set it aside for now. Next, remove all of the cartridge cell trays above the damaged cartridge cell, one at a time, working from the top to the bottom. Finally, remove the damaged cartridge cell tray **2**.

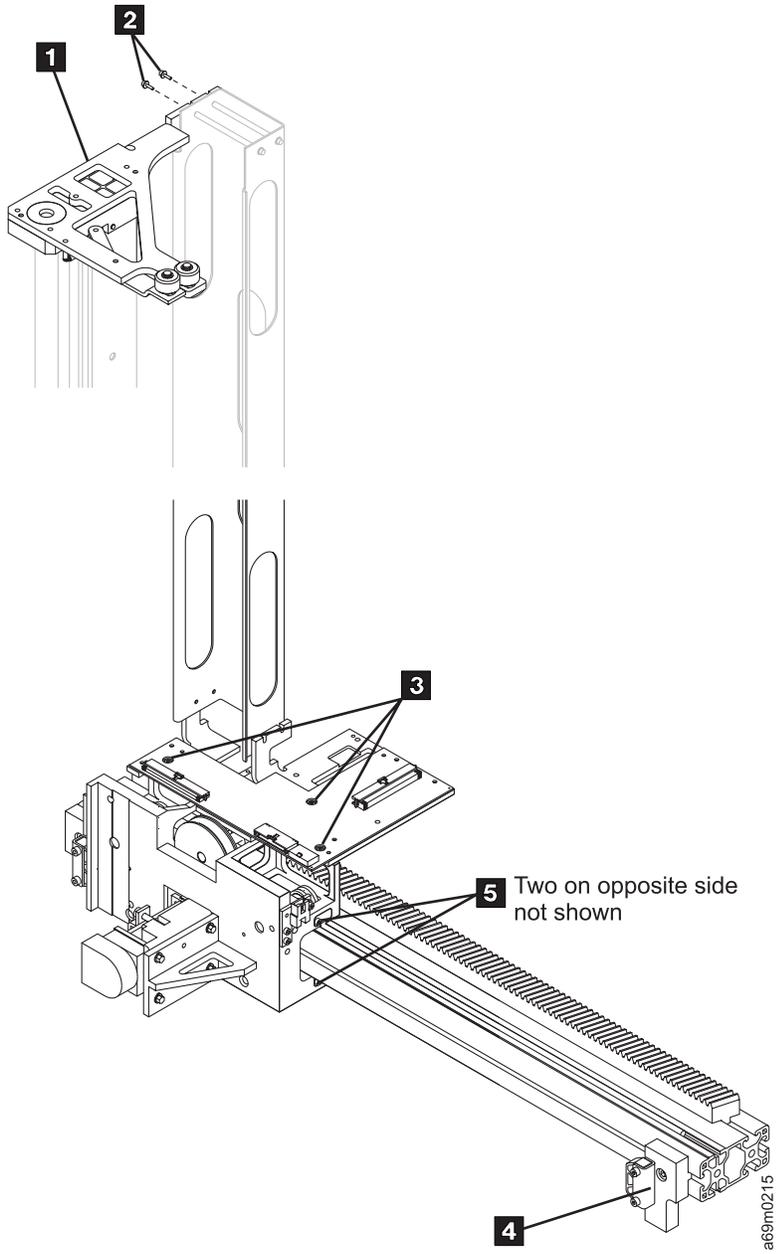
Figure 150. X-Axis Assembly

1. Prepare the accessor for servicing (see “Service Procedures” on page 535).
2. Remove the Y-axis mast assembly (see “Y-Axis Mast Assembly” on page 668).
3. Refer to Figure 150 on page 651. Remove the screws **3** , and move the AXY card and Y-axis cable trough out of the way.
4. Remove the right side door (the right end window panel).
5. Remove the right side X-axis bumper and bracket assembly **4** .
6. Slide the X-axis assembly to the right — off the end of the X-axis rail.

1. Install the X-axis assembly onto the X-axis rails.
Attention: When sliding the X-axis assembly onto the X-rail use a screwdriver to lift the (four) felt wiper pads **5** as they slide onto the guide rods on the top and bottom surfaces of the X-rail. If you do not guide the felt wipers they will be damaged, leading to corrosion of the rail rods.
2. Move the X-axis assembly back and forth to ensure that the assembly does not bind anywhere along the X-axis rail.
3. Reverse the rest of the removal procedure.
4. Close the front door.
5. Complete the accessor servicing (see “Service Procedures” on page 535).
6. Perform the “Library Verify Test” on page 507, using the **no drives** selection.
7. Return to the procedure that sent you here; otherwise, go to “End of Call” on page 489.

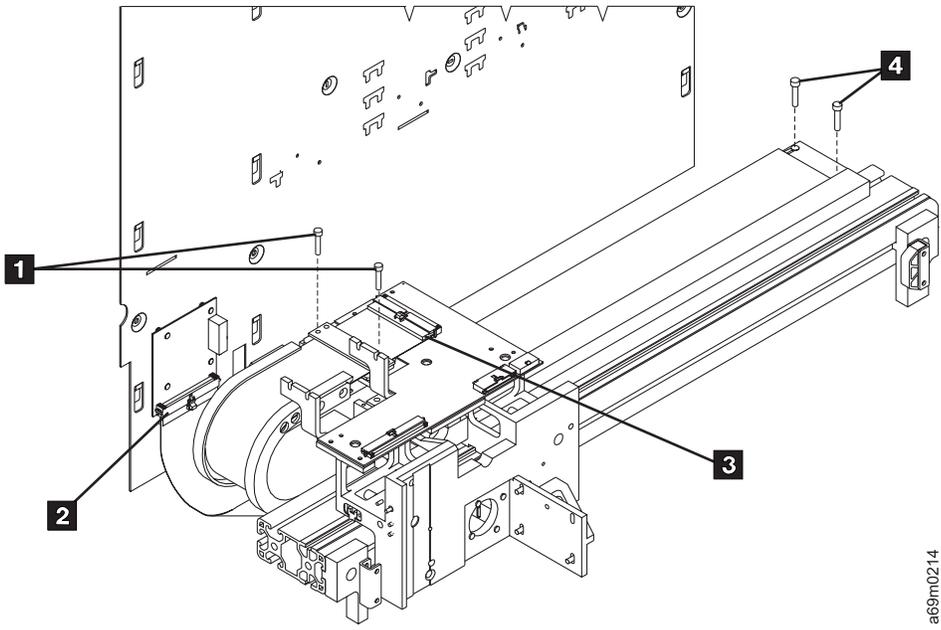
Figure 152. X-Axis Cable Removal

2. Prepare the accessor for servicing (see “Service Procedures” on page 535).
3. Remove the trough covers on either side of the mid point where the X-cable is mounted. In a single frame library, there is only one trough cover to remove.
4. Remove the trough cover in the L32 to gain access to the XCP card on the left-hand side. In a single frame library, this cover is already removed.
5. Refer to Figure 152 on page 654
6. Move the accessor to the left of where the X-cable mid point is mounted at the base of the frame, and remove two screws **4** that secure the X-cable mid point to the bottom frame.
7. Pivot the grippers to the front. Remove two screws **1** and unplug the X-cable from the AXY card **3**.
8. Unplug the X-cable from the XCP card **2** in the L32. The cable has a retention clip that must be depressed to disconnect the cable.
9. Remove the X-cable from the right-hand side.

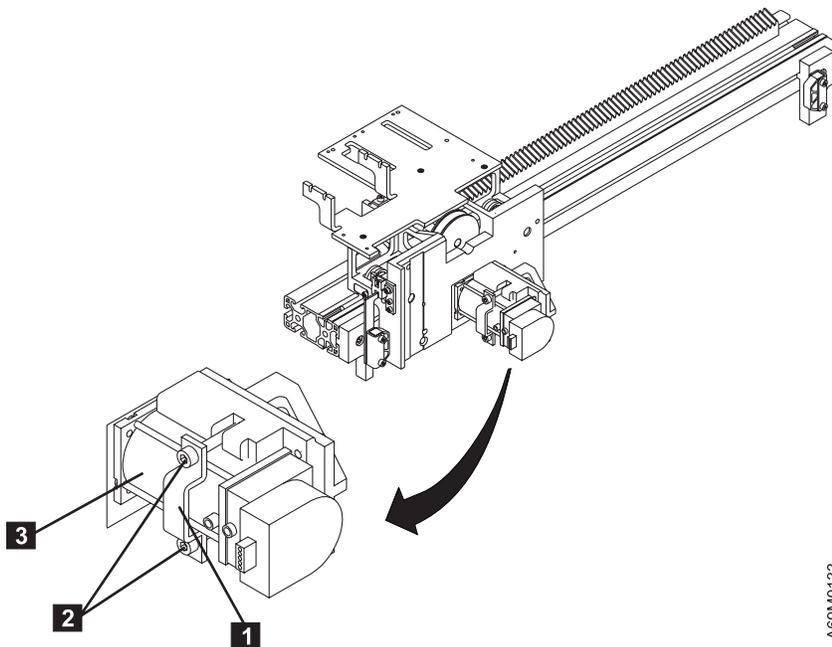
Figure 153. X-Axis Motor

1. Prepare the accessor for servicing (see “Service Procedures” on page 535).
2. Remove the MDA (see “Motor Driver Assembly (MDA)” on page 566).
3. Refer to Figure 154 on page 658. Remove the four screws **4** to remove the motor and its mounting bracket.
4. Refer to Figure 153 on page 658. Remove the two screws **2** to remove the bracket **1**.
5. Remove the X-axis motor **3** from the mounting and from the X-axis belt.
6. Remove the X-axis belt by working the belt past the pinion shaft pulley.

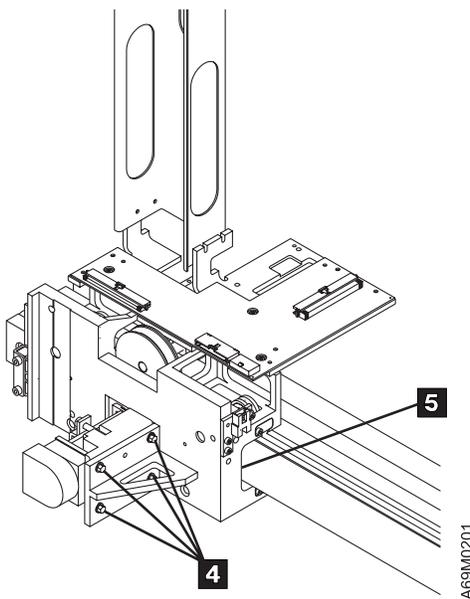
Figure 154. X-Axis Assembly (Motor) – Early Style

Note: Because of insufficient access, you may not be able to check the pulley adjustment using your finger. From the right side, slide an end wrench into the channel (shown at **5** in Figure 154 on page 658), between the X-axis casting and the front of the X-axis rail. Use the end wrench to press on the belt. Observe the travel of the end wrench to determine if belt tension is correct.

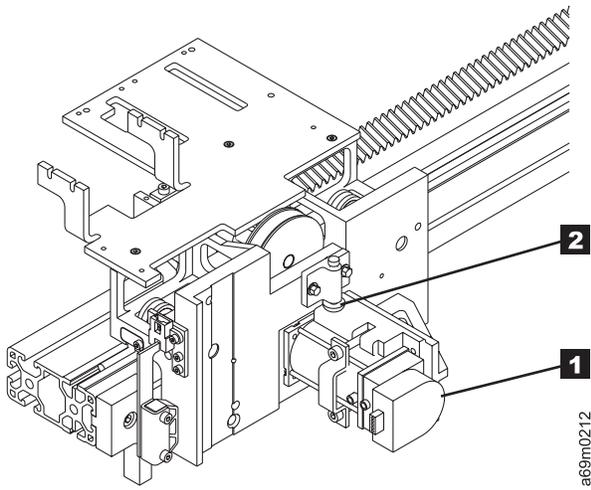
Figure 155. X-Axis Assembly – Later Style

4. See Figure 155 on page 659. Push on the X-motor **1** to compress the spring-loaded belt tensioner **2**.
5. Work the belt onto the X-motor pulley and release the motor. X-axis belt tension is automatically set.

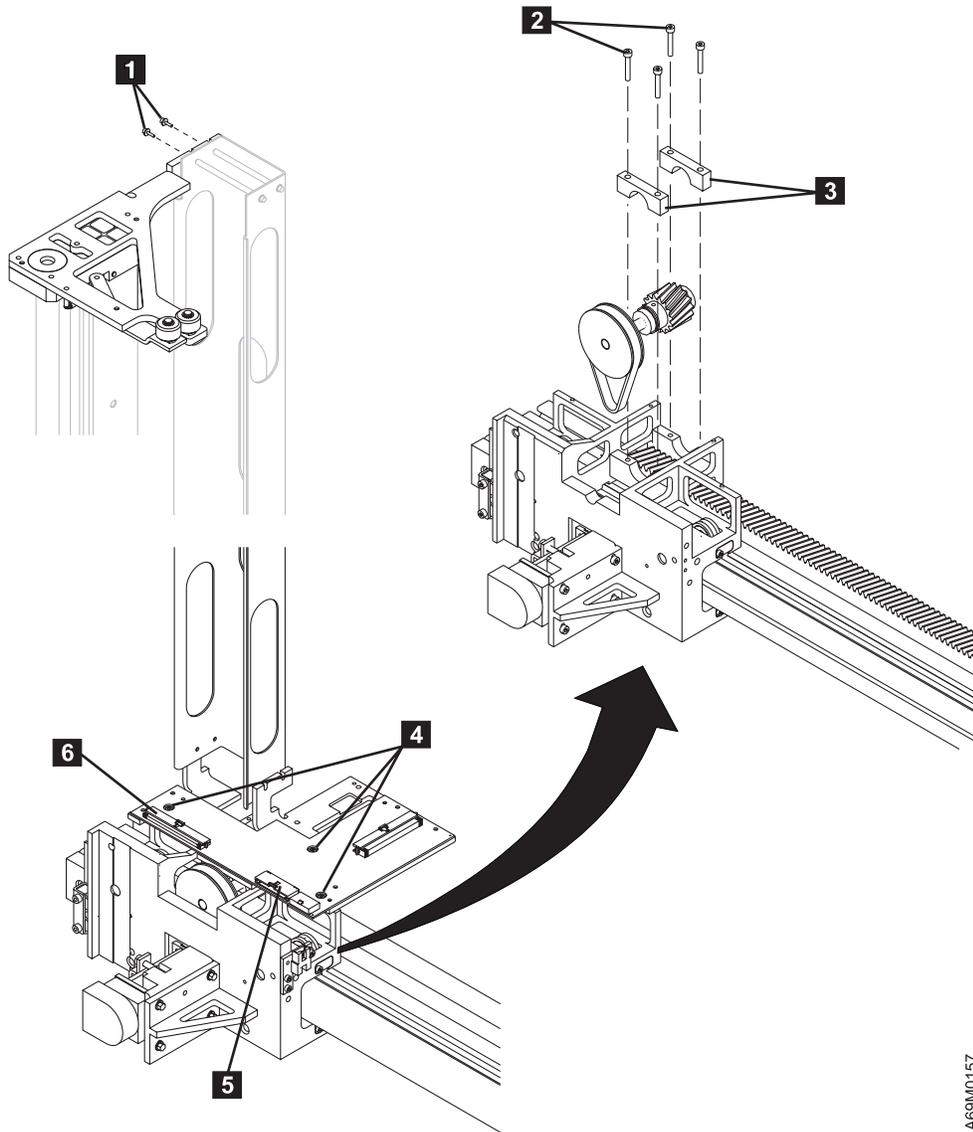
Figure 156. X-Axis Pinion Shaft

1. Prepare the accessor for servicing (see “Service Procedures” on page 535).
2. Raise the dual gripper assembly about halfway up the Y-axis mast assembly and secure it in place by inserting a hex wrench or screwdriver through the Y-axis access hole.
3. Remove the Y-axis trough holding screws **1** (see Figure 156 on page 661).
4. Disconnect the Y-axis cable connector **6**.
5. Disconnect cable connectors **5**.
6. Remove the AXY card holding screws **4**.
7. Slide the X-axis assembly out from under the AXY card.
8. Remove four screws **2** to remove the holding brackets **3**.
9. Remove the pinion shaft.

1. Inspect the belt for wear before putting in the new pinion shaft assembly. Replace the belt if necessary.
2. Reverse the removal procedure.
3. Adjust the X-axis motor belt tension by pulling the motor away from the X-axis pinion shaft.
The belt tension is correct if light finger pressure (in the center of the belt between the two pulleys) deflects the belt 3 to 5 mm (1/8 to 3/16 in.).
4. Ensure that the hex wrench or screwdriver inserted into the Y-axis access hole is removed.
5. Close the front door.
6. Complete the accessor servicing (see “Service Procedures” on page 535).
7. Perform the “Library Verify Test” on page 507, using the **no drives** selection.
8. Return to the procedure that sent you here; otherwise, go to “End of Call” on page 489.

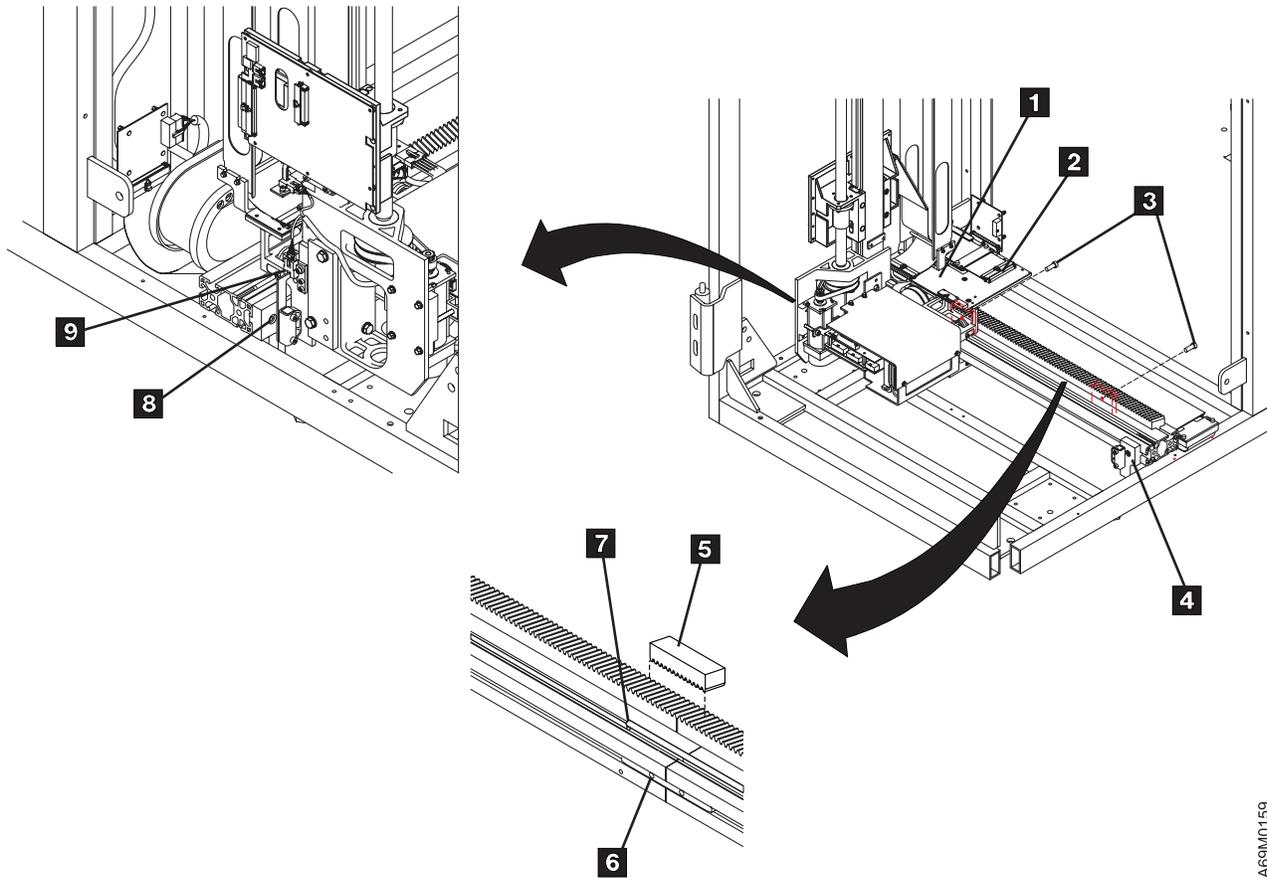
Figure 157. X-Axis Rail Assembly

7. Loosen the set screws **6** in the long T-nuts (front and back) on the other end of the rail that is being replaced (not required if this is the base frame).
8. Remove the screws **3** and remove the X-axis rail assembly.

9. Repeat steps 3 through 6 until all rails are aligned and tightened.
10. If this is a single frame library, when you are sliding the X-axis assembly back onto the rails, lift the four wiper pads **9** with a screwdriver.

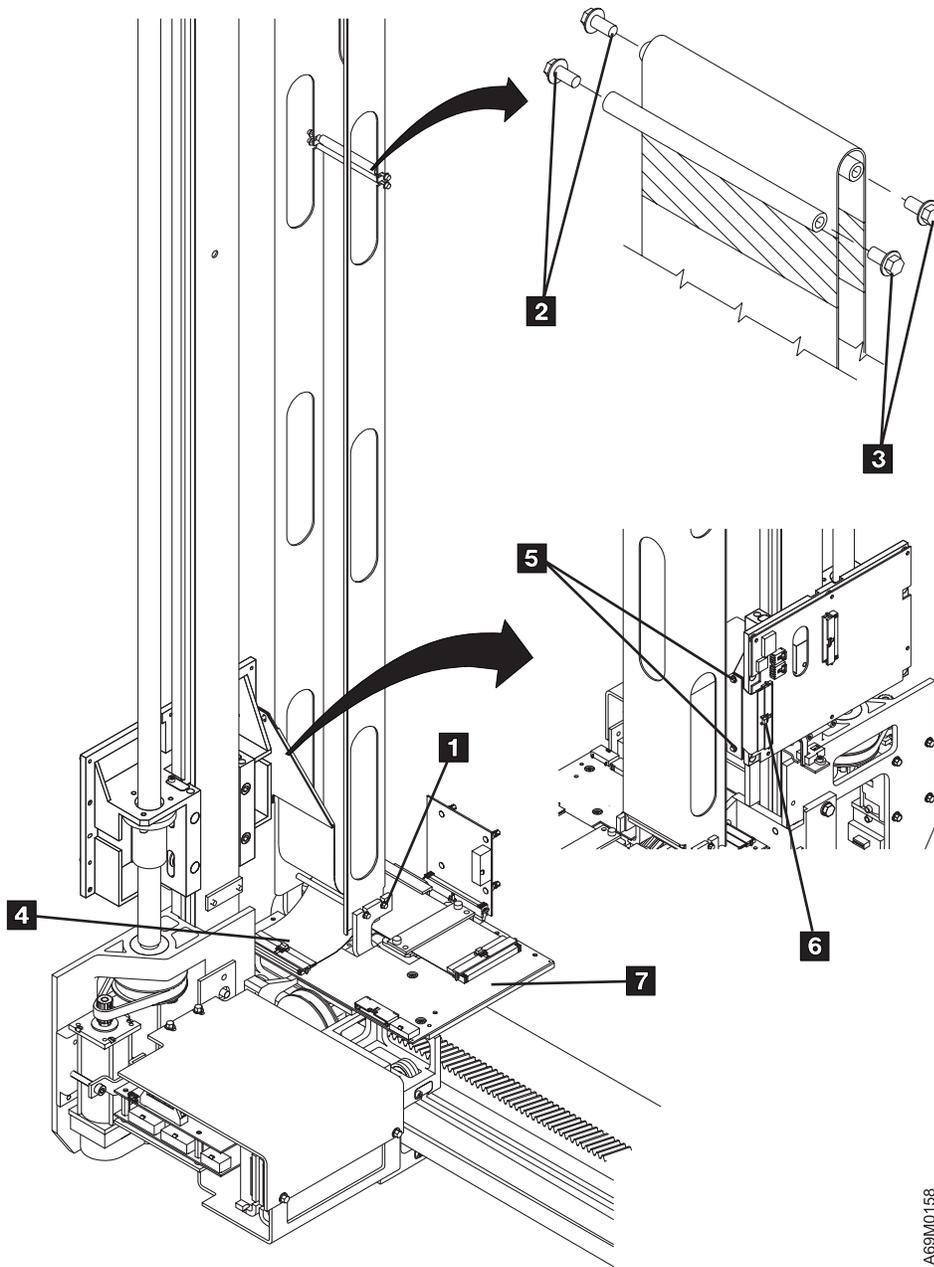
Figure 158. Y-Axis Flex Cable

1. Prepare the accessor for servicing (see “Service Procedures” on page 535).
2. Remove the cable assembly screws **5** at the ACC card.
3. Disconnect the cable **6** from the ACC card.
4. Disconnect the cable **4** from the AXY card **7**.
5. Loosen the screws **1**, and slide the cable out of the trough.
6. Loosen the screws **2** and **3**, and slide the cable out of the trough.
7. Remove the Y-axis flex cable.

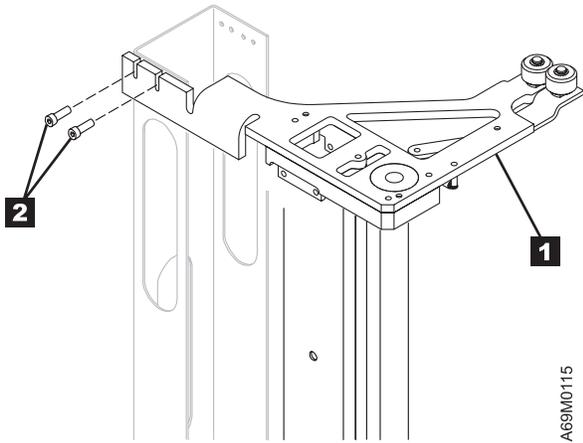
Figure 161. Y-Axis Mast – Top

6. Refer to Figure 161 on page 669 and remove the screws **2** holding the top portion of the Y-axis mast assembly **1** to the top rail assembly.
 7. Refer to Figure 162 on page 669. Loosen the two screws **1** on the left side of the Y-axis mast assembly (see Figure 162 on page 669).

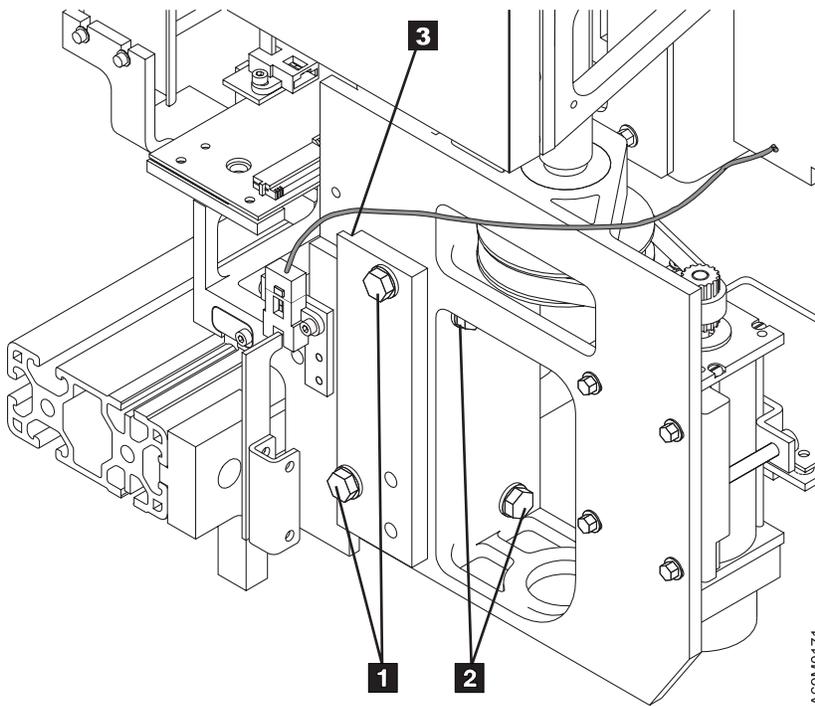
Figure 162. Y-Axis Mast – Bottom

- a. The bolts and screws that secure the Y-axis mast assembly to the X-axis carrier must be tightened in the correct sequence.
 - b. Snug, but do not tighten the four screws. Ensure the lip on the stiffener plate **3** is pushed back firmly against the accessor.
 - c. Tighten the front screws **2** just enough to pull the mast against the accessor.
 - d. Tighten the side screws **1** sequentially top and bottom. Now firmly tighten all screws. Verify the mast is straight.
2. Close the front door.
 3. Complete the accessor service (see “Service Procedures” on page 535).
 4. Perform a library calibration (see “Library Calibration” on page 530).
 5. Perform the “Library Verify Test” on page 507, using the **no drives** selection.
 6. Return to the procedure that sent you here; otherwise, go to “End of Call” on page 489.

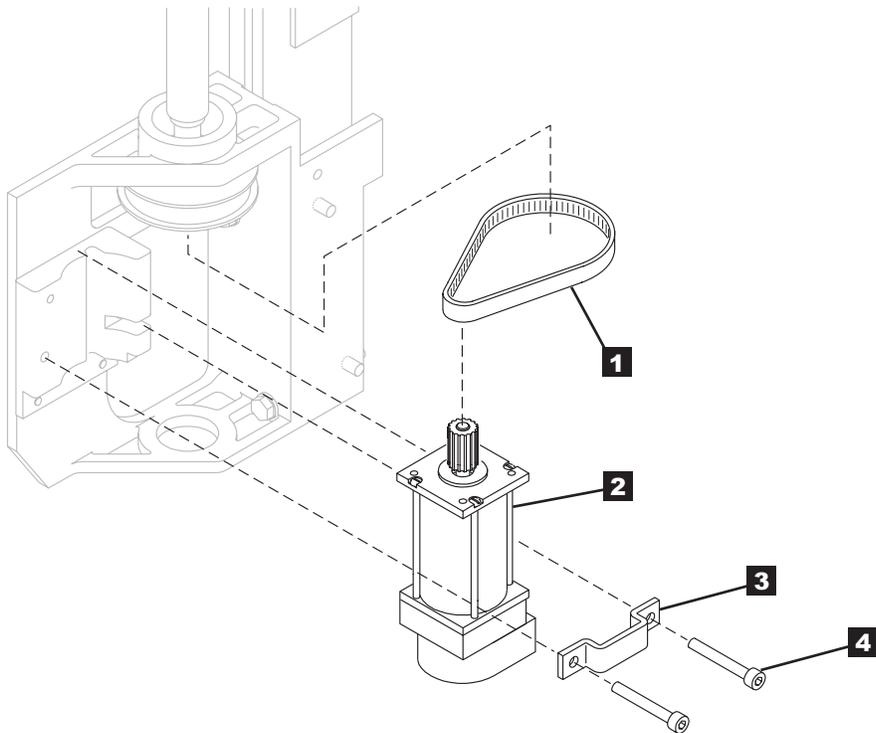
Figure 163. Y-Axis Motor

1. Prepare the accessor for servicing (see “Service Procedures” on page 535).
2. Move the X-axis assembly to a convenient position. Raise the lift mechanism to be above the Y-axis access hole located halfway up the assembly. Insert a hex wrench or screwdriver into the access hole to support the mechanism.
3. Remove the MDA (see “Motor Driver Assembly (MDA)” on page 566).
4. Refer to Figure 163 on page 671.
5. Remove the screws **4**, from motor mount on the Y-axis assembly.
6. Remove the belt **1** and the bracket **3**.
7. Remove the Y-axis motor **2**.

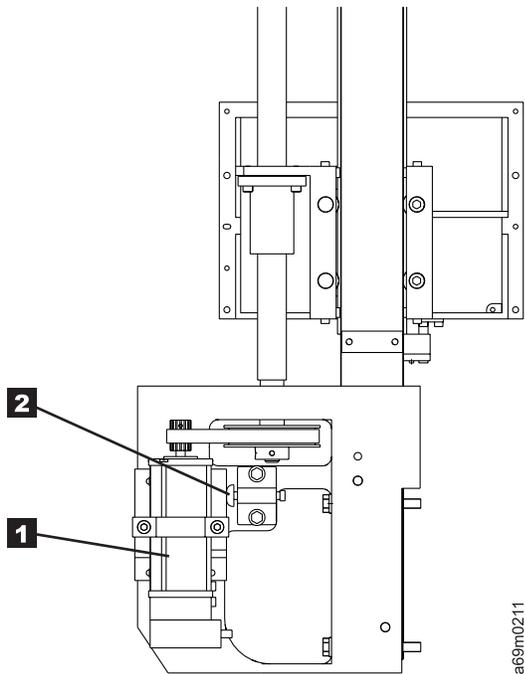
Figure 164. Y-Axis Motor Belt Tensioner (Later Style)

3. See Figure 164 on page 671. Push on the motor **1** to compress the spring-loaded belt tensioner **2**.
4. Work the belt onto the Y-motor pulley and release the motor. Y-axis belt tension is automatically set.

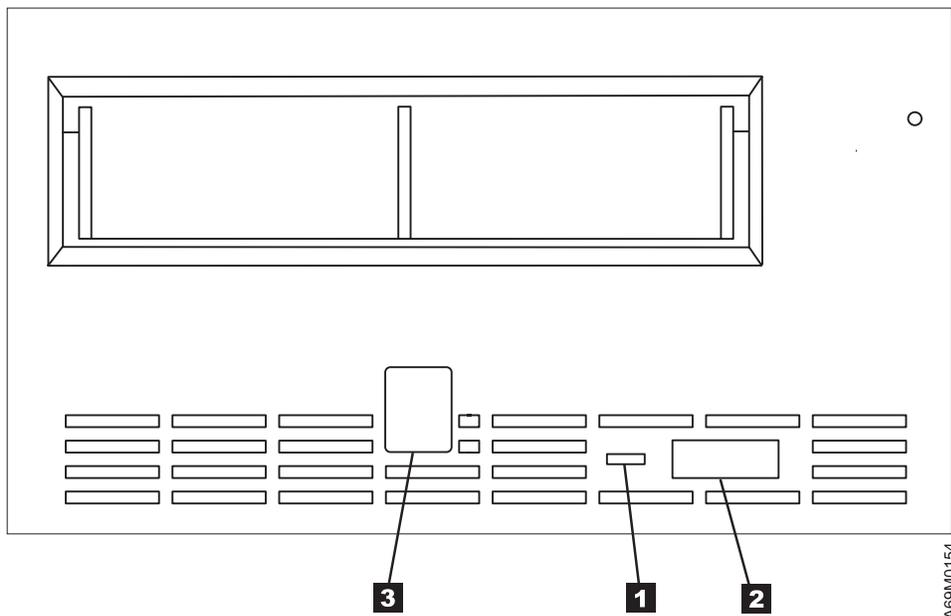
Figure 165. LTO Drive – Front View

If you cannot move the cartridge into the gripper, slide the cartridge into the drive and continue with the next step.
 7. Move the lift and gripper assembly away from the drive.
 8. Push the drive unload button **2**. If the cartridge unloads, go to step 11. If the cartridge does not unload, go to “From an LTO Drive When Cartridge is Stuck in Loader” on page 679.
 9. Finish Drive Replacement (see “Service Procedures” on page 535).
 10. Run Library Verify Test to test the drive (see “Library Verify Test” on page 507). Use the option **One Drive**. When prompted about the Read/Write Test, select **Yes**.
 11. If you manually removed any cartridges, give them to the customer. Advise the customer to install the cartridges using the I/O station.
 12. Return to the procedure that sent you here; otherwise, go to “End of Call” on page 489.

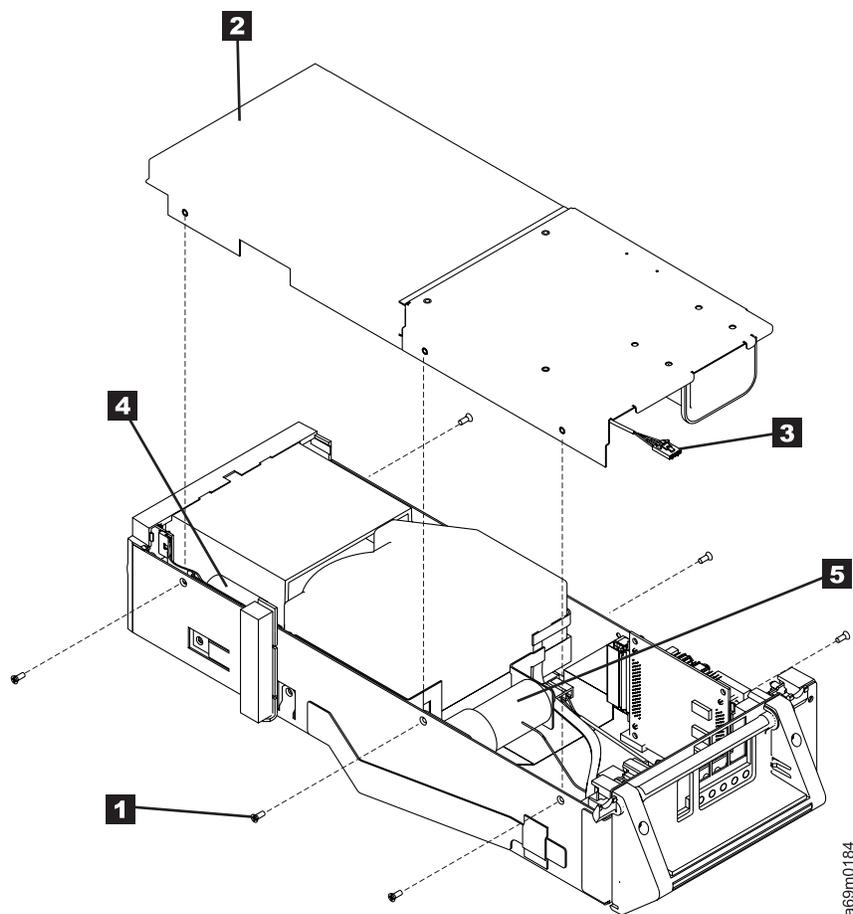
Figure 166. Manually Ejecting DLT-8000 Tape Cartridge from Drive

5. Open the rear door.
6. Remove the tape drive (see "Drive Canister Assembly – DLT-8000 SCSI Hot Swap" on page 590).
7. Refer to Figure 166 on page 677. Remove the six screws **1**, and carefully remove the canister lid **2**. The fan is attached to the canister lid and the cable from the fan is attached to the drive canister.

8. Rotate the canister lid and lay the canister lid next to the drive canister.
9. Open the cable clamp inside the drive canister.
10. Detach the fan cable plug J7 **3** from the DCC card.

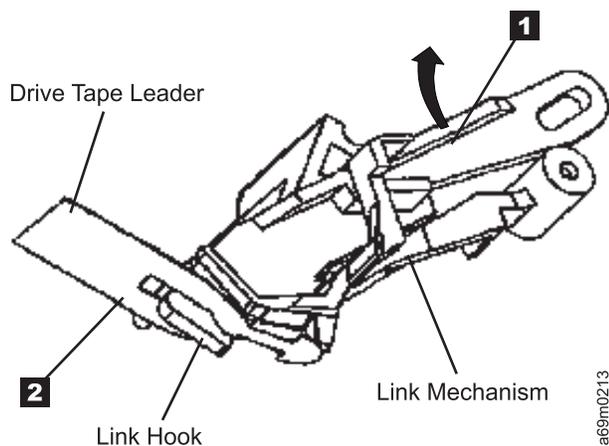
Figure 167. DLT-8000 Drive Tape Leader

2. See Figure 167. Look inside the cartridge loader to see if the drive tape leader is correctly hooked into the link assembly. If it is, return to the procedure that sent you here. If it is visible, but detached from the link assembly, continue at the next step.

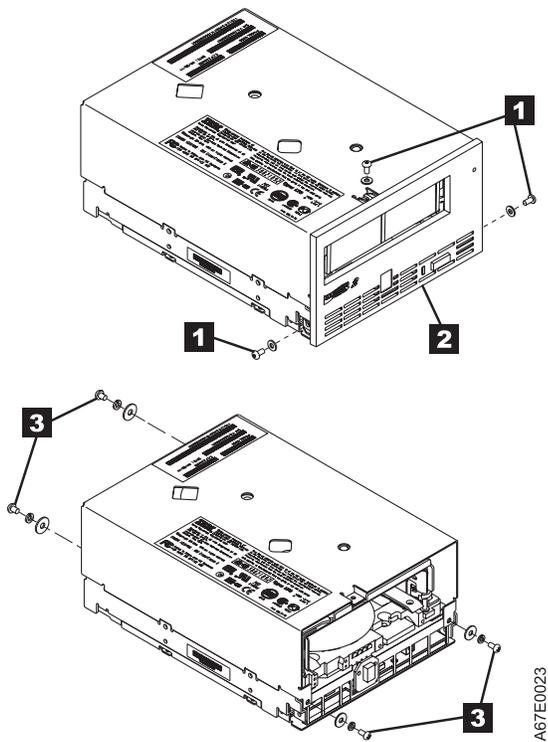
Figure 168. Removing Drive Top Cover

2. Place the drive tray on a nonslip work surface.
3. If you have not already removed the fan cover, refer to Figure 109 on page 586 for the procedure. Loosen the captive screws **6**, and remove the fan cover **5** at the rear of the drive.
4. Remove the drive from the drive tray assembly by unplugging the SCSI, power, and RS-422 cables from the rear of the drive.
5. Remove the four drive mounting screws **4** (see Figure 168 on page 680).
6. Remove the three screws and washers **1** to remove the bezel **2**.
7. Remove the four screws and washers **3** to remove the top cover from the drive.

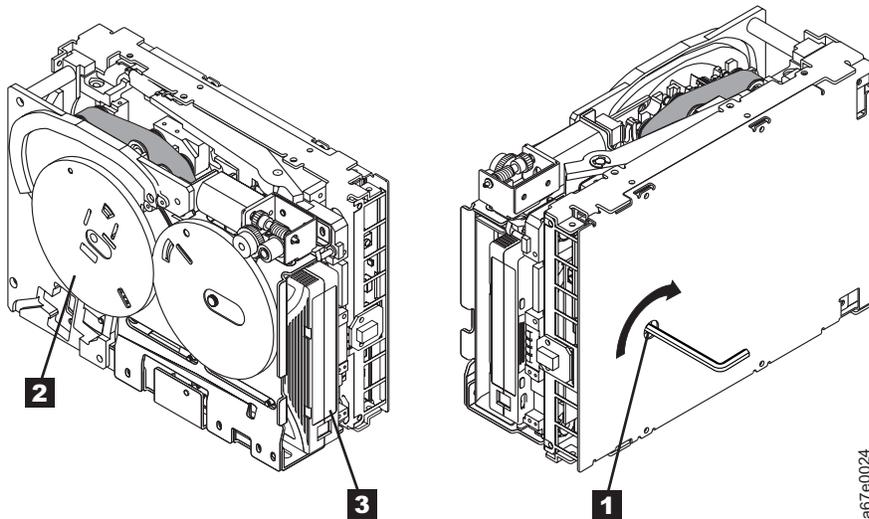
8. Position the drive with the front facing you, then tilt the drive on its left side (see Figure 169 on page 681).
9. Locate the access hole **1** at the bottom of the drive, (see Figure 169 on page 681) and the advance screw within the hole. The advance screw is attached to the supply reel motor.

10. Insert a 2.5 mm hex wrench into the access hole **1**, and rotate the advance screw clockwise. The tape rewinds inside the cartridge, from the take-up reel **2** to the supply reel **3**. As it rewinds onto the supply reel, ensure the tape stays taut by gently pressing your finger against the take-up reel. Stop rotating the screw when you feel resistance. The tape has been rewound as far as it can go.

Figure 169. Rewinding Tape from Take-up Reel to Cartridge Supply Reel. Rotate the advance screw **clockwise** only.
