IBM TotalStorage UltraScalable Tape Library 3584

Maintenance Information

Ninth Edition (June 2003)

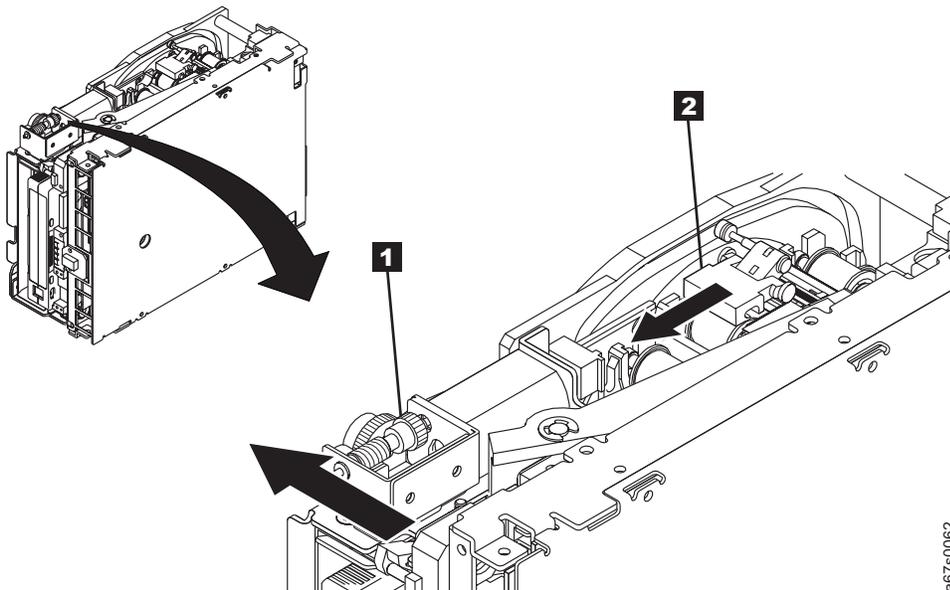
11. Locate the loader motor gear **1** (see Figure 170). While applying just enough clockwise torque to the advance screw **1** (see Figure 169) to keep the tape tight, rotate the loader motor gear in the unload direction (see arrow **1** in Figure 170). The rotation of the loader motor gear causes the leader-pin block **2** to move from the take-up reel towards the supply reel. When the leader-pin block reaches the cartridge, it should disengage from the leader pin, then rotate away from the cartridge:
 - a. If the leader pin disengages from the leader-pin block **2**, rotate the hex wrench clockwise to rewind the tape until the leader pin snaps into the retaining clips in the cartridge. Remove the hex wrench and go to step 15 on page 682.
 - b. If the leader pin does not disengage, go to step 12 on page 682.

Figure 170. Moving Leader-Pin Block from Take-up Reel to Supply Reel. When the leader-pin block reaches the cartridge, it disengages the leader pin, then rotates away from the cartridge.

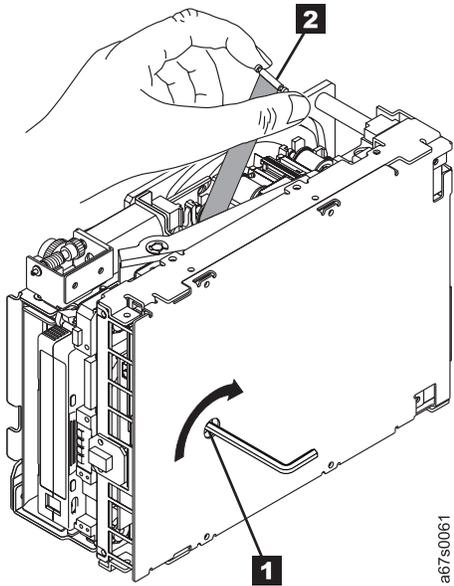
Figure 171. Rewinding Leader Pin into Tape Cartridge

12. Being careful not to allow the leader-pin block to contact and damage the head, use clean, needle-nose pliers to grasp the end of the leader pin, if necessary. Pull the leader pin out of the leader-pin block so that you can grip it with your fingers (see **1** in Figure 171).
13. Use your fingers to keep the tape taut, as you rotate the hex wrench **2** **clockwise** to wind the excess tape into the cartridge. Guide the leader pin toward the cartridge, and drop it inside the cartridge door. Ensure that no tape is left outside of the cartridge.
14. Remove the hex wrench.

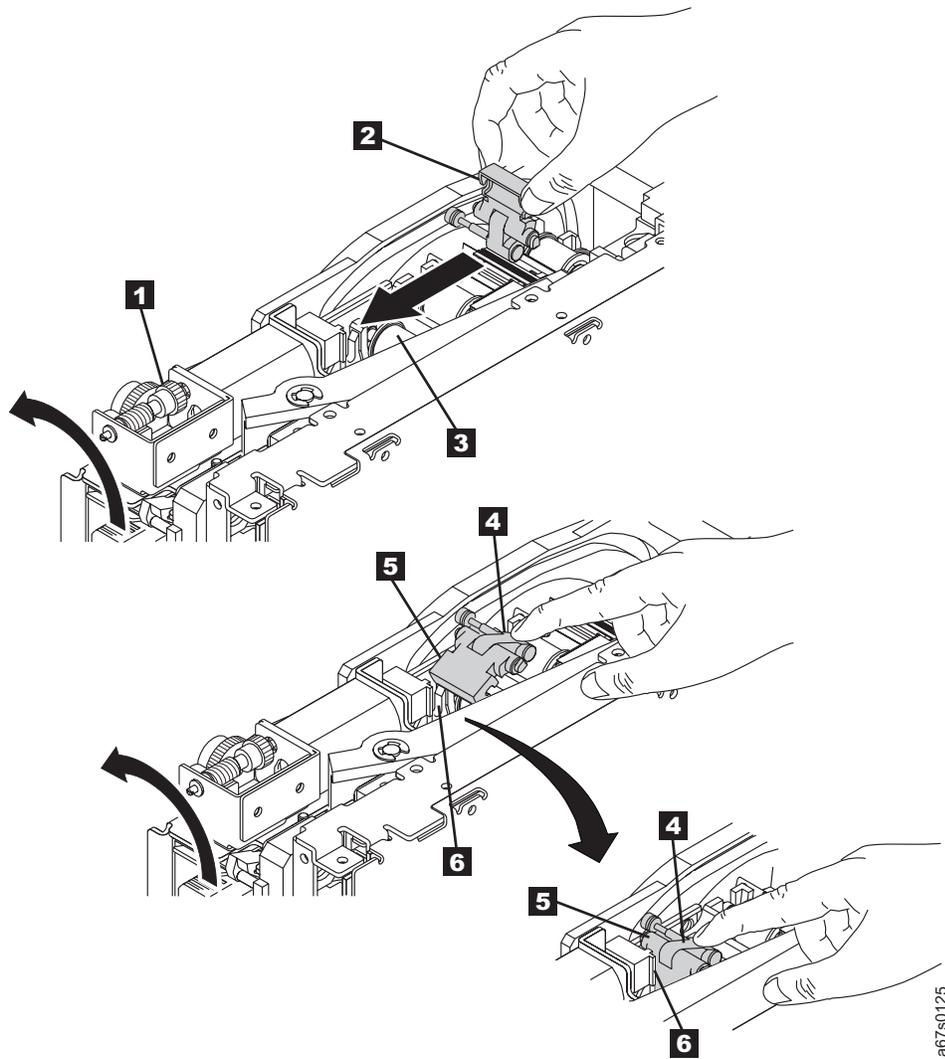
Figure 172. Guiding Leader Pin into Tape Cartridge

15. Manually rotate the loader motor gear (see **1** in Figure 172 on page 683) in the unload direction until the leader pin block **2** reaches the last roller **3**.
16. To prevent the leader pin block from jamming, press down on the linkage of the leader block **4** to force up the hinged section of the block.
17. While manually rotating the loader motor gear in the unload direction, guide the end of the leader pin block **5** into the block guide **6**.
18. Continue to rotate the loader motor gear counterclockwise until you feel resistance, and the cartridge rises and ejects.
19. Remove the stuck tape cartridge, and visually check for any damage to the tape or the leader pin. If there is no obvious damage, give the cartridge to the customer. Ask the customer to copy the data from the tape to another cartridge, and ask them to discard this potentially-damaged cartridge.

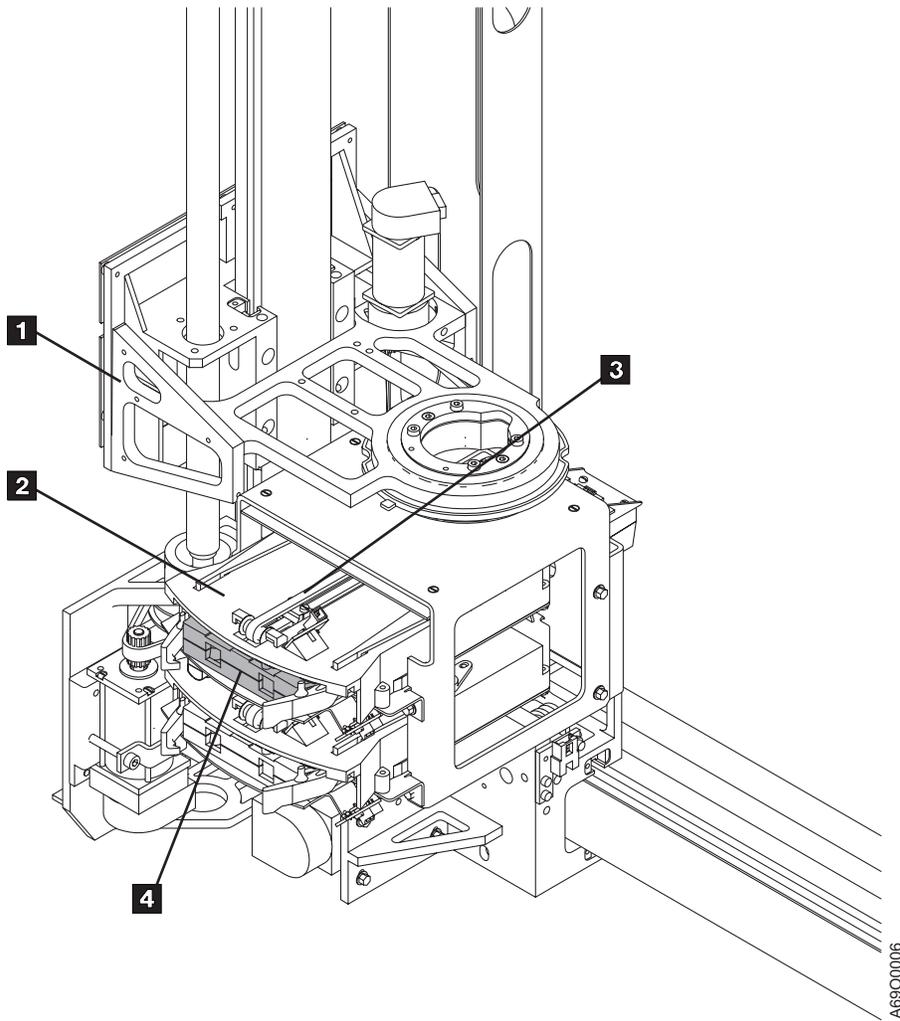
Figure 173. Manually Removing Cartridge from Dual Gripper Assembly

1. Prepare the accessor for service (see).
2. Open the door nearest the gripper.
3. Move the Y-axis on the rail until it is at a convenient position for you to remove the cartridge.
4. Rotate the gripper assembly until the cartridge is facing you.
5. Refer to Figure 173 on page 685 and move belt **3** in a direction toward the gripper exit while manually guiding the cartridge **4** toward you.
6. Remove the cartridge from the gripper **2**.
7. If you manually removed any cartridges, give them to the customer.
8. Close the front door.
9. Complete the accessor servicing (see).
10. Perform the "Library Verify Test" on page 507.
11. Return to the procedure that sent you here; otherwise, go to "End of Call" on page 489.

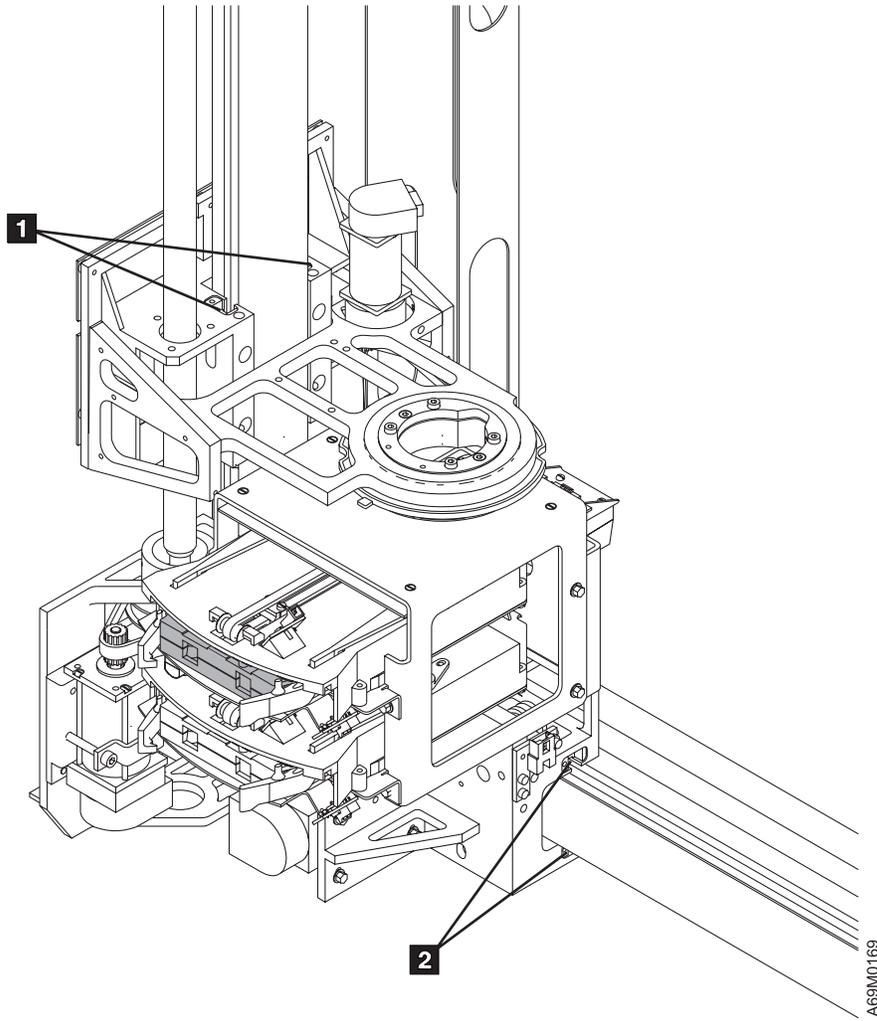
Figure 174. Lubrication Points

1. Lubricate the two wiper pads **1** on the top Y-axis (shown) and two on the bottom (not shown), using IBM Lubricant #6 (see Figure 174 on page 687).
2. Lubricate the two wiper pads **2** on each side of the X-axis (four, total), using IBM Lubricant #6.
3. Put a few drops of IBM Lubricant #6 on a cloth and wipe the top and bottom X-rail rods and the front and back Y-rail rods.
4. Inspect and, if indicated, replace the pivot belt, X-axis drive belt, and Y-axis drive belt. Refer to the procedures in this chapter.
5. Record the date and Y-axis meters traveled for this PM.

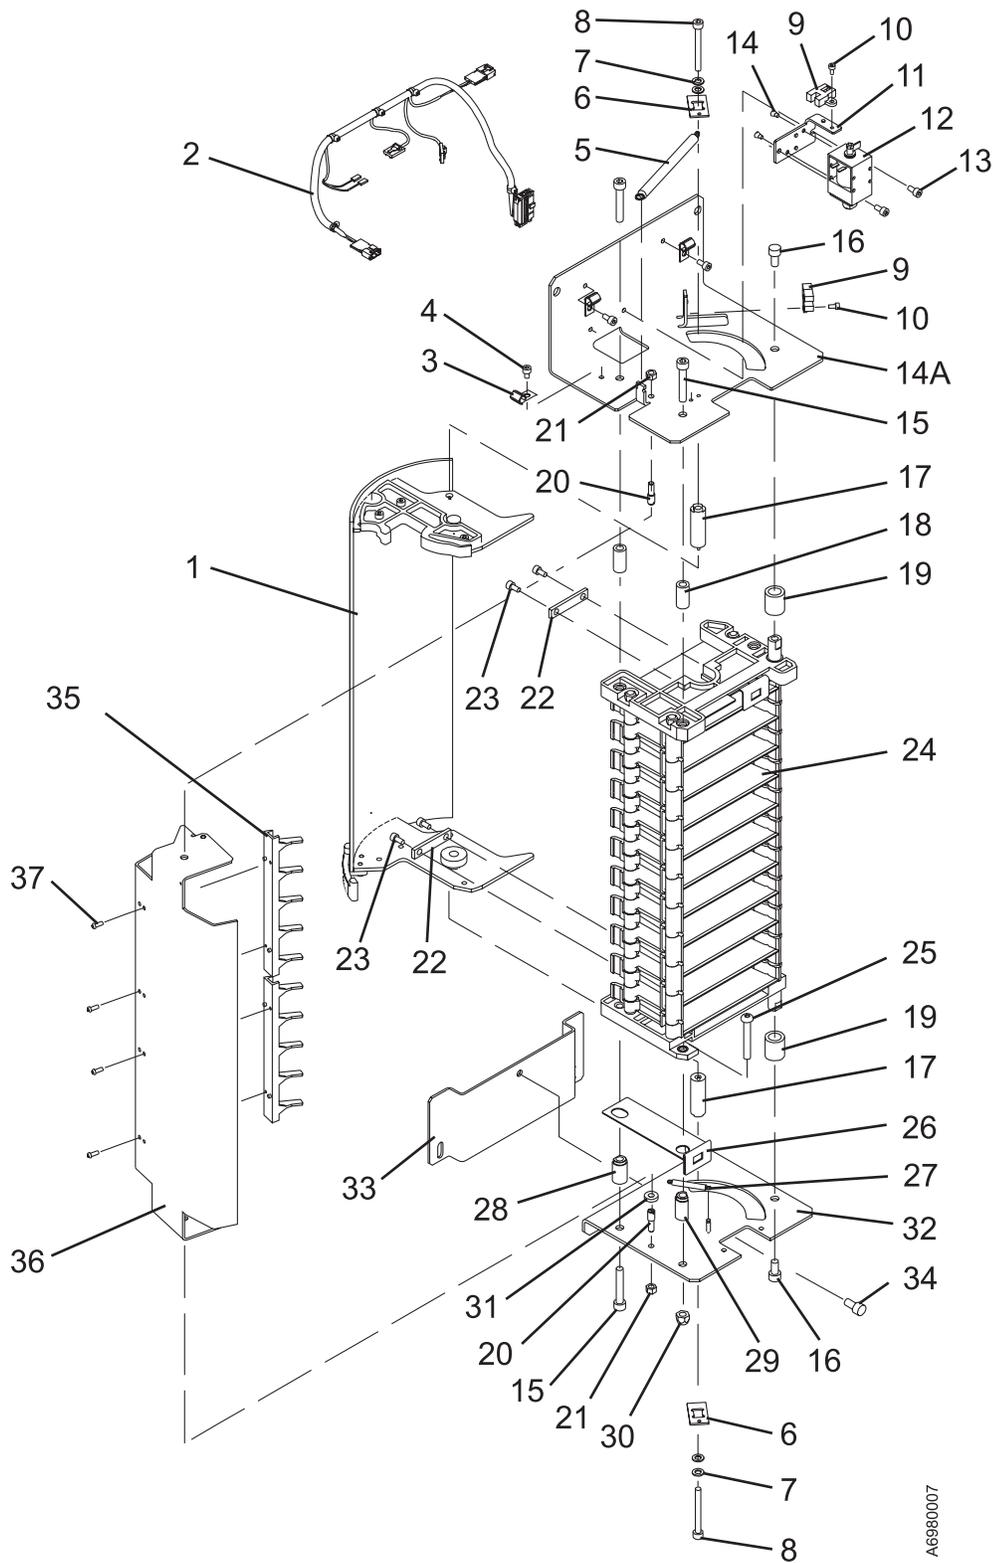
Assembly 2: Upper I/O Station Assembly

-20		NP	• Pin, Toggle
-21		NP	• Nut, Hex, M5
-22	94F6807	2	• Clamp, Door Mounting, LTO
-23		NP	• Screw, Soc Hd Cap, M4 X 8 mm
-24		NP	• I/O Cells, 10-Cartridge (LTO)
-25		NP	• Screw, Button Hd, M6 X 40 mm
-26		NP	• Bracket, Lower Fiducial
-27	35L0778	1	• Spring, Toggle Stop, LTO
-28		NP	• Spacer, Shoulder
-29		NP	• Spacer, Flat
-30		NP	• Locknut, M6
-31		NP	• Washer
-32		NP	• Bracket, Lower Mounting
-33		NP	• Bracket, Bottom Adapter
-34		NP	• Screw, Soc Hd Cap, M6 X 12 mm
-35		NP	• Fingers, Toggle
-36		NP	• Bracket, Toggle Stop
-37		NP	• Screw, M3 X 8 mm

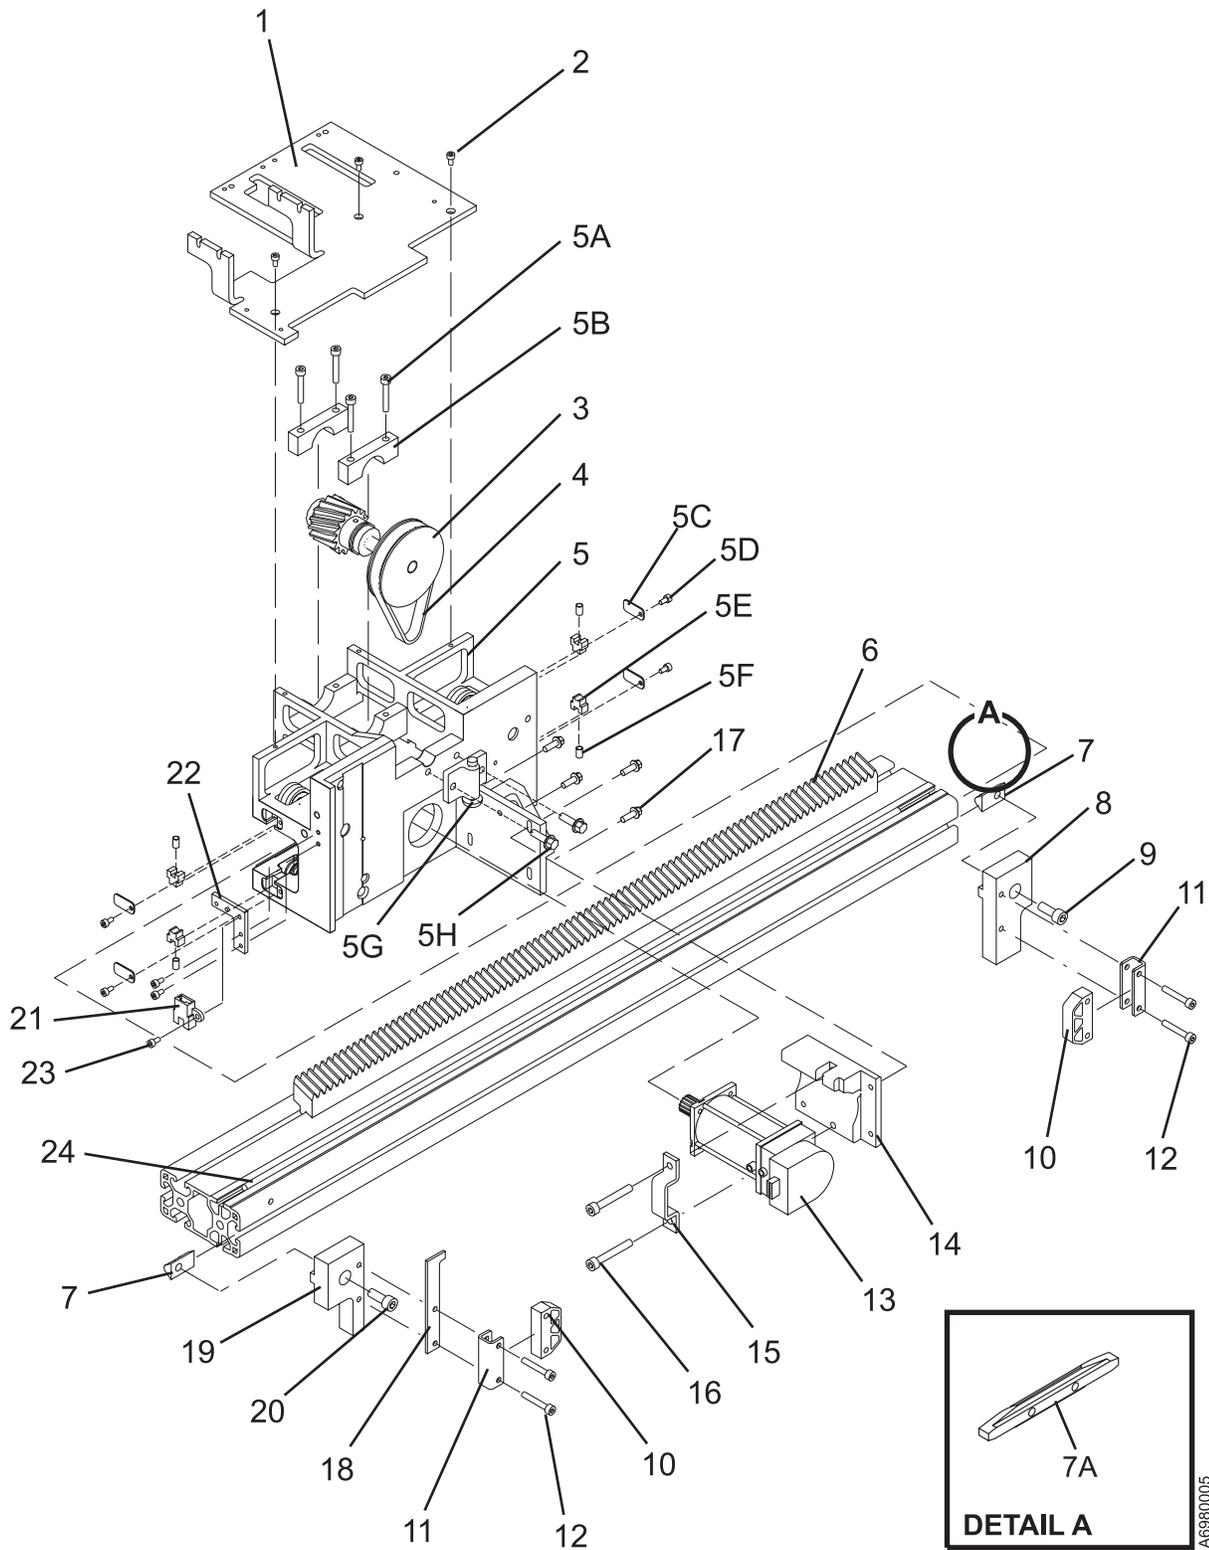
Assembly 3: X-Axis Assembly

-18		NP	• Bracket, EOT Flag
-19		NP	• Block, EOT Mounting (Left)
-20		NP	• Screw, Soc Hd Cap, M6 X 16 mm
-21	05H8407	1	• Sensor, Home, X-Axis
-22		NP	• Bracket, Sensor
-23		NP	• Screw, Soc Hd Cap, M3 X 6 mm
-24	34G9620	2	• Rod, X-Axis Bearing Way (Used on Base Frame only)
-24	05H8105	2	• Rod, X-Axis Bearing Way (Used on Expansion Frames only)

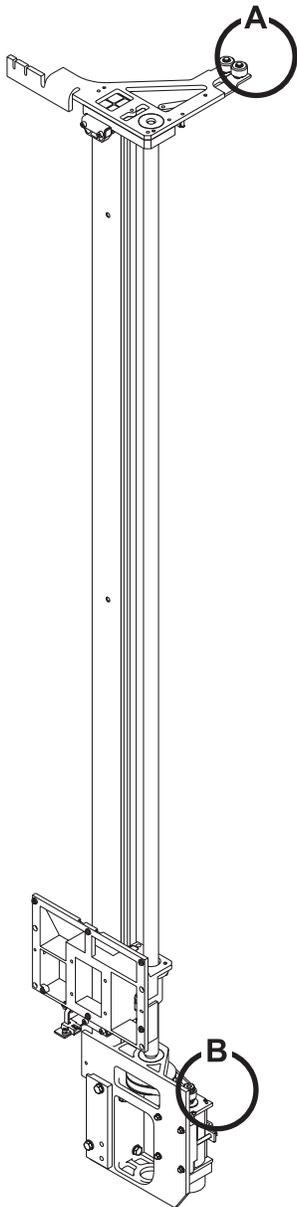
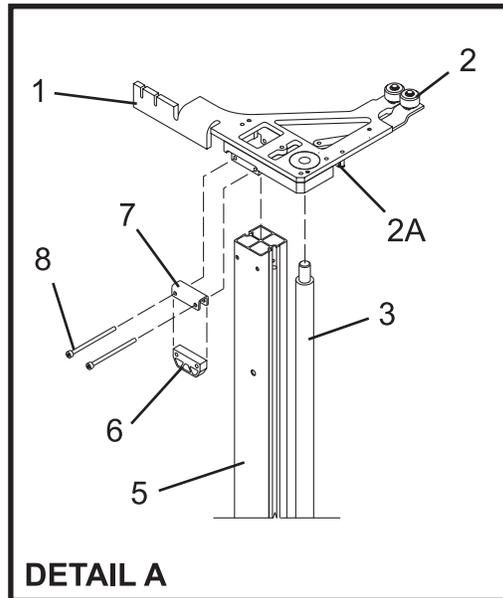
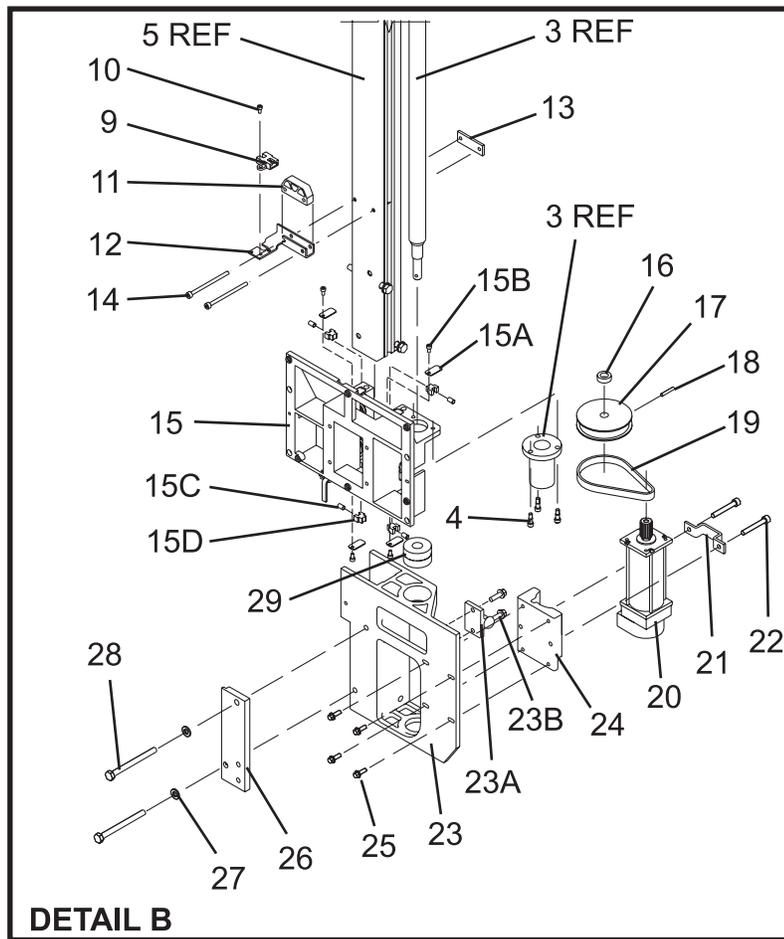
Assembly 4: Y-Axis Assembly

-23		NP	• Block, Y-Mounting
-23A		NP	• Tensioner, Spring
-23B		NP	• Screw, Hex Flat Head, M5 X 16
-24		NP	• Block, Y-Motor Mount
-25		NP	• Screw, Flng Hd Hex, M4 X 12 mm
-26		NP	• Bracket, Y-Axis Mounting
-27		NP	• Washer, Flat, M6
-28		NP	• Screw, Hex Hd Cap, M6 X 70 mm
-29		NP	• Y-Bearing

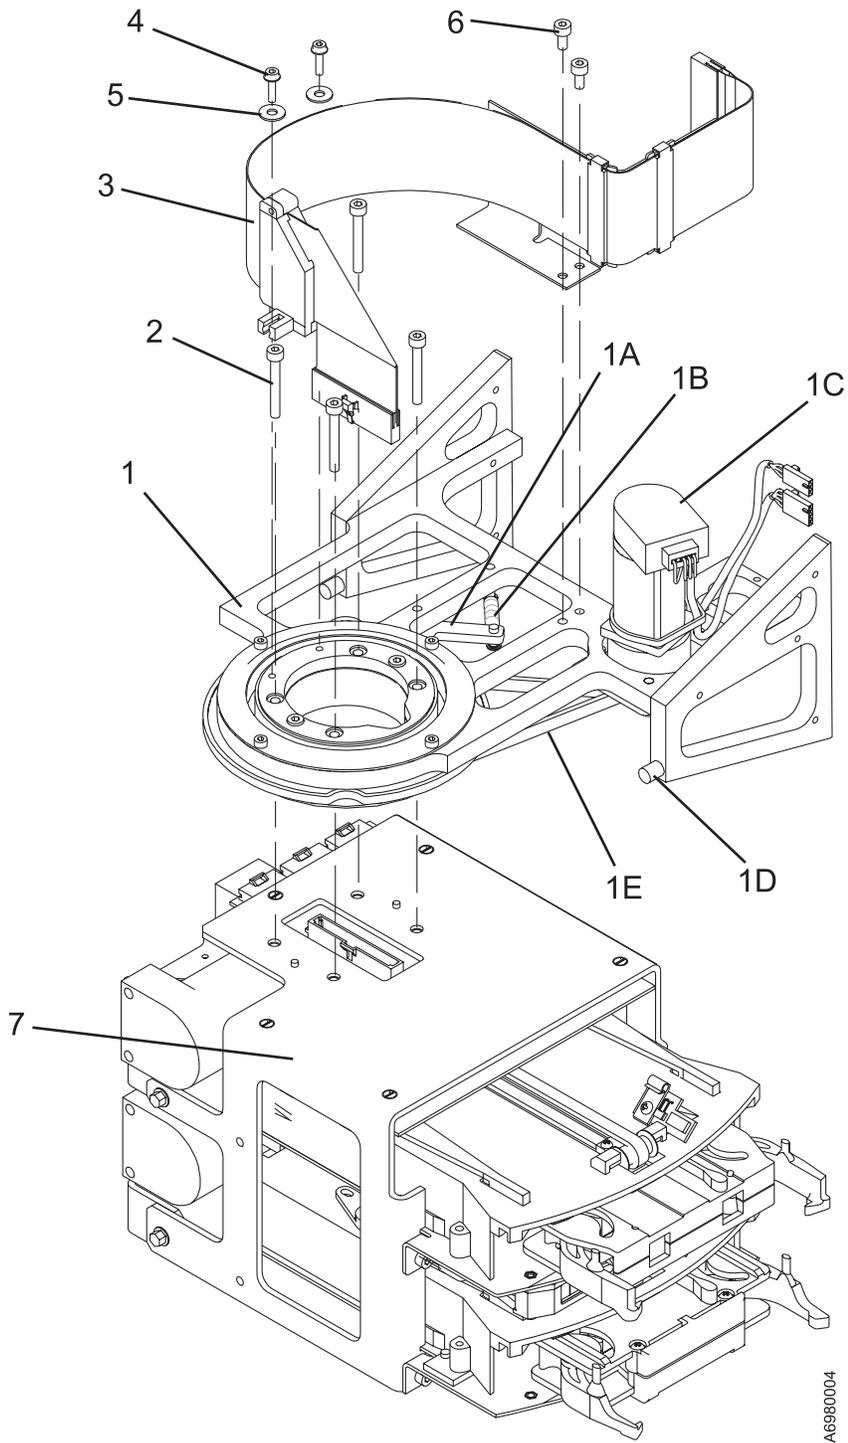
Assembly 5: Gripper and Pivot Assembly

Asm-Index	Part Number	Units	Description
5-		NP	Gripper and Pivot Assembly For next higher assembly, see 1-30 on page 713
-1	35L1784	1	• Pivot Assembly
-1A	34G9360	1	• • Detent Arm Assembly
-1B	34G9363	1	• • Spring, Detent Arm
-1C	35L0274	1	• • Motor/Tach Assembly, Pivot (old style)
-1D	34G9352	2	• • Bumper, Pivot
-1E	35L0277	1	• • Belt, Pivot (old style)
-1E	19P0745	1	• • Pivot Motor and Belt Assembly (new style with captive pivot belt)
-2		NP	• Screw, Soc Hd Cap, M4 X 30 mm
-3	35L0212	1	• Cable, Pivot Flex
-4		NP	• Screw, Soc Hd Cap, M3 X 12 mm
-5		NP	• Washer, Flat, M3
-6		NP	• Screw, Soc Hd Cap, M4 X 8 mm
-7		NP	• Dual Gripper Assembly For detail breakdown, see "Assembly 6: Dual Gripper Assembly" on page 724
