# IBM INSTALLATION INSTRUCTIONS

## FC 5780 (3590 Model B11/B1A) FC 5781 (3590 Model E11/E1A) Drive Update to Support Extended High Performance Tape

Document Number 35L2021 EC D19600A

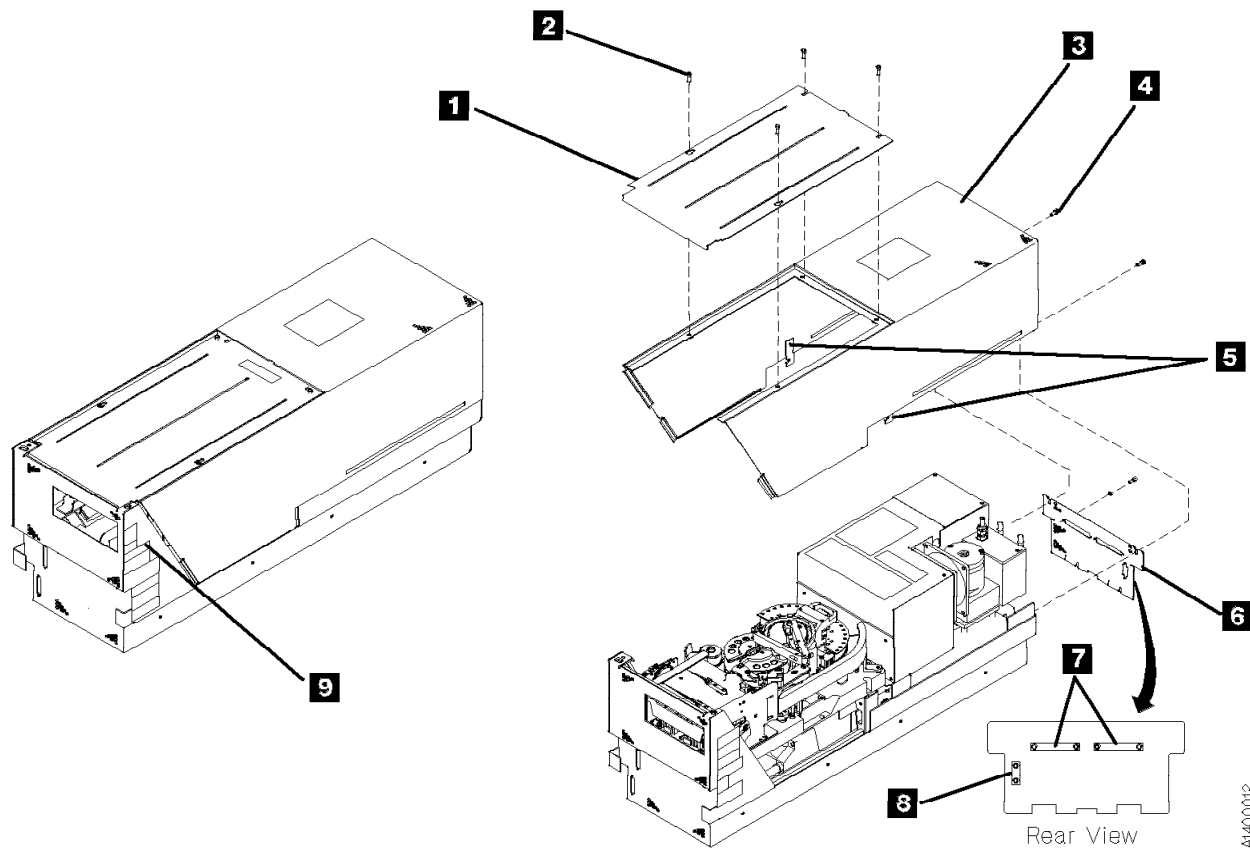
Figure 1. Deck Enclosure Covers

**Note:** Removal of four screws **2** and the top access panel **1** are not required.

- 2. Slide the cover toward the rear of the drive to disengage the two hooks **5** and lift off the back cover.

Refer to Figure 1.

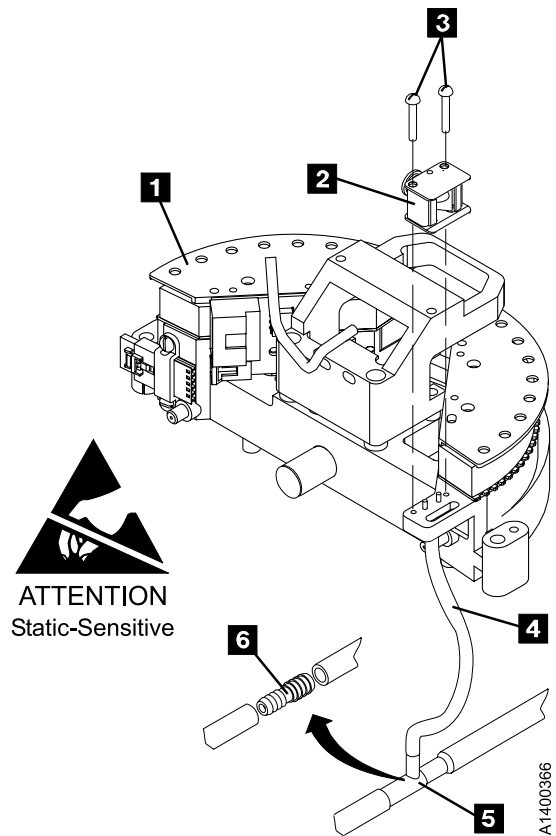
Figure 2. Cleaner Blade Removal

**Attention:** If the HGA has a cleaner blade attached **2** use the following procedure to remove it. **Not removing the cleaner blade can damage the new Extended High Performance Tape!**

- 1. Remove the two screws **3** holding the cleaner blade on the HGA **1**.
- 2. Remove and discard the cleaner blade **2**.
- 3. Remove and discard the cleaner blade vacuum hose **4**.
- 4. Install the in-line connector (P/N 09L4687) **6** in place of the tee connector **5**.

**Note:** If the cleaner blade is removed it will be necessary to readjust the vacuum at the end of this Feature Installation. This will

See Figure 2.

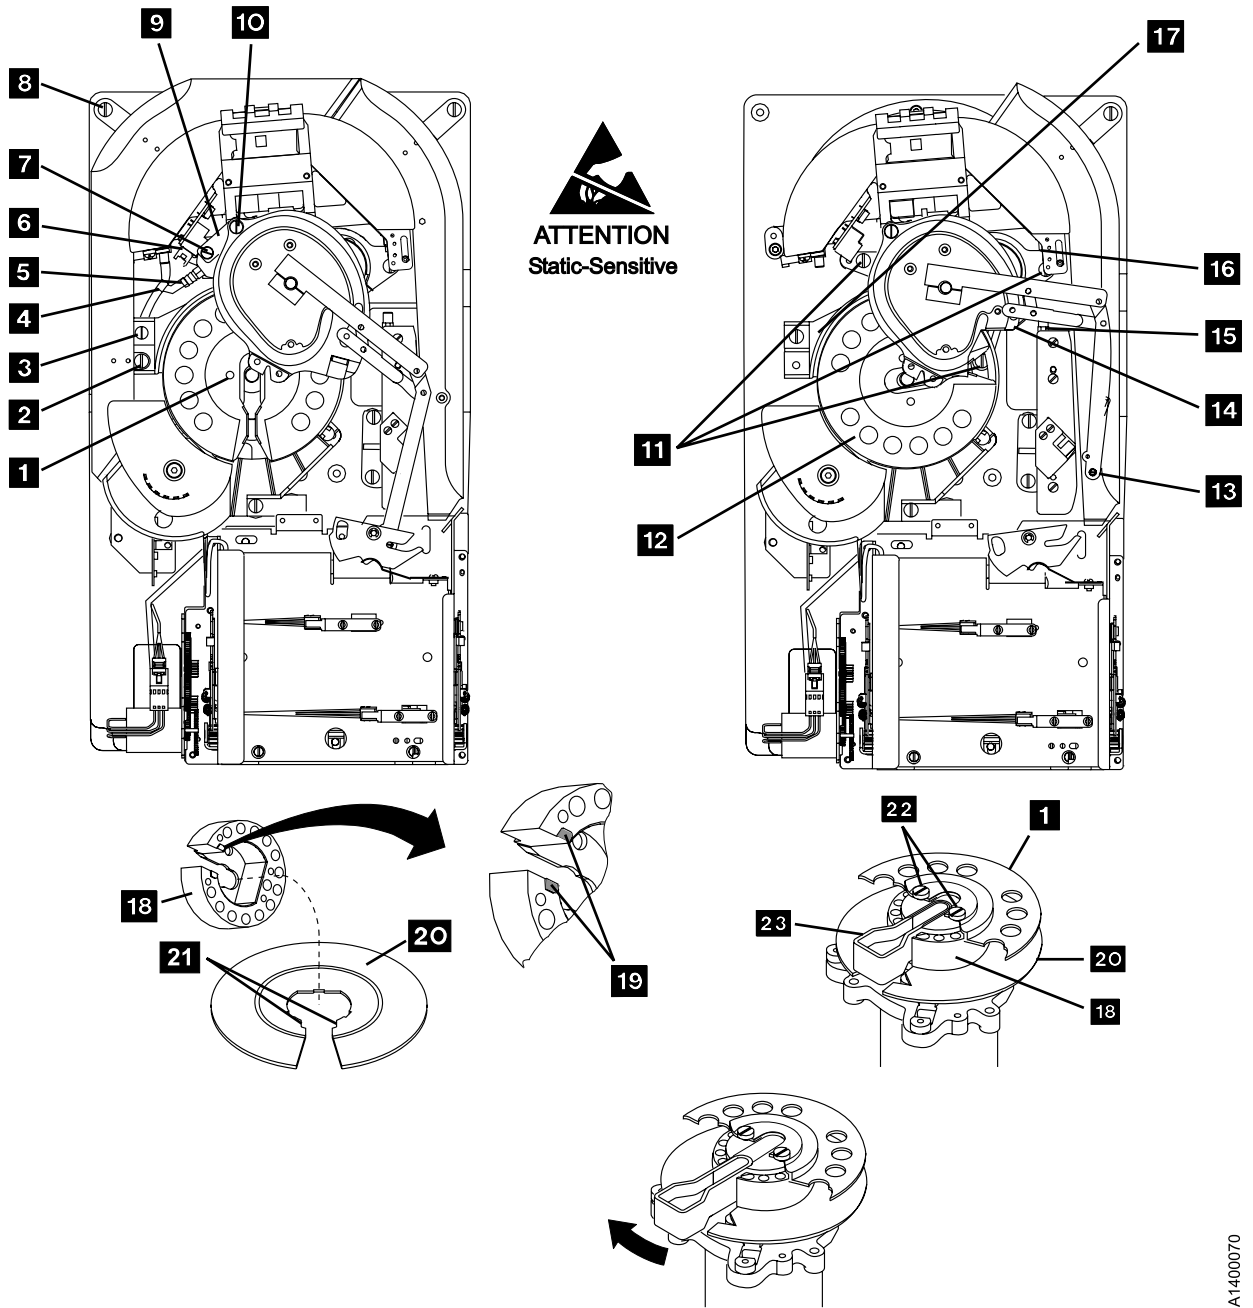
Figure 3. Pantocam

- \_\_\_ 5. Insert the gap set tool (PN 05H4671) **23** into the gap in the hub **18**.
- \_\_\_ 6. Now refer to Figure 6 on page 16.

Reconnect the VPD cable connector **6**.
- \_\_\_ 15. Reinstall the tape-lifter solenoid mounting bracket screw **10**.
- \_\_\_ 16. Reinstall the right D-bearing hose **16** and the rear decoupler hose **15**.
- \_\_\_ 17. Reinstall the large hose **5** to the tape-lifter solenoid and the tee connection **4**.

See Figure 3 on page 13.

Now refer to Figure 3 on page 13

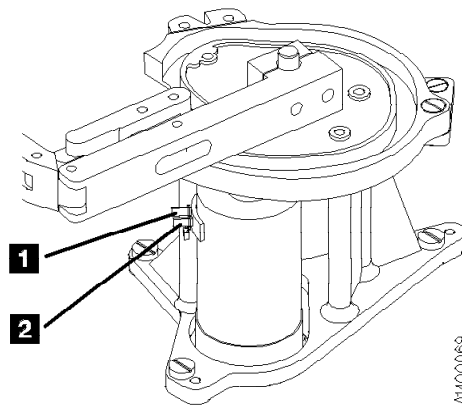
Figure 5. Pantocam Motor Connectors

- Black motor lead: right terminal **2**
- Yellow motor lead: left terminal **1**

**Note:** If the motor leads are too short, loosen the cable clamp to relieve the strain, then tighten the cable clamp.

\_\_\_ 1. See Figure 5.

\_\_\_ 3. See Figure 5.

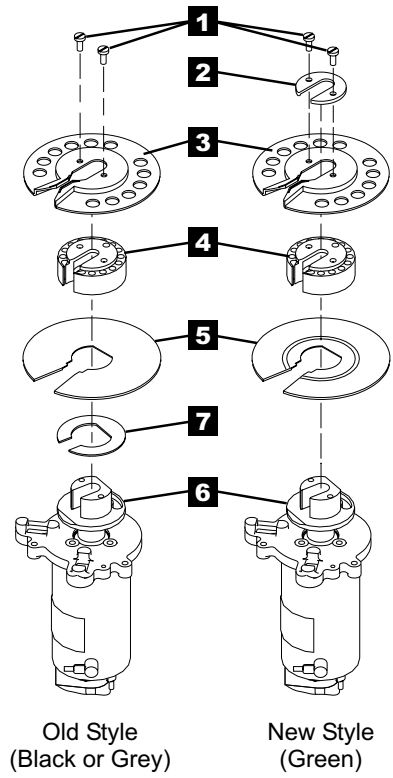
Figure 6. Machine Reel Motor

**Note:** Some later model 3590 drives will have a retainer (item **2** in Figure 6 on page 16) on top of the upper flange. If this retainer is present, remove and discard it.
- \_\_\_ 10. **Attention:** Do not get the old and new retainers mixed up. They are both black metal parts, but the old level retainer has a raised ridge on one side. The new level retainer is flat on both sides, and is thicker than the old level retainer.
- \_\_\_ 11. **Do not use tools to remove the hub; damage to the hub may result.** Rotate the hub **18** so the opening is toward you. Use both thumbs to spread the opening apart **19** then lift off and discard the hub.
- \_\_\_ 12. Remove and discard the lower flange **20** .
- \_\_\_ 13. Some early 3590 drive models have a shim under the lower flange. If present, **remove and discard any shims under the flange.**

- \_\_\_ 1. Ensure that any shims **7** on the motor hub **6** have been removed and discarded.
- \_\_\_ 2. Place the new lower flange (PN 35L0815) **5** onto the motor hub **6**. Ensure that the groove on lower flange **5** is facing up as shown in Figure 6 on page 16.
- \_\_\_ 3. Install the new take-up hub (PN 34L2659) **4** onto motor hub **6**.
- \_\_\_ 4. Refer to Figure 3 on page 13.

Refer to Figure 6 on page 16.

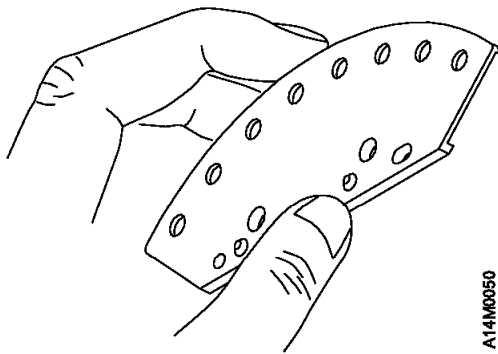
Figure 7. How to hold the compliant guide

**Warning:** The white ceramic buttons on the compliant guides are mounted on very sensitive springs. These buttons and springs can be damaged very easily. When handling the compliant guides, hold them by the edges as shown in Figure 7 on page 18. If you have to lay the guide down while installing the shim, be sure the white buttons are facing **UP**. When you pick up the guide be **VERY** careful not to touch the white buttons. **DO NOT** attempt to clean the white buttons.

See Figure 7 on page 18.

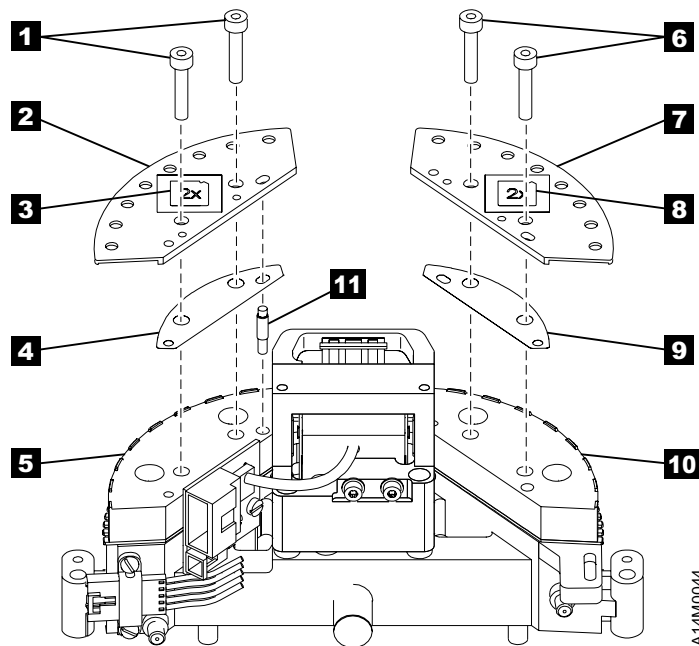
Figure 8. Shim Installation

**Attention:** The left compliant guide **2** and the right compliant guide **7** are identical parts, but they should **NOT** be interchanged. The surfaces develop a unique wear pattern with use, and may cause intermittent problems if they are installed on the wrong side. Complete the shim installation procedure on one side before removing the guide on the other side.

- 1. Remove the 2 screws **1** from the left 'D' bearing assembly **5**.
- 2. The locating pin **11** closest to the R/W head on the left 'D' bearing is designed to be loose in the hole in the 'D' bearing. But it may be tight in the hole in the compliant guide. Use a small allen wrench or similar tool to hold the pin down while you lift up on the compliant guide.
- 3. Remove the left compliant guide **2**. Be careful not to let the pin come out of the hole in the 'D' bearing, because it may fall down into the HGA assembly and become lost.

If the pin does come out of the hole, note that the two ends of the pin are different. Refer to Figure 8 on page 18, item **11**, to determine how to put it back in the hole.

- 12. Install the 2X labels (P/N 34L2660) **3** and **8** as shown.

See Figure 8 on page 18.

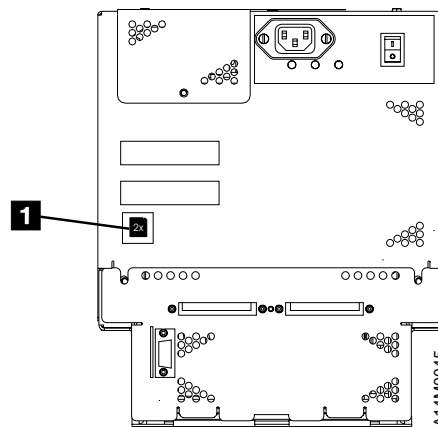
Figure 9. Label Attachment to Rear of 3590E Drive

- \_\_\_ 7. Power off the drive and disconnect the power cable from the drive.
- \_\_\_ 8. Install the deck enclosure back cover.
- \_\_\_ 9. Install the 2X label (PN 34L2660) **1** next to the Magstar Model label. Refer to Figure 9.
- \_\_\_ 10. Connect the power cable to the drive.
- \_\_\_ 11. Power on the drive.
