Pentium® Processor Specification Update

Release Date: November 12, 1997

Order Number 242480-032

The Pentium® processor may contain design defects or errors known as errata which may cause the product to deviate from published specifications. Current characterized errata are documented in this Specification Update.

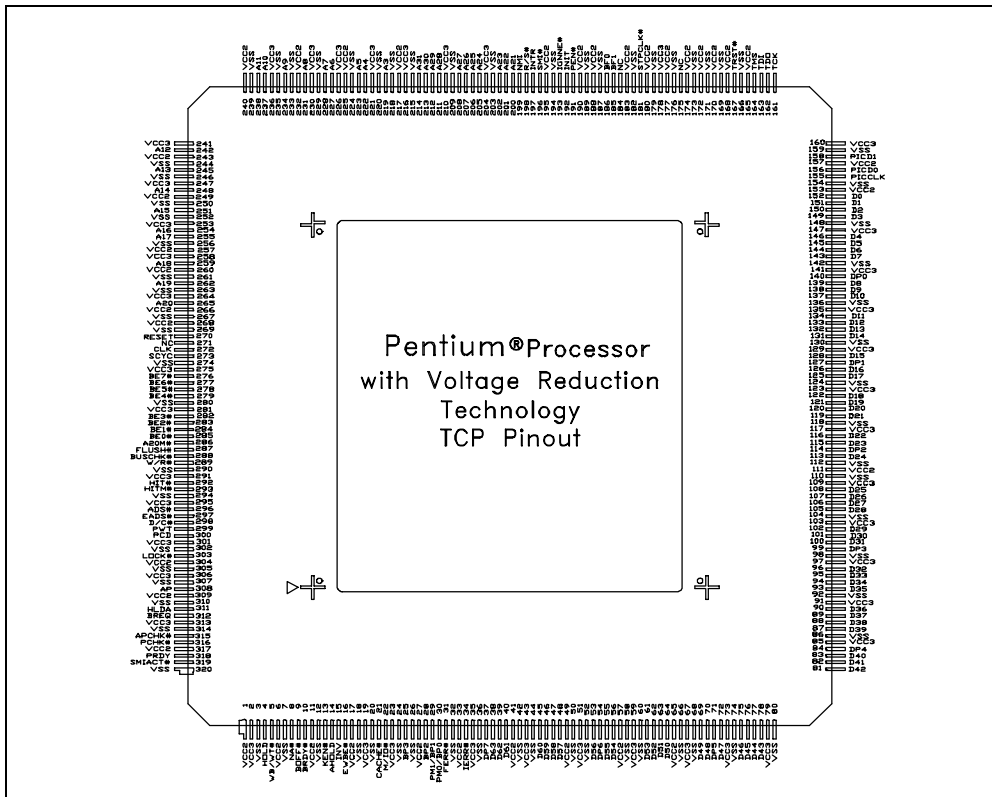
2. **Incorrect TCP Pinout Drawing**

The TCP pinout drawing on page 8 of the *Pentium Processor with Voltage Reduction Technology* datasheet was inadvertently rotated. The correct orientation is shown below.

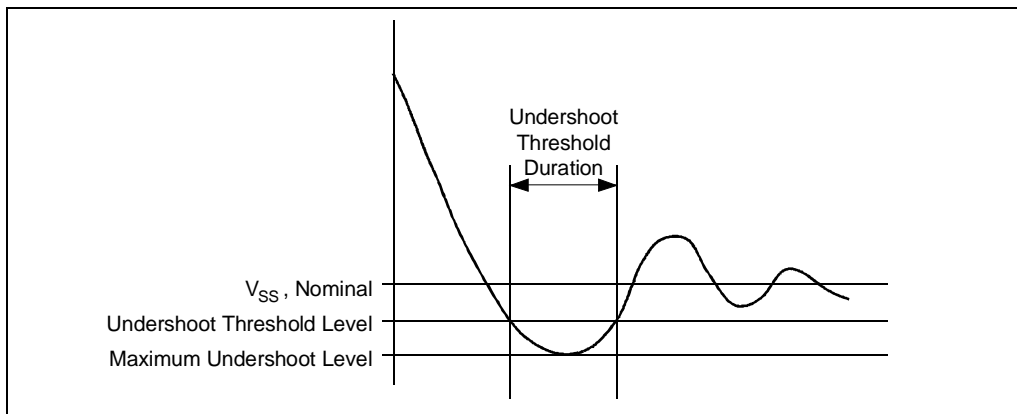
Figure14-1. Maximum Undershoot Level, Undershoot Threshold Level, and Undershoot Threshold Duration

UNDERSHOOT THRESHOLD DURATION SPECIFICATION: A snapshot of the clock signal should be taken at 500 mV/div and 500 pS/div (for CLK). Adjust the vertical position and horizontal offset position to view the threshold duration. The undershoot threshold duration is defined as the sum of all time during which the clock signal is below -0.5V within a single clock period. The undershoot threshold duration must not exceed 20% of the period.

This undershoot specifications are illustrated graphically in Figure 14-1 and Figure 14-2.

MAXIMUM RINGBACK SPECIFICATION: The maximum ringback of CLK associated with its low state (undershoot) must not exceed 0.8V as shown in Figure 14-1.

1. See Figure 14-1 and Figure 14-2.
