7208 20GB External 8mm Tape Drive
Model 341

Service Guide

Document Number SA37-0320-00

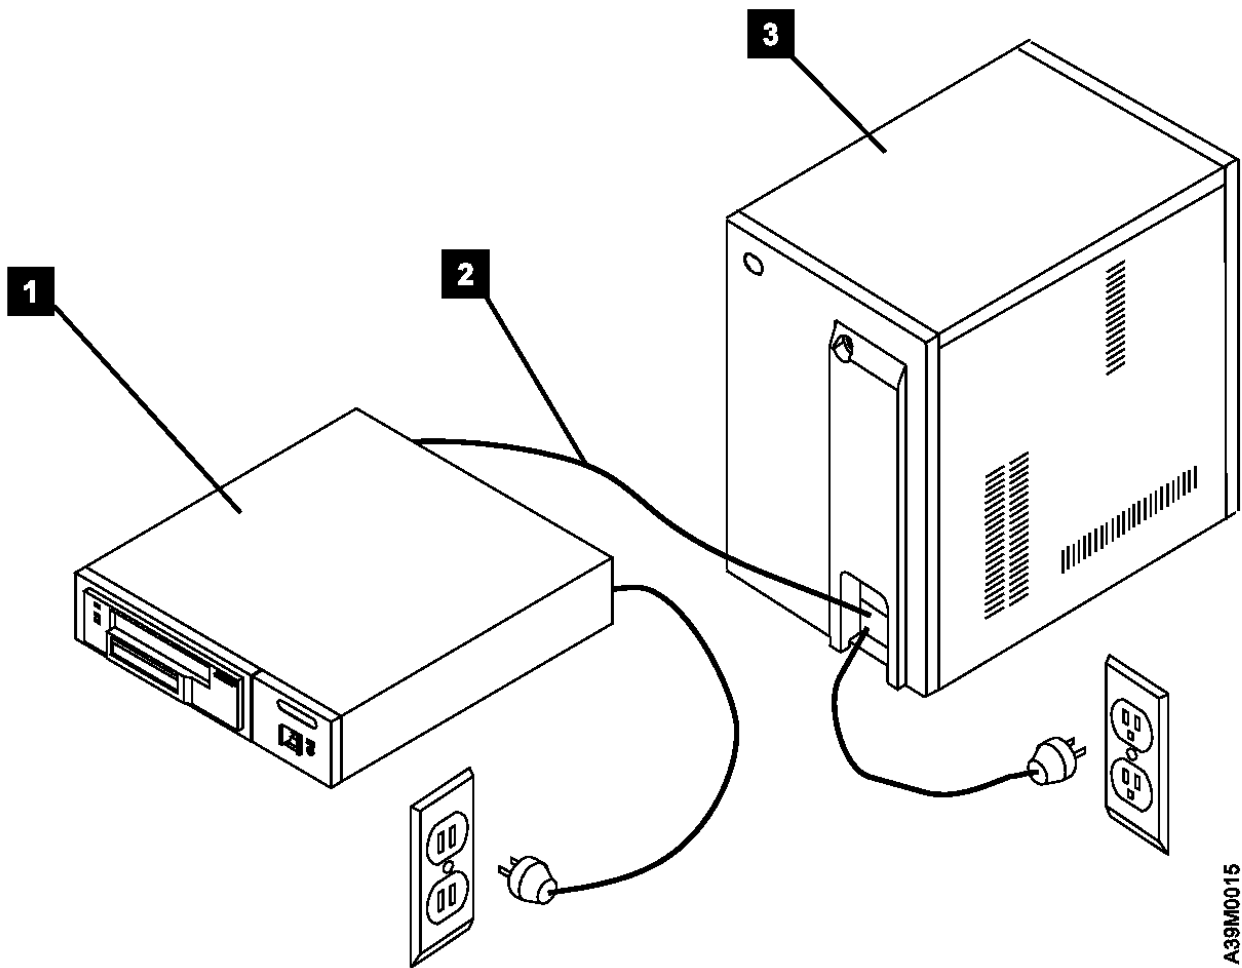
Figure 1. Safety Inspection

Figure 1 shows the components to review during the service inspection.

5. Unplug the system unit power cable from the electrical outlet.
6. Check the 7208 Tape Drive external power cable for damage.
7. Check the external SCSI bus cable 2 for damage.

8. Check the terminator for damage.
9. Check the covers for sharp edges, damage, or alterations that expose the internal parts of the 7208 Tape Drive.
10. Check the covers for proper fit. They should be in place and secure.

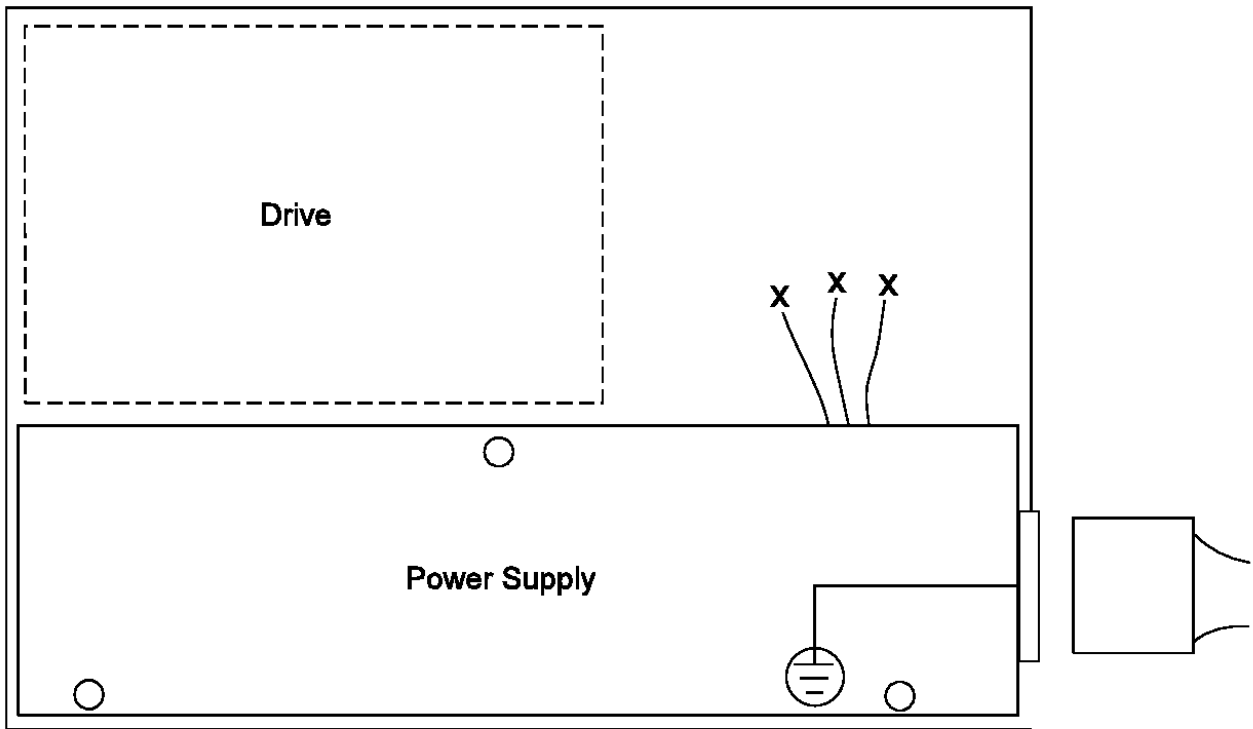
Figure 2. AC Grounding Diagram (50 Hz and 60 Hz)

11. Check the voltage label on the bottom of the 7208 Tape Drive to make sure it matches the voltage at your outlet.
12. Check the voltage level at the outlet and also check for proper grounding (see Figure 2 in topic FRONT_1.3).

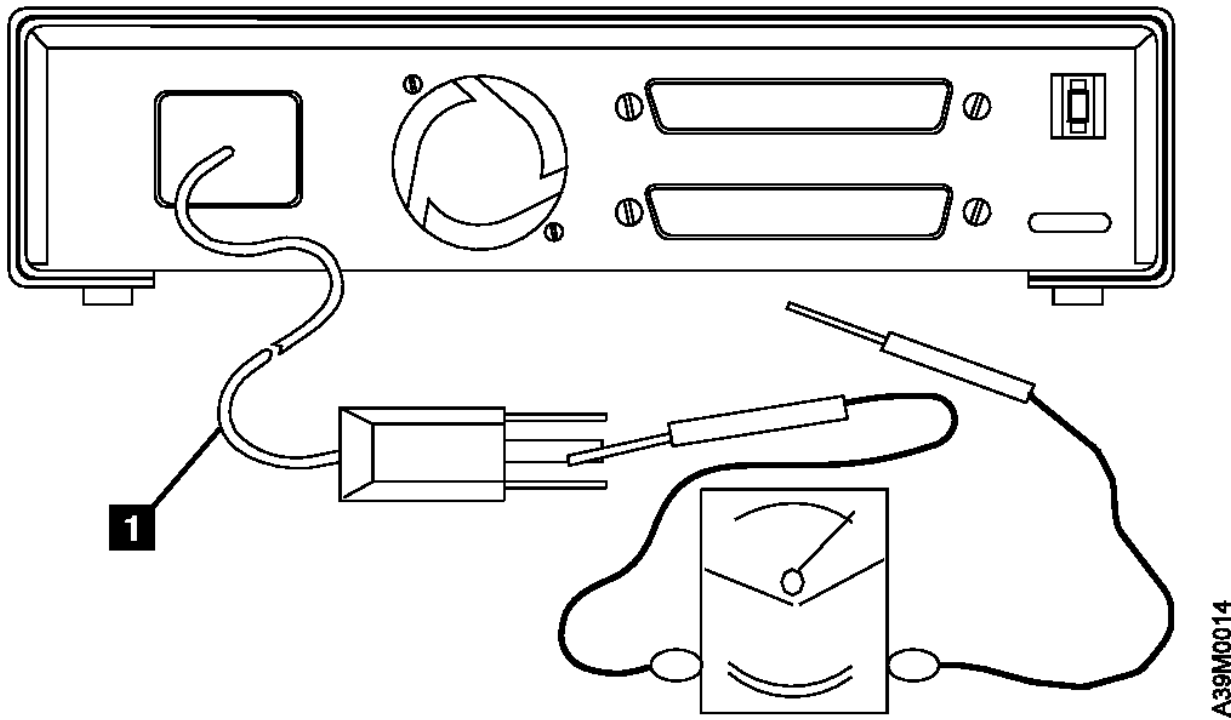
Figure 3. Safety Inspection - Back View of the 7208 Tape Drive Model 341

13. With the external power cable (1 in Figure 3) connected to the 7208 Tape Drive, check to ensure 1.0 ohm or less resistance between the ground lug on the external power cable plug and the metal frame.

Note: Use an analog meter to measure grounding resistance; do not use a digital multimeter.

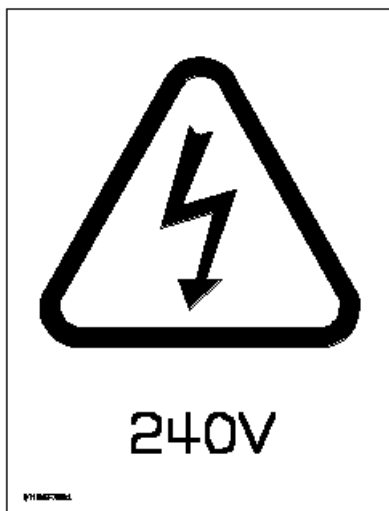
Note: Safety Information Label, Part Number 85F7884, located on top of the power supply under the top cover, shows the following symbol:

This symbol indicates a hazard arising from dangerous voltage inside. Do not open.

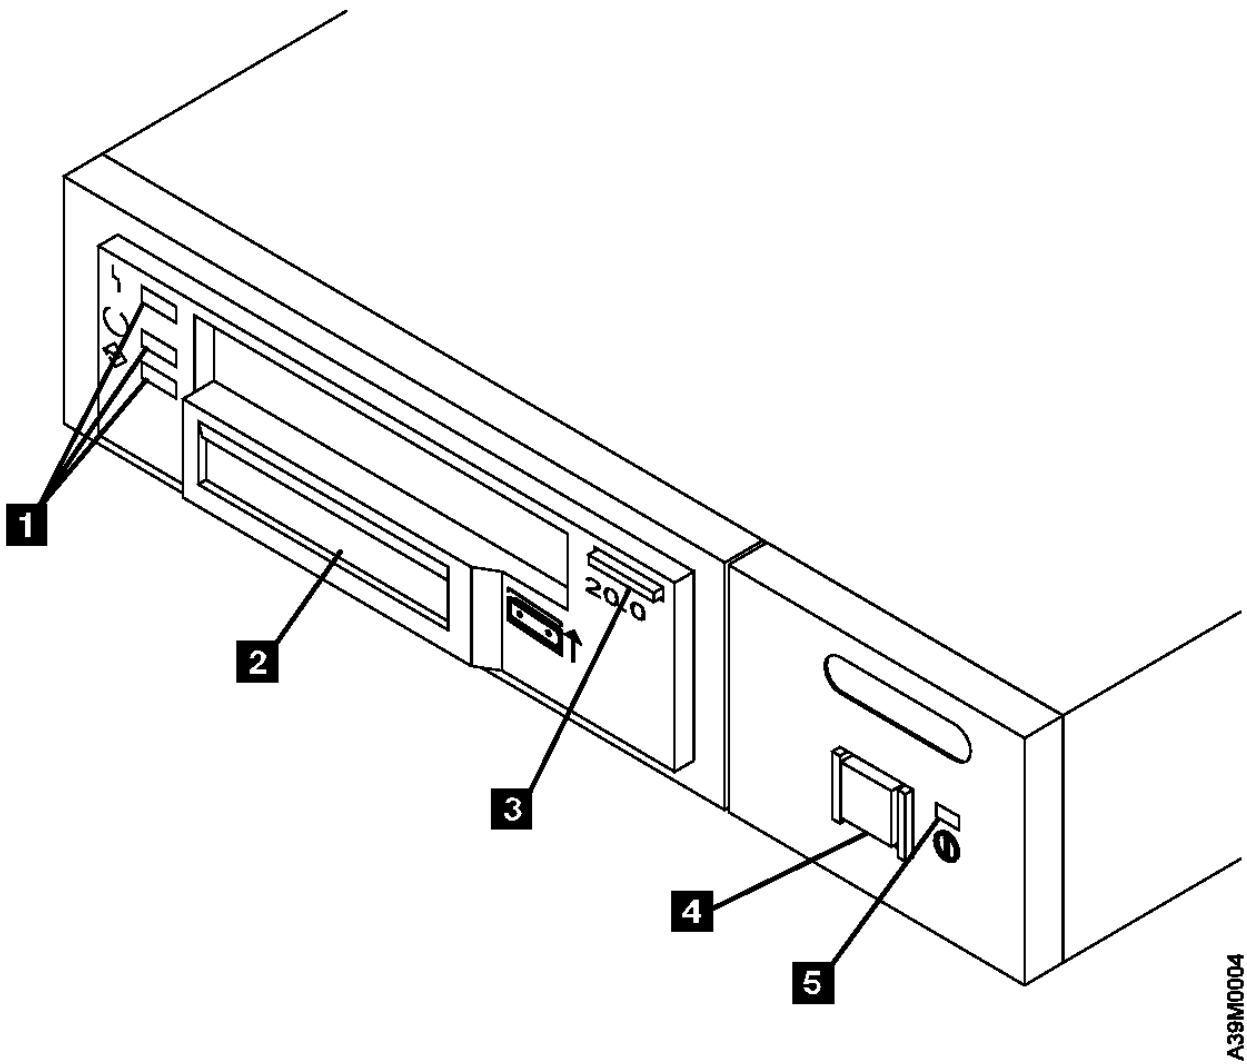
Figure 4. Front View of 7208 Tape Drive Model 341

Figure 4 shows the front view of the 7208 Tape Drive Model 341.

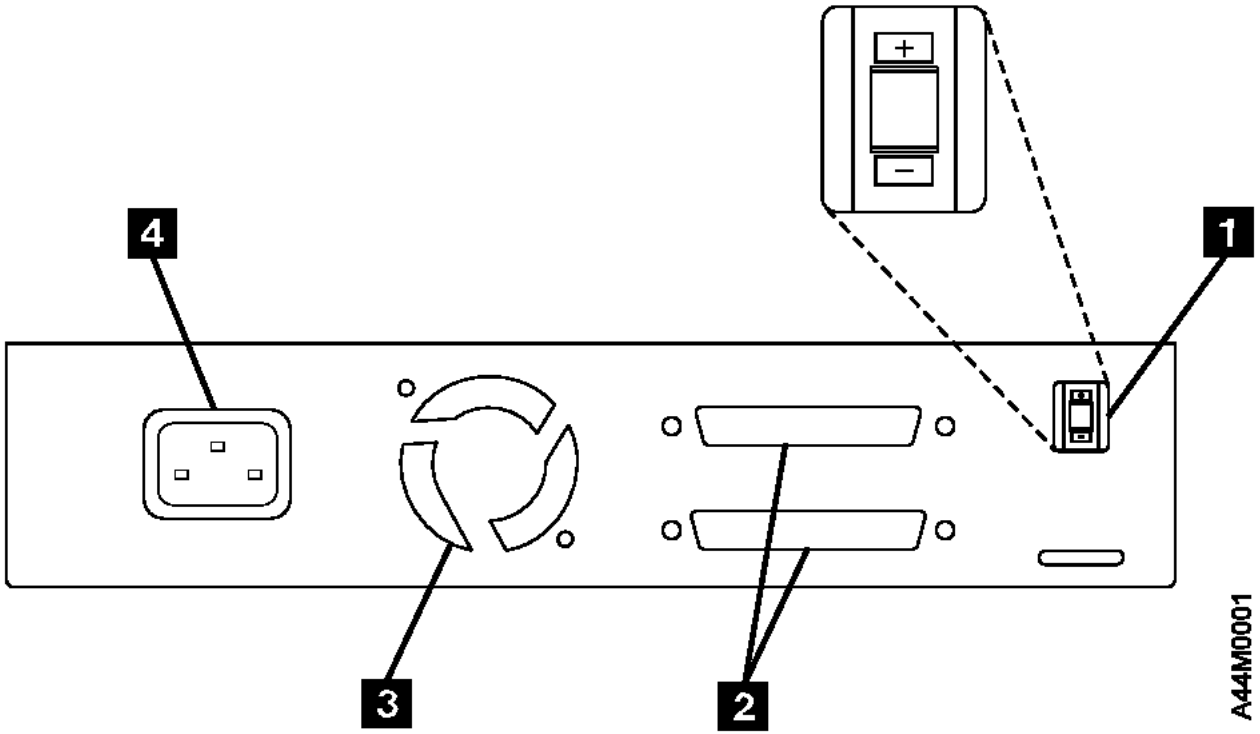
Figure 7. Connector Locations on the 7208 Tape Drive Model 341

| 1 | SCSI address switch | 3 | Fan |
| 2 | SCSI bus cable connectors | 4 | Power cable connector |

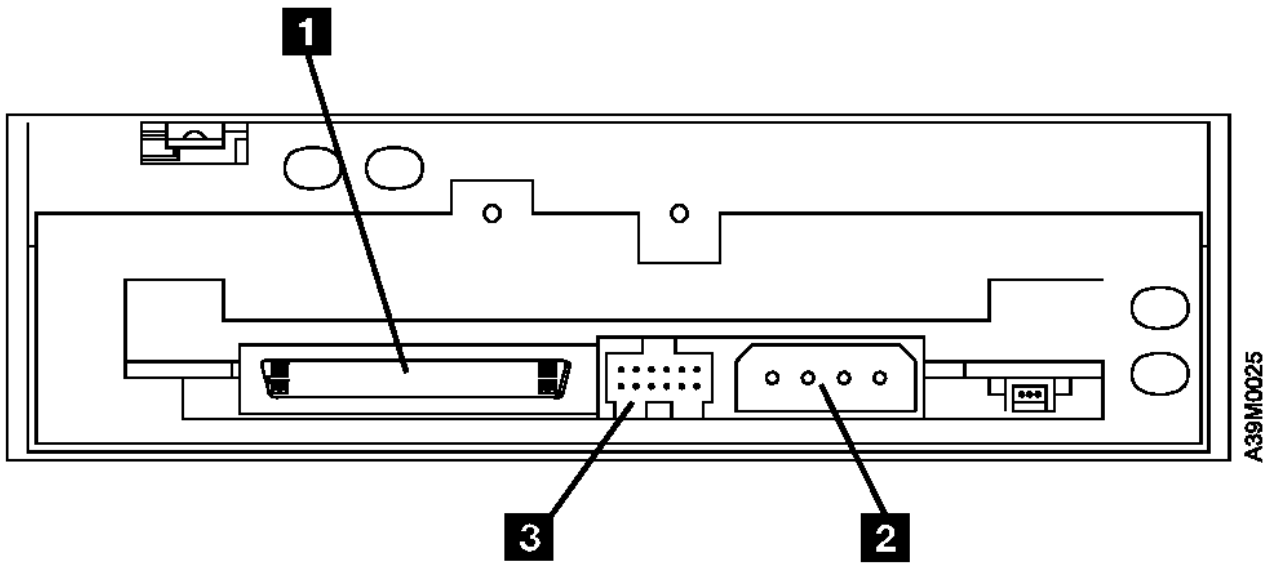
Figure 8. Connector Locations on the Drive

| 1 | Internal SCSI bus connector | 3 | Internal SCSI address connector |
| 2 | Power supply connector | | |

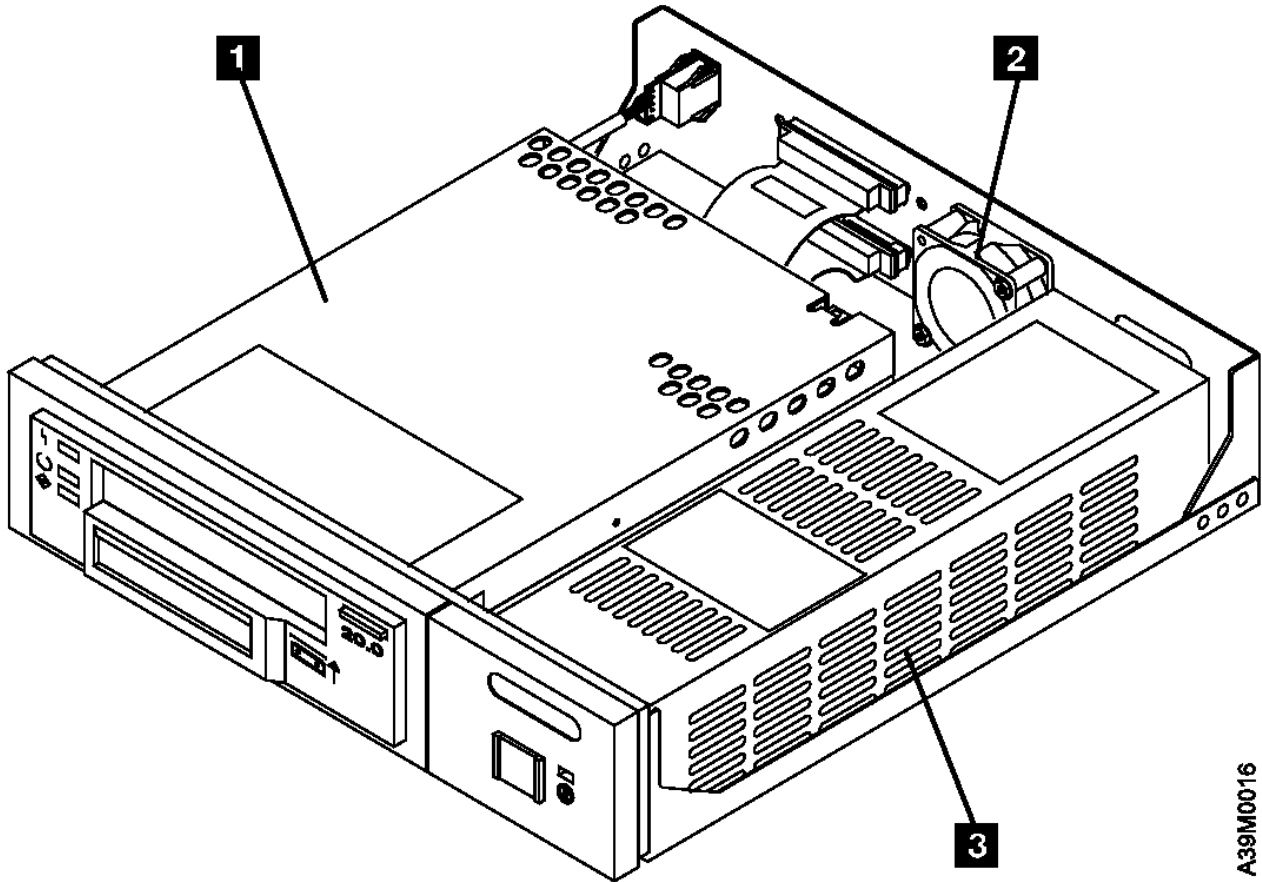
Figure 9. Internal View of the 7208 Tape Drive Model 341

Figure 9 shows the inside of the 7208 Tape Drive Model 341:

- 1 Drive
- 2 Cooling fan
- 3 Power supply

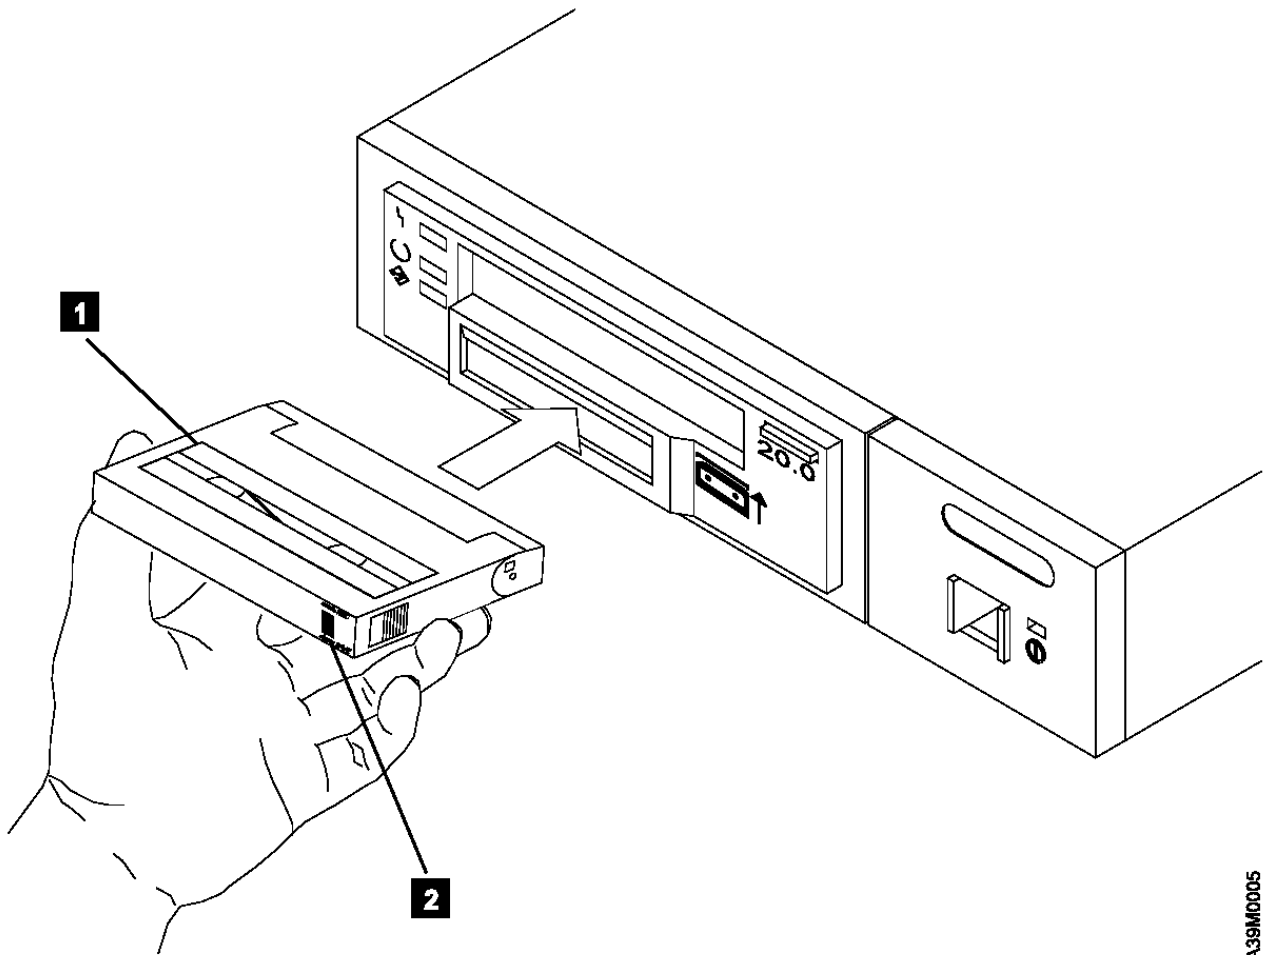
Figure 11. Loading the Cleaning Cartridge

1. Make sure that the 7208 Tape Drive power is on and the Power-On Self Test has completed.
2. Grasp the cleaning cartridge (1 in Figure 11) by the outer edges, with the window side up and the write-protect switch 2 facing you.

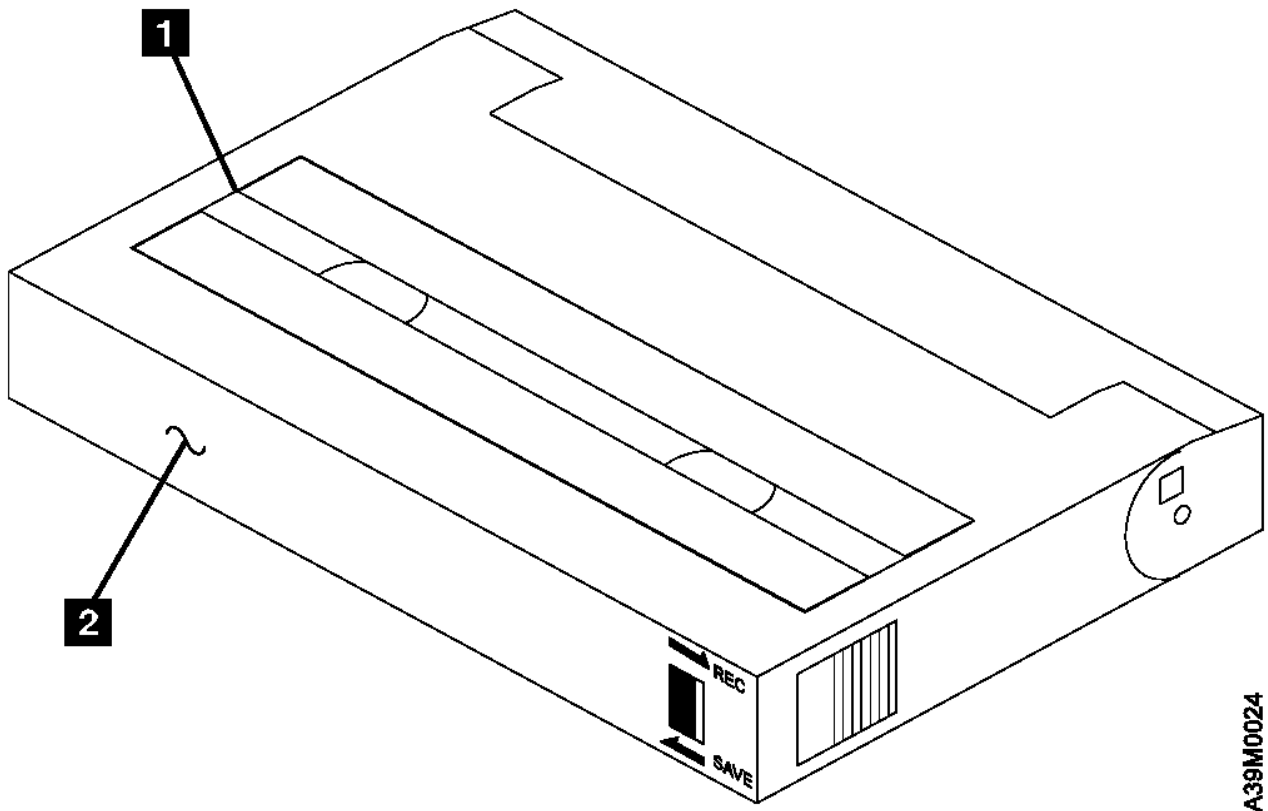
Figure 12. Placement of Label on an 8mm Data Cartridge

To avoid problems with loading and unloading a tape, use only one label on the tape cartridge. Place the label in location 1 or 2 as shown in Figure 12.

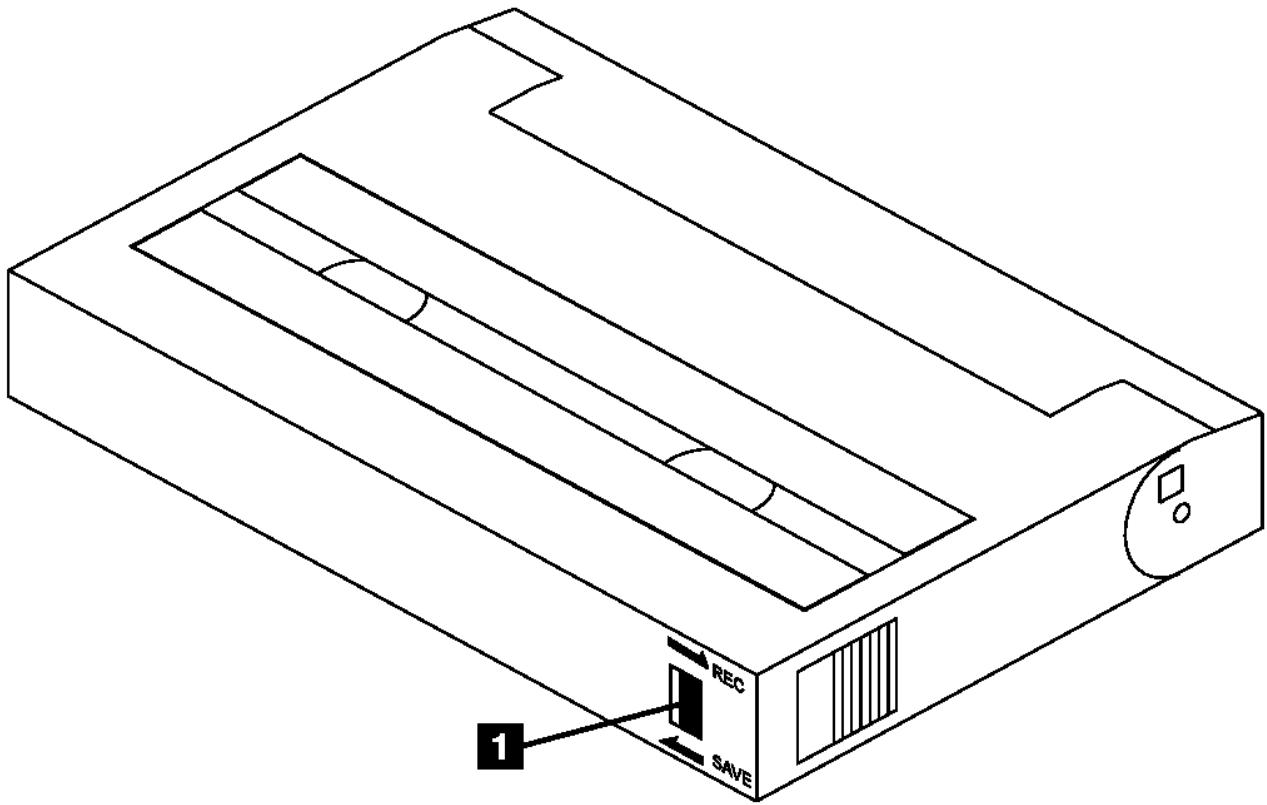
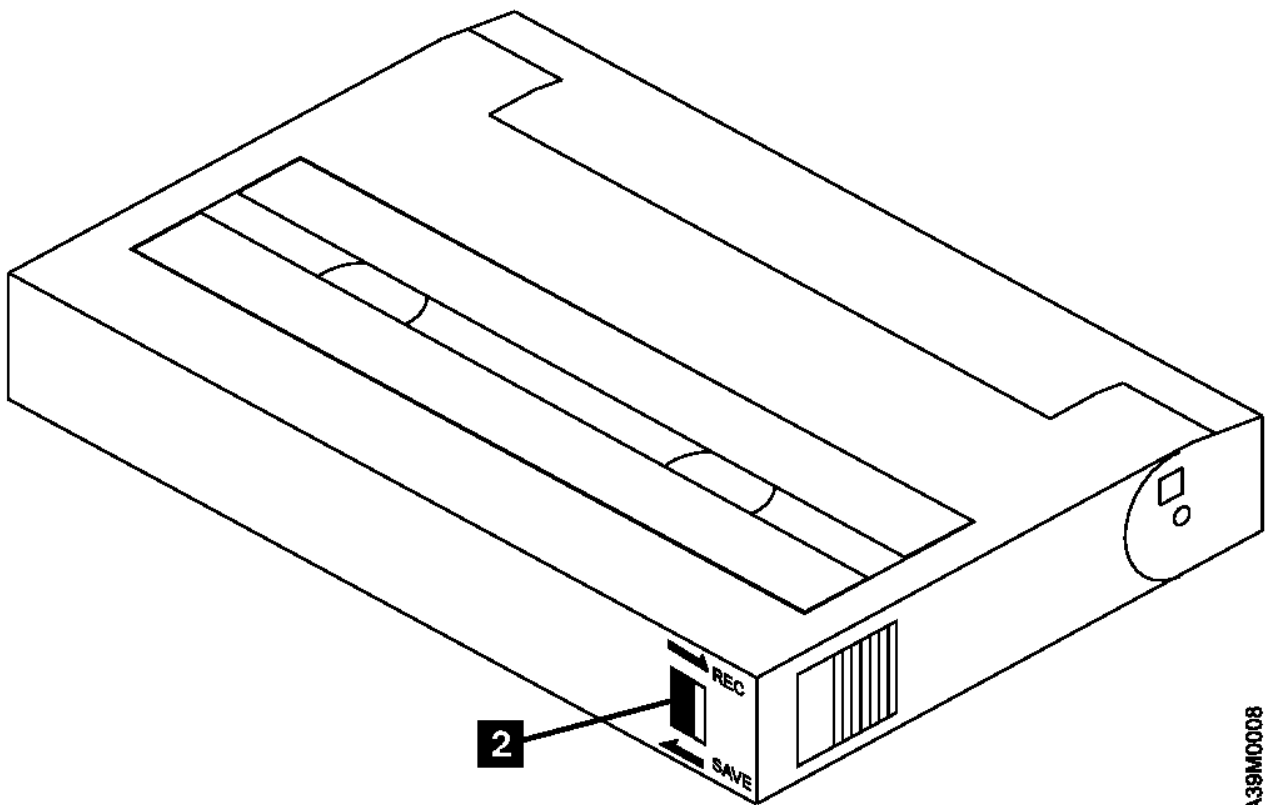
Figure 14. Setting the Write-Protect Switch

Figure 14 shows the write-protect switch in the **REC** and **SAVE** positions.

An attempt to write to a data cartridge with the switch in the **SAVE** position will cause an error.

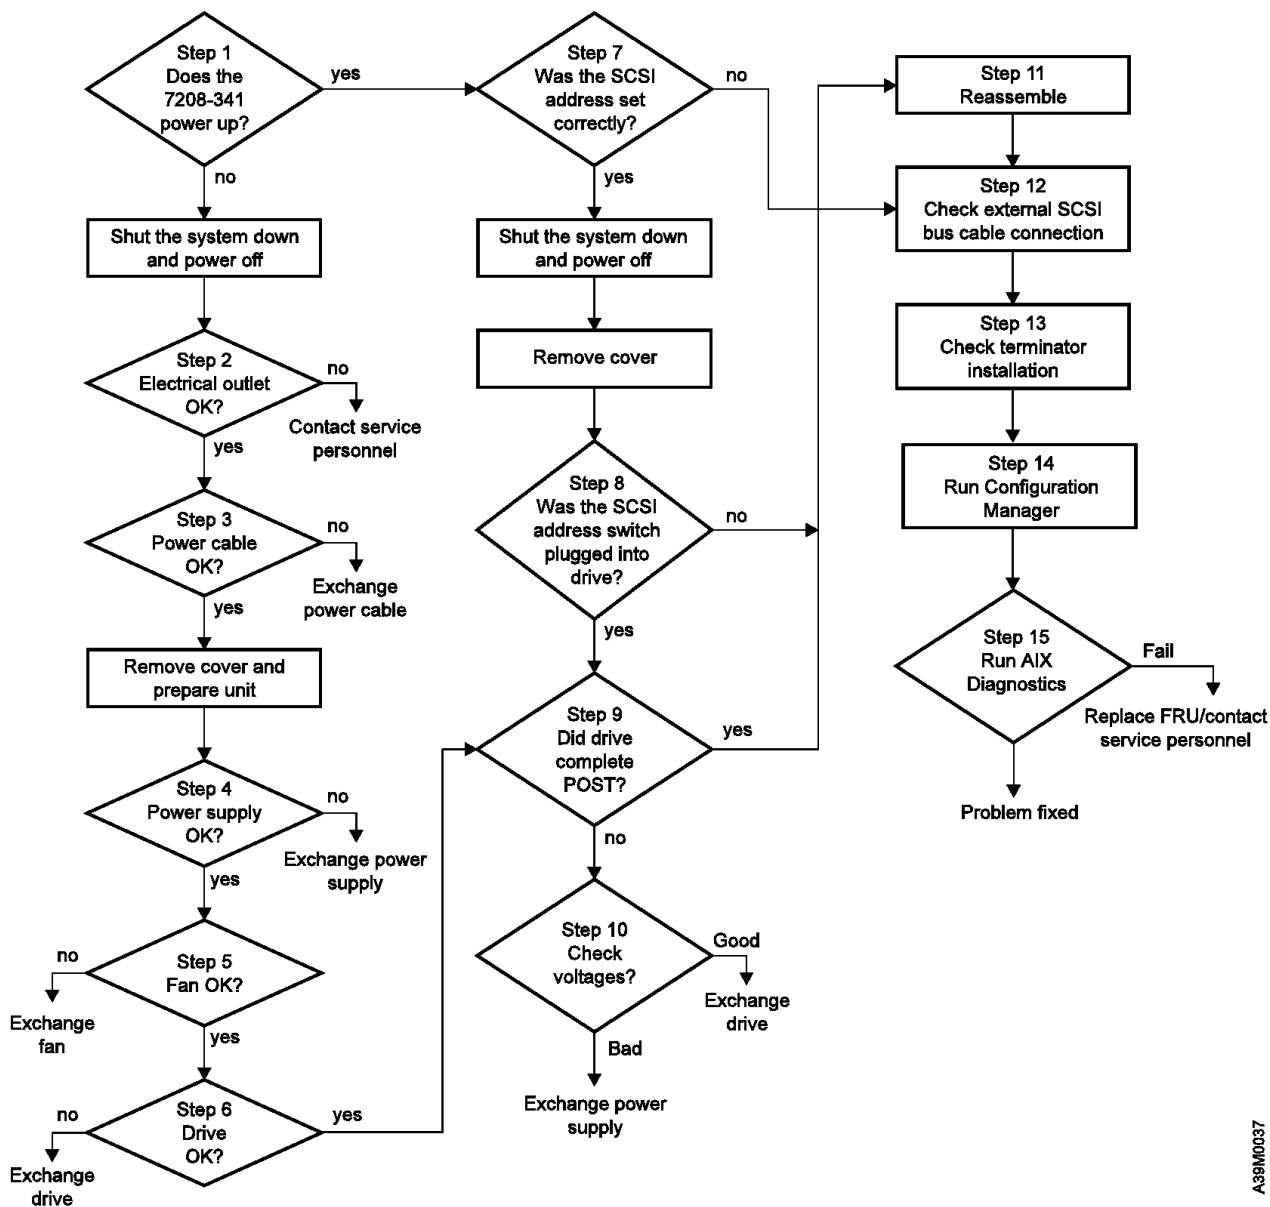
Figure 16. Flowchart of Maintenance Analysis Procedures (MAPs)

Figure 16 in topic 3.2 provides a flowchart to be used as a guide to the MAPs. For detailed instructions on how to perform each procedure safely and correctly, refer to the steps in this topic.

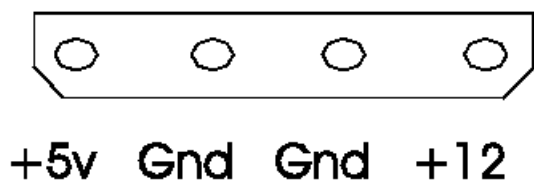
Figure 17. Power Supply Connector J1

1. Press the power switch to turn off the power.
2. Perform the cover removal procedure. Refer to "Removing and Replacing the Cover" in topic 4.2.
3. Disconnect the power supply connector (J1) from the drive.
4. Disconnect the power supply connector (J2) between the power supply and the cooling fan.
5. Connect the power cable to both the 7208 Tape Drive and the electrical outlet.
6. Press the power switch to turn on the power.
7. On the power supply connector J1 (see Figure 17), check the following:
 - The +12V signal falls between a minimum of +11.5 volts and a maximum of +12.6 volts
 - The +5V signal falls between a minimum of +4.8 volts and a maximum of +5.25 volts

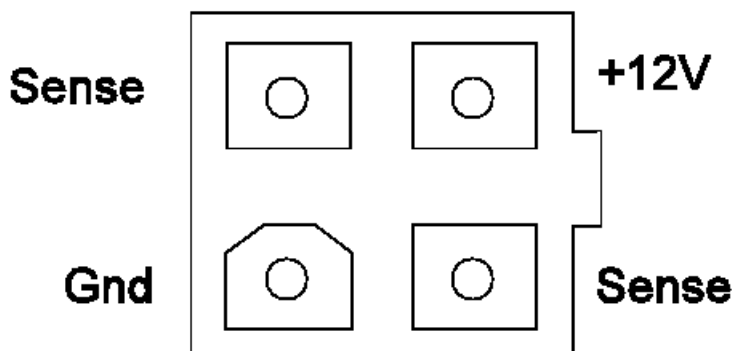
Figure 18. Power Supply Connector J2

8. On the power supply connector J2 (see Figure 18), check that the +12V signal falls between a minimum of +11.5 volts and a maximum of +12.6 volts.

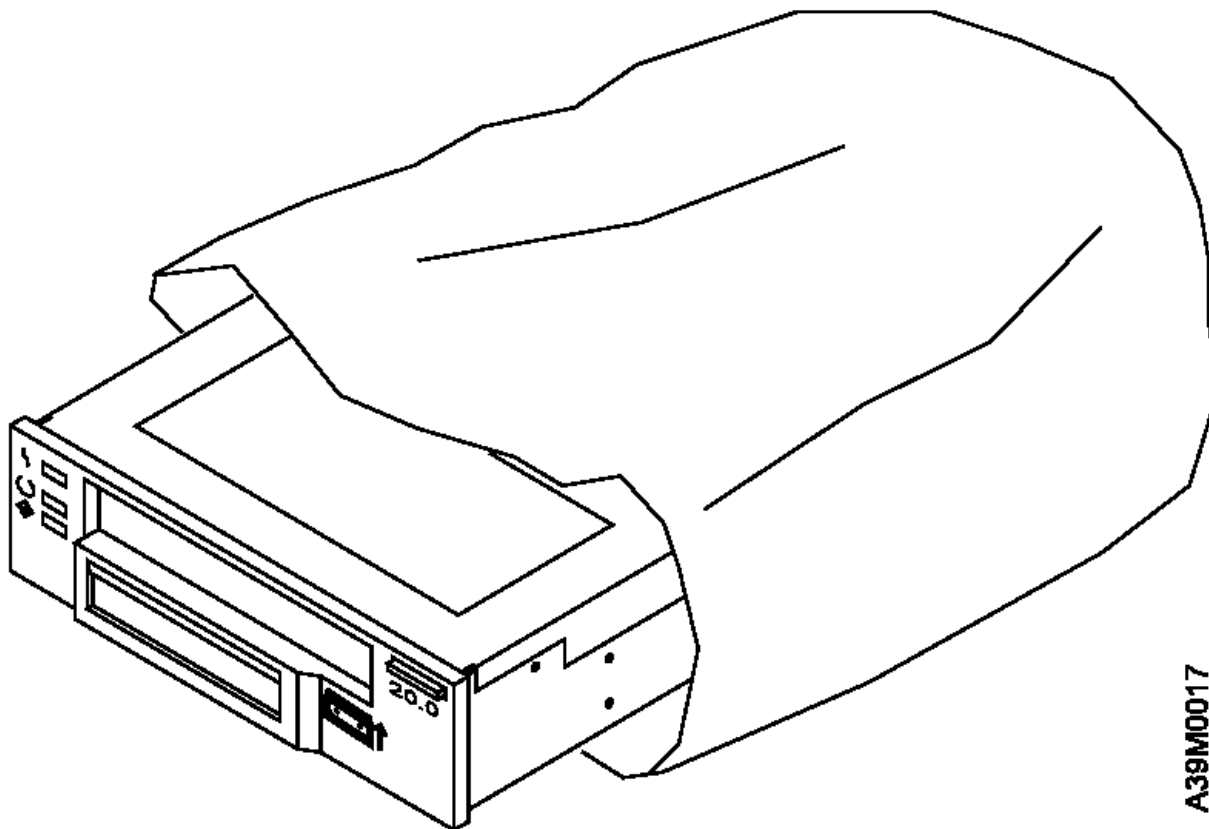
Figure 19. Handling Static-Sensitive Devices

Attention: Tape drives are sensitive to static electricity discharge. When handling a tape drive, wrap it in an antistatic bag to prevent damage (see Figure 19).

- Do not remove the drive from the antistatic bag until you are ready to install it.
- With the drive still in its antistatic bag, touch it to the metal frame of an electrically grounded surface.
- Hold the drive by the frame. Avoid touching the solder joints or pins.
- Handle the drive carefully to prevent permanent damage.

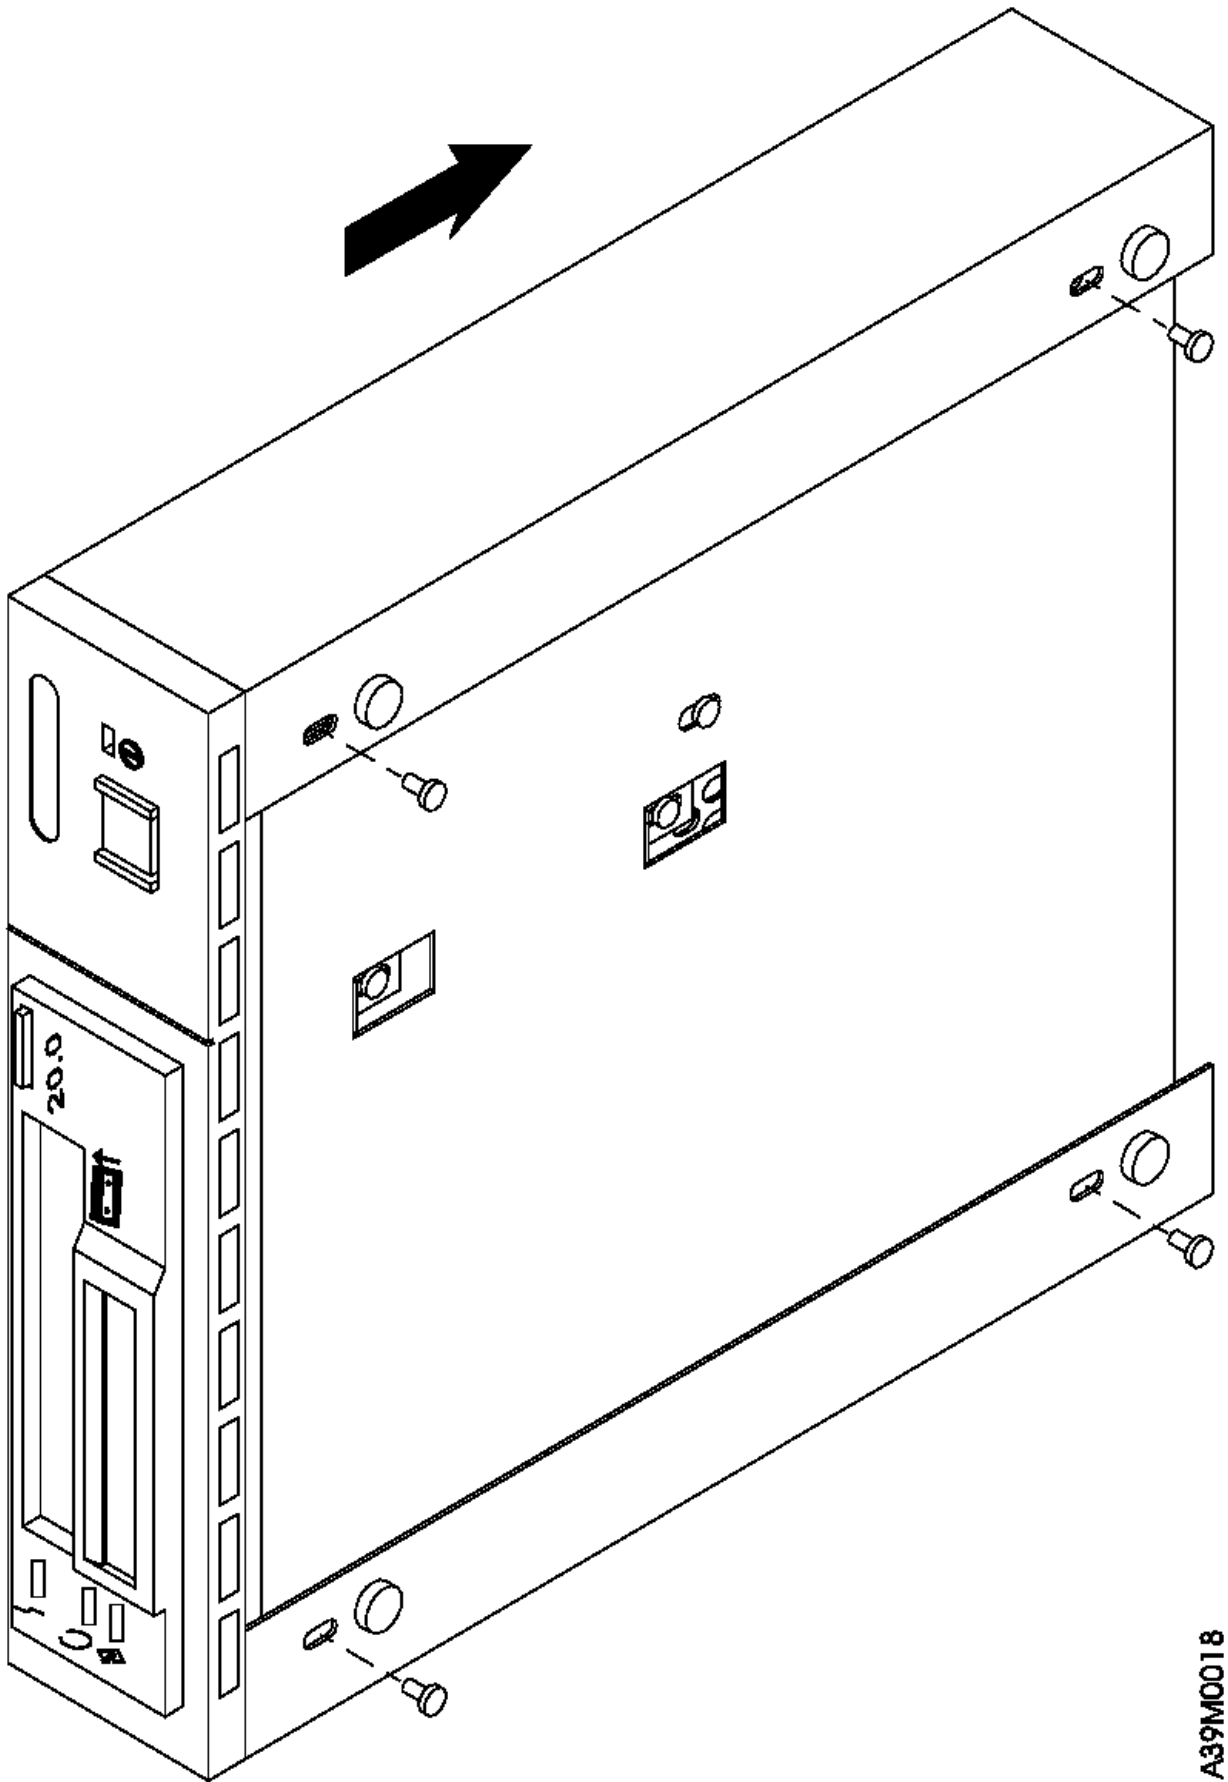
Figure 20. Removing and Replacing the Cover

1. If a tape cartridge is loaded in the drive, eject it.
2. Do a controlled system shutdown (refer to the instructions in Topic 2, "Setting Up the 7208 Tape Drive," in the *7208 20GB External 8mm Tape Drive Model 341 Setup and Operator Guide*).
3. If it is on, turn off the power to the 7208 Tape Drive.
4. Unplug the 7208 Tape Drive power cable from the electrical outlet.
5. Disconnect the power cable from the 7208 Tape Drive.
6. Disconnect the SCSI bus cable from the 7208 Tape Drive.
7. Tilt the 7208 Tape Drive on its side and remove the four cover mounting screws from the bottom (see Figure 20).
8. Remove the cover by sliding it to the rear (see the directional arrow in Figure 20).

To replace the cover, reverse the removal procedure.

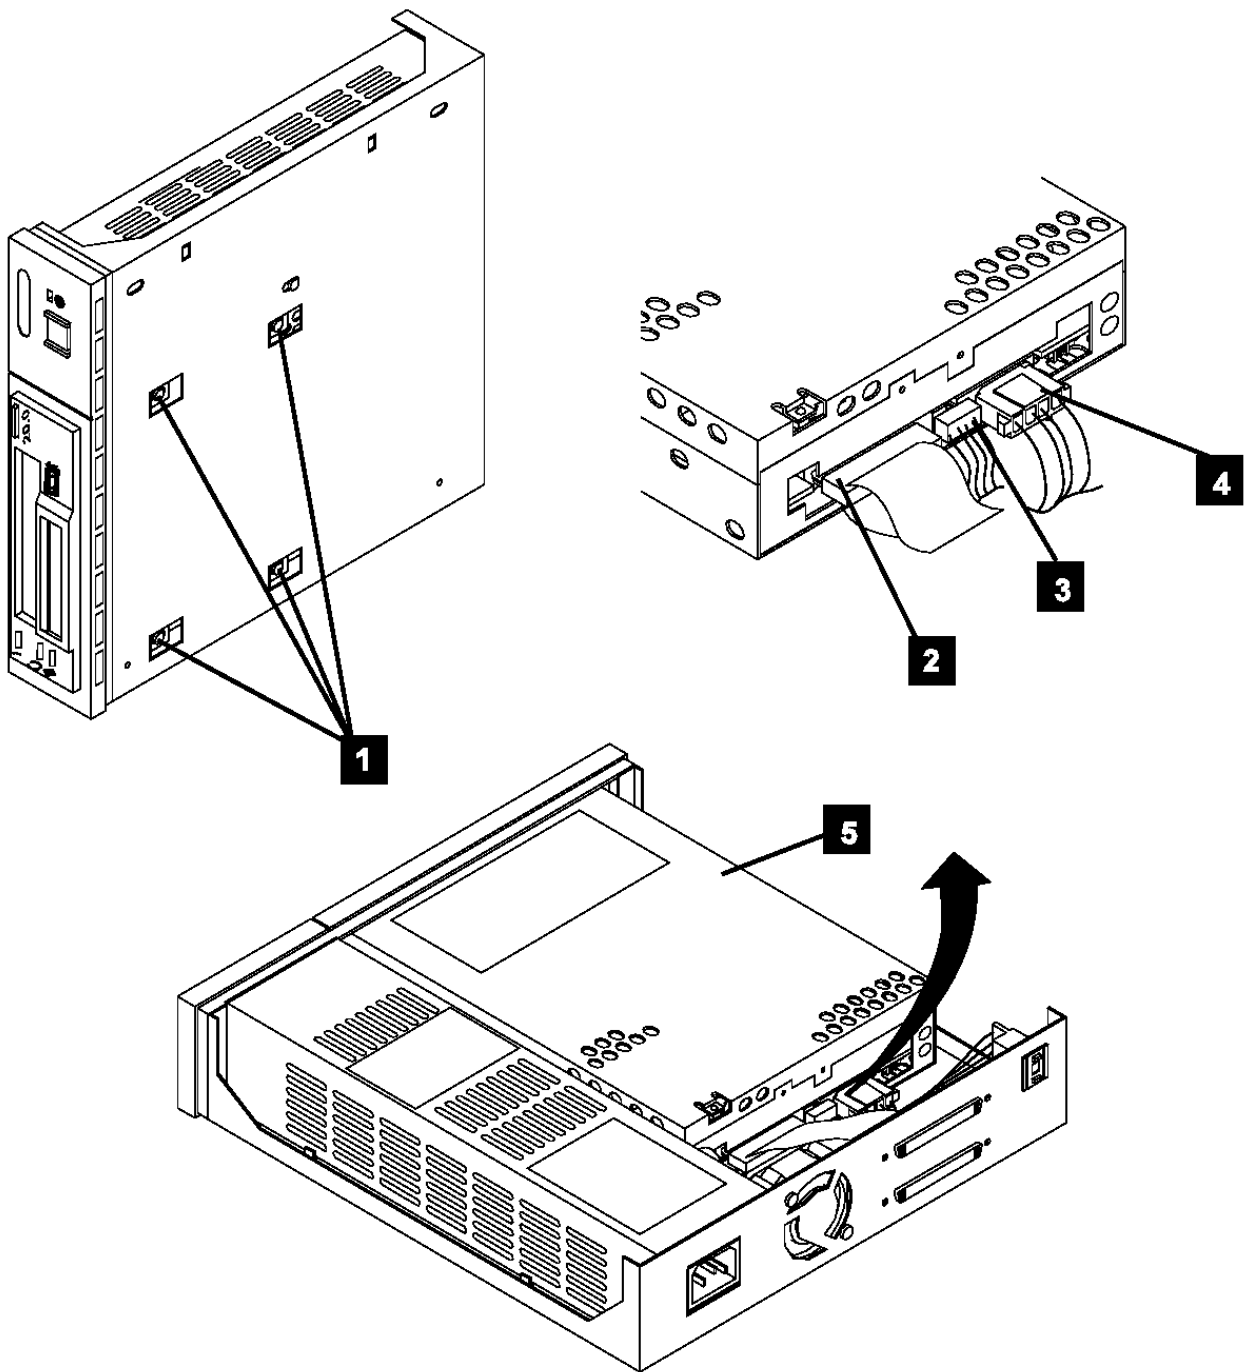
Figure 21. Removing and Replacing the Drive

1. Perform the cover removal procedure. Refer to "Removing and Replacing the Cover" in topic 4.2.
2. Tilt the 7208 Tape Drive on its side. Support the drive (5 in Figure 21) while removing the four screws that secure the drive to the chassis.
3. Support the drive while returning the 7208 Tape Drive to its original position.
4. Disconnect the power supply connector (J1) 4 from the drive.
5. Disconnect the internal SCSI bus cable 2 from the drive.
6. Disconnect the internal SCSI address cable 3 from the drive.
7. Slide the drive forward and out of the chassis.

- Correctly insert and engage each cable to its proper connector.
- Arrange the cables so that they do not interfere with the cooling fan blades or the replacement of the cover.
- After installing the cover, align the drive with the front of the cover, then tighten the four screws (1 in Figure 21) that secure the drive to the chassis.

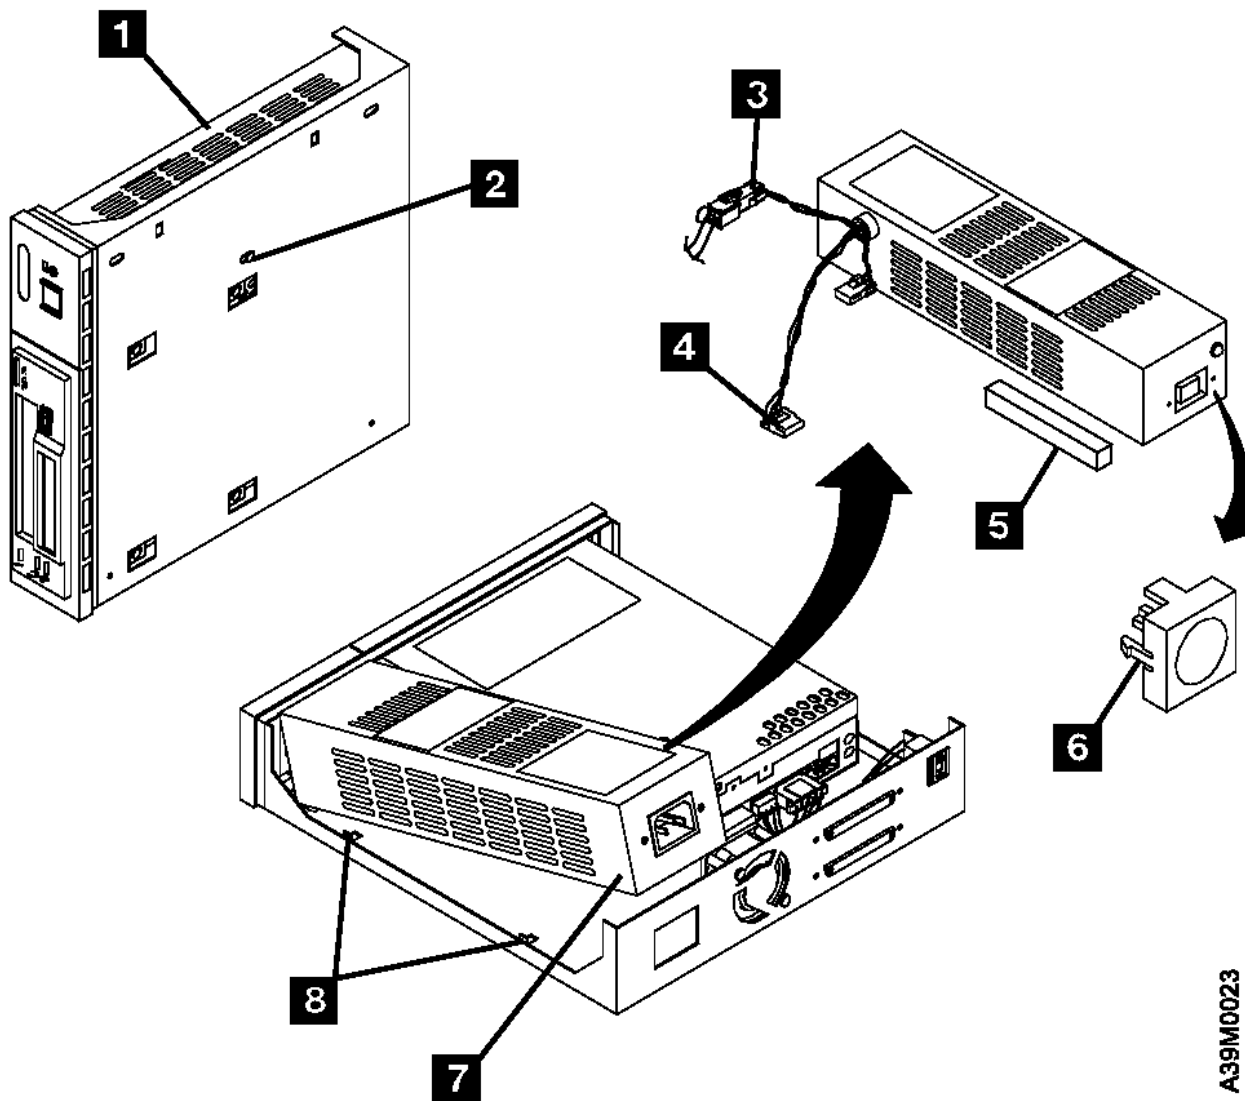
Figure 22. Removing and Replacing the Power Supply

1. Perform the cover removal procedure. Refer to "Removing and Replacing the Cover" in topic 4.2.
2. Tilt the 7208 Tape Drive (1 in Figure 22) on its side. Support the power supply while removing the power supply mounting screw 2 from the bottom.
3. Support the power supply while returning the 7208 Tape Drive to its original position.
4. Disconnect the power supply connector (J1) 4 from the drive.
5. Disconnect the power supply connector (J2) 3 between the power supply and the cooling fan.
6. Grasp the rear of the power supply 7 and while pressing it toward the front panel, lift the rear of the power supply, then remove it from the chassis.
7. Push the power switch pushbutton 6 out of the front panel and set it aside.
8. Remove the electromagnetic interference (EMI) gasket 5 and save it for installation with the replacement power supply.

Note: If the power switch does not work properly, loosen the power supply mounting screw 2 , slide the power supply to the rear of the chassis, and retighten the mounting screw.
