7208 20GB External 8mm Tape Drive
Model 341

Service Guide

Document Number SA37-0320-00

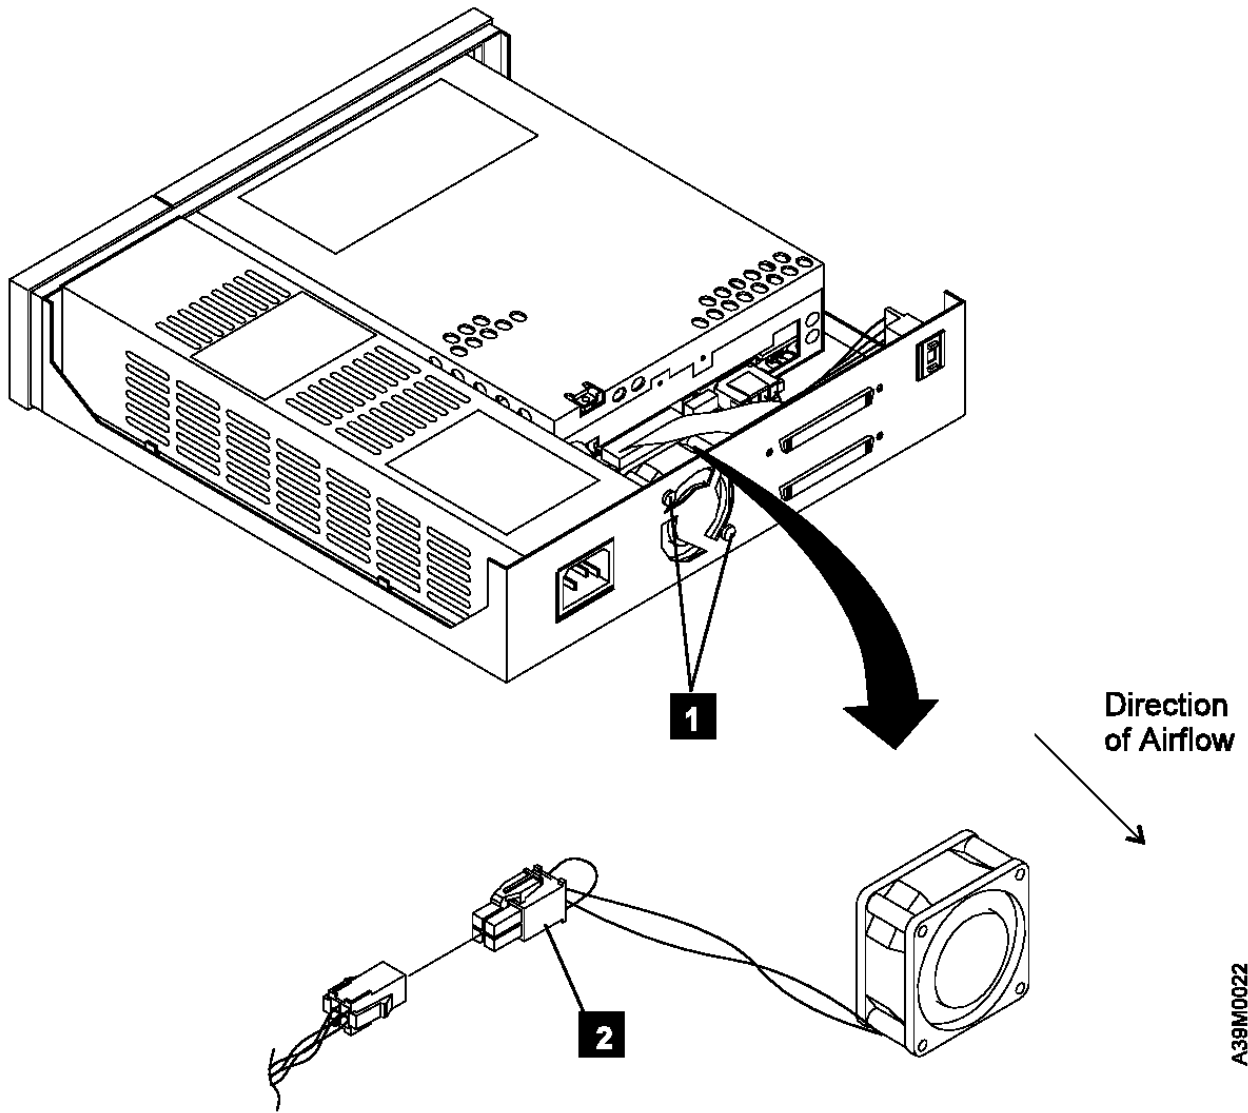
Figure 23. Removing and Replacing the Cooling Fan

1. Perform the cover removal procedure. Refer to "Removing and Replacing the Cover" in topic 4.2.
2. Disconnect the power supply connector (J2) (2 in Figure 23) between the power supply and the cooling fan.
3. Remove the two screws, lockwashers, and nuts 1 that secure the cooling fan to the rear of the 7208 Tape Drive.
4. Lift the cooling fan out of the 7208 Tape Drive.

To replace the cooling fan, reverse the removal procedure. Make sure that the cooling fan is oriented so that air blows out of the 7208 Tape Drive.

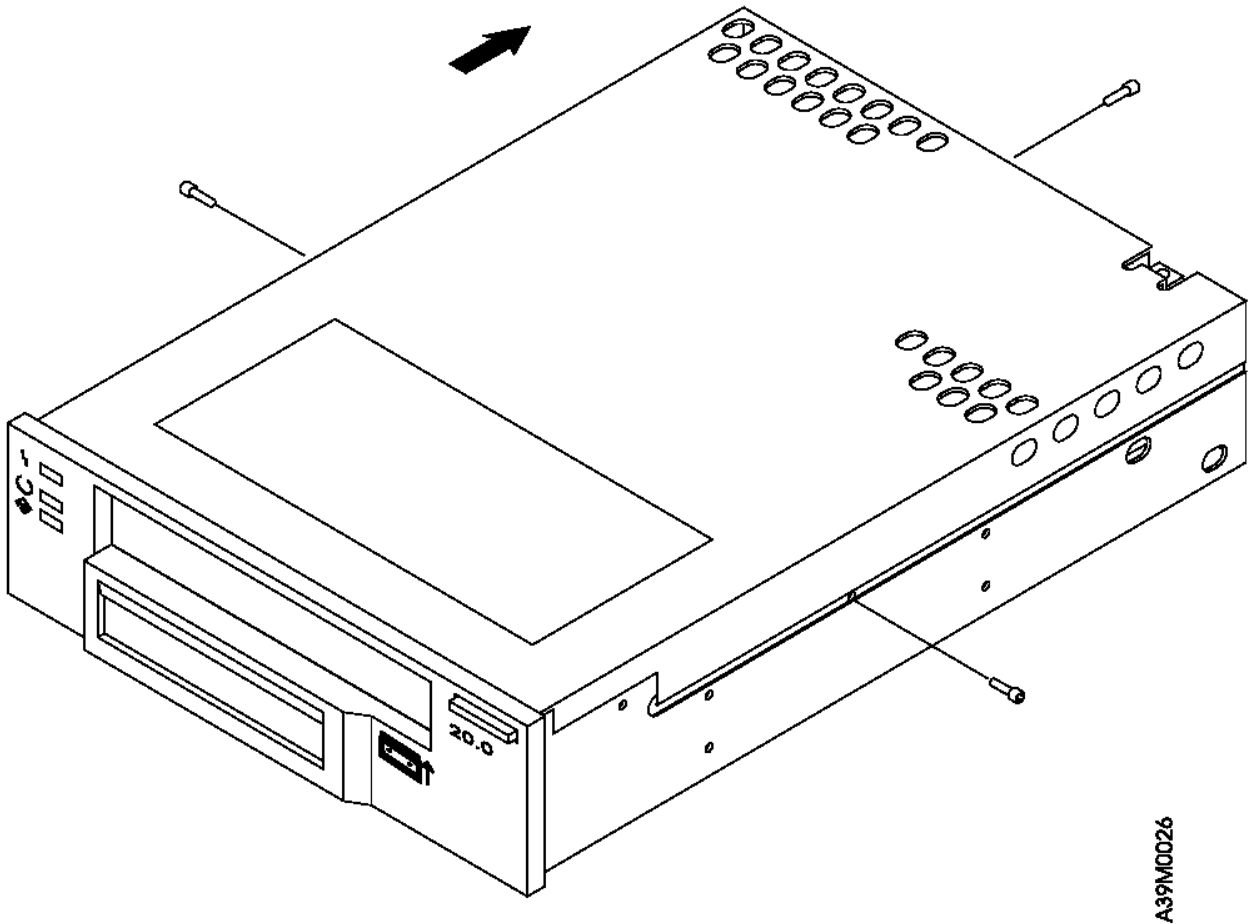
Figure 24. Removing the Top Cover of the Drive

- ___ 1. Perform the cover removal procedure. Refer to "Removing and Replacing the Cover" in topic 4.2.
- ___ 2. Perform the drive removal procedure. Refer to "Removing and Replacing the Drive" in topic 4.3.
- ___ 3. Using the Torx screwdriver that is supplied with the replacement drive, remove the three T-6 screws that secure the top cover of the drive (one on the rear and two sides of the drive). See Figure 24.

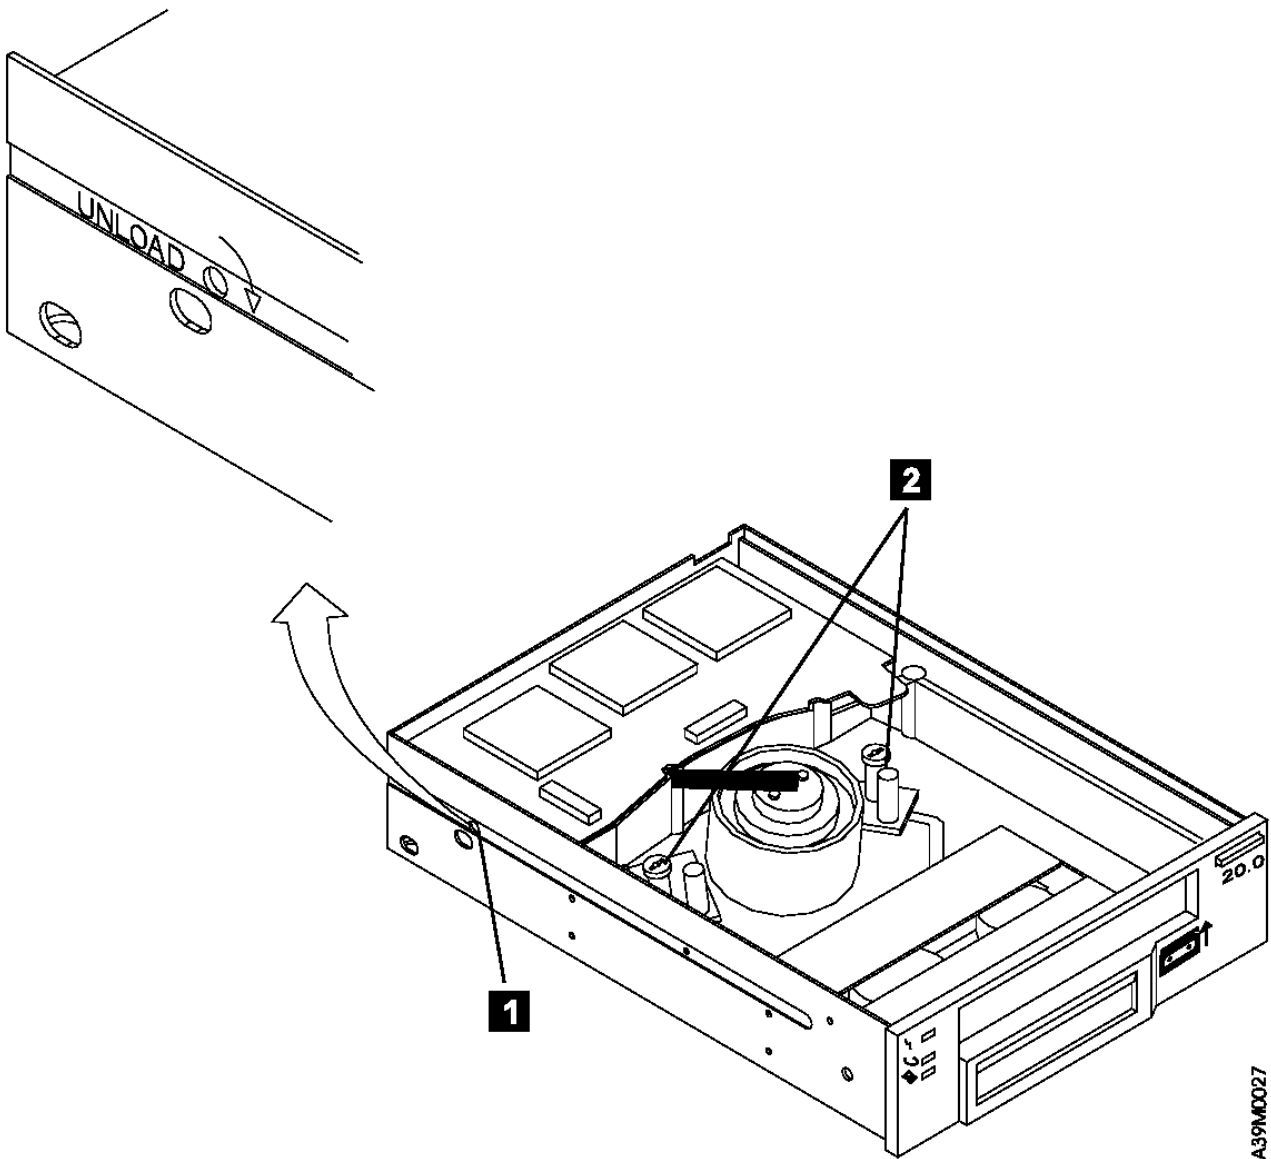
Figure 25. Moving the Trolleys

- a. On the left side panel of the drive (toward the rear) locate the hole marked **UNLOAD** (1 in Figure 25).
- b. Insert the 2.5-mm L-Hex (allen) wrench (supplied with the replacement drive) approximately 43 mm (2 in.) into the **UNLOAD** hole. Position it so that it seats securely into the inner socket.
- c. Turn the wrench in the direction marked on the drive (clockwise).
- d. Rotate the wrench until the trolleys 2 stop moving.

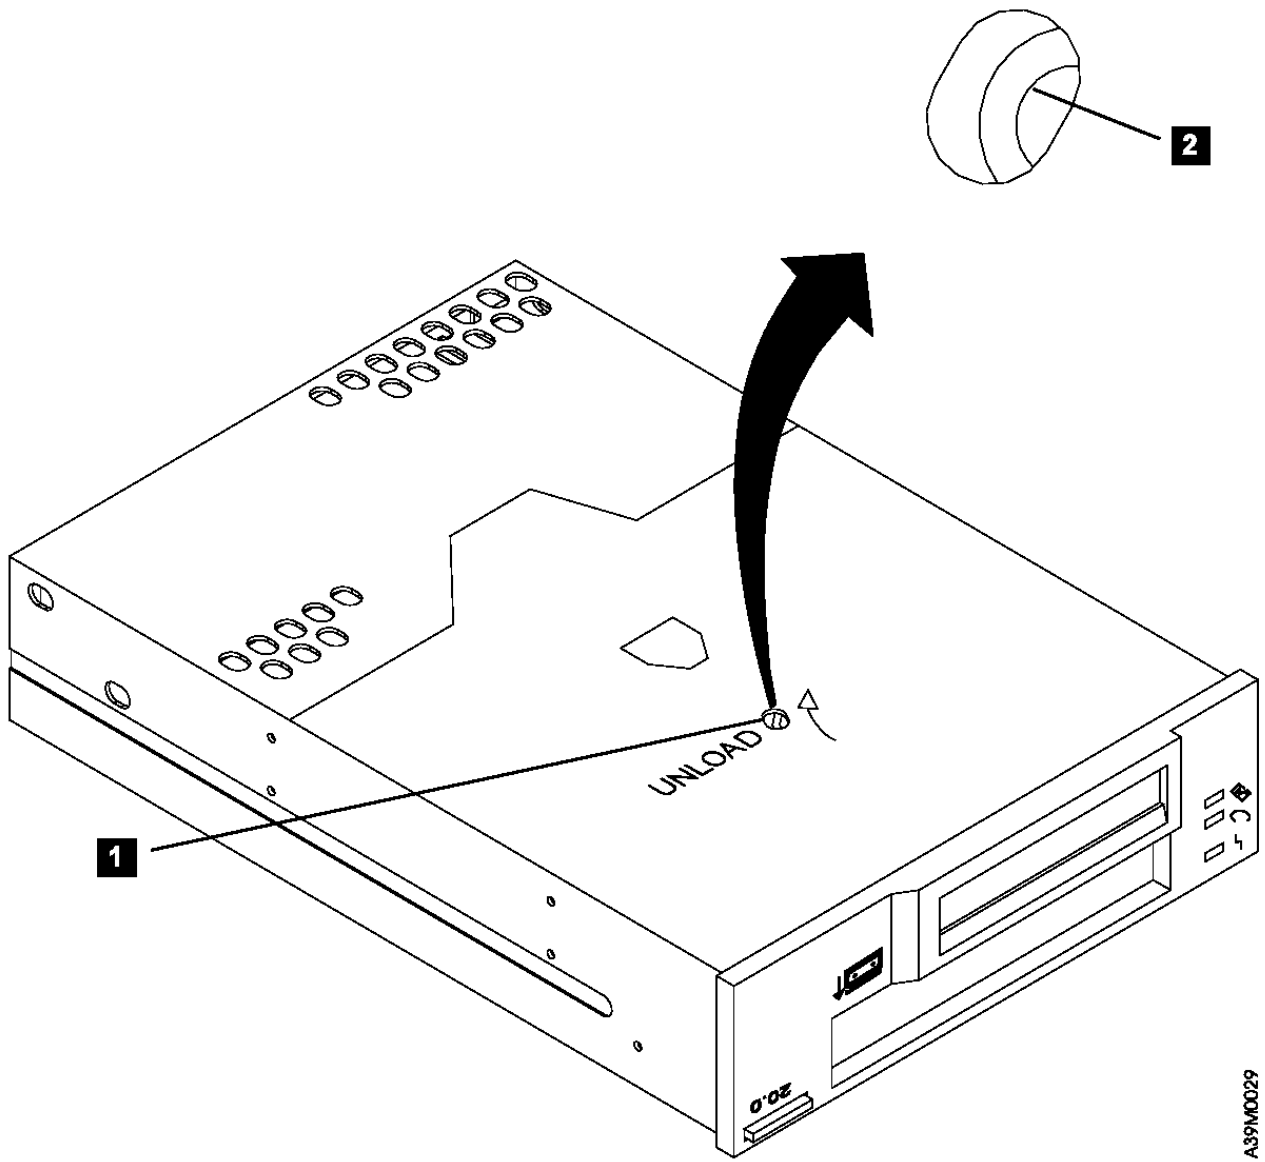
Figure 26. Moving the Supply Reel Motor. The drive is turned upside down.

- To move the supply reel motor:
 - a. On the bottom of the drive, locate the hole marked **UNLOAD** (1 in Figure 26). If there is a seal over the hole, remove it.
 - b. Insert a non-metallic probe (such as the wooden end of a swap) approximately 0.64 cm (0.25 in.) into the **UNLOAD** hole and position it so that it rests on the inner flange 2 .
 - c. Gently push the flange with the probe in the direction marked on the drive (clockwise).
 - d. Repeat the preceding step until there is no slack in the tape.

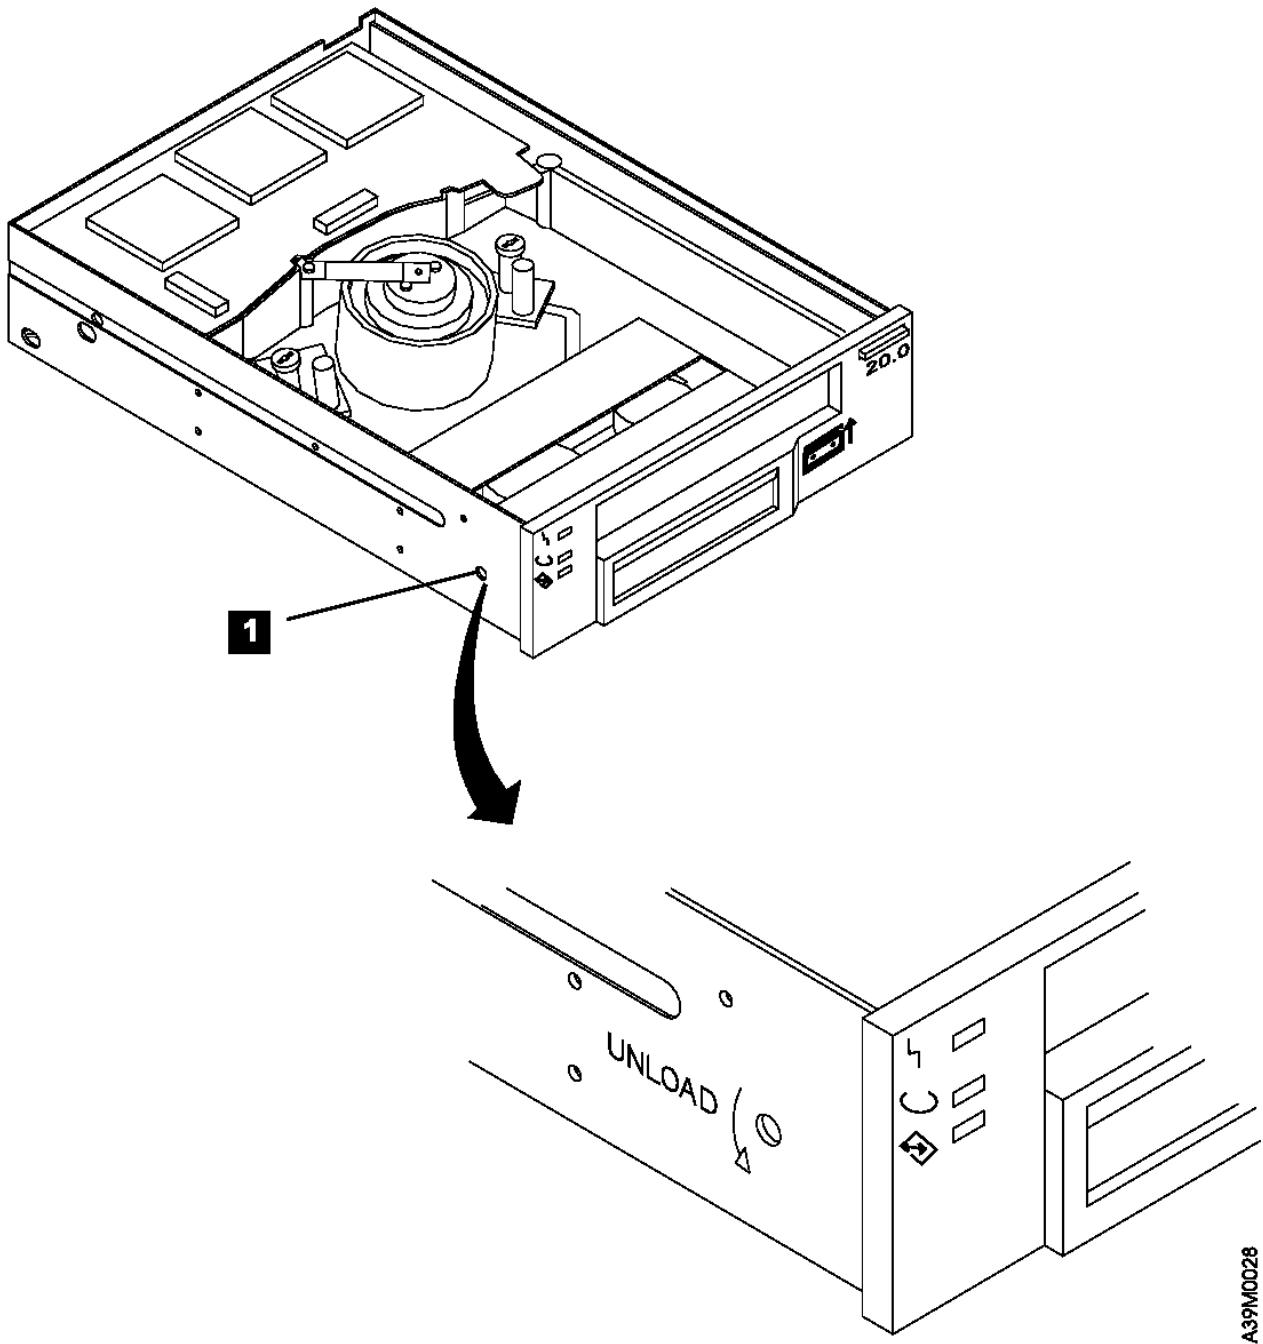
Figure 27. Unloading the Tape Cartridge

- __ 8. Ensure that the tape is fully retracted into the cartridge.
- __ 9. Unload the tape cartridge by doing the following:
 - a. At the left front of the drive, insert a 2.5-mm L-Hex wrench into the hole marked **UNLOAD** (1 in Figure 27).
 - b. Turn the wrench in the direction marked on the drive (counterclockwise) until the tape ejects.

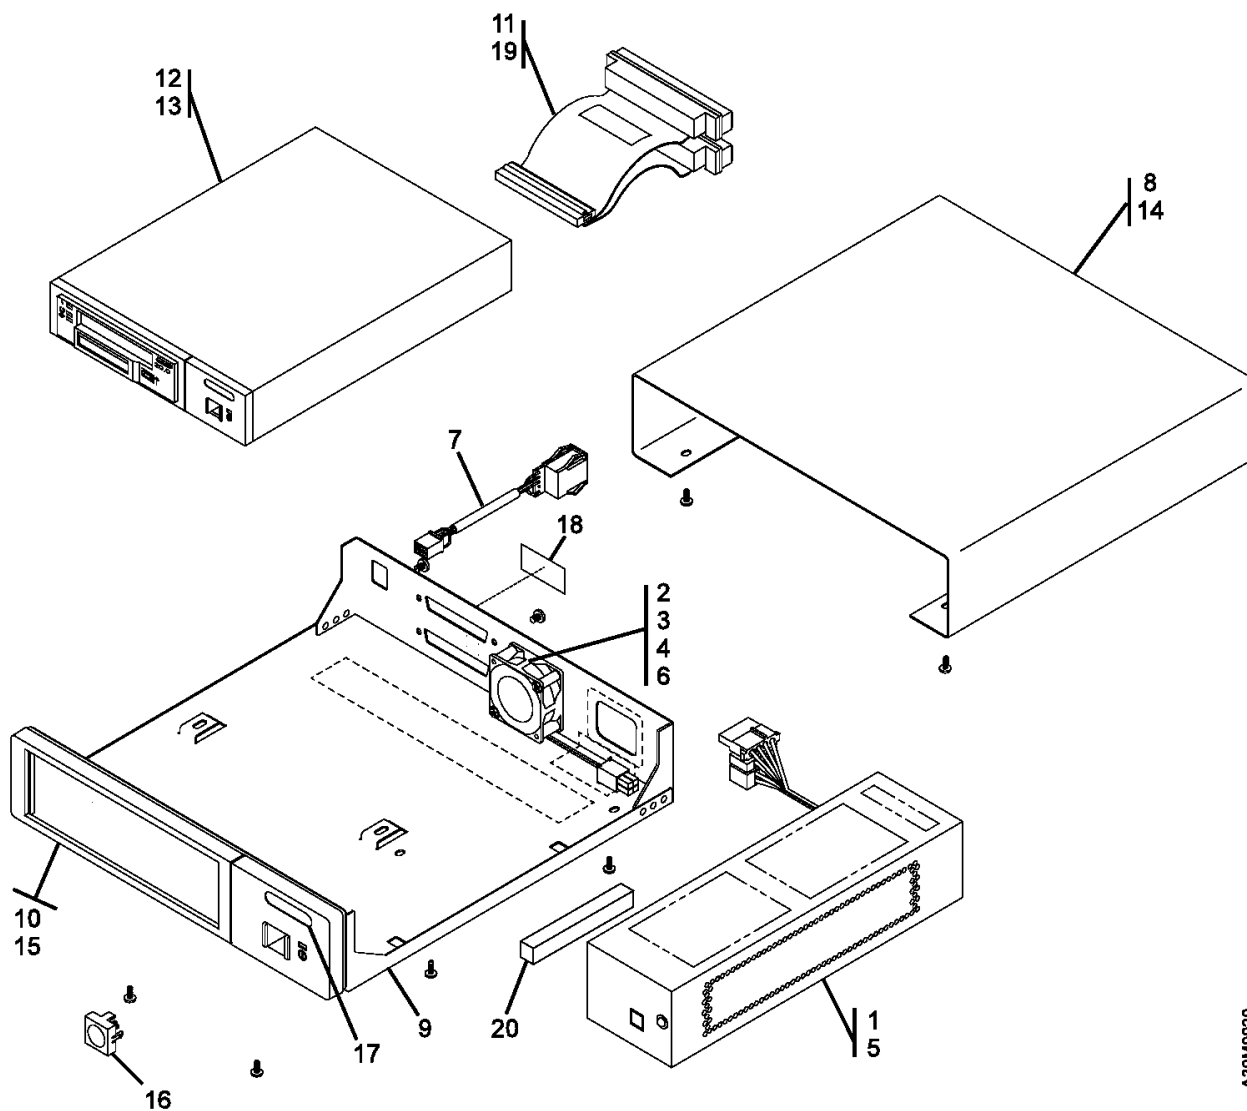
5.1.2 Assembly 1: *Parts Diagram*

Asm-Index	Part Number	Units	Description
1-1	87G1642	1	Power supply
-2	1622401	2	Nut, cooling fan, M3 hex
-3	1622344	2	Washer, cooling fan, optional P/N 0338169
-4	42F7300	1	Cooling fan
-5	46G2677	1	Screw, power supply, M3 x 6mm
-6	46G2676	2	Screw, cooling fan, M3 x 25mm
-7	59H2694	1	Cable, SCSI address
-8	46G2677	4	Screw, cover, M3 x 6mm
-9	59H2689	1	Chassis
-10	59H2886	1	Bezel assembly
-11	59H2690	1	Cable, SCSI-2 internal
-12	59H2835	1	Drive (20GB fast/wide differential interface)
-13	46G2677	4	Screw, drive
-14	74G8500	1	Cover, includes feet
-15	1622673	2	Screw, bezel
-16	74G8497	1	Pushbutton, power supply
-17	59H2705	1	Logo
-18	74G8294	1	Label, SCSI differential
-19	74G8269	4	Screw, standoff, cable mounting
-20	71F0734	1	EMI gasket
-NS	59H2678	1	Data cartridge, 170 m (558 ft)
-NS	59H2671	1	Data cartridge, 22.5m (74 ft)
-NS	59H2677	1	Test cartridge (short length for customer engineer use)
-NS	59H2898	1	Cleaning cartridge
